ASIA **TURBOMACHINERY** & **PUMP** SYMPOSIUM
22-26 FEBRUARY 2021 | NOW VIRTUAL!

Investigation & Solution of Steam turbine Governor Valve Repetitive Failure

M DASUKI YUSOFF – PETRONAS GAS BERHAD
NIK AHMAD RIDHWAN NIK MOHD – UNIVERSITI TEKNOLOGI MALAYSIA

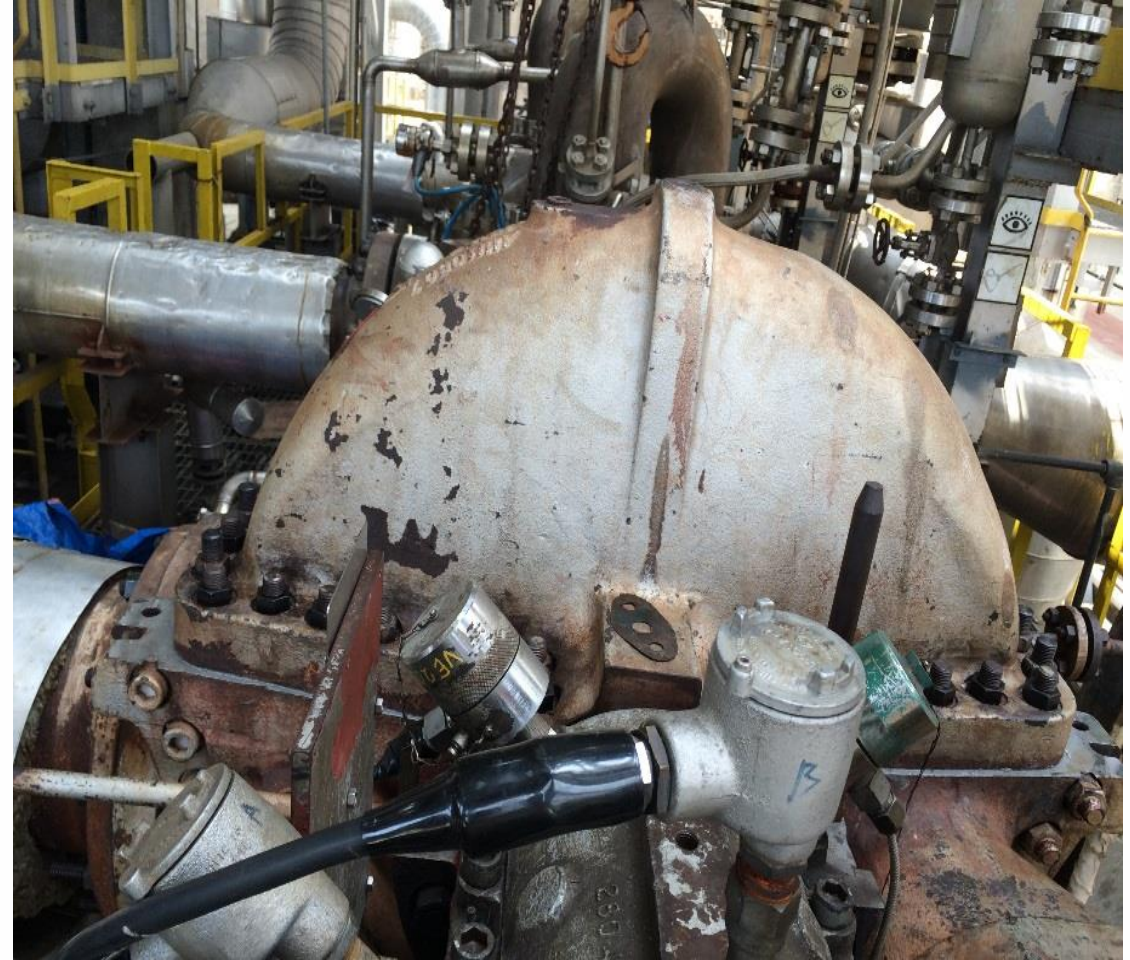
- Train consists of a 1st driver steam turbine & 2nd driver Hydraulic Power Recovery Turbine (HPRT) driving multistage BB1 pump (2 running modes for steam reduction)
- Operating speed is 4515 rpm
- Total 8 units of identical turbine experiencing repetitive governor valve failure since commissioning 2001
- Average MTBF of less than 2 years
- Same failure pattern and mechanism were observed

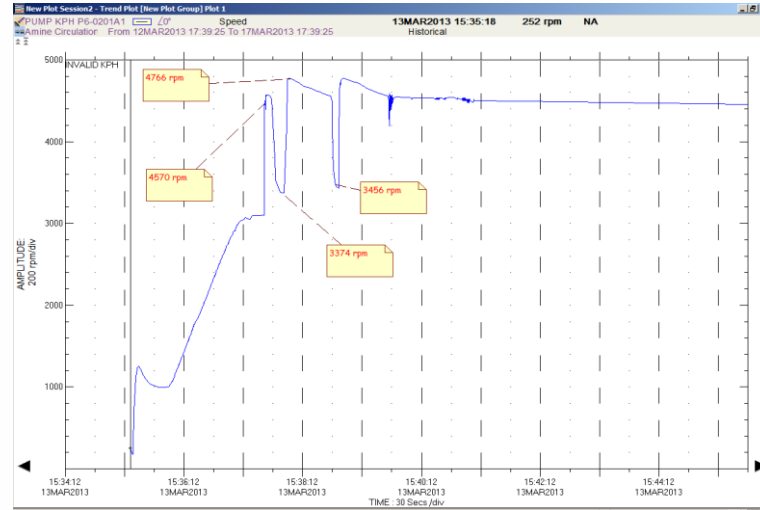
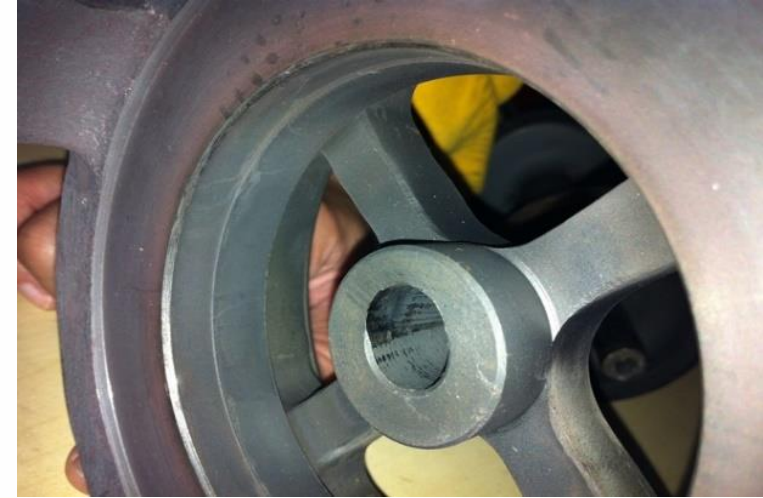
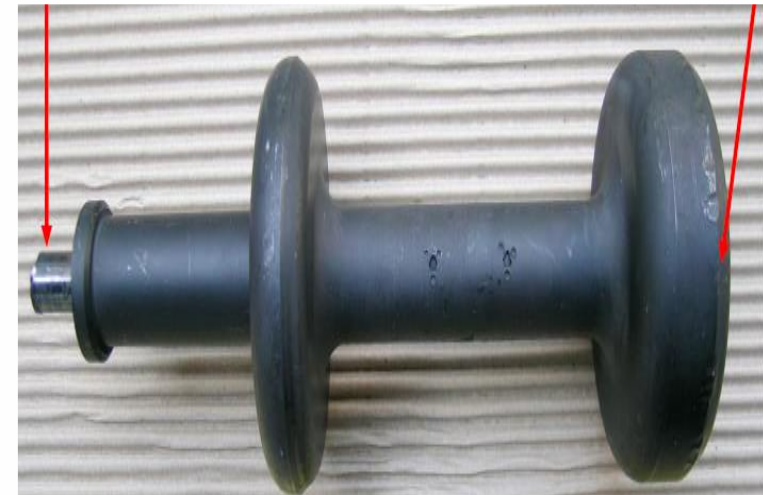
Findings : Failure Mechanism

- Steam admission unable to be regulated leading to speed fluctuation.
- Evidence of excessive radial wear on the valve cage ID bushing.
- Evidence of excessive surface wear and thinning at the valve stem surfaces lead material losses.
- Valve stem found broken either at the short end (steam chest side) or long end (actuator side) causing steam turbine to trip.

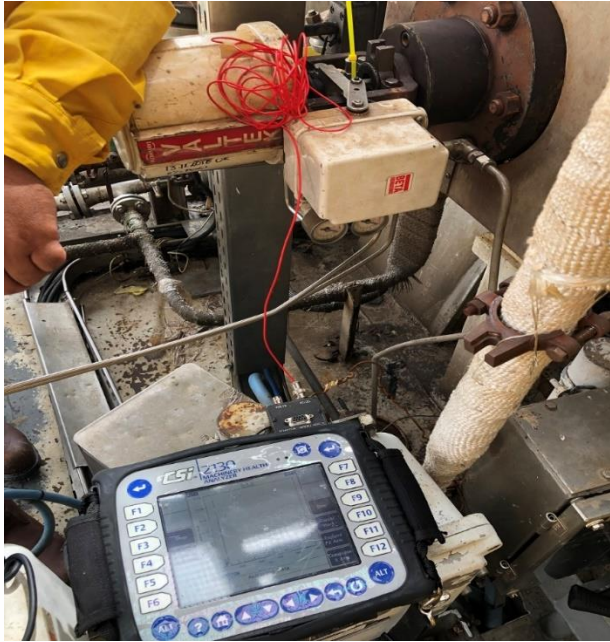
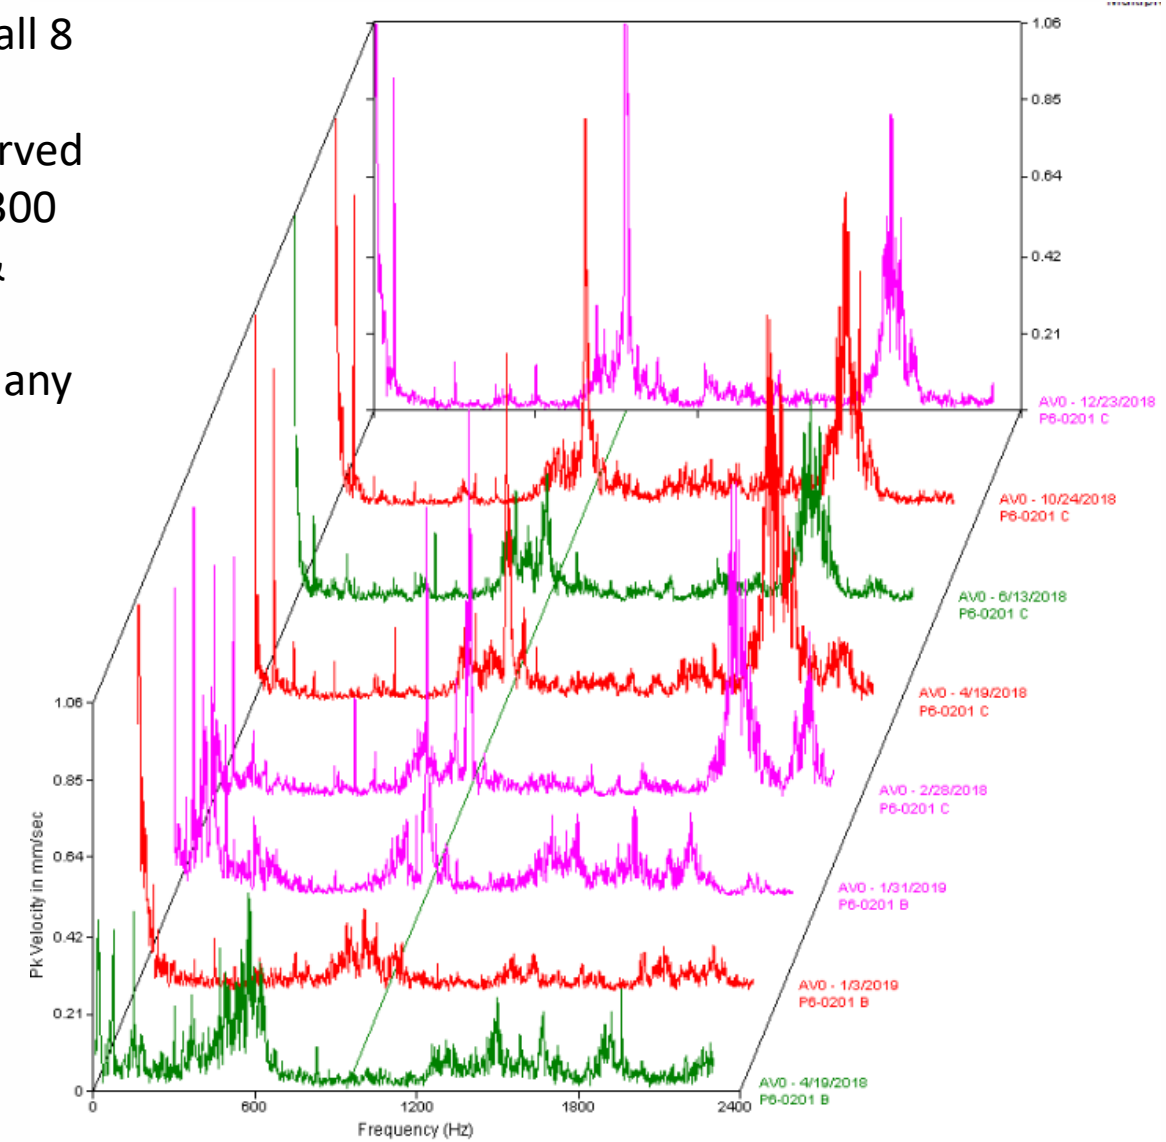
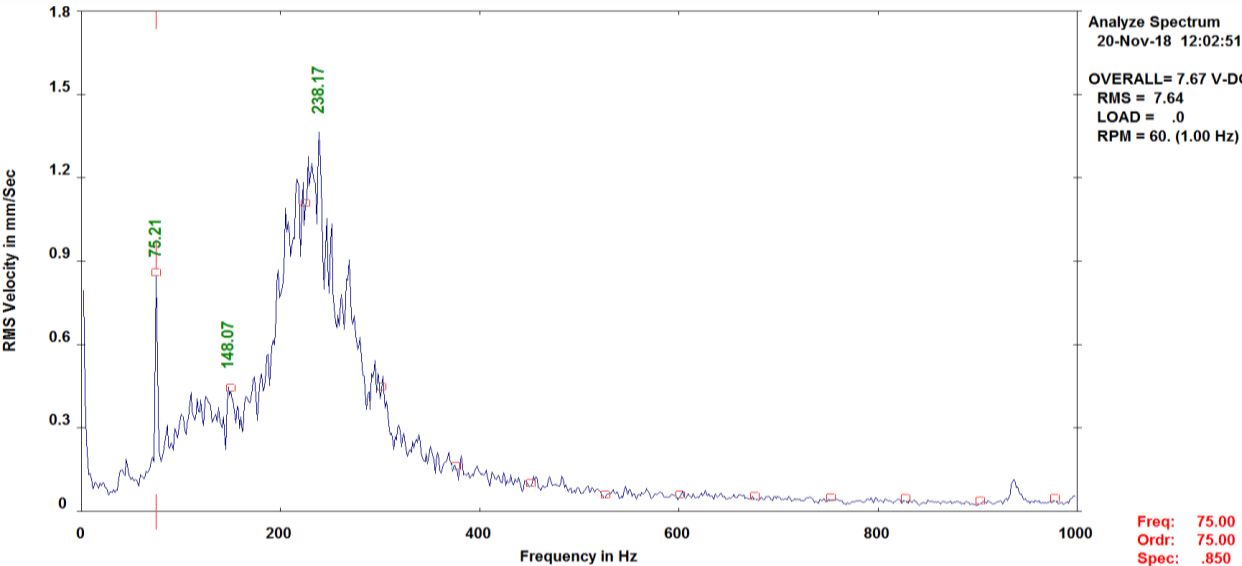
Site Vibration Gathering

- Vibration data at valve stem collected and monitored for all 8 running turbines
- Broad band high peaks observed at 3 spectrum regions : 200-300 Hz, 400-600Hz, 800-900 Hz & 1800-2000 Hz
- The peaks not coincide with any synchronous components of turbine speed

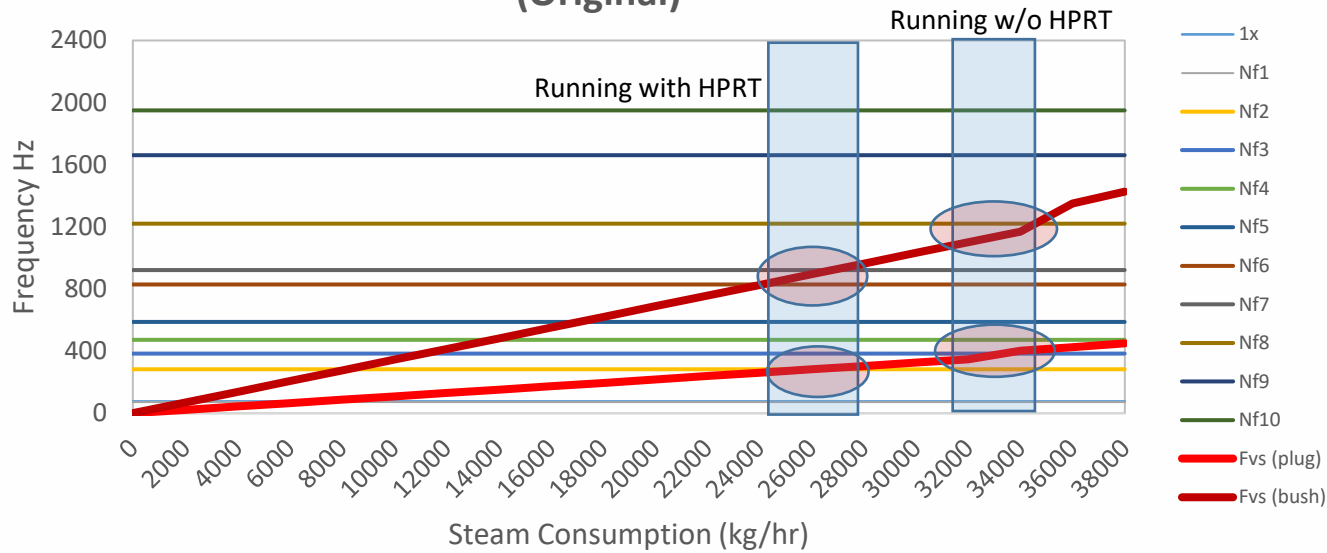
Vortex Shedding Frequency vs Stem Natural Frequency
(Original)

- Vortex shedding frequencies, F_{vs} plotted against stem natural frequencies, $Nf_{1,2,3...}$
- Structural resonance (bending mode) – close separation margin between Nf and F_{vs}
- Modification of valve stem geometry to push further the stem natural frequencies resulted from higher stiffness
- Bending modes natural frequency of modified stem separated from vortex frequencies (for all running modes)

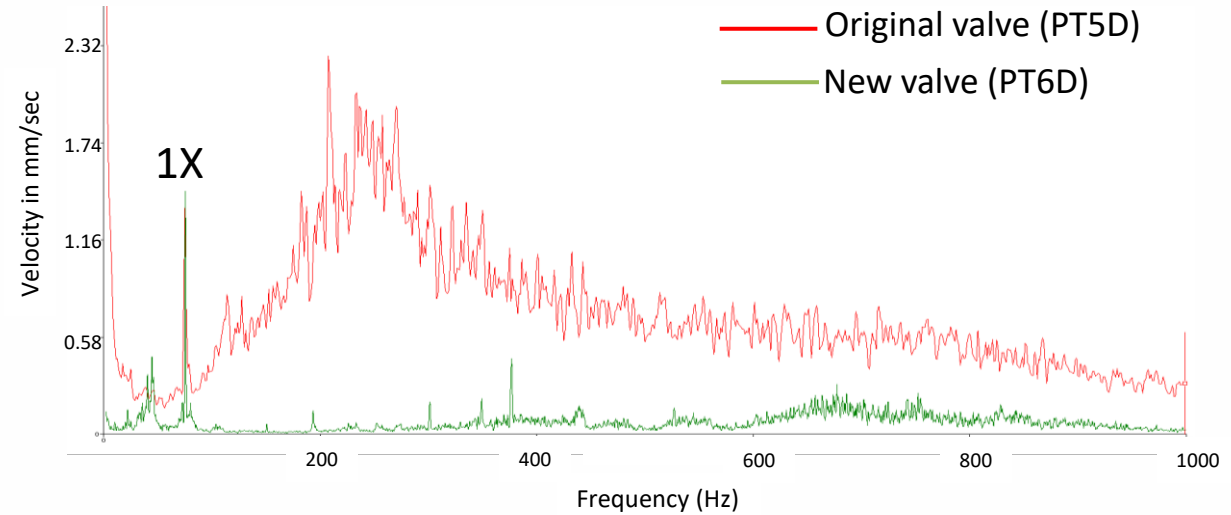
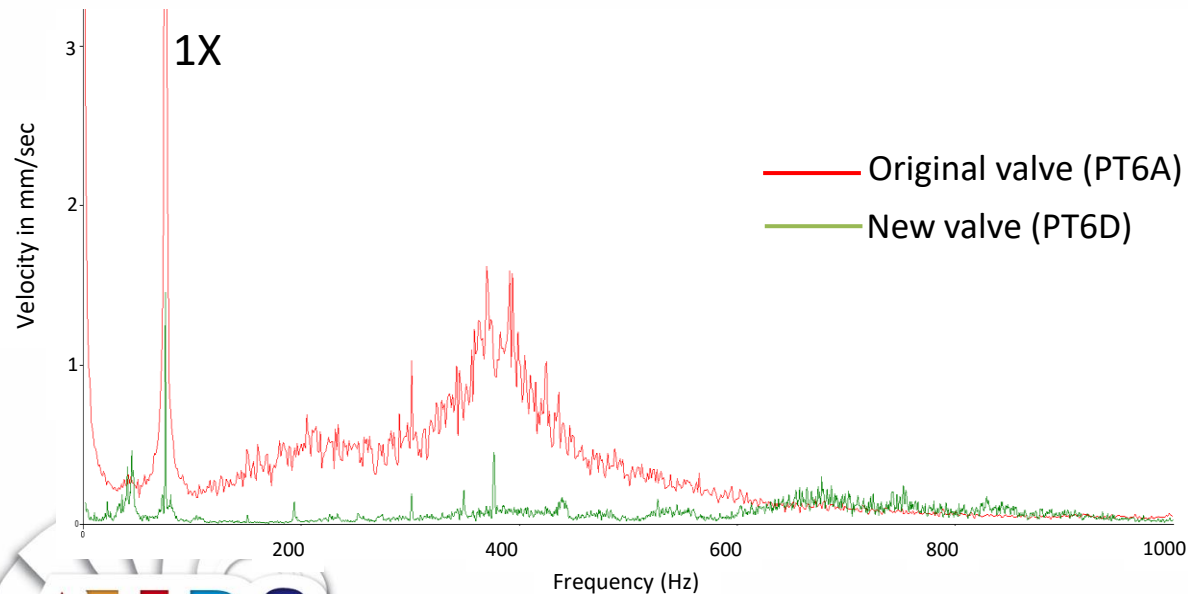
Vibration Result – Post Modification

- Previously dominant broadband peaks (between 200-800 Hz) have been eliminated
- Overall stem vibration for new valve is attenuated as compared to original valve under similar running condition

- Improved geometry of governor valve was installed in 2019 and no broken stem was recorded
- First bending mode of stem natural frequency shift to 754 Hz which is giving more comfort separation margin ($> 25\%$) from calculated vortex shedding frequencies for all running conditions
- Dominant peaks (broadband) have been eliminated with new governor valve stem

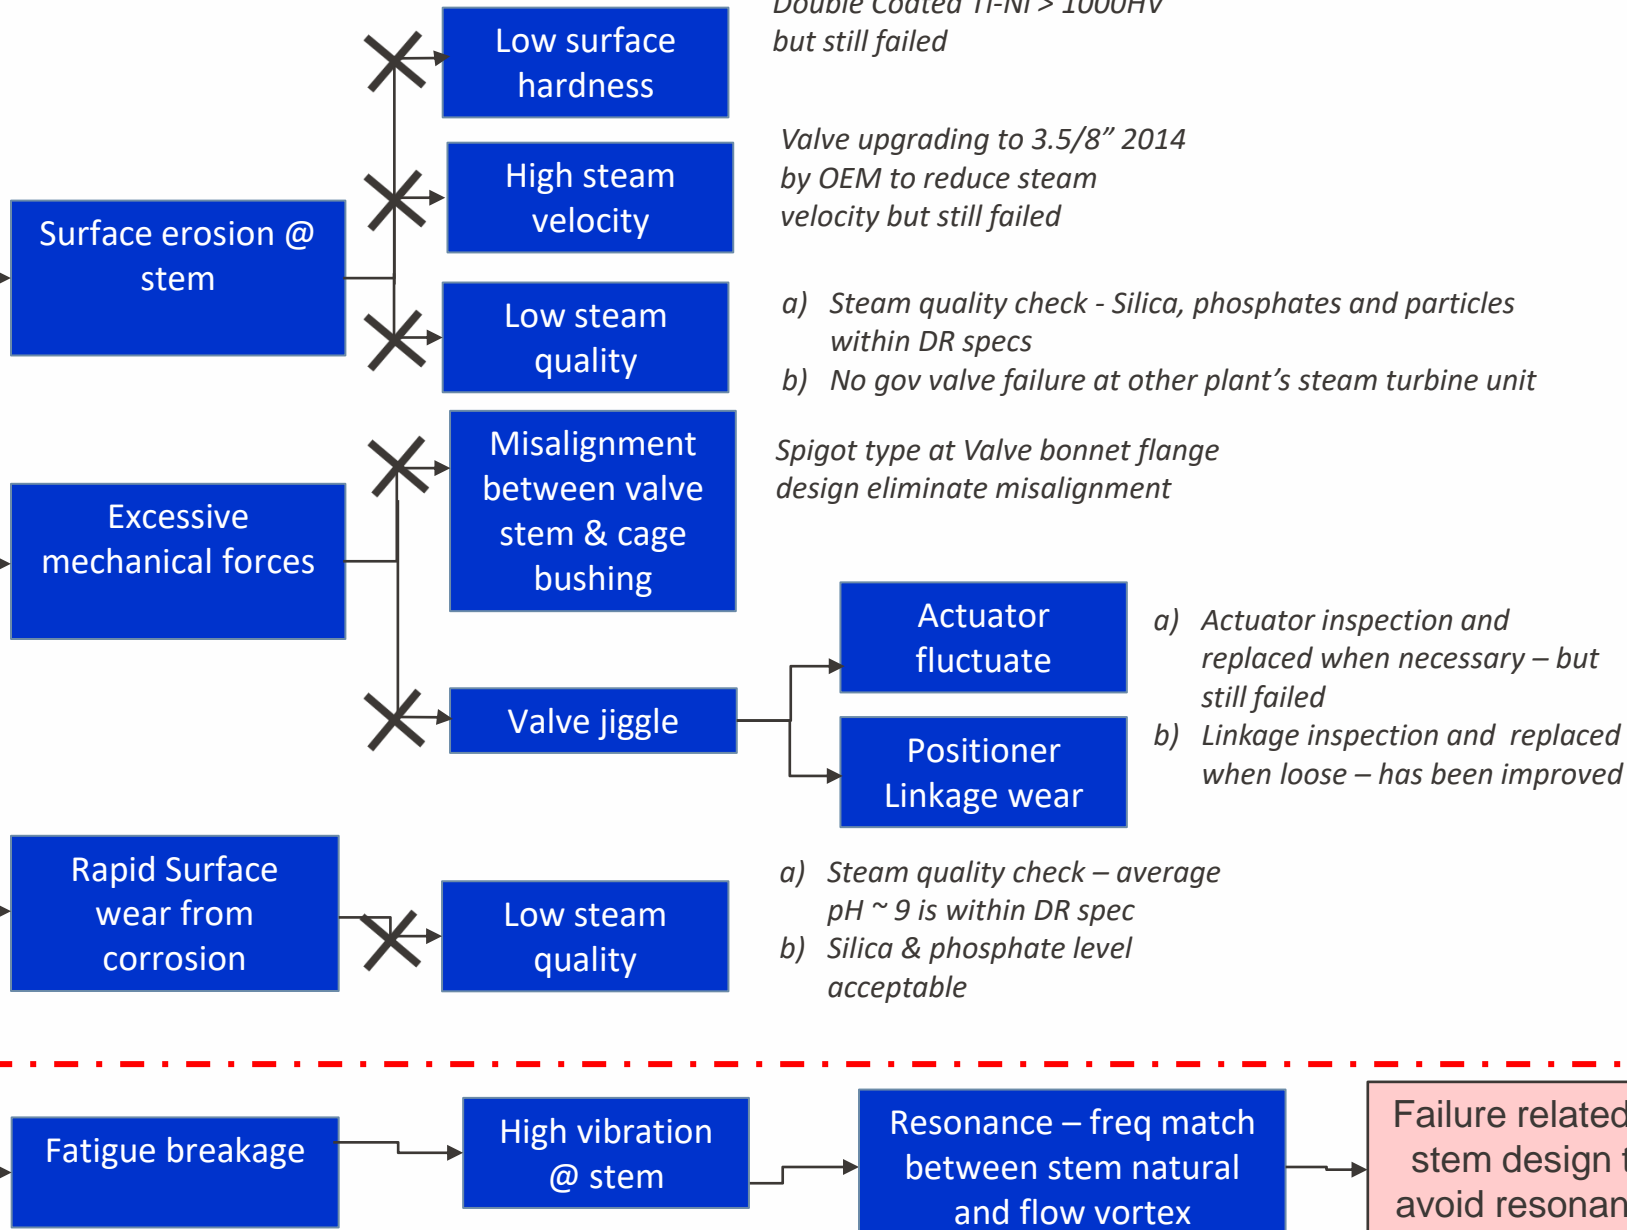
RCA Tree

Frequent Steam Turbine Governor Valve Stem Breakage
