ASIA **TURBOMACHINERY & PUMP** SYMPOSIUM

## SOLVING CENTRIFUGAL PUMP INSTALLATION AND HIGH VIBRATION ISSUE DUE TO IMPELLER DIAMETER UPGRADE (CASE STUDY)

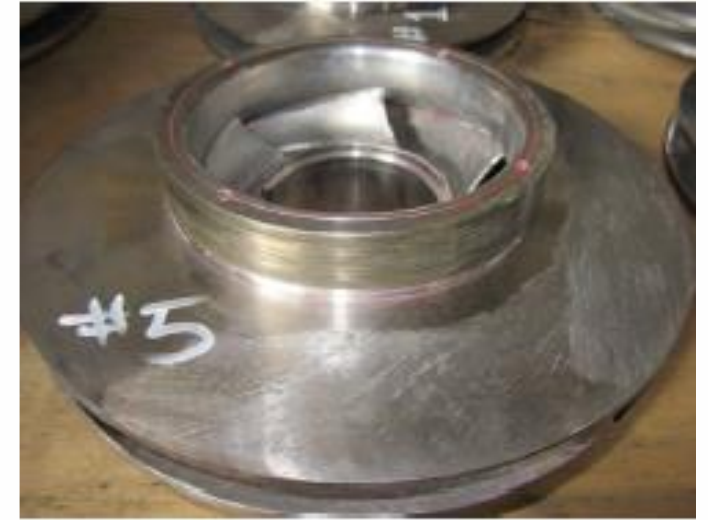
Sample of Impeller wear ring

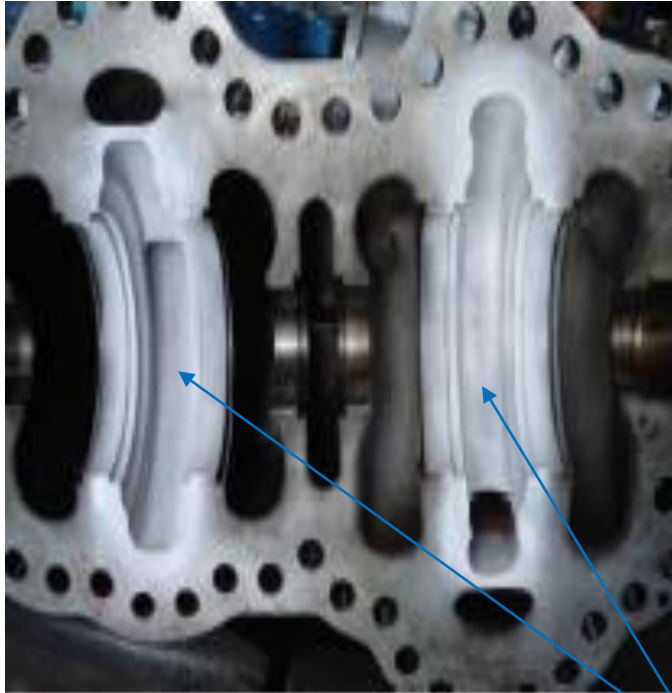
- During the installation of the new rotor, it could not fit into the casing as the volute size is smaller than the impeller diameter. The volute size is just about 2.61% higher than the original impeller size – about 357.1 mm .
- As remedial action, the volute diameter size is bored further to obtained the inside diameter of clearance 3.4% than the original impeller size ( 0.3% of the new impeller size ) – about 360.6 mm.

- Action taken to increase further the volute diameter gap size to about 3% of the new impeller size- about 369.8 mm.

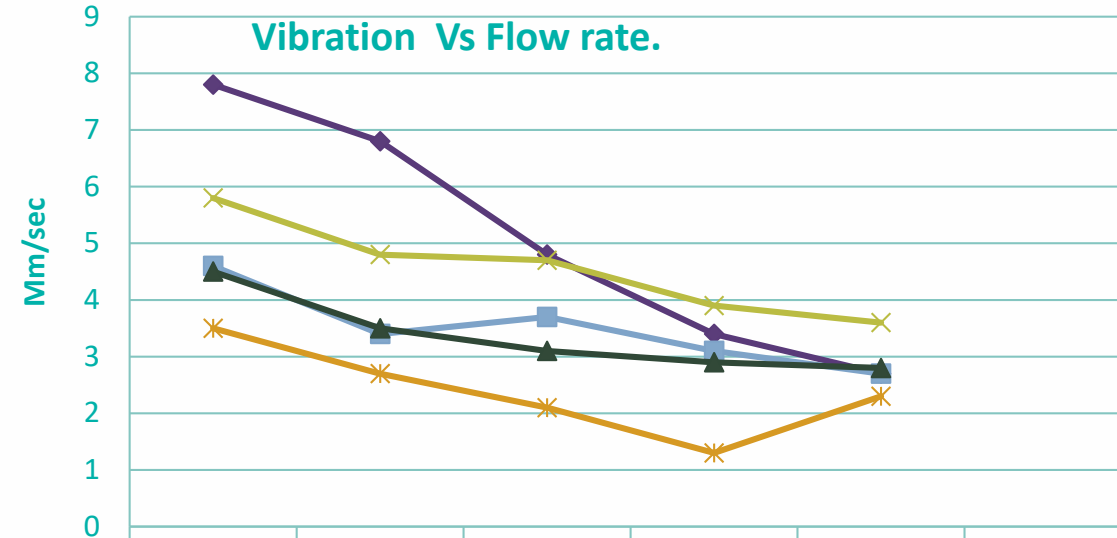
## Vibration Vs Flow rate.

◆ In board Horz.	7.8	6.8	4.8	3.4	2.7
■ In board Vert.	4.6	3.4	3.7	3.1	2.7
▲ Out board Horz.	4.5	3.5	3.1	2.9	2.8
✕ Out board Vert.	5.8	4.8	4.7	3.9	3.6
✱ Out board Axial.	3.5	2.7	2.1	1.3	2.3

Note : The value mentioned above are an approximate value

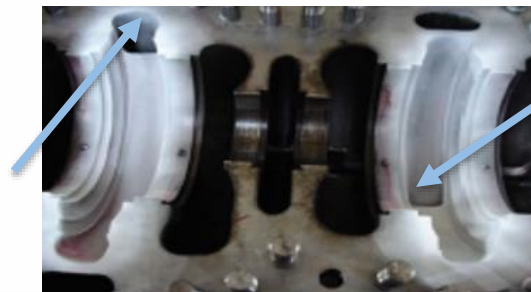
Volute start point location contributes to the Vibration at Inboard Horizontal and Outboard Vertical

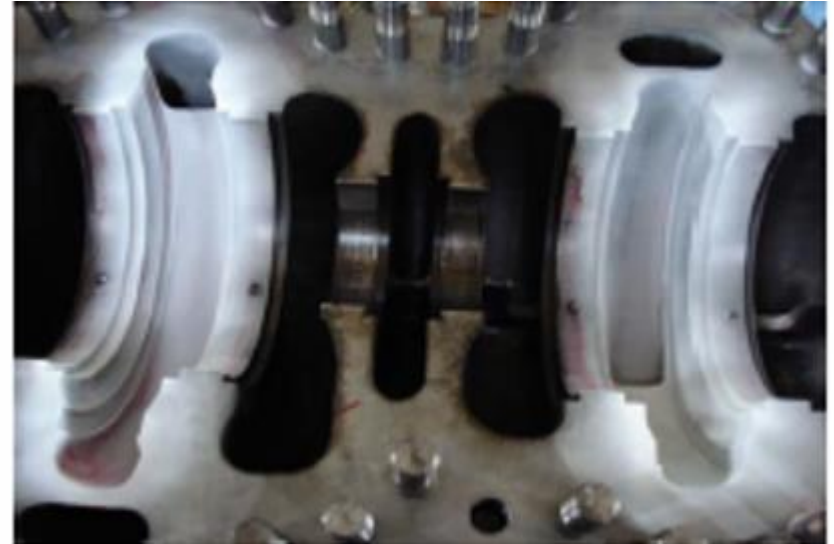
The volute was bored using boring machine and Die Penetration Tested - Result Acceptable

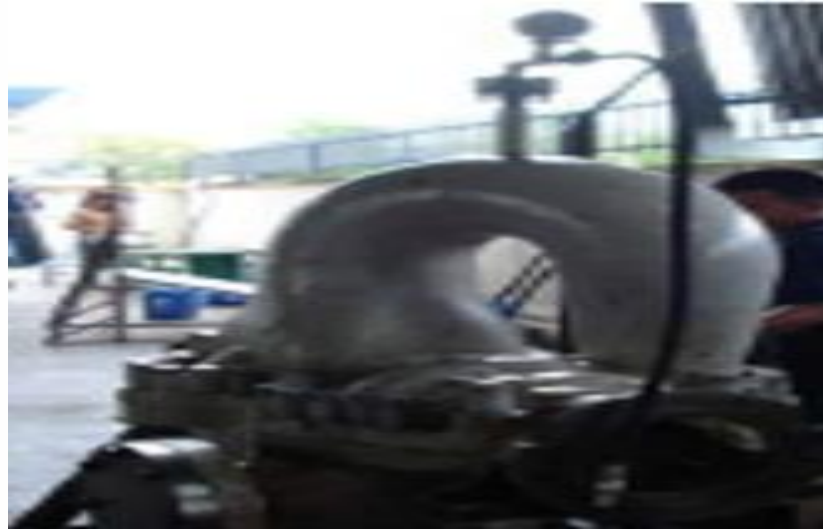
Hydrotested at 1.5 x MAWP
