BEAR CREEK: A CASE STUDY IN LOCATING HISTORIC SITE

REMAINS IN SOUTHEAST TEXAS

A Thesis

December 2004

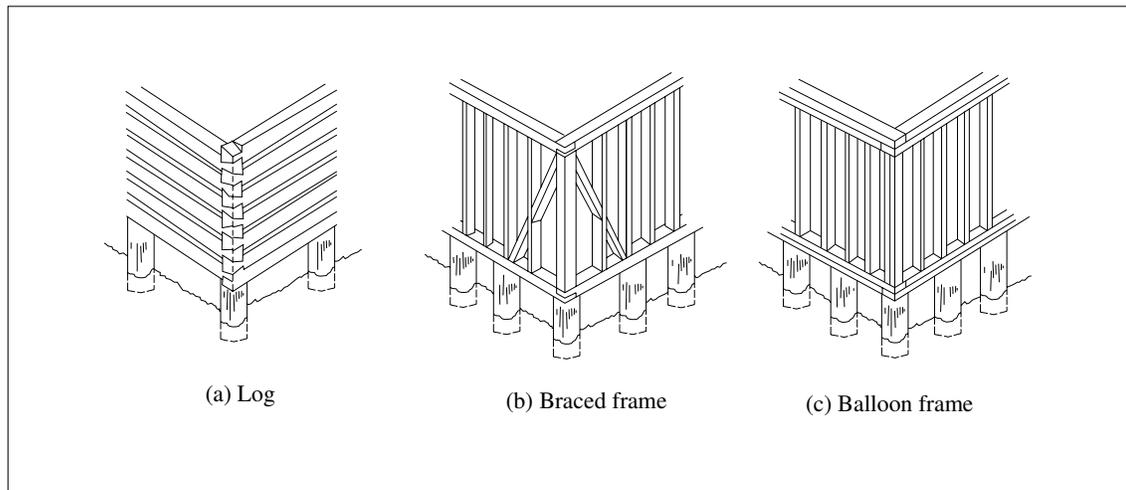
**FIGURE 3.2. Log and frame construction designs (adapted from McAlester and McAlester 1998:35).**

During the late 19th century, a building technique known as stud frame or balloon frame construction began to replace braced frame construction (Figure 3.2 c) (Jurney 1987a:9; Crosby 1977:21). Peterson states that several major factors contributed to the rise of balloon frame construction from the 1830s to the 1890s: (1) the standardization of lumber dimensions at saw mills, (2) decreased cost of machine-cut nails, (3) advances in water and overland transportation systems; and (4) the labor-saving approaches of local carpenters (Peterson 2000:3). The labor conserved via balloon framing in turn decreased construction costs. It eliminated the use of heavy beams and complex joinery that had characterized braced frame construction, instead substituting lighter 2 x 4s and 2 x 6s spaced close together and held in place by nails (Lienhard 2003). Developed in Chicago, balloon framing spread first to Midwestern states in the 1840s, then west by the 1860s, and finally east in the 1870s (Howard 1989:15).

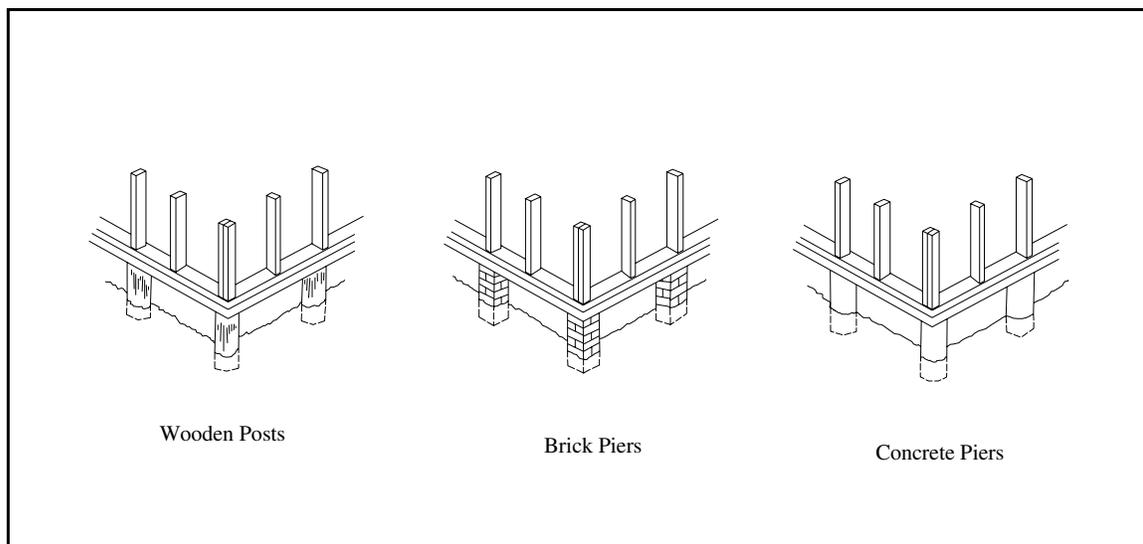
**FIGURE 3.3. Pier typology (adapted from McAlester and McAlester 1998:35).**

Due to the effects of decay, destruction, and displacement, often the only remains of a pier and beam structure are the piers themselves. It is important to note that piers, like all building materials, evolved over time (Figure 3.3). Dating the shifts in consumer choice of pier materials may prove helpful in future archaeological investigations by

providing an approximate date for a building's construction. Furthermore, an analysis of pier placement can aid in determining building dimensions and perhaps shed light on the interior layout of such structures. However, piers could be, and often were, replaced during the use-life of a structure. Therefore, dates indicated by pier materials should be compared to results of archival research.

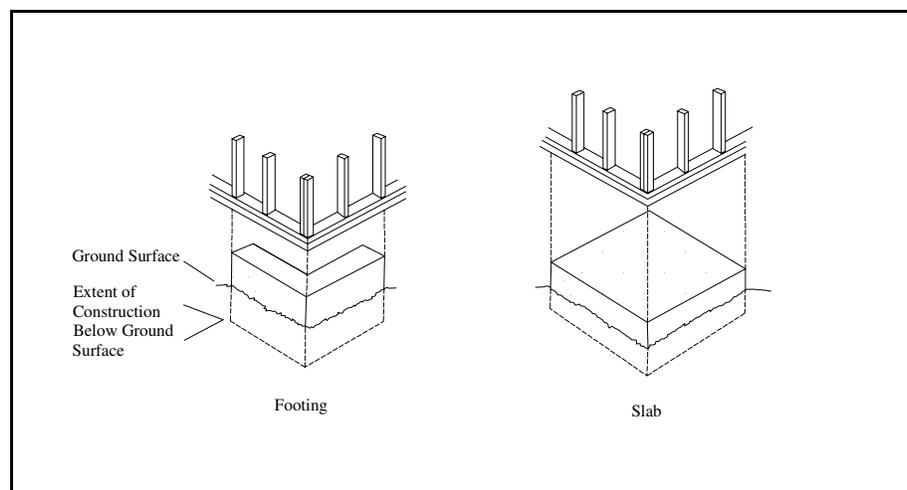
**FIGURE 3.4. Concrete foundations (adapted from McAlester and McAlester 1998:35).**

By the first half of the 20th century, home construction began to evolve beyond the traditional pier and beam structure. Concrete footings (Figure 3.4), continuous concrete walls reinforced with internal steel rods, appeared in the late 19th century and had largely replaced perimeter piers by the mid-20th century. Concrete, like brick, was favored for its weather resistance, and as such, was placed around the perimeter of a house. Despite the addition of footings, the interiors of most frame construction buildings were still supported by piers of some type. By the 1950s poured concrete slabs (Figure 3.4) eliminated the need for internal piers altogether and have since become the

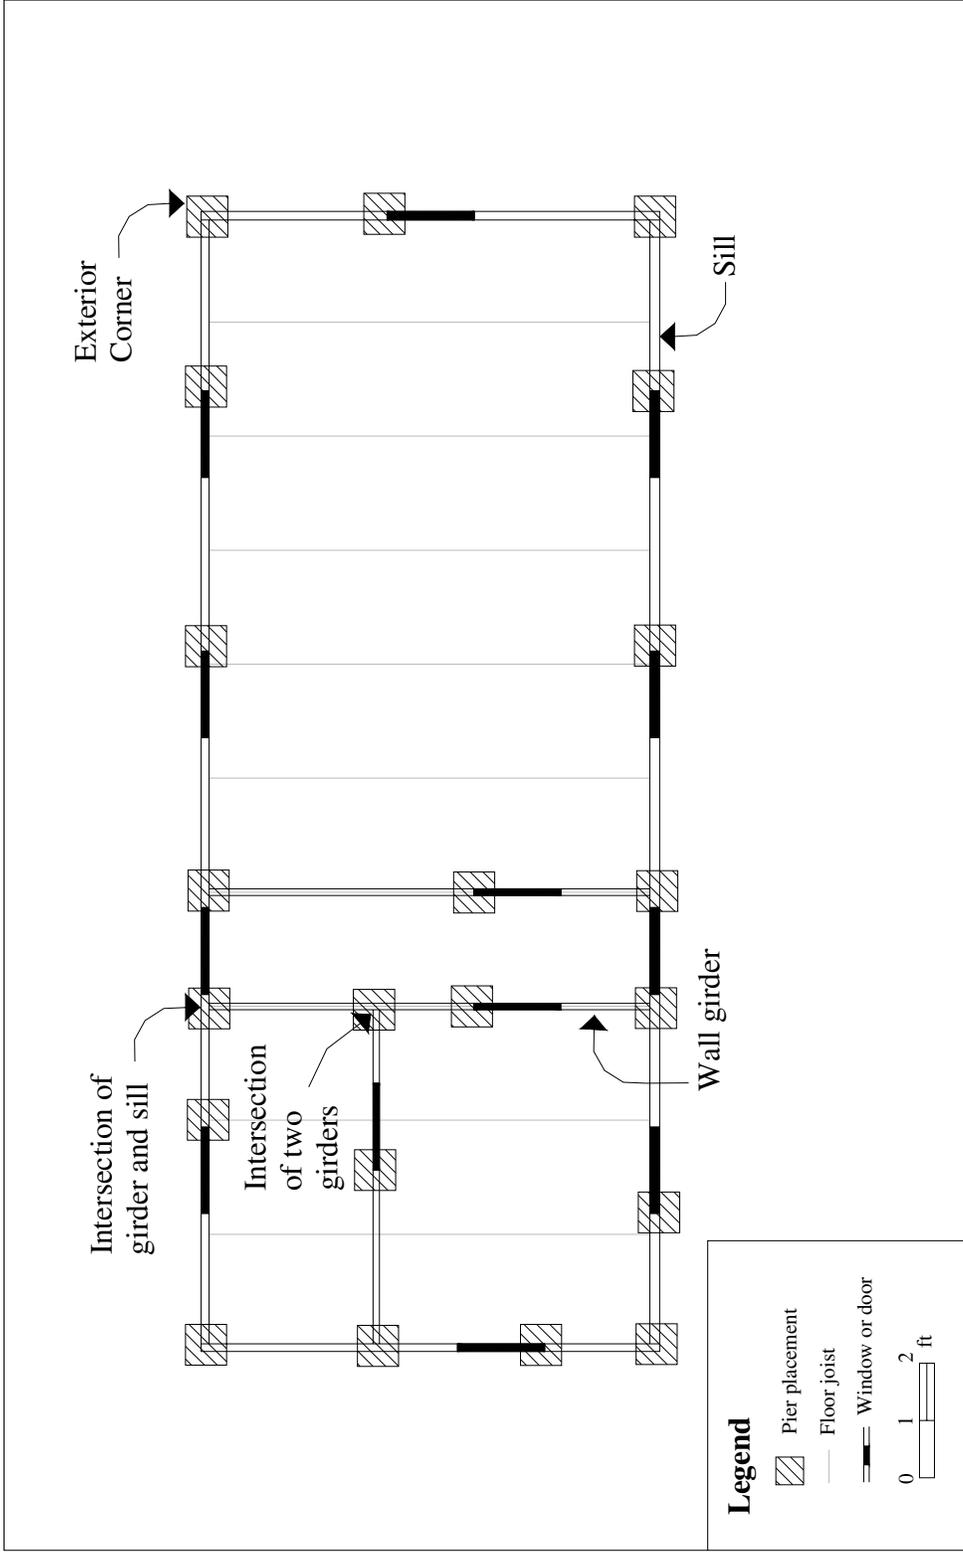
**FIGURE 3.5.** Figure illustrates common pier placements at load-bearing intervals including exterior corners, the intersections of two girders, the intersections of girders and sills, and beneath doors and windows.

Other placement locations were more discretionary. Floor joists, or sleepers, were typically spaced 24 in. on center, studs 16 in. on center (Jordan 1978:39; Sprague 1983:38). At times, a pier was placed under every other stud along an exterior wall (see Figure 3.2). Beyond these load bearing locations, piers were needed to add support to

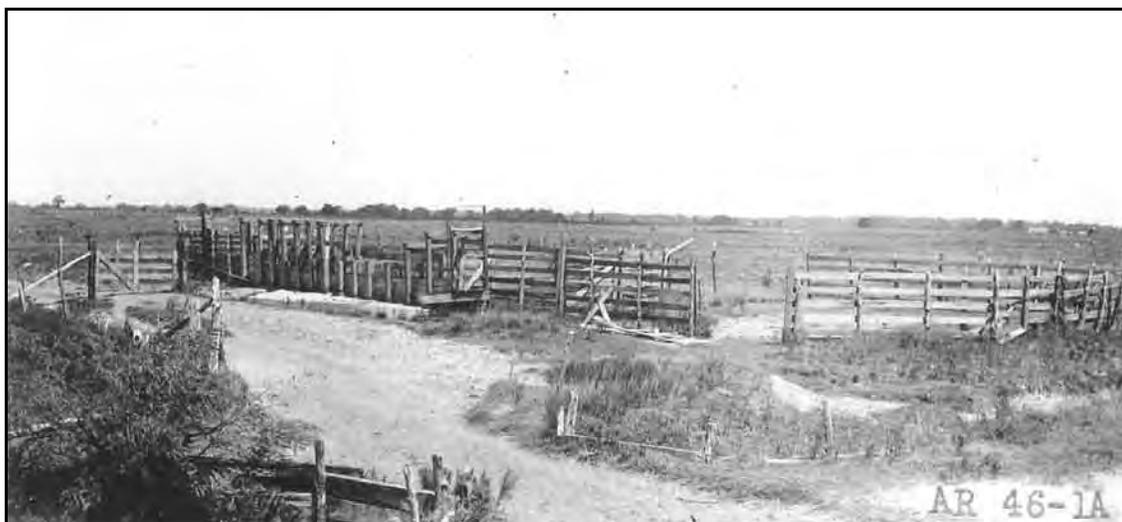
**FIGURE 4.8. Photo of the cattle dipping vat on Addicks-Satsuma Road, 1944. (Photo digitally enhanced by author; courtesy of Martha Freeman.)**

By 1922, Bear Creek cattle became the subject of a large-scale fever tick eradication program. Established by the federal government in 1906, the program required dipping cattle in an arsenic solution. Despite fervent opposition, local farmers were required to report to the local dipping vat located on Addicks-Satsuma Road every two weeks to dip their herds (Figure 4.8) (Sizemore 1991:126-127). The program successfully eradicated the fever tick within forty years and the concrete dipping vat became obsolete.

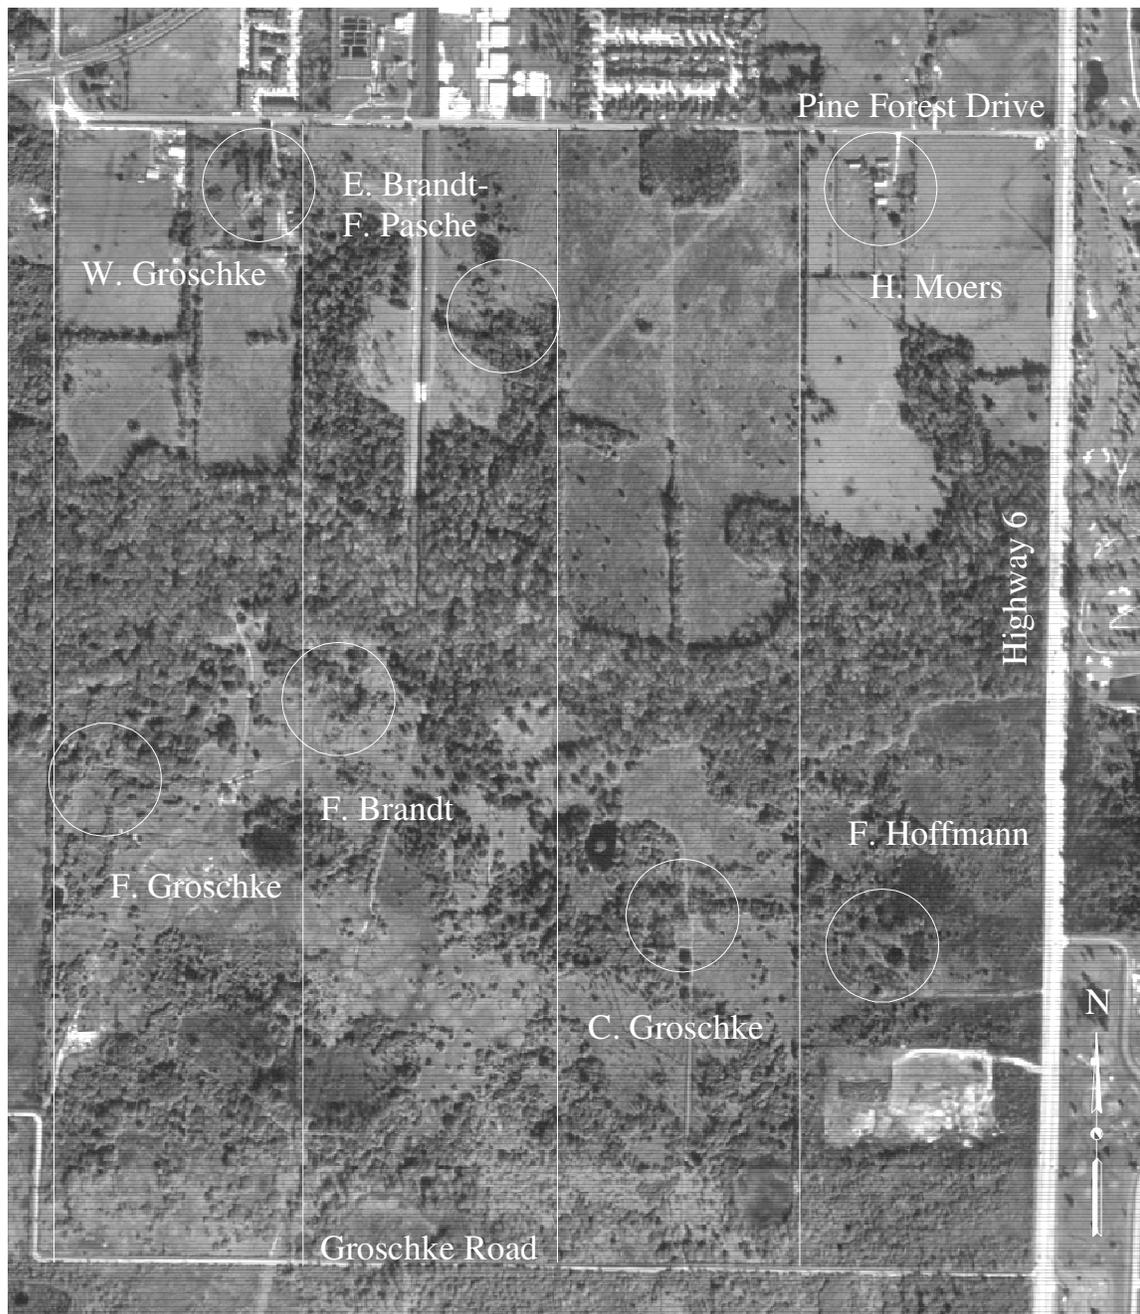
**FIGURE 5.4.** Aerial photograph of the survey area, taken 1998 (Downloaded from the Texas Natural Resources Information System (TNRIS) Website, [www.tnr.is.state.tx.us/index.htm](http://www.tnr.is.state.tx.us/index.htm)). Property boundaries have been drawn in and farmstead complexes investigated by survey are indicated with ellipses.

photograph (see Figures 5.2 and 5.3) that shows the open nature of the landscape with few visual barriers between neighbors. A contrasting image of the area showing the degree of thicketization that has occurred during the latter half of the 20th century is provided in Figure 5.4.

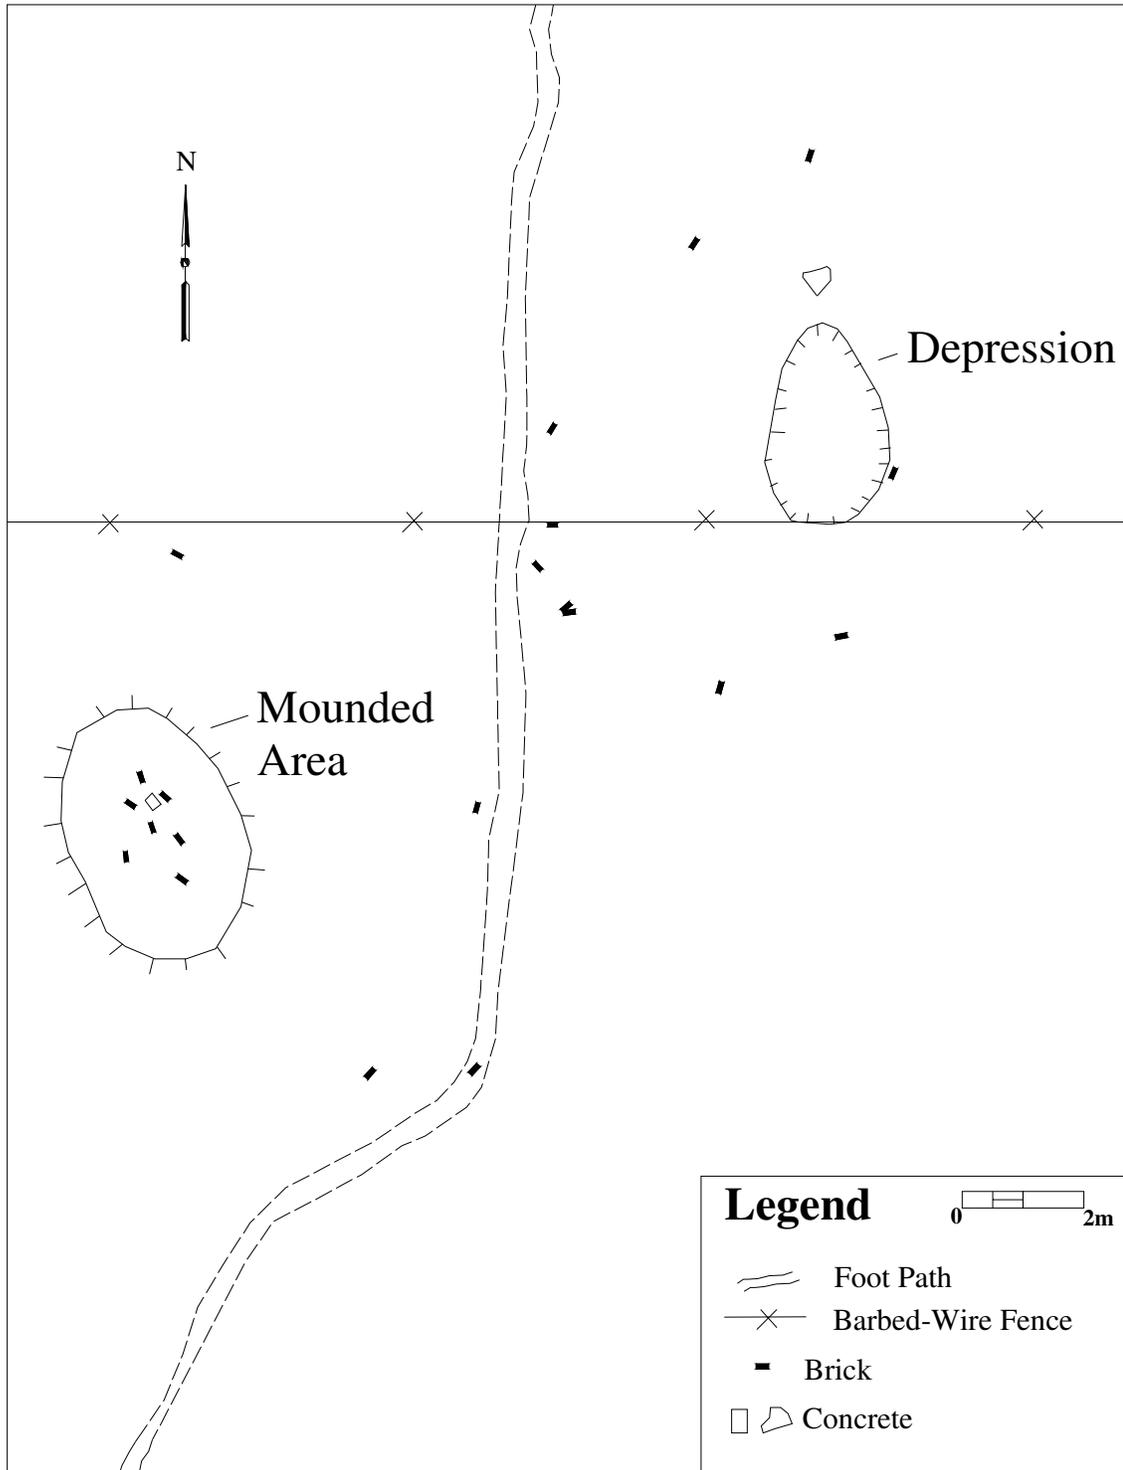
**FIGURE 5.8.** Site map of remains at the Fred Brandt farmstead.

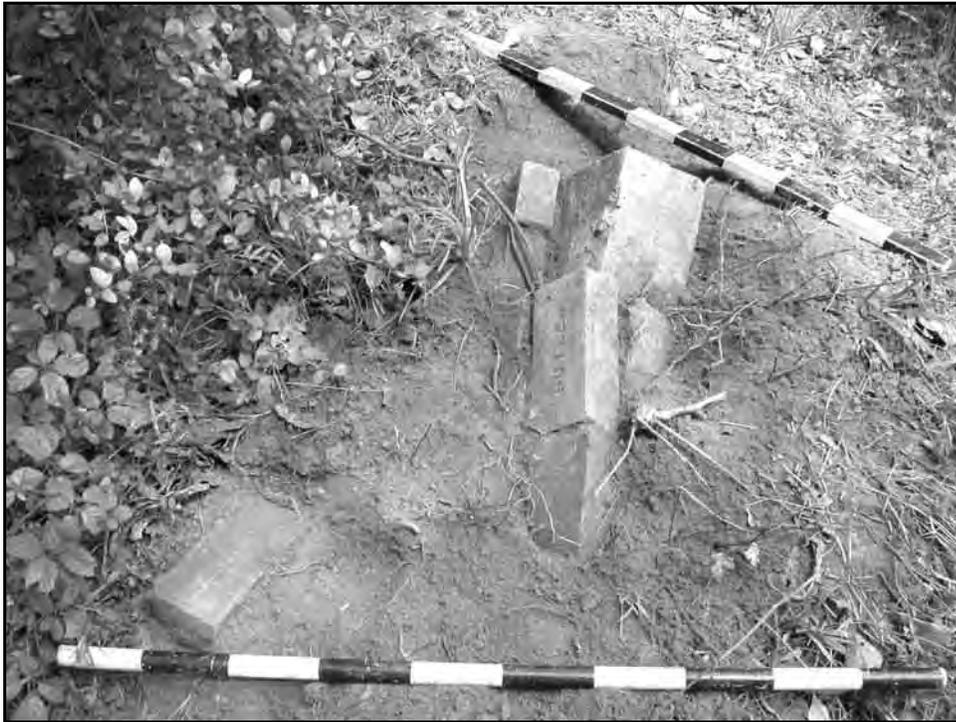
**FIGURE 5.9. Photo of the brick and concrete feature at the Frederick Brandt Site. Facing northeast. Photo taken by author on April 11, 2003.**

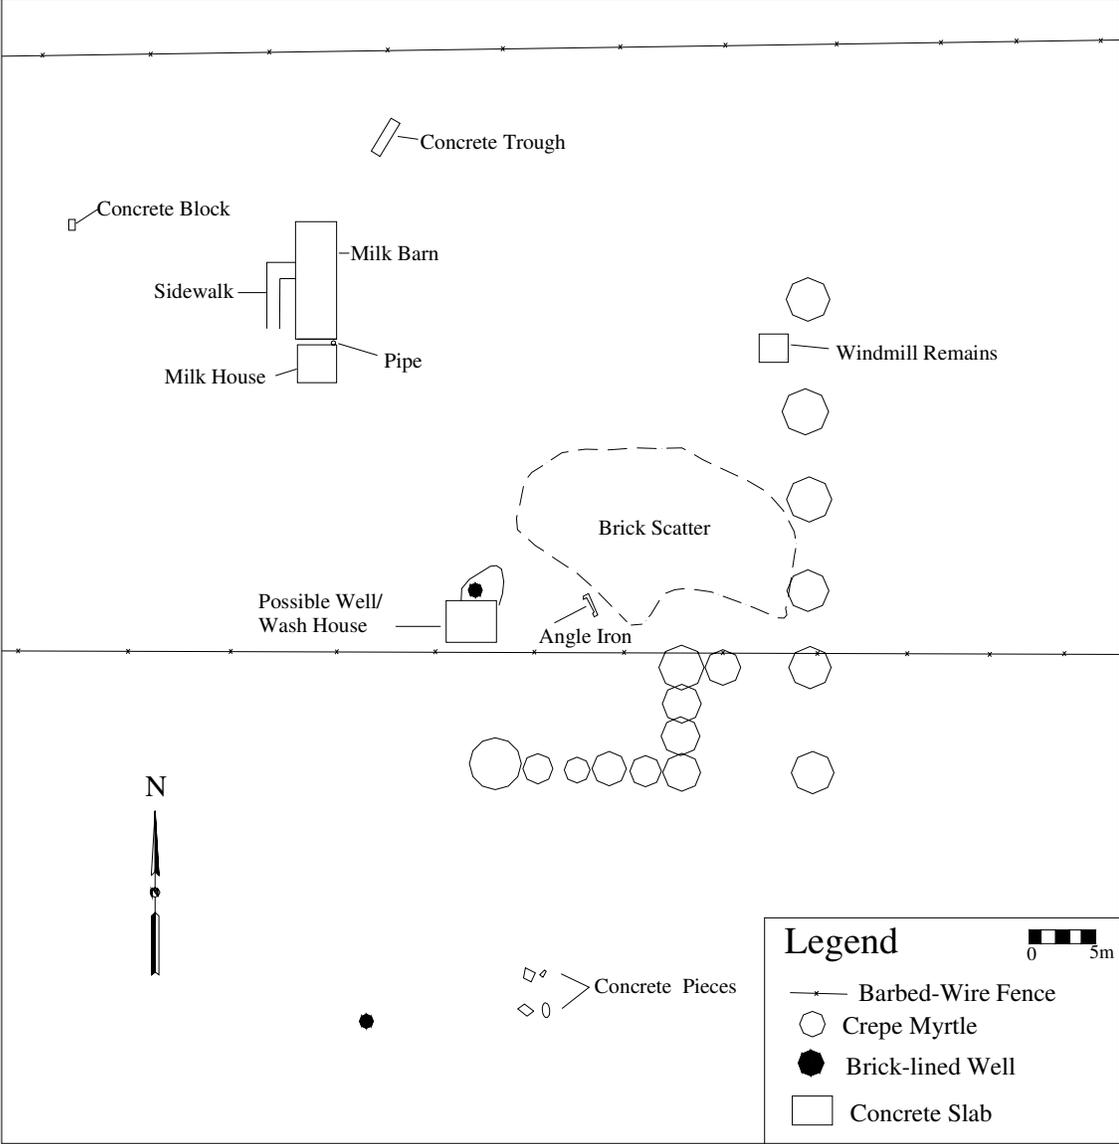
FIGURE 5.11. Site map of remains at the Brandt-Pasche farmstead.

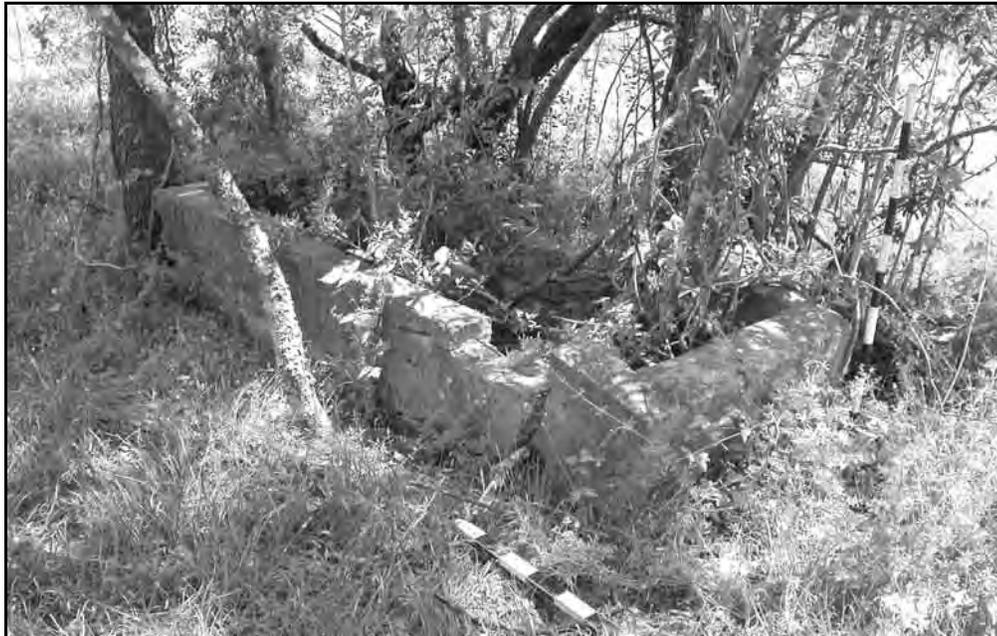
**FIGURE 5.14.** Photo of concrete trough on the Brandt-Pasche tract. Facing northeast. Photo taken by author on April 5, 2003.

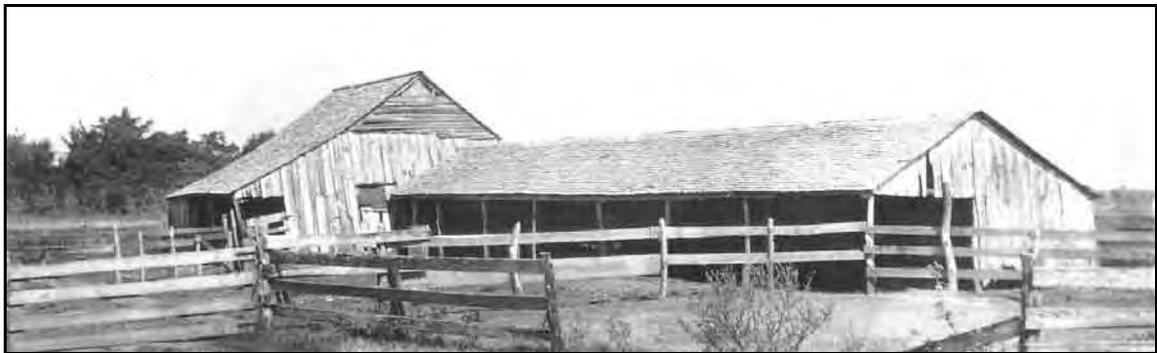
**FIGURE 5.15.** Photo of feed shed and barn enclosure at the Brandt-Pasche farmstead taken by the U. S. Army Corps of Engineers on July 26, 1946. (Courtesy of Martha Freeman.) Facing northwest.

A concrete water trough recorded during survey (Figure 5.14) was once located inside a fenced enclosure with the barn and feed shed (Figure 5.15). Concrete slabs are all that remain of the milk barn and milk house (Figures 5.16 and 5.17). The concrete block located west of the milk barn in Figure 5.11 was likely associated with the barn shown in Figure 5.18. Remains of the windmill consist of four angle irons protruding from the ground surface north of a large brick scatter (Figure 5.19). No surface remains of the wooden platform for the elevated cistern were observed. A large brick scatter marks the location of the Pasche home. At the southwest corner of this scatter was an open brick-lined well and concrete slab (Figure 5.20). The structure associated with this slab has not been identified; however, it probably served as a well/wash house. The second brick-lined well was located about 32 m to the south-southwest. A scatter of

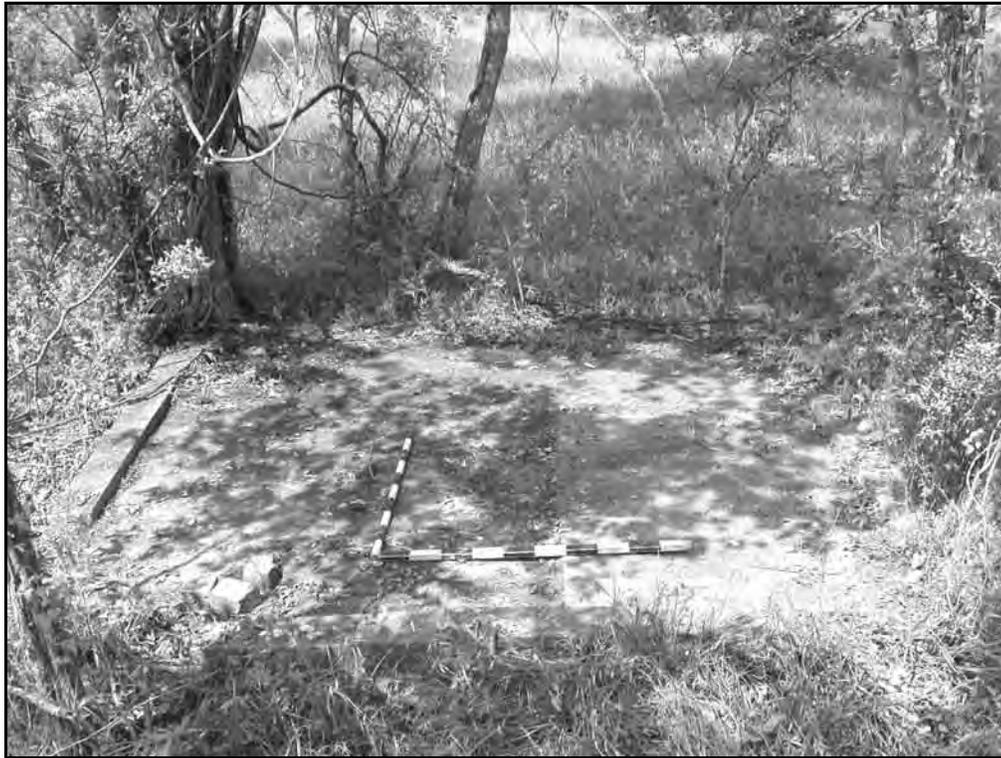
**FIGURE 5.16.** Photo of milk barn slab at the Brandt-Pasche farmstead. Facing west. Photo taken by author on April 5, 2003.

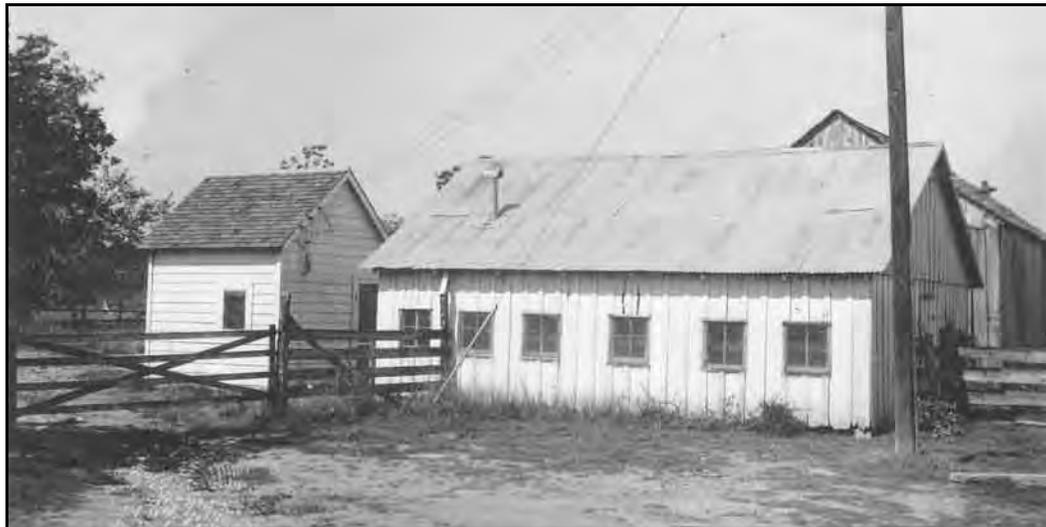
**FIGURE 5.17.** Photo of milk house and milk barn at the Brandt-Pasche farmstead taken by the U. S. Army Corps of Engineers on July 26, 1946. (Courtesy of Martha Freeman.) Facing southwest.

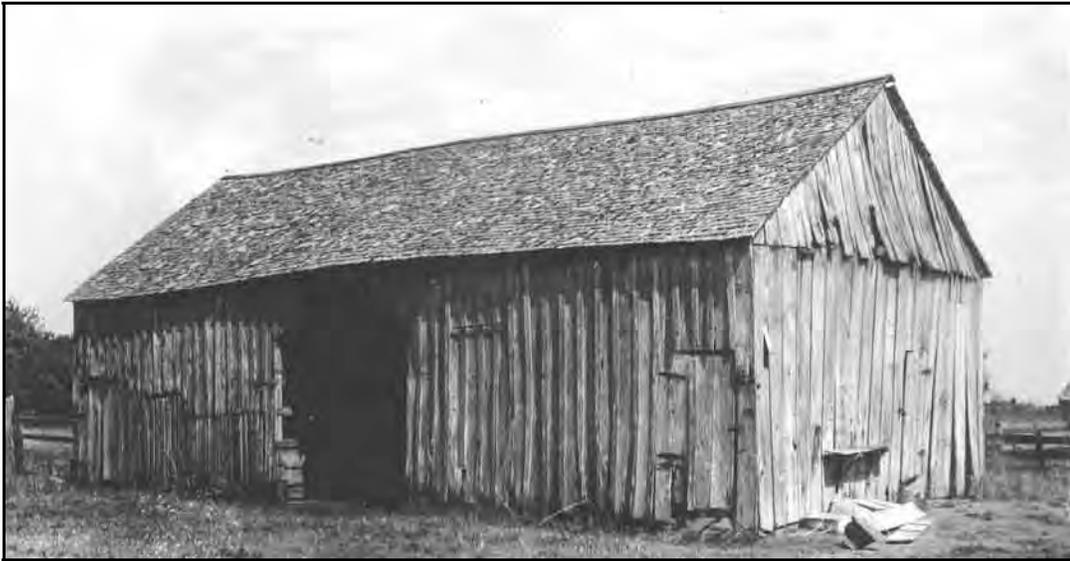
**FIGURE 5.18.** Photo of barn with loft, Brandt-Pasche farmstead taken by the U. S. Army Corps of Engineers on July 26, 1946. (Courtesy of Martha Freeman.) Facing northwest.

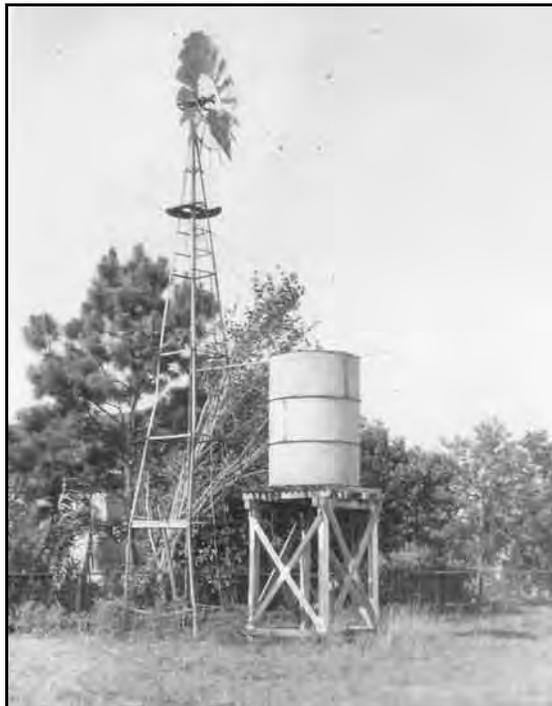
**FIGURE 5.19.** Photo of windmill and elevated cistern at the Brandt-Pasche farmstead taken by the U. S. Army Corps of Engineers on July 26, 1946. (Courtesy of Martha Freeman.) Facing southwest.

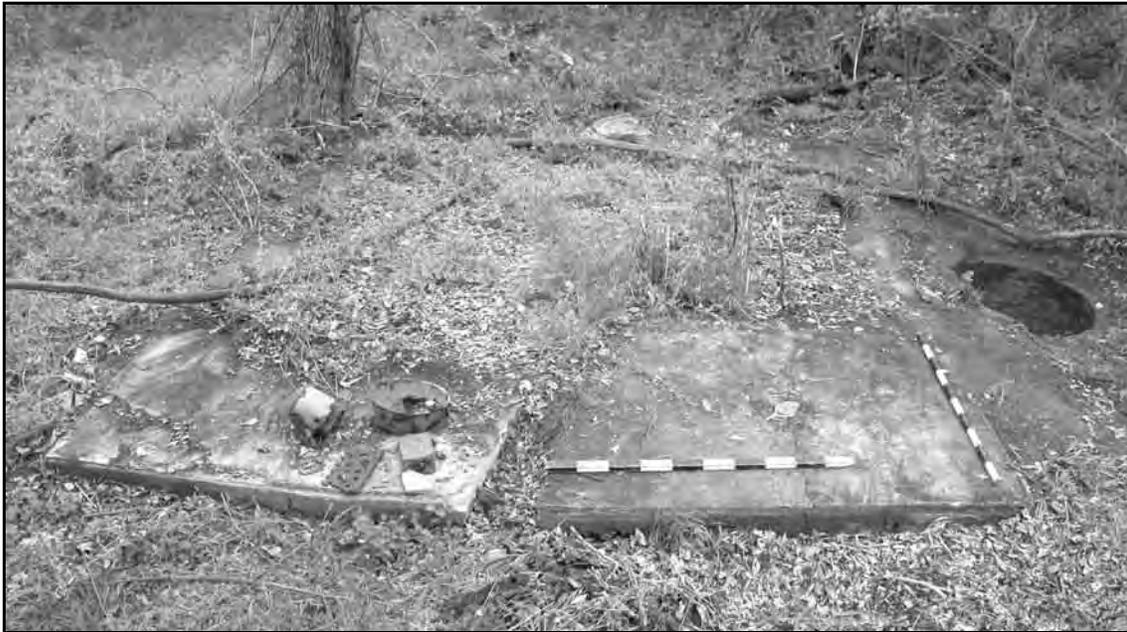
**FIGURE 5.20.** Photo of two concrete slabs and an open brick-lined well, likely the remains of a well house and wash house, Brandt-Pasche farmstead. Artifacts appearing on the left side of the frame include stoneware, enamelware and iron. Facing west. Photo taken by author on April 5, 2003.

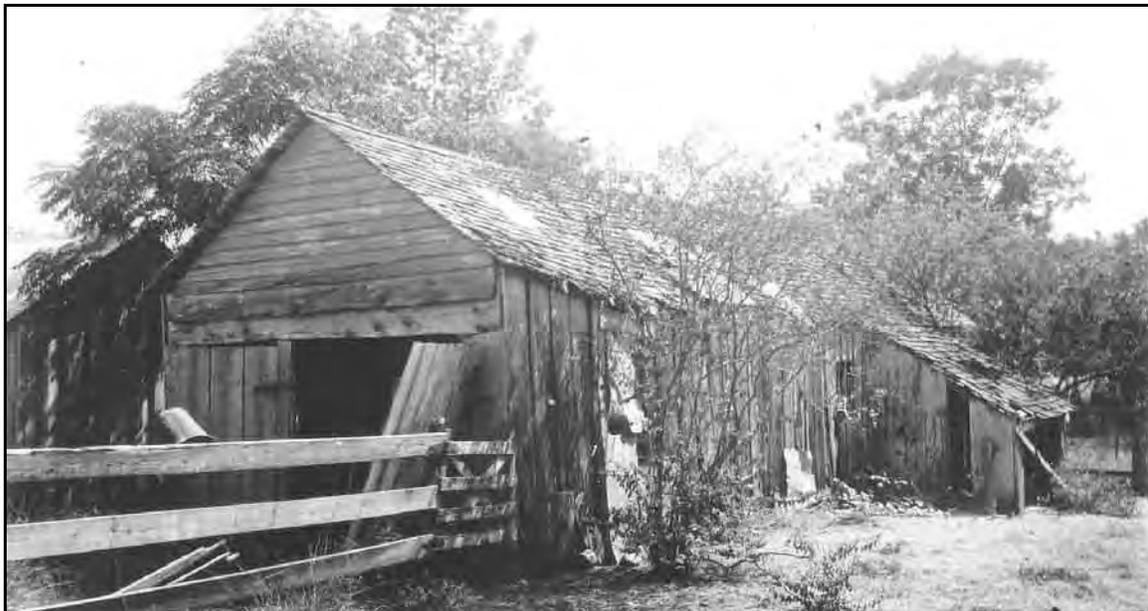
**FIGURE 5.21.** Photo of implement shed, Brandt-Pasche farmstead taken by the U. S. Army Corps of Engineers on July 26, 1946. (Courtesy of Martha Freeman.) Facing northeast.

concrete fragments east of the second well likely marks the remains of the implement shed (Figure 5.21).

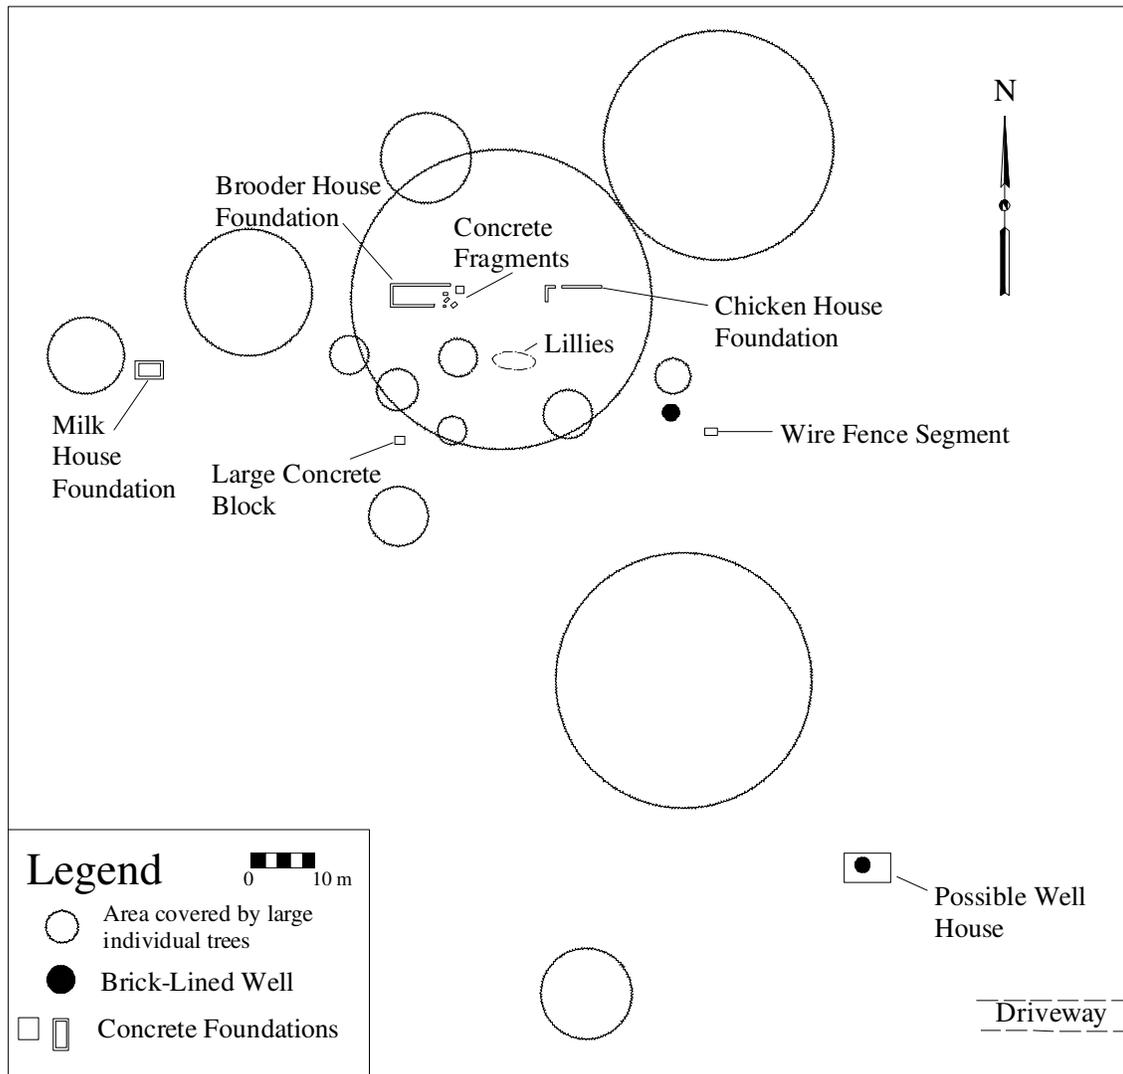
**FIGURE 5.23.** Site map of remains at the Fritz Hoffmann farmstead. Trees noted date from the period of occupation and have been verified from photographs of the farmstead from the 1930s and 40s.

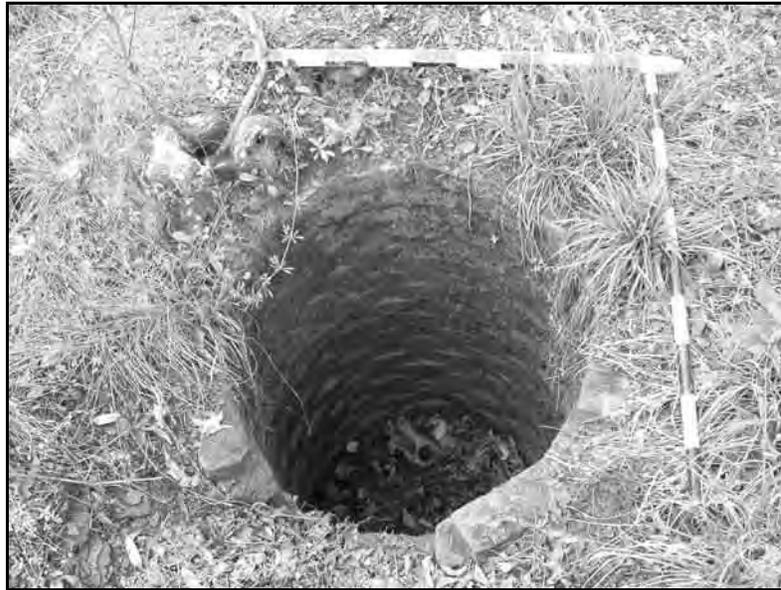
**FIGURE 5.24.** Photo of a brick-lined well near the Hoffmann home. Facing west. Photo taken by author on March 25, 2003.

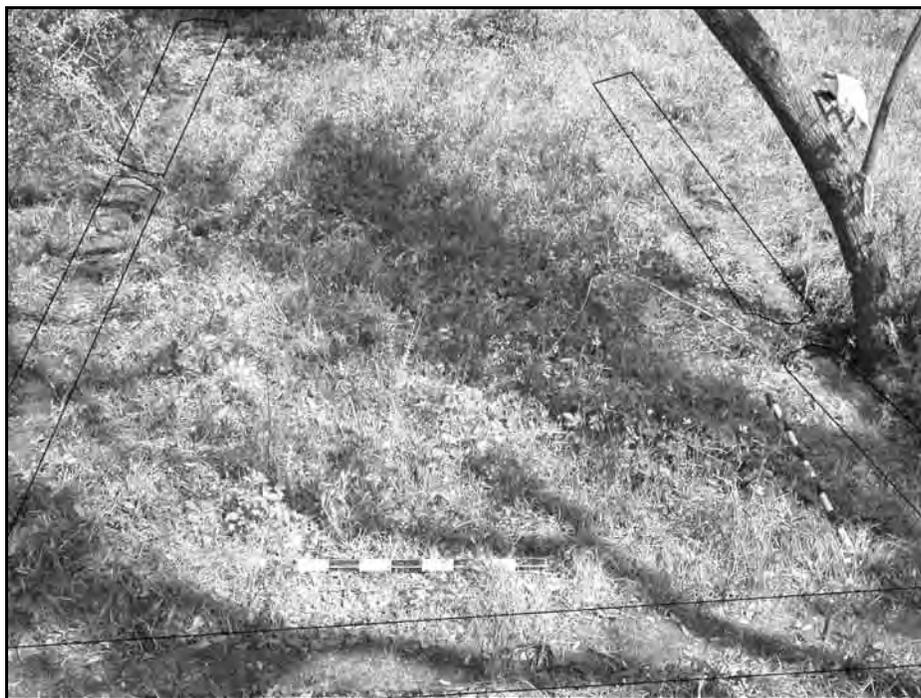
**FIGURE 5.25.** Photo of concrete footings attributed to brooder house, Hoffmann farmstead. Facing east. Photo taken by author on March 25, 2003. Lines have been added to depict footing locations otherwise obscured by soil and vegetation.

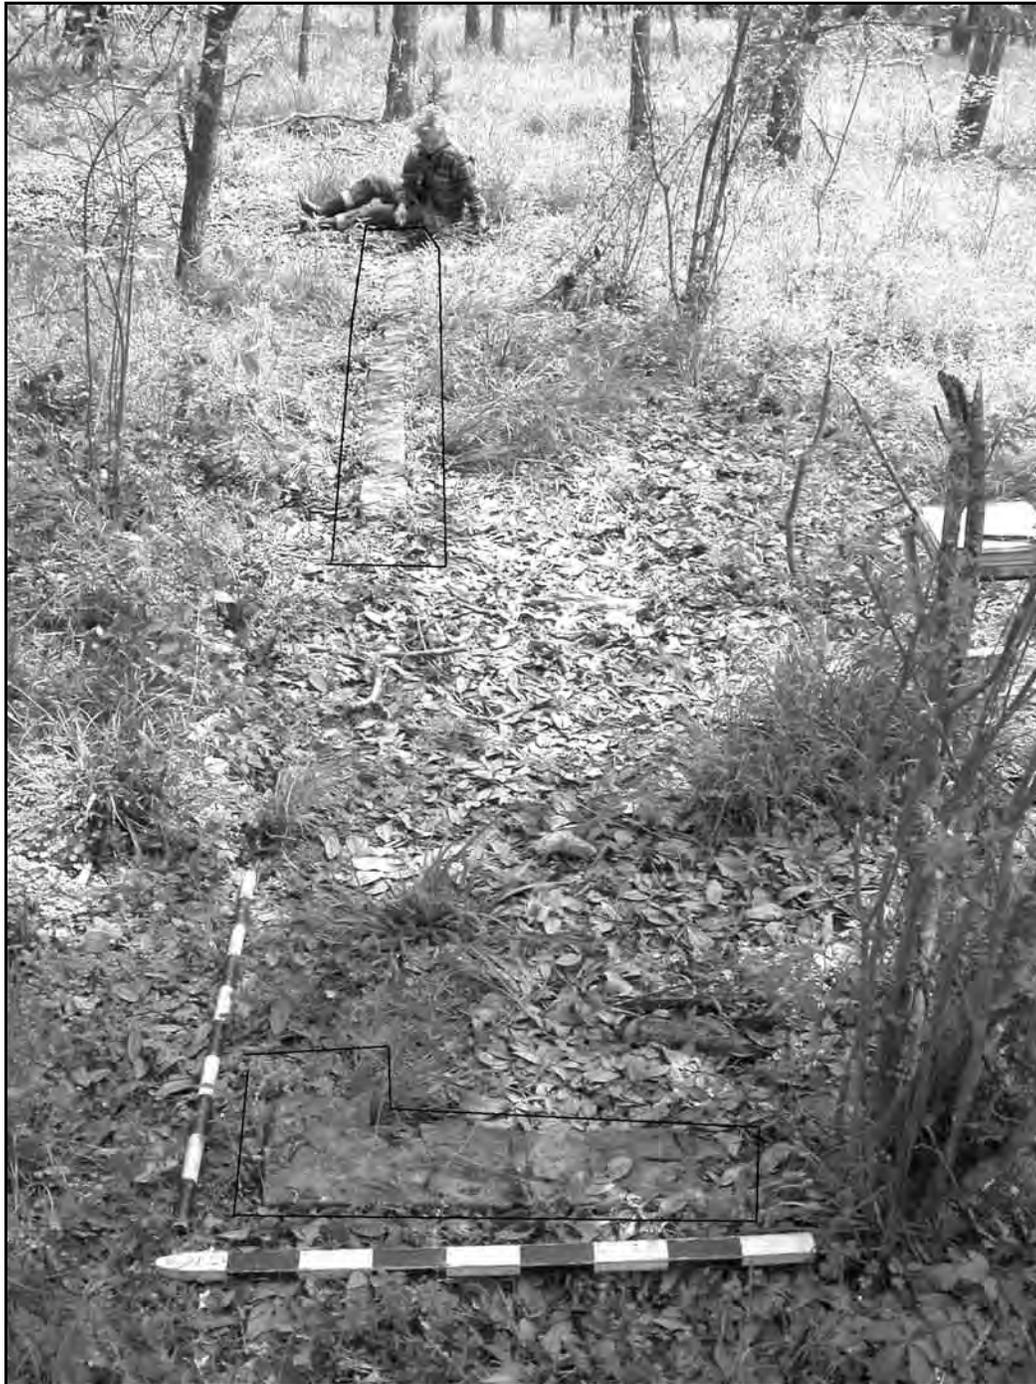
**FIGURE 5.26.** Photo of concrete footings of the chicken house, Hoffmann farmstead. Facing east. Photo taken by author on March 25, 2003. Lines have been added to depict footing locations otherwise obscured by soil and vegetation. Notice the imprints of chicken feet in the footing near the bottom of the photo.

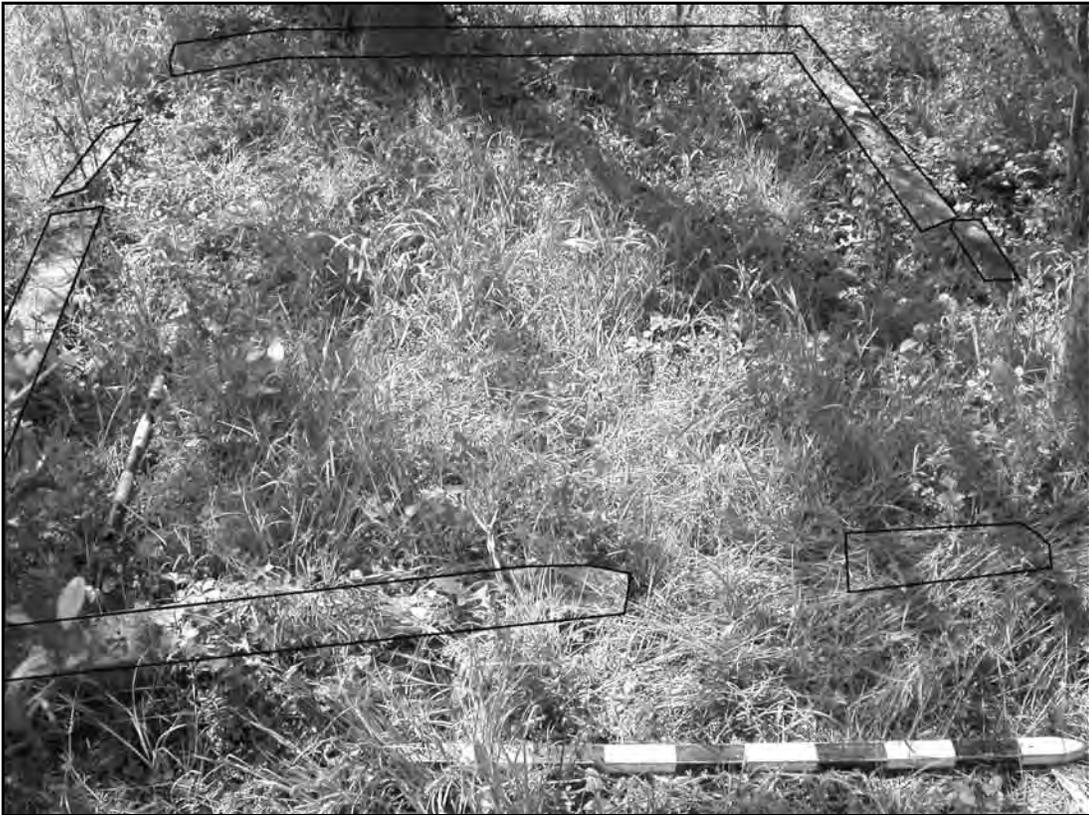
**FIGURE 5.27. Photo of concrete footings of the milk house, Hoffmann farmstead. Facing west. Photo taken by author on March 25, 2003. Lines have been added to depict footing locations otherwise obscured by soil and vegetation.**

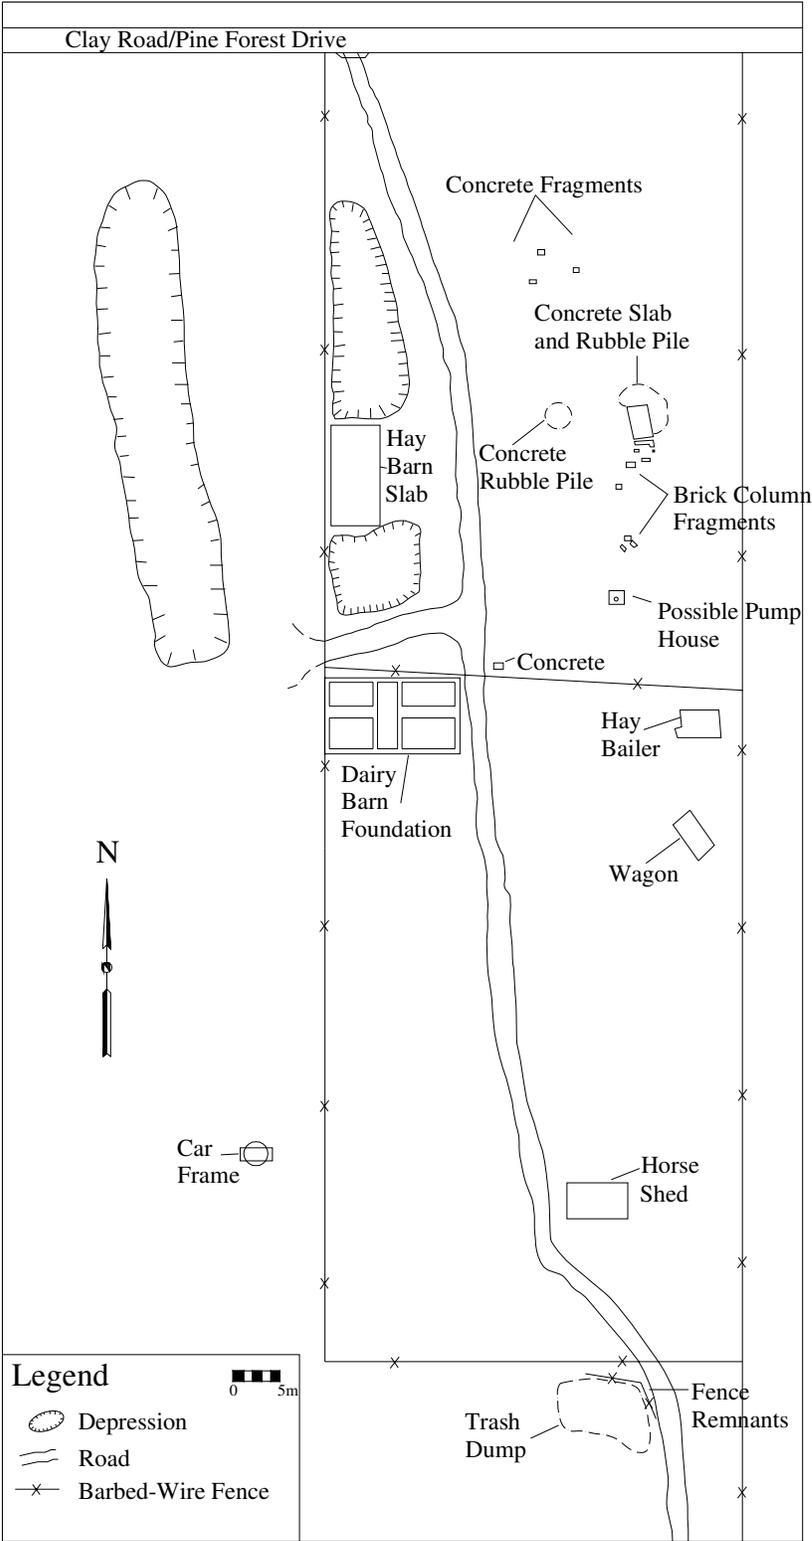
FIGURE 5.29. Site map of remains at the Walter Groschke farmstead.
