BEAR CREEK: A CASE STUDY IN LOCATING HISTORIC SITE

REMAINS IN SOUTHEAST TEXAS

A Thesis

December 2004

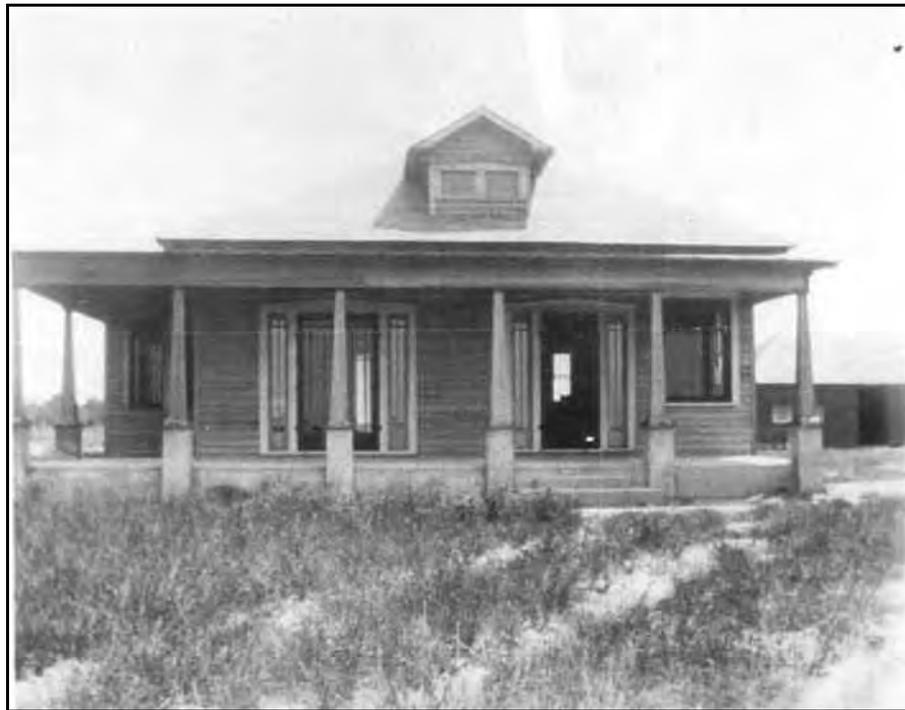
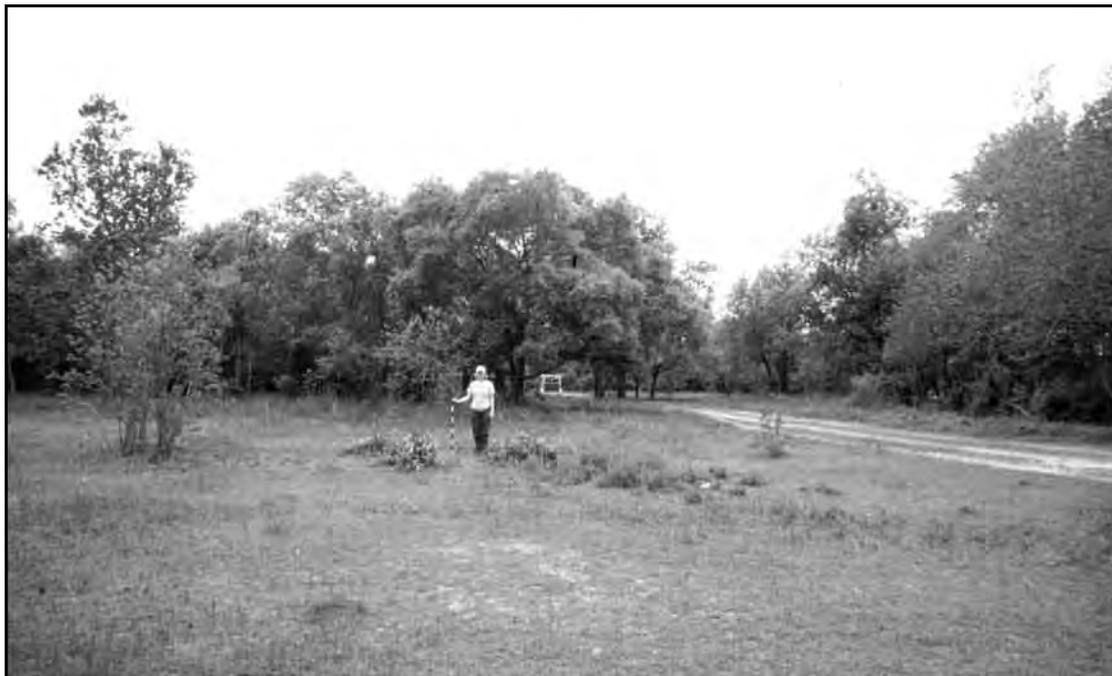
**FIGURE 5.30.** Photo comparison of the Walter Groschke home. Top photograph was taken by Minnie Groschke in 1925. (Courtesy of Norman Ray.) Bottom photograph was taken of the same location by the author on April 3, 2003. Facing south.

Several features were recorded during survey of the Walter Groschke farmstead (Figure 5.29). Among these were the foundations of the Groschke home (Figure 5.30), which consisted of scattered pieces of concrete, brick column fragments, and the remnants of a concrete slab (Figures 5.31 and 5.32). Clear and green glass fragments

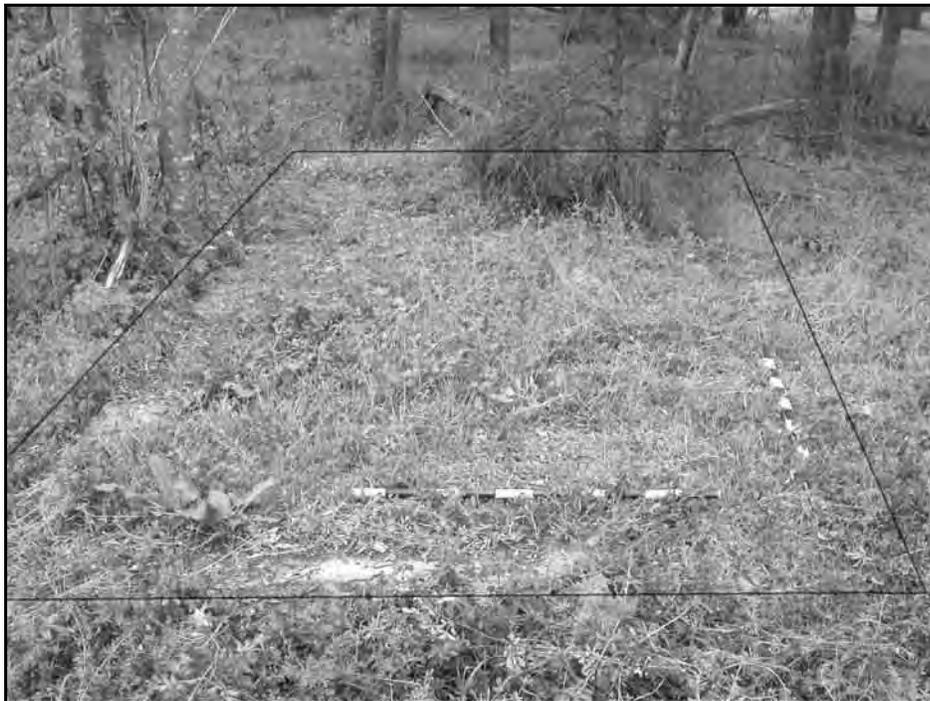
**FIGURE 5.31.** Photo of remains of the original concrete house slab, Walter Groschke farmstead. Facing south. Photo taken by author on April 3, 2003. Lines have been added to enhance edges of slab otherwise obscured by soil and vegetation.

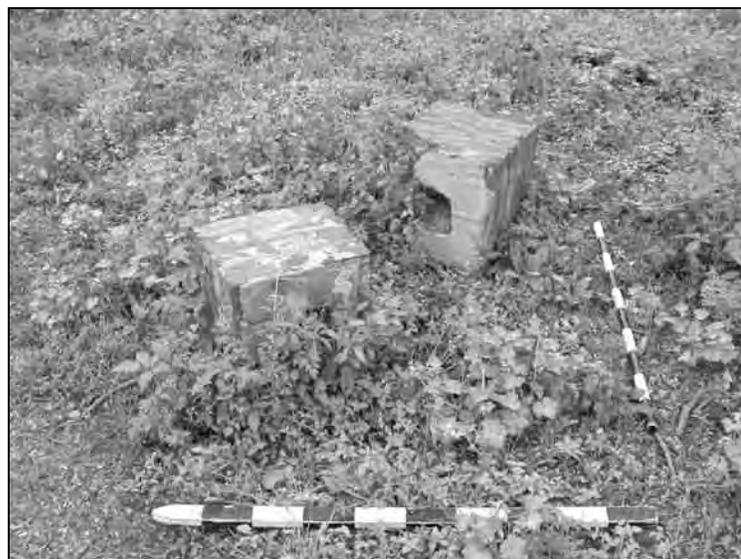
**FIGURE 5.32.** Photo of brick column fragments from the Walter Groschke home. Facing west. Photo taken by author on April 3, 2003.

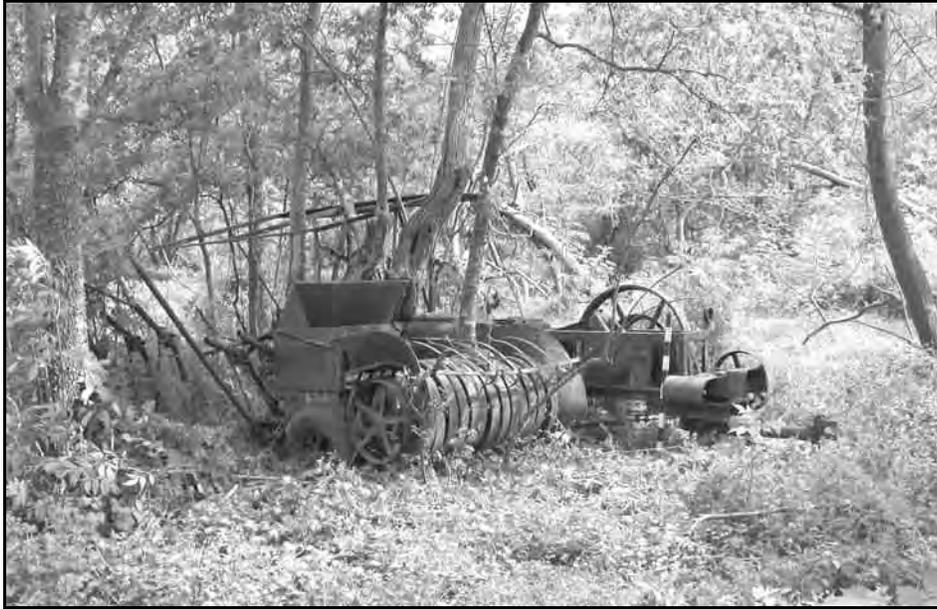
**FIGURE 5.33.** Photo of hay baler, Walter Groschke farmstead. Facing southeast. Photo taken by author on April 3, 2003.

Remnants of the farming operation are also evident at the site. Pieces of discarded farm equipment, including a stationary hay bailer and wagon, were noted during survey (Figure 5.33 and 5.34). In addition, several large depressions measuring 10 to 55 m north-south and 10 m east-west were observed at the site. All were in close proximity to the hay barn (now marked by a large concrete slab) and may have been used to store silage, a green fodder (Phil Wise March 19, 2003, pers. comm.). Unidentified metal fragments were scattered across the hay barn concrete slab. The foundations of the dairy barn were recorded nearby (Figure 5.35). The only standing structures on the property were a horse shed and pen (Figure 5.36). These structures were attributed to the Groschke family's occupation of the farmstead and were located at the southern end of the property (Phil Wise March 19, 2003, pers. comm.).

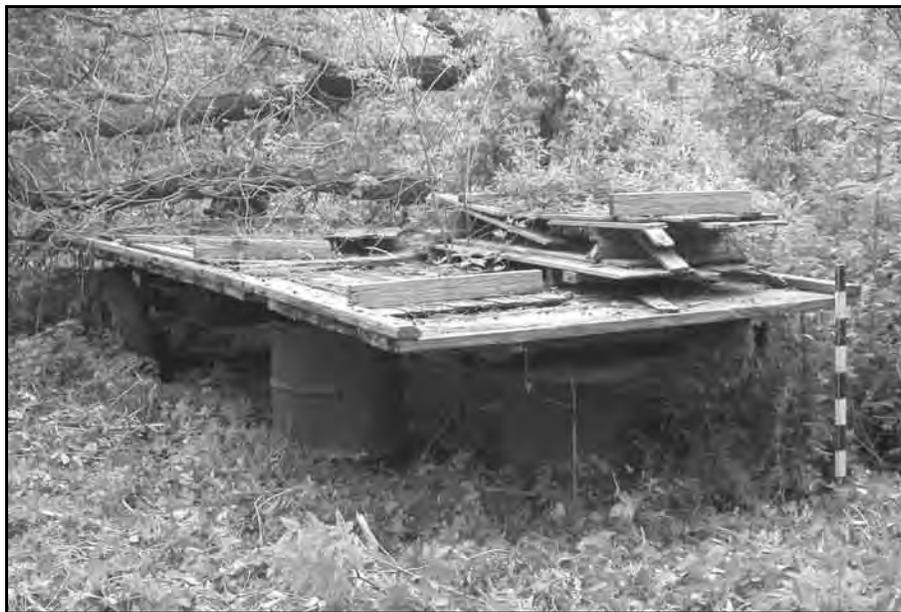
**FIGURE 5.34.** Photo of wagon, Walter Groschke farmstead. The front wheels have been removed and the front end is now resting on two 50-gallon drums. The wheels of this wagon had wood spokes and treaded rubber tires. Facing southeast. Photo taken by author on April 3, 2003.

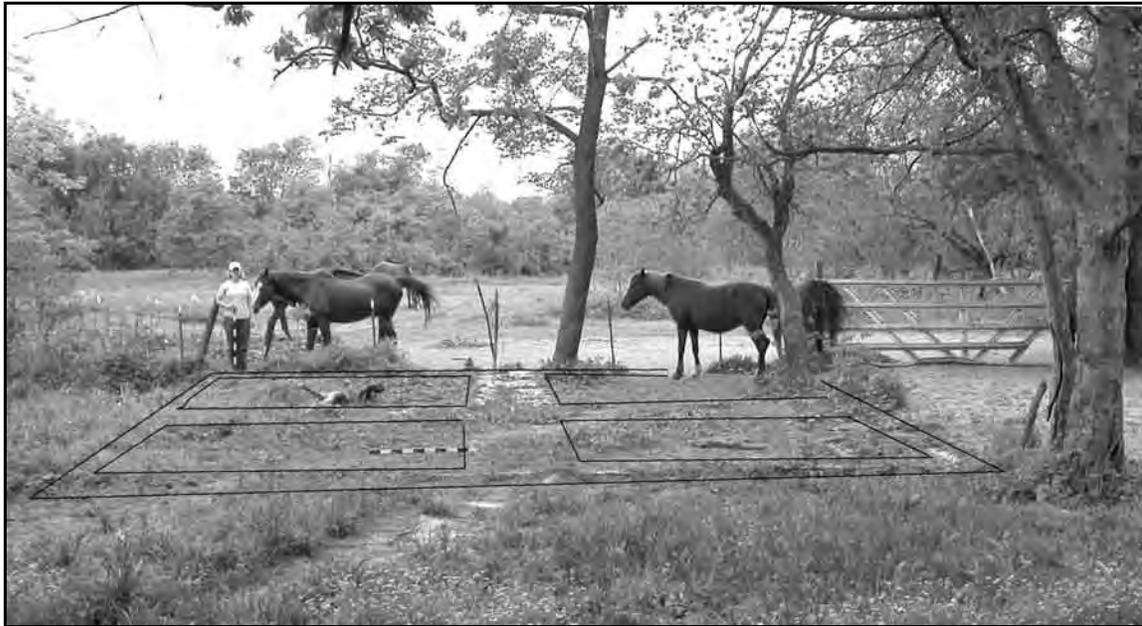
**FIGURE 5.35.** Photo of dairy barn concrete foundations, Walter Groschke farmstead. Facing west. Photo taken by author on April 3, 2003. Lines have been added to depict footing locations otherwise obscured by soil and vegetation.

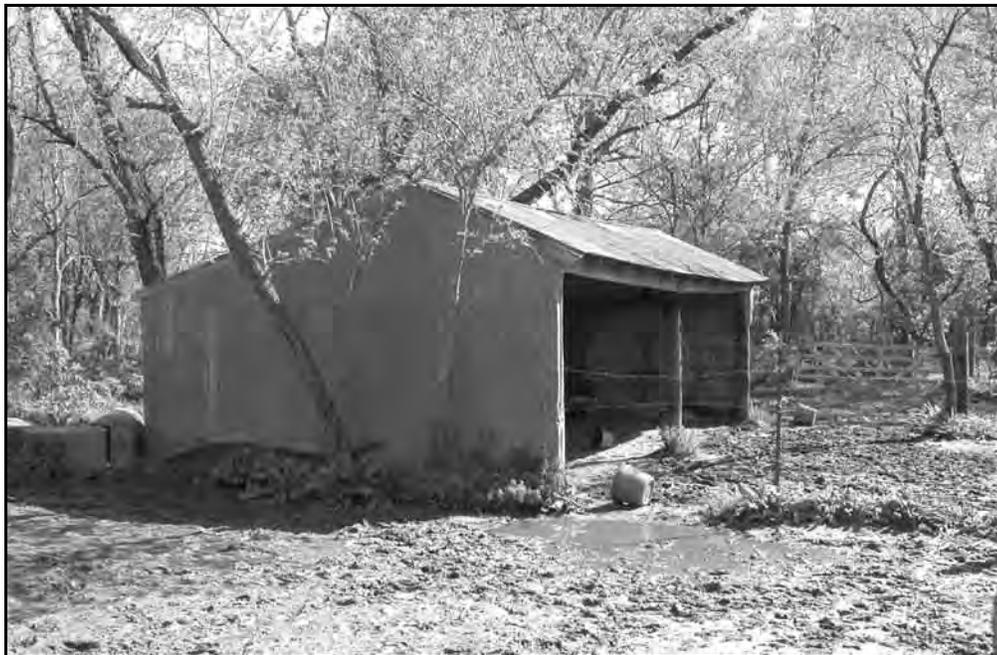
**FIGURE 5.36.** Photo of horse shed and pen, Walter Groschke farmstead. Facing east. Photo taken by author on April 3, 2003.

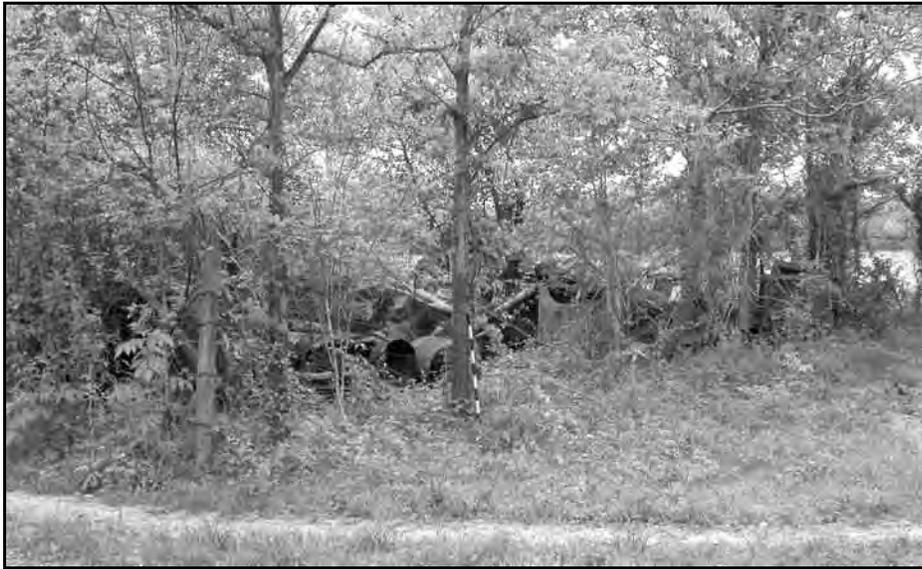
A dump site was recorded south of the horse shed and pen (Figure 5.37). Items found here indicate that the area has been used primarily as an equipment dump since the early 20th century. Objects included a tractor, two corn pickers, an International Harvester truck ca. 1930 (Figure 5.38), a 1940s era car, several electric light poles, and a modern Honda generator deposited by the current lease holder.

**FIGURE 5.37.** Photo of dump, Walter Groschke farmstead. Facing southwest. Photo taken by author on April 3, 2003.

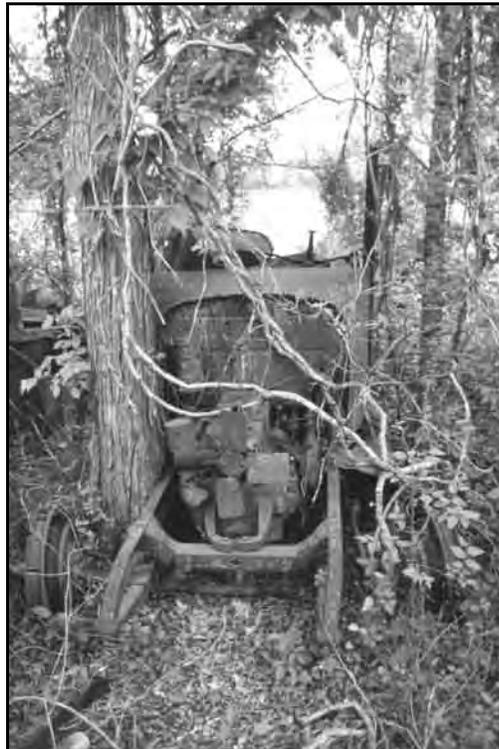
**FIGURE 5.38.** Photo of International Harvester truck from dump, Walter Groschke farmstead. Facing west. Photo taken by author on April 3, 2003.

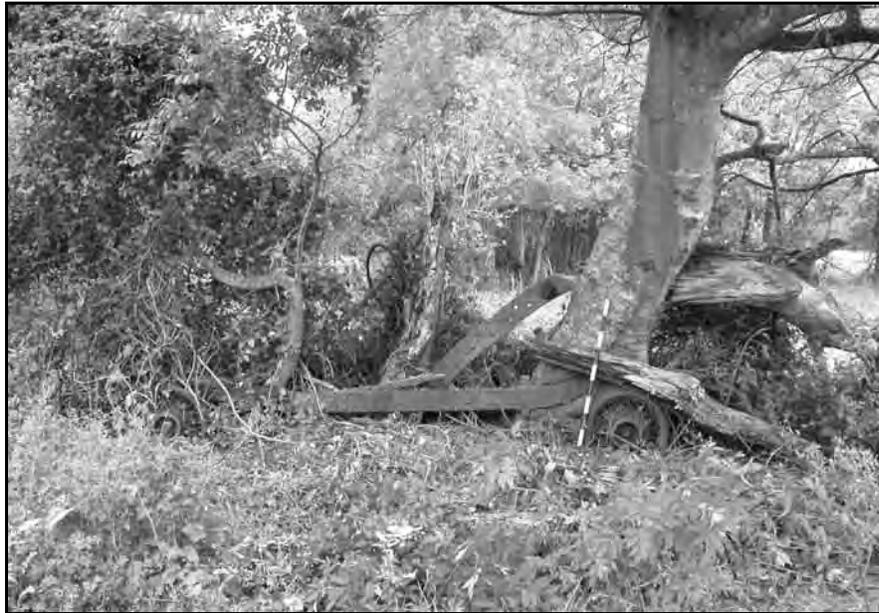
vehicle. A large hackberry tree has enveloped much of the automobile's back end (Figures 5.39 and 5.40).

**FIGURE 5.39.** Photo of trees growing through car, Walter Groschke farmstead. Facing south. Photo taken by author on April 3, 2003.

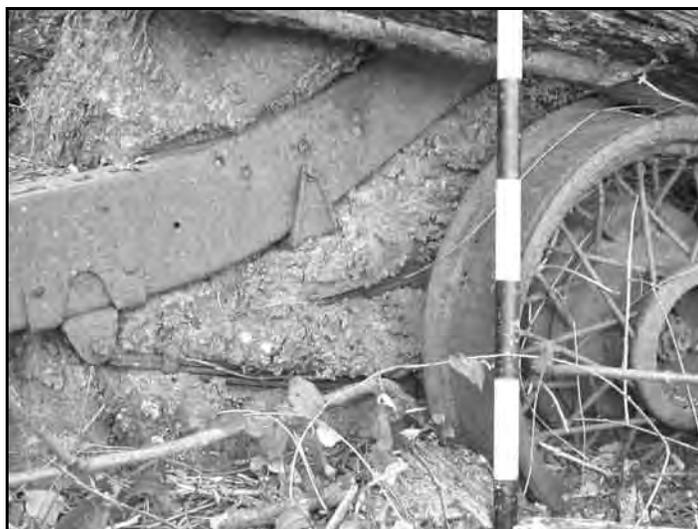
**FIGURE 5.40.** Photo shows the degree to which this hackberry tree has consumed the frame of this vehicle. Facing south. Photo taken by author on April 3, 2003.

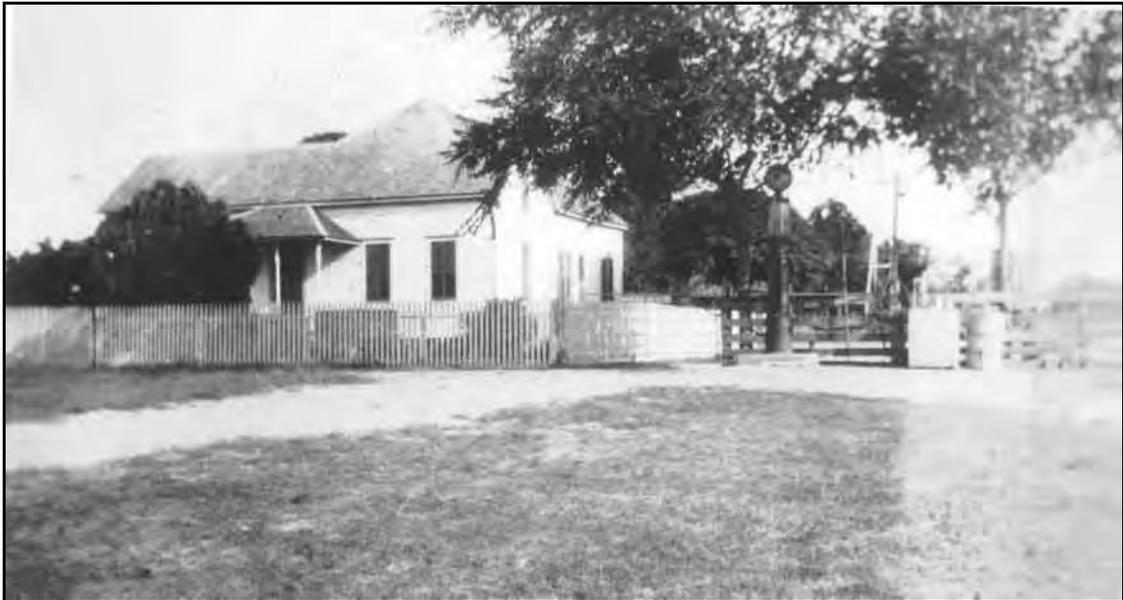
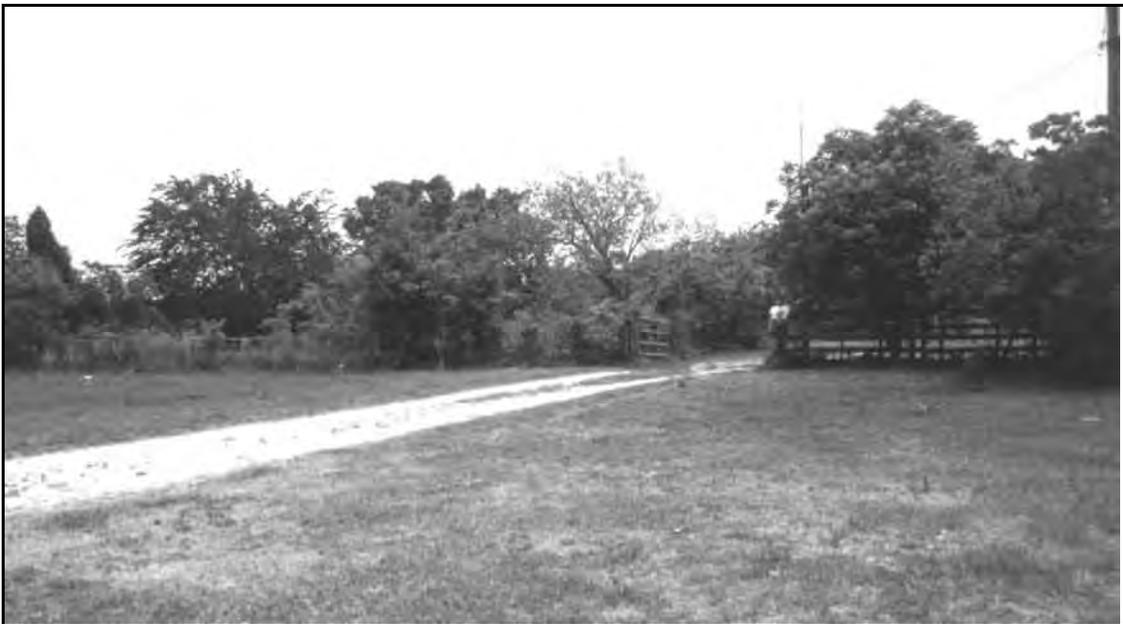
**FIGURE 5.42.** Photo comparison of the Moers farmstead. Top photograph was taken by Victoria Hoffmann in 1931. Bottom photograph was taken by the author of the same location on April 18, 2003. Facing southeast.

The Moers farm appears on both a 1915 topographical map (see Figure 5.2) and 1930 aerial photograph of the area (see Figure 5.3). Comparison of farmstead as it appears in the 1930 aerial photograph with the same area identified on a 1998 aerial photograph (see Figure 5.4) shows little variation over time. A ground-level view of the same comparison is provided in Figure 5.42.

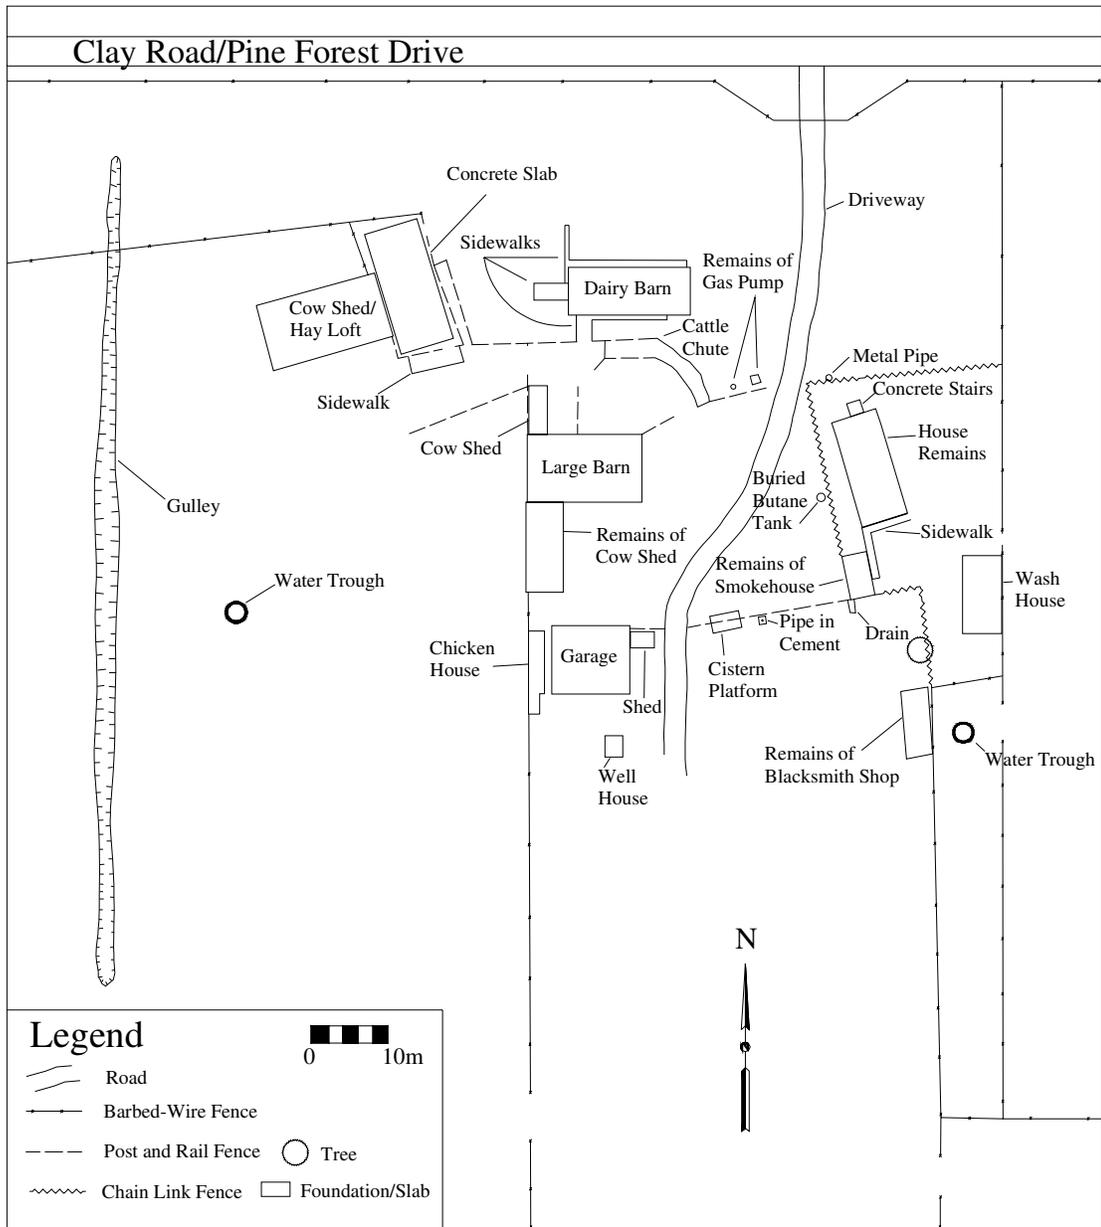
**FIGURE 5.43. Site map of the Henry Moers farmstead.**

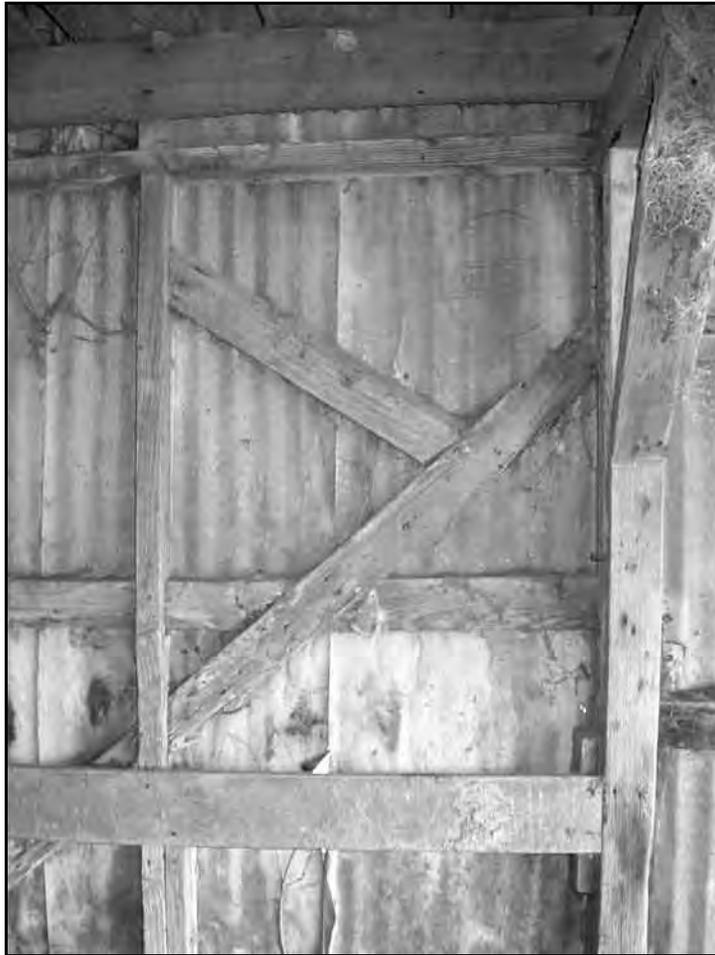
**FIGURE 5.44.** Photo of bracing technique in Hay Loft/Cow Shed, Moers farmstead. Photo taken by the author on April 18, 2003.

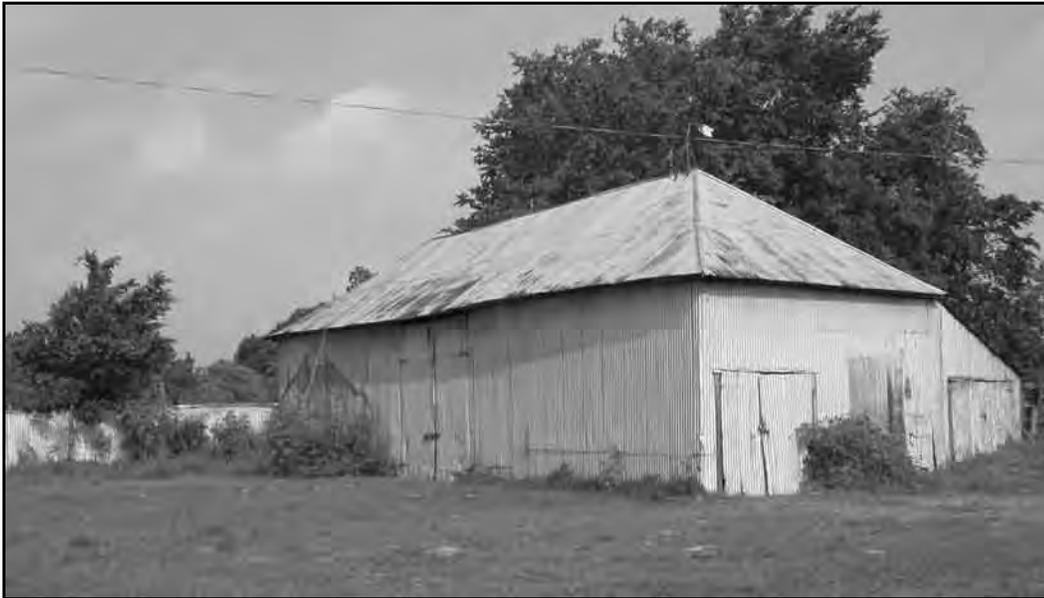
**FIGURE 5.45.** Photo of the large barn, Moers farmstead, 2003. Facing northwest. Photo taken by the author on April 18, 2003.

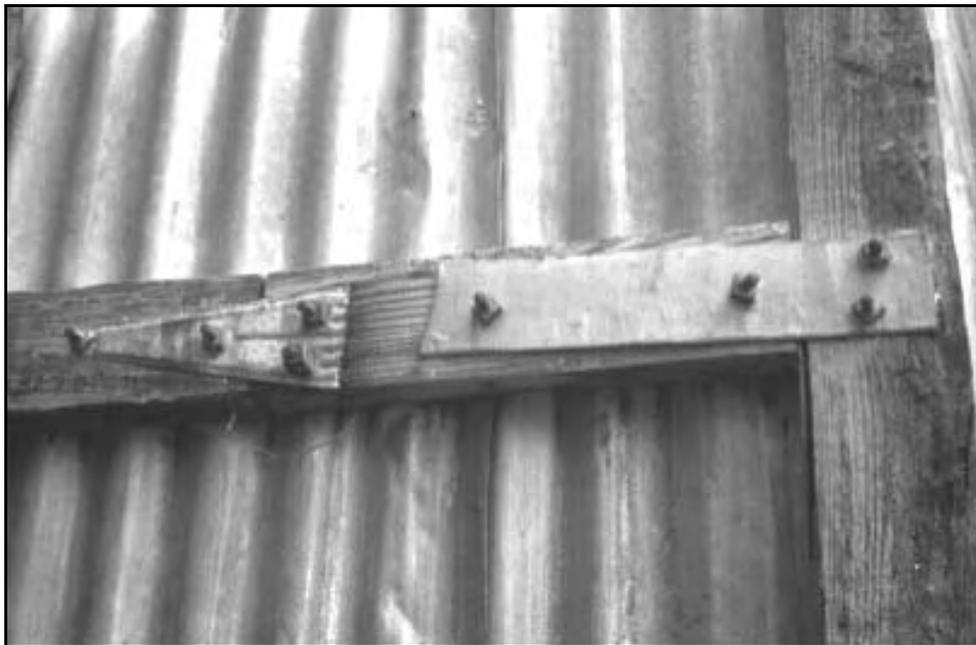
**FIGURE 5.46.** Photo of recycled materials in construction of a door at the large barn, Moers farmstead. Notice the use of an old hinge and a scrap of angle iron as brace for this door. Photo taken by the author on April 18, 2003.

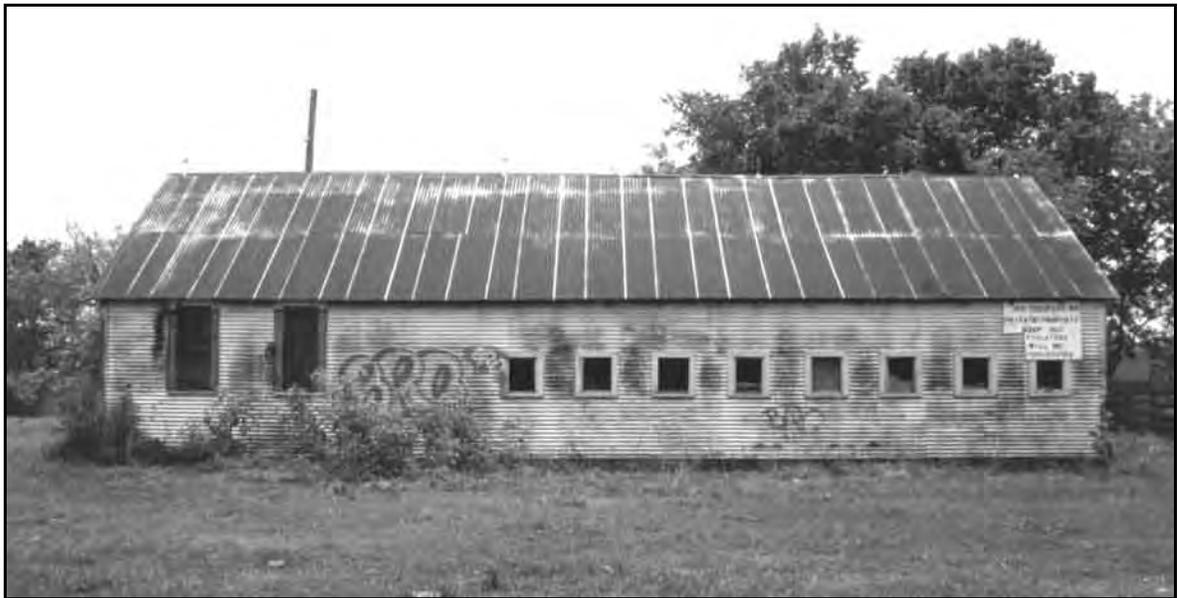
**FIGURE 5.47.** Photo of the dairy barn at the Moers farmstead showing vandalism. Facing south. Photo taken by the author on April 18, 2003.

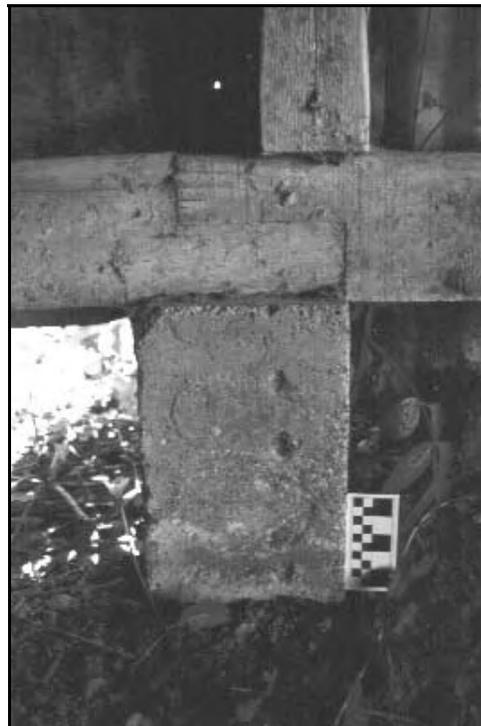
Another interesting aspect of the Moers farmstead is the range of foundation types represented in its many structures (see Chapter III). For instance, concrete blocks support the walls of the cow shed/hay loft (Figure 5.48) while another, now collapsed, cow shed displays concrete footings. The foundations of the dairy barn (Figure 5.49) and the former smokehouse are both comprised of concrete slabs whereas the foundation of the former blacksmith shop is comprised of concrete footings. The wash house is supported by brick footings (Figure 5.50), while half of the house foundation was supported by piers and a later section was comprised of substantial concrete footings.

**FIGURE 5.48.** Photo of a concrete pier supporting cow shed, Moers farmstead. Facing east. Photo taken by the author on April 18, 2003.

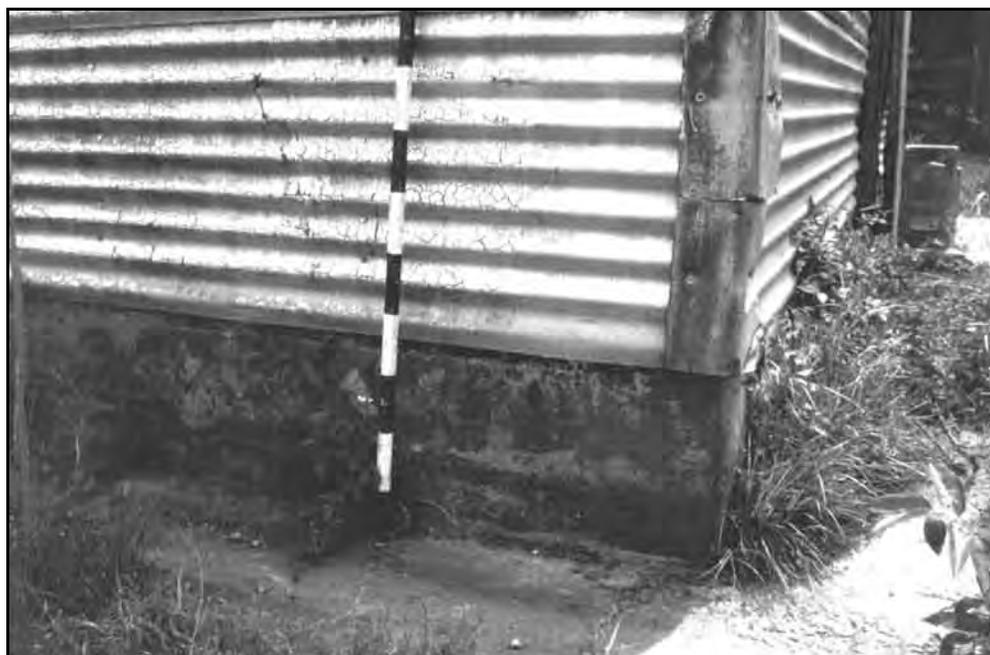
**FIGURE 5.49.** Photo of concrete footings and slab at the dairy barn, Moers farmstead. Facing south. Photo taken by the author on April 18, 2003.

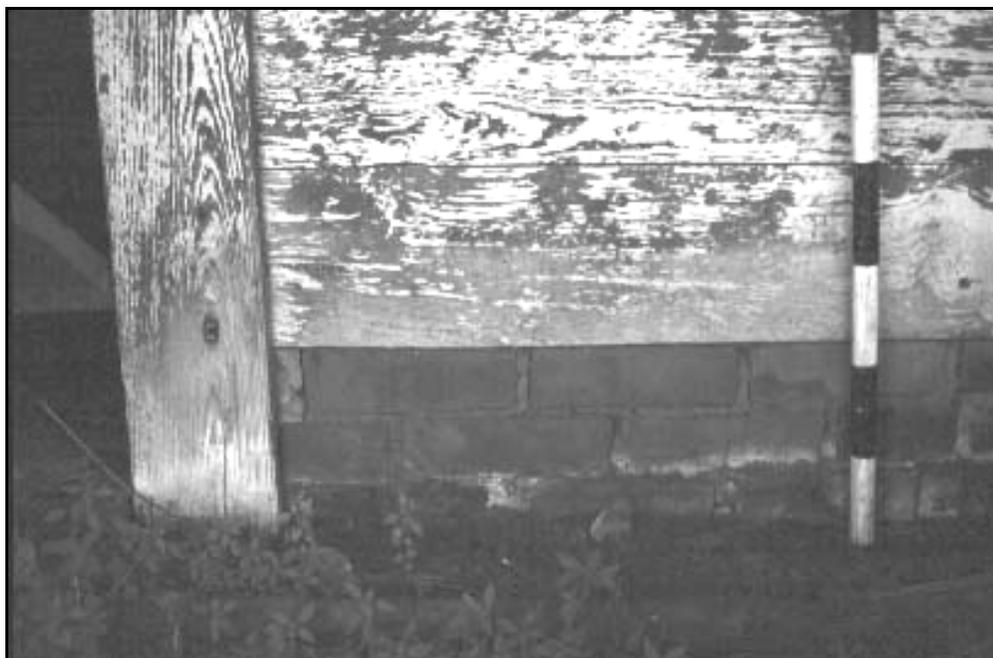
**FIGURE 5.50.** Photo of brick footings at the wash house, Moers farmstead. Facing east. Photo taken by the author on April 18, 2003.

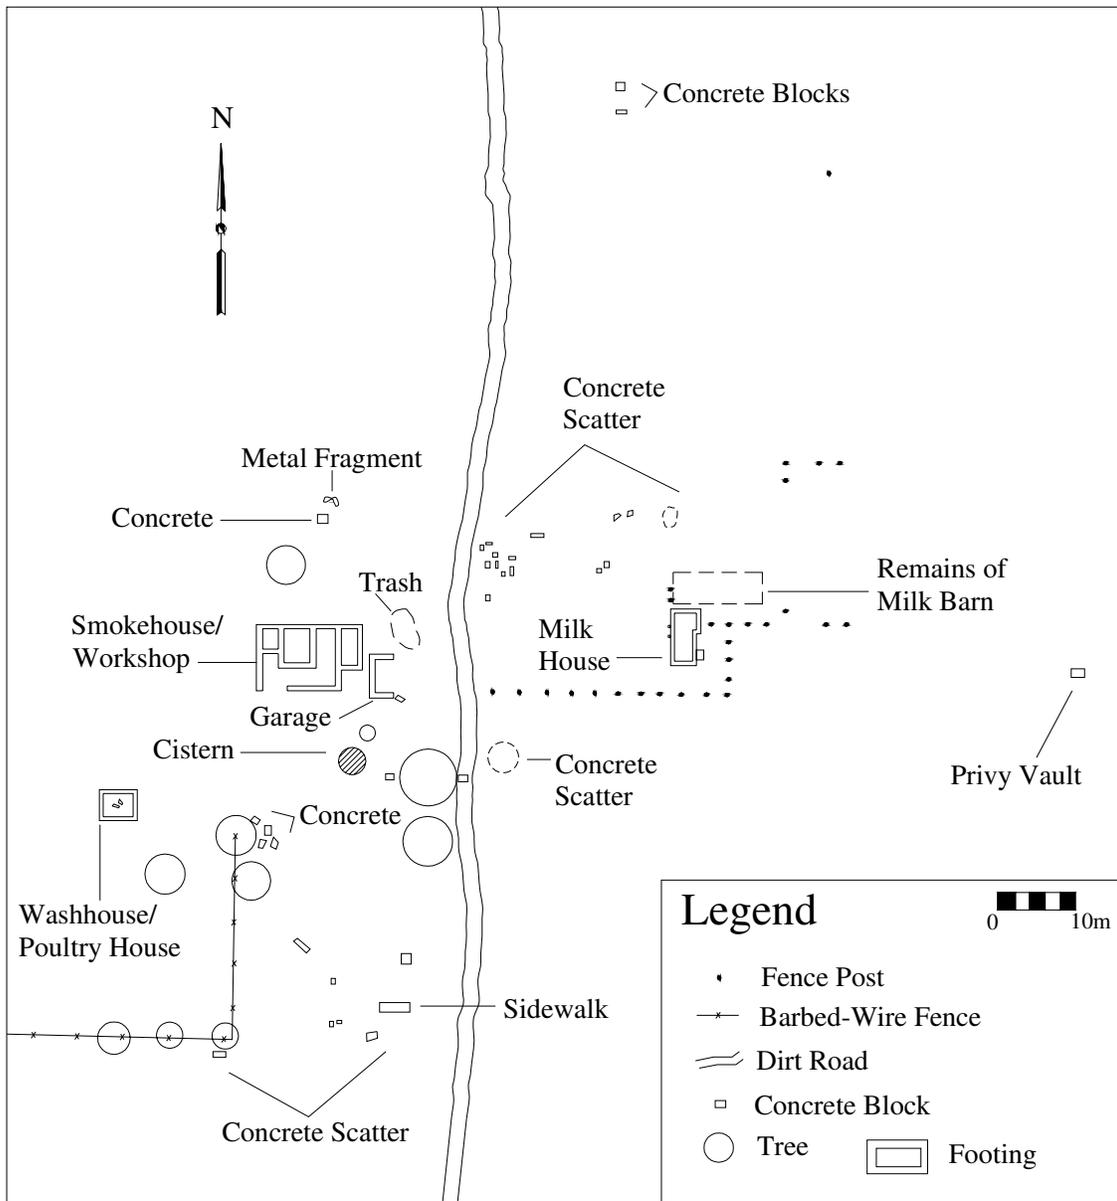
**FIGURE 5.51. Site map of remains at the Carl Ernst Groschke farmstead.**

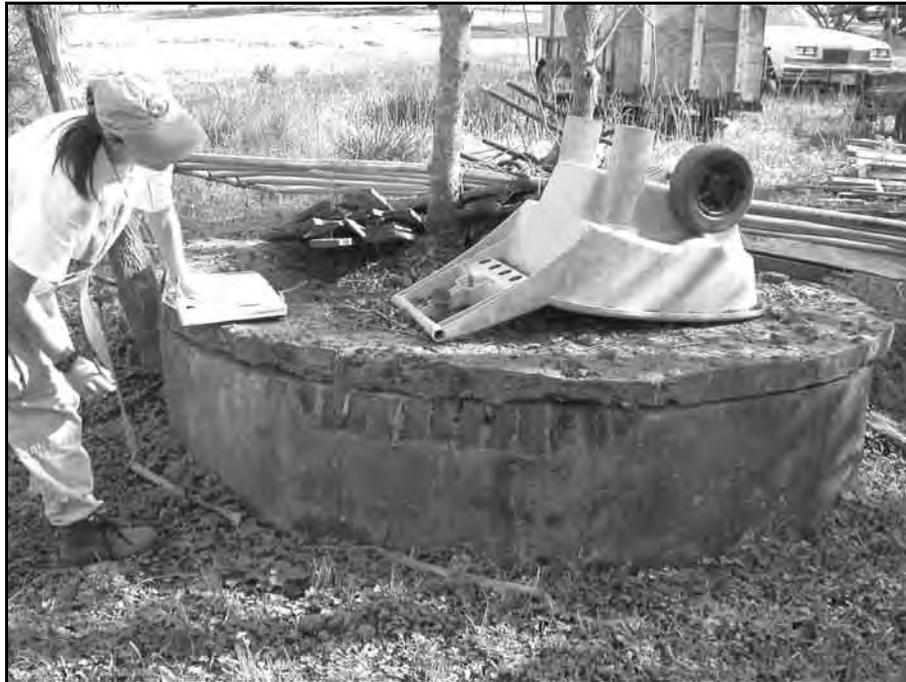
**FIGURE 5.55. Photo of the cistern at the Carl Ernst Groschke farmstead. Facing south. Photo taken by Robert Burden on March 18, 2003.**

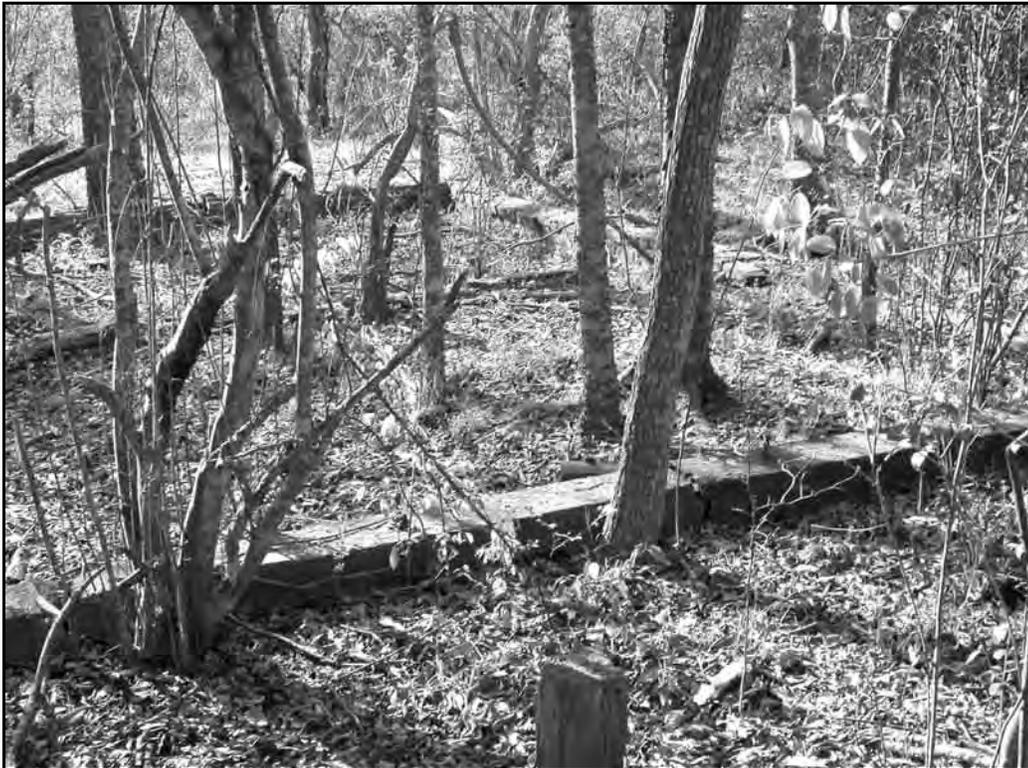
**FIGURE 5.56. Photo of the concrete footings of the smokehouse, Carl Ernst Groschke farmstead. Facing northwest. Photo taken by author on April 12, 2003.**

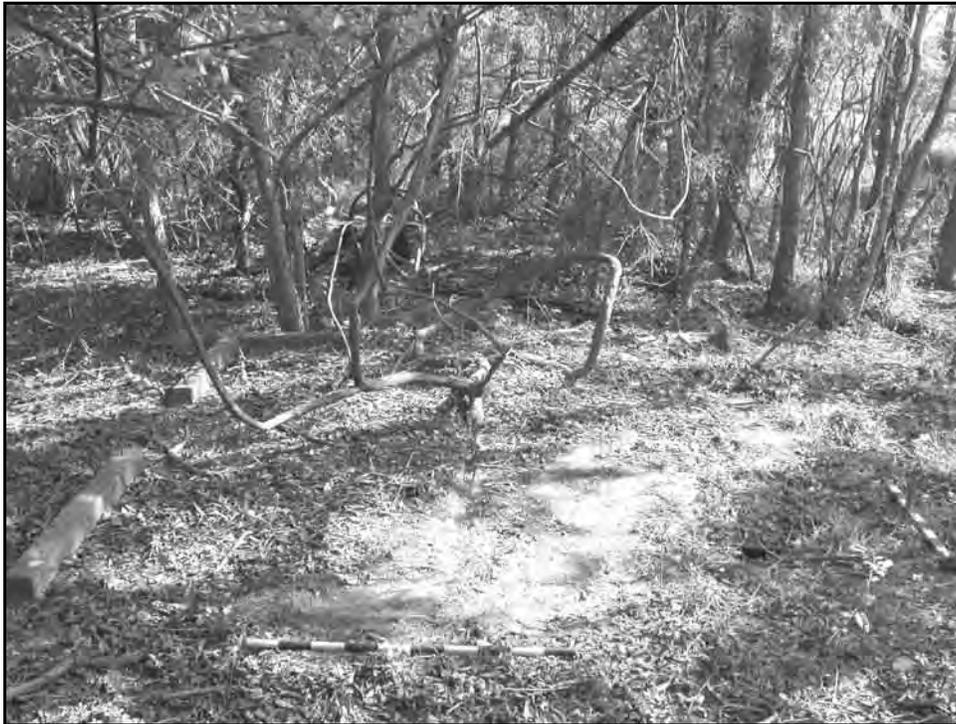
**FIGURE 5.57. Photo of concrete footings and slab of milk house, Carl Ernst Groschke farmstead. Facing south. Photo taken by author on April 12, 2003.**

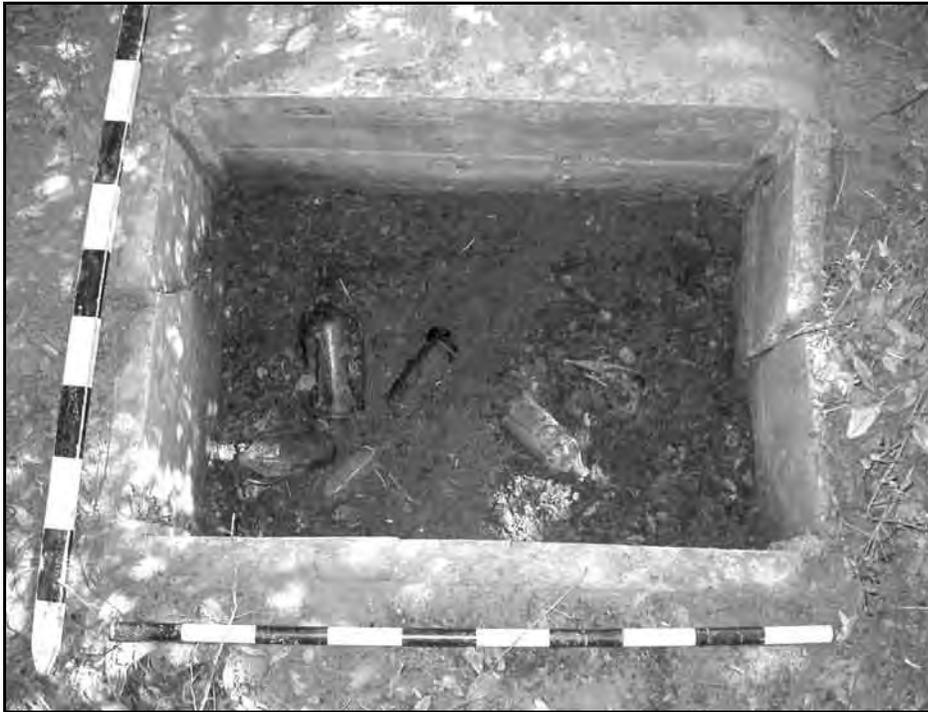
**FIGURE 5.58.** Photo of concrete privy vault with bottles, Carl Ernst Groschke farmstead. Photo taken by author on April 12, 2003.

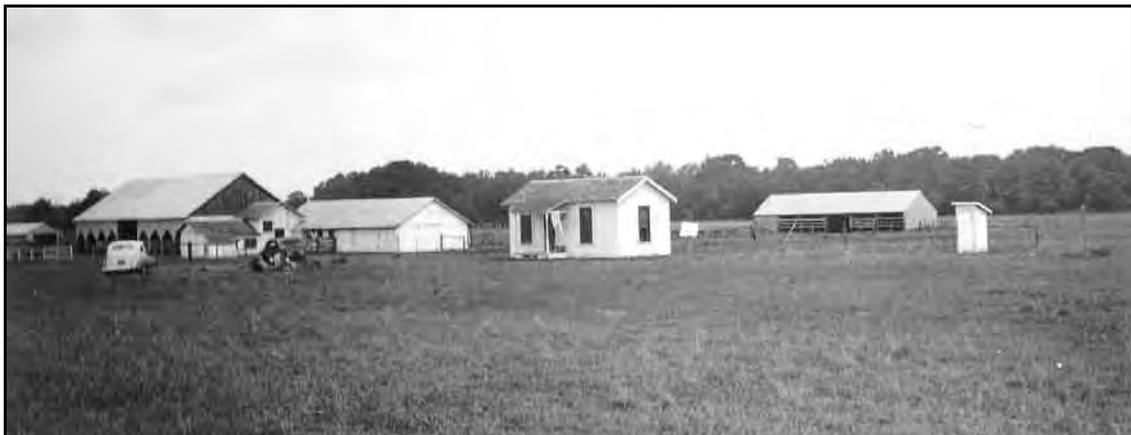
concrete box (Figure 5.58). This last feature of the Groschke farmstead was no doubt the privy vault for the tenant outhouse (Figure 5.59). The vault was filled with 15 cm of humic matter and below this were several bottles, including soda bottles and bleach bottles.

**FIGURE 5.59.** Photo of the tenant house and outhouse on the Carl Ernst Groschke farmstead, taken by the U. S. Army Corps of Engineers on July 12, 1944. (Courtesy of Martha Freeman.)

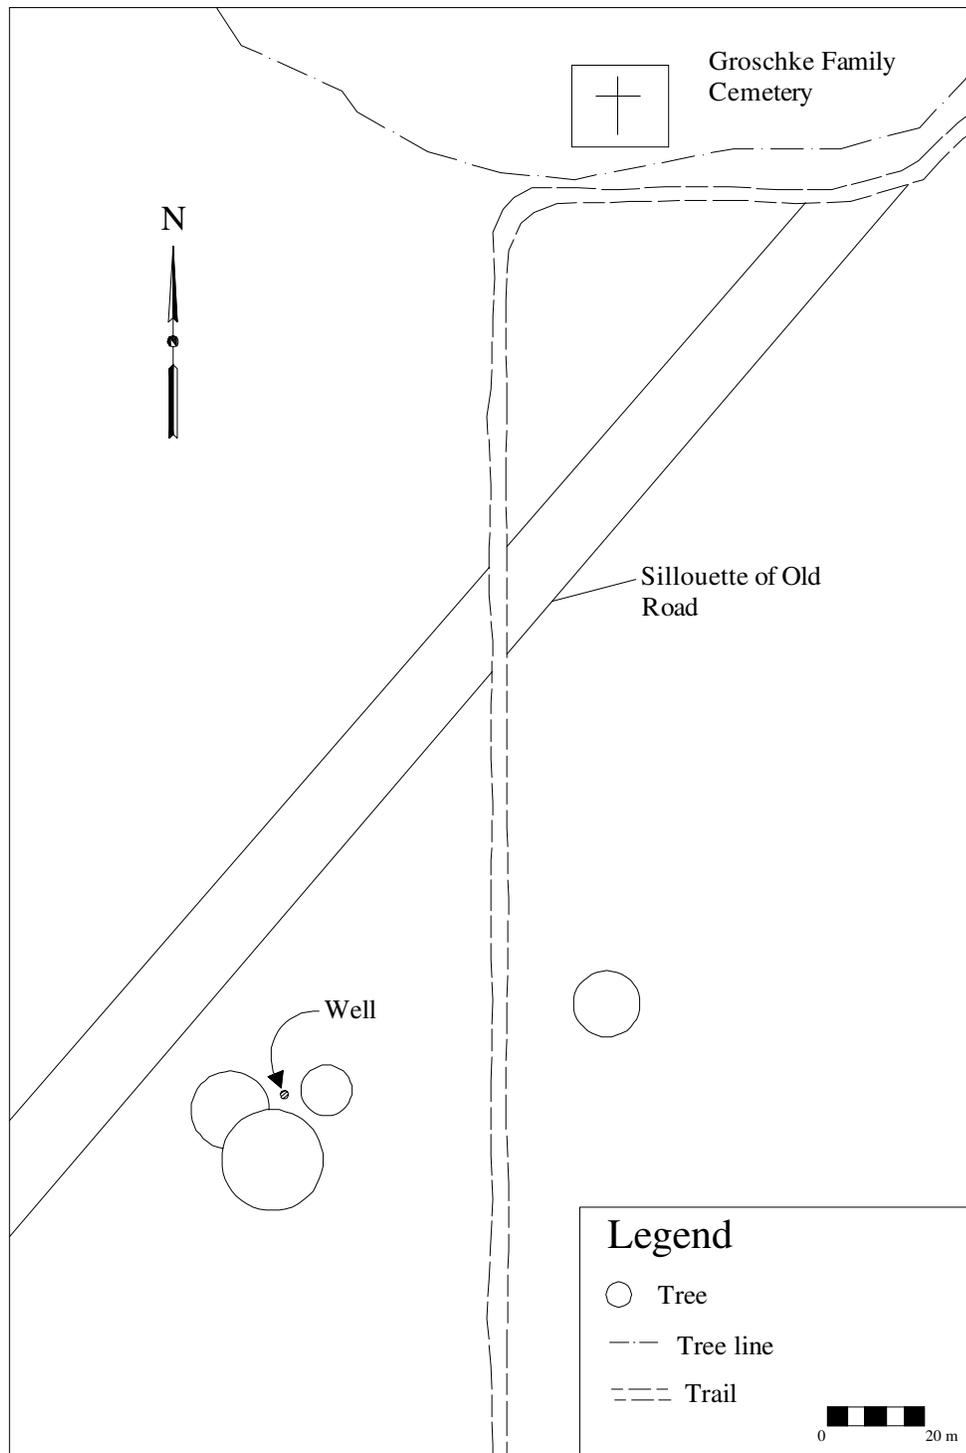
**FIGURE 5.60.** Features identified on the northern end of the 160-acre Carl Ernst Groschke tract.

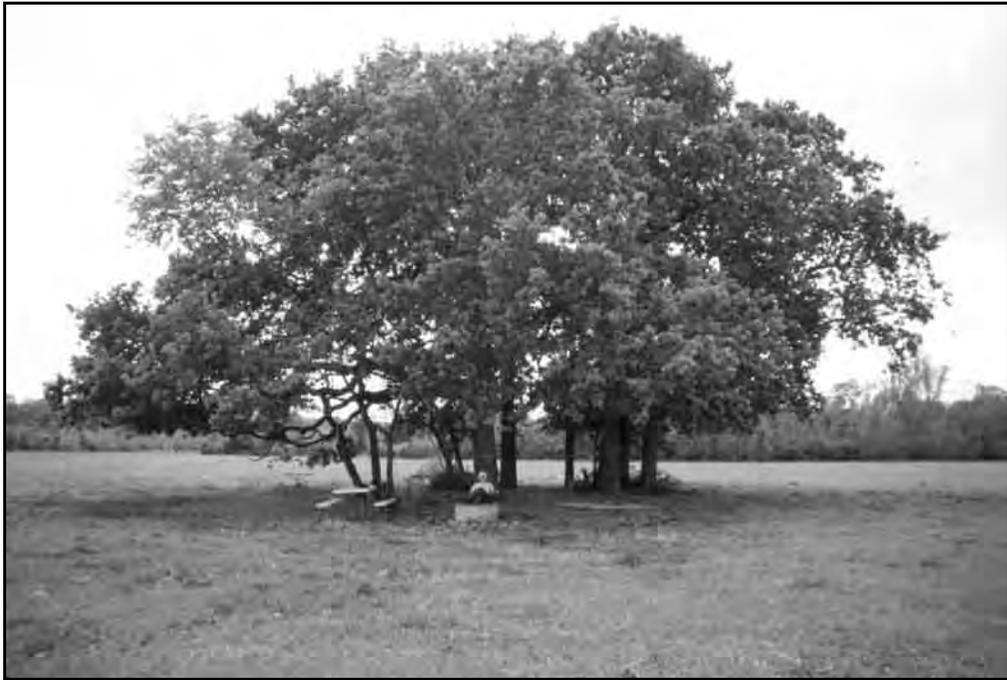
Other related farm features were located on the northern end of the 160-acre preemption grant. These features include a brick-lined well and the Groschke Family Cemetery (Figure 5.60, Figure 5.61). This well is exceptional in that unlike similar wells on surrounding properties, it has retained its above-ground enclosure wall (Figure 5.62). The well was filled with sediment at some point in the past and is currently utilized as a fire pit by the property lease holder. No household or farmstead debris was observed on the surface.

**FIGURE 5.61.** Photo of additional features of the C. E. Groschke property. Facing south. Well is in center of frame. Photo taken by author on April 3, 2003.
