BEAR CREEK: A CASE STUDY IN LOCATING HISTORIC SITE

REMAINS IN SOUTHEAST TEXAS

A Thesis

December 2004

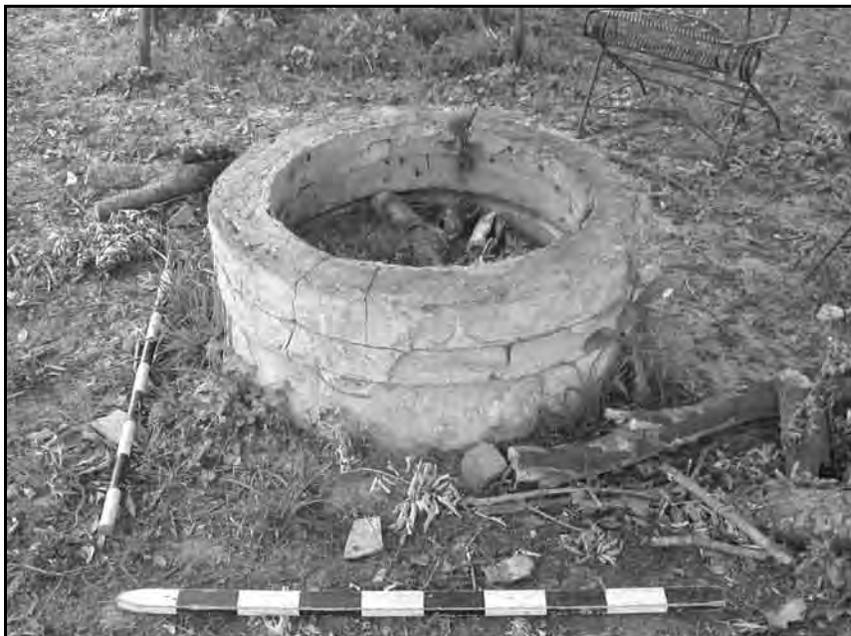
Other related farm features were located on the northern end of the 160-acre preemption grant. These features include a brick-lined well and the Groschke Family Cemetery (Figure 5.60, Figure 5.61). This well is exceptional in that unlike similar wells on surrounding properties, it has retained its above-ground enclosure wall (Figure 5.62). The well was filled with sediment at some point in the past and is currently utilized as a fire pit by the property lease holder. No household or farmstead debris was observed on the surface.

**FIGURE 5.62.** Well on the northern end of the C. E. Groschke property. Facing west. Photo taken by author on April 3, 2003.
