Eliminating Humidity and Condensation Problems in University Dormitories – Case Study

Texas A&M University, College Station, Texas

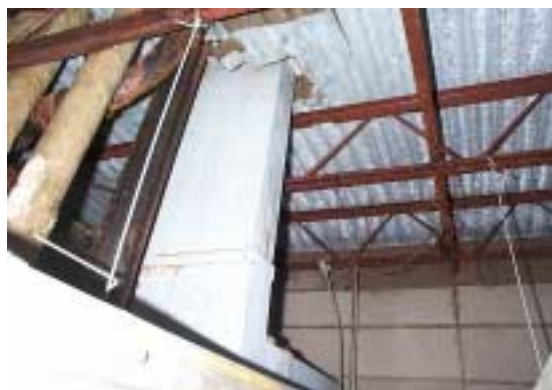
The temperature above the bathroom was measured at 80°F and its relative humidity was 90%. Significant amounts of water were found condensing on surfaces. Small open areas (gaps) were noticed at various locations around the cinderblock firewalls. Utility piping through the floor was obviously not sealed properly. Figure 2 shows a glimpse of the condensation situation in the space above the ceiling in one particular bathroom.

Figure 2: Condensation in the crawl space above the ceiling in bathrooms

We now knew how and why this problem was occurring the next step was to implement a cure. To close all the gaps was not feasible, it would be nearly impossible to gain access to all the areas. Reversing the air flow to exit the attic space above the bathroom ceiling would solve the problem that had eluded everyone for years. We opened all the crawl space vents, closed the doors to the utility tunnels, and placed a temporary vent fan to pull the crawl space air out from under the building and into the surrounding atmosphere. Within a couple of days the moisture was gone from above the bathrooms and the problems were resolved. How simple and easy to correct once you discover the problem.

- Opened all the crawl space vents.
- Fully shut both doors between primary hot water loop tunnel and the crawl space to isolated hot air from tunnel and the building.
- Installed a temporary ventilation fan to ventilate the crawl space temporarily until a permanent one could be purchased.

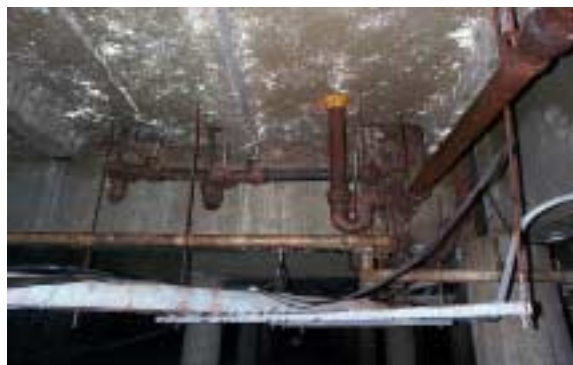
Continued investigation uncovered that conditions in the basement crawl space (a subterranean area with dirt flooring) were identical to that in the space above ceiling in the bathrooms. Figure 3 shows the condensation in another area above a bathroom in Krueger. The condensing water is dripping from all available surfaces (concrete floor, pipes, cross beams, pillars, etc.). Similar condensation was observed in the basement. While in the basement it was also noted that the crawl space vents to the outside were shut completely.

Figure 3: Condensation of the crawl space

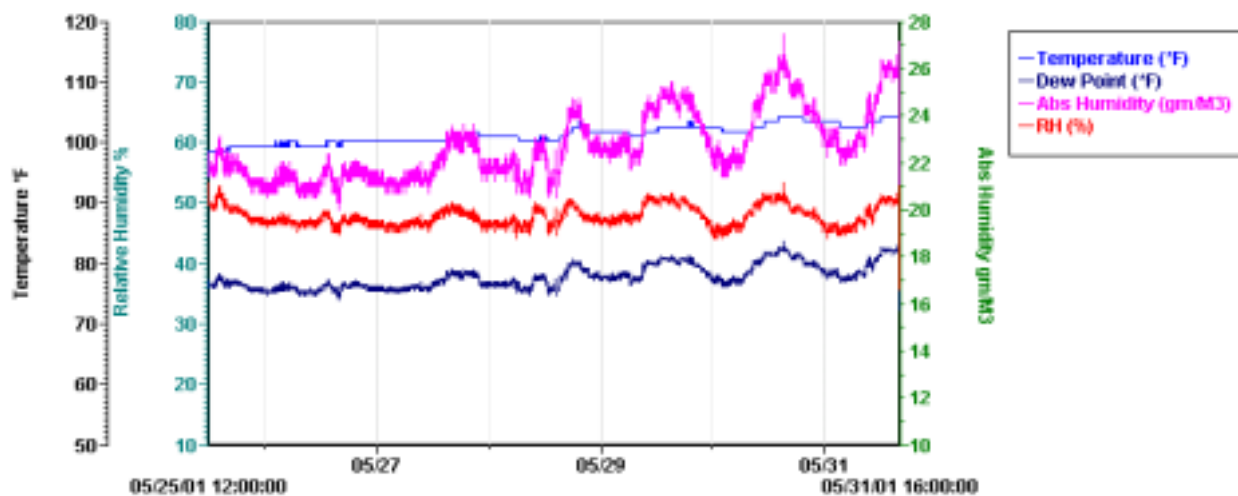
We monitored heating tunnel with temperature and humidity data recorders. Plots in figure 4 show average dry bulb temperature was 103°F, dew point temperature was 78°F, absolute humidity was from 21 ~ 26 gm/m³ and average relative humidity was 48%. Hot air from the utility tunnel was flowing

Figure 4: Monitored heating tunnel air conditions from May 25, 2001 to May 31, 2001

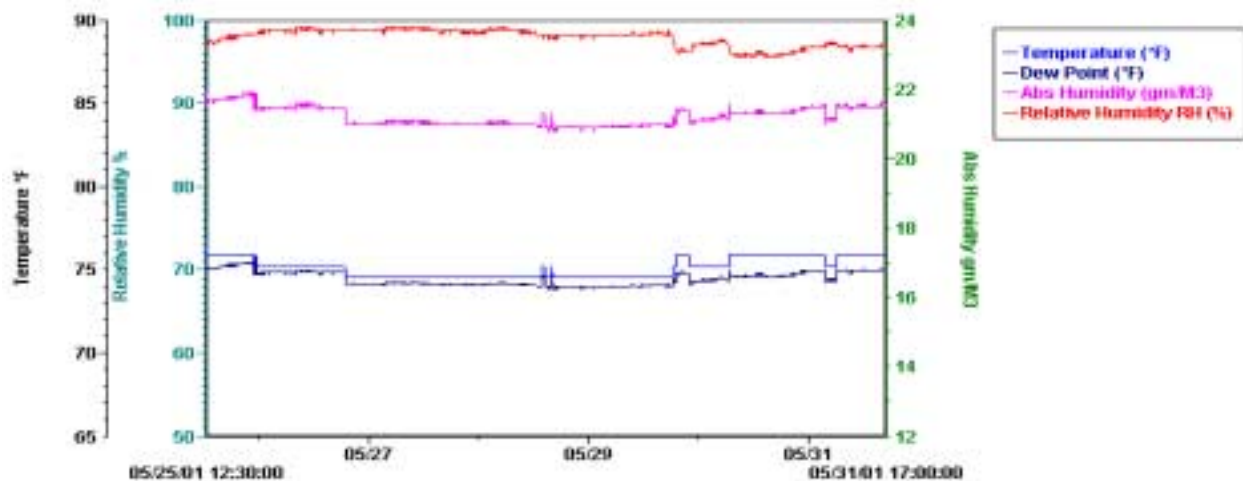
freely into the crawl spaces. We also monitored the crawl space. Figure 5 shows that the average dry bulb temperature was 78°F and its dew point temperature was around 76°F; the crawl space relative humidity range was from 80 ~ 90%. The various surfaces (beams, pillars, floors, pipes, etc.) had temperatures of around 73°F. When the surface temperature of various surfaces was less than the dew point of the tunnel air (76°F), condensation would occur in the surfaces in the crawl space. Hot and humid air was being pulled into the buildings through the utility piping chases from the first floor to the fourth floor. As this air traveled, condensation on surfaces occurred. Figure 6 shows monitored space air conditions above the bathroom in room 142 during the test period from May 25, 2001 to May 31, 2001. It is clear that the crawl space air's relative humidity was close to 100% and the dry bulb air temperature was very close to its dew point of 75°F.

Figure 6: Monitored space air conditions above bathroom of room 142 from May 25, 2001 to May 31, 2001
