Retro-Commissioning Phase I Demonstration Project Shanghai, China

Peter Keithly
Keithly Barber Associates Inc.
pete@keithlybarber.com

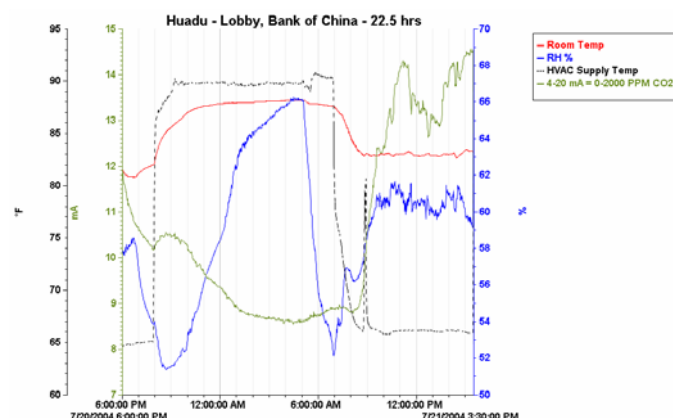
Sample of Plots From Random Data-Logging In Various Locations

Comments Related to Above Data: Profile indicates good temperature control during occupied

periods. Zone temperature setpoint was maintained very high during the occupied period due to energy

reduction constraints enforced by the local jurisdiction. Note: High occupied CO₂ levels as would be expected in a bank lobby. Ventilation rates should be further investigated for this zone. HVAC supply air temperature spike at 9 AM seems curious and should be further investigated.
