Continuous Commissioning® of a Medical Research Facility

**Energy Systems Laboratory
Texas A&M University System**

November 2007

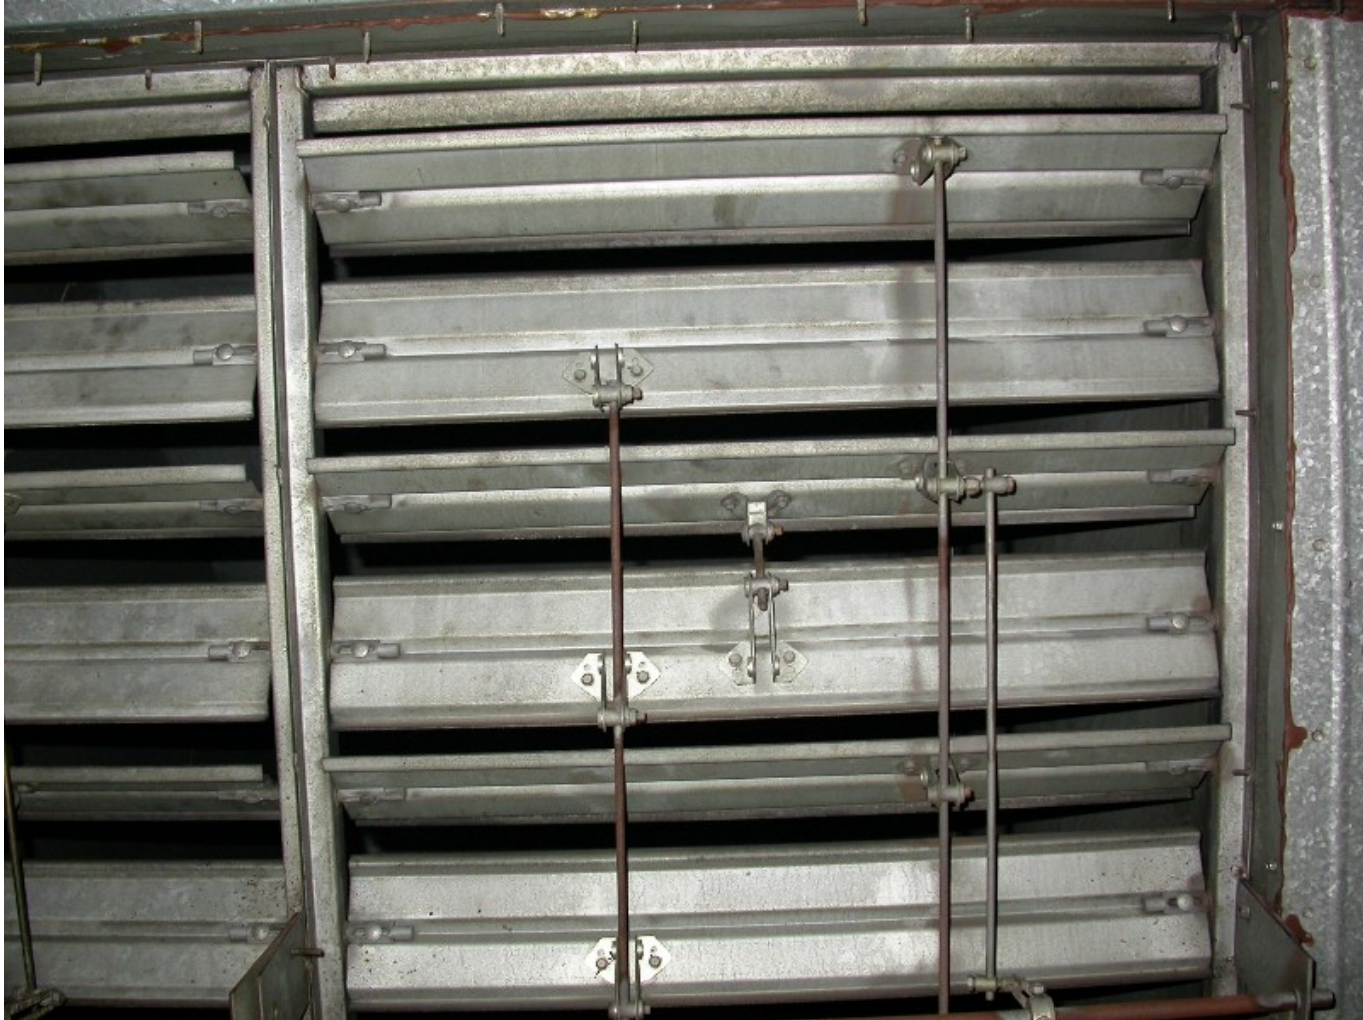
Heat Exchanger Dampers

- Terminal box airflow readings were incorrect
- AHU-10 outside air dampers are stuck and one return air control damper is problematic
- Reheat water was a constant 105°F
- Air-to-air heat exchanger dampers not working
- Some dampers were frozen in various positions and could not move

Bypass Damper Original condition, fully open

- Heat exchanger dampers fixed open
- Bypass dampers still able to modulate
- Modified control of dampers to be based on discharge temperature
- Discharge setpoint for damper control 73°F in summer, 1°F above supply setpoint in winter

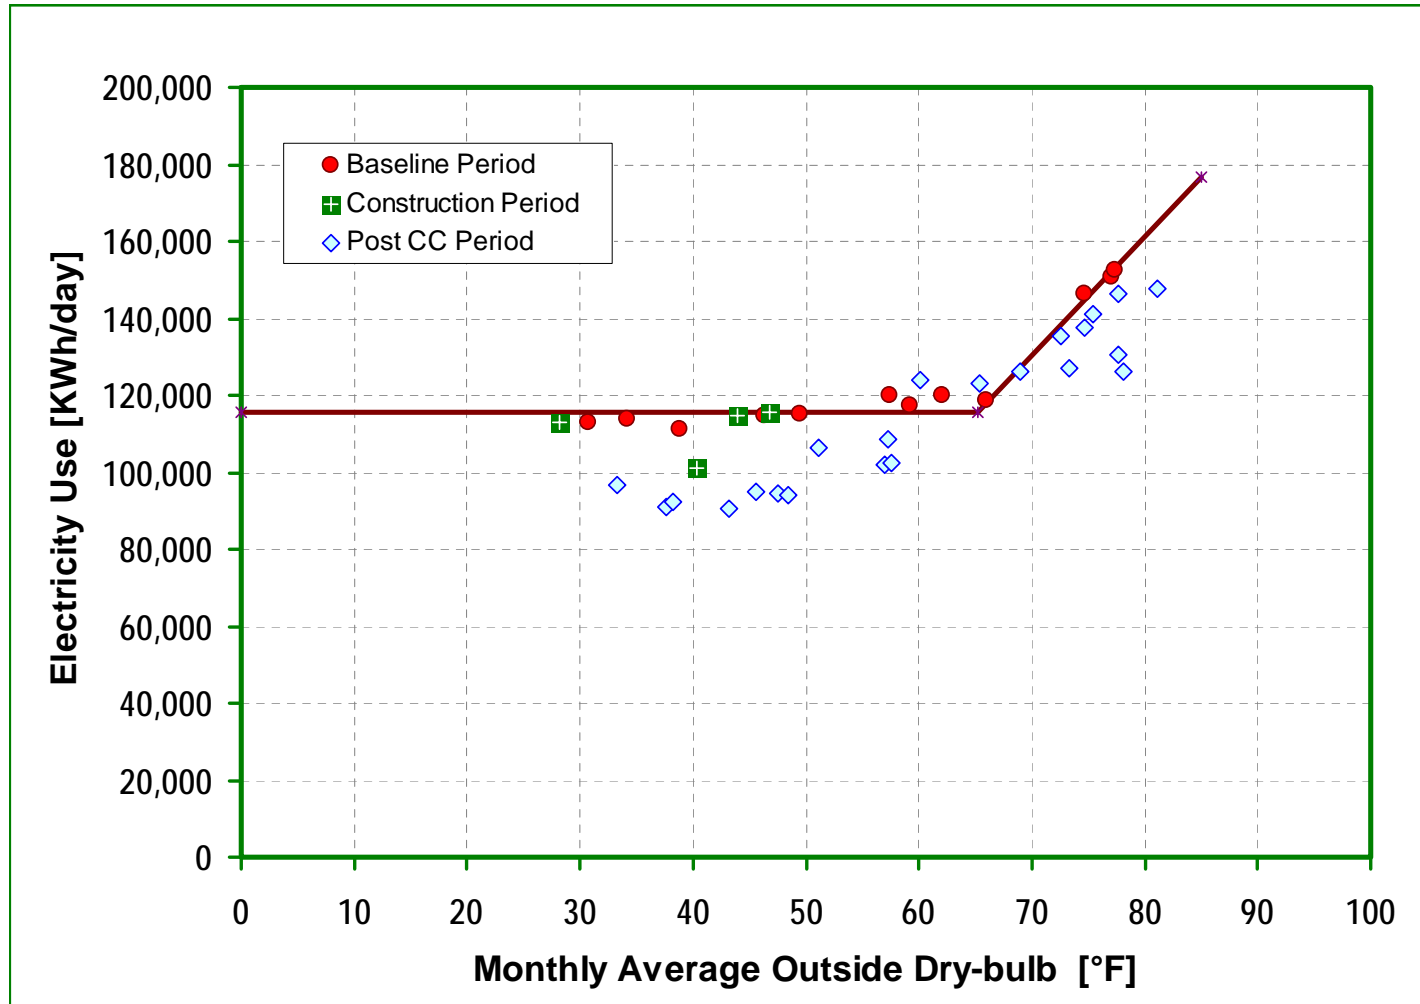
Savings From CC[®]

- Developed a baseline model
 - Based on utility bills and outside air temperature
 - Beginning FY 2002 for electricity and FY 2003 for gas
- Savings determination
 - Difference between baseline estimate and actual utility bills
 - Utility rates of \$0.0641 - \$0.1193 /kWh and \$0.8147 - \$1.1654 /therm
 - Savings were determined from April 2004 Through July 2006

- Total savings estimate: \$1,910,000
- \$1,102,000 from electricity
- \$808,000 from gas
