**Water Loss Test Results
Main 'J' Canal
Delta Lake Irrigation District**

WATER LOSS TEST RESULTS

MAIN 'J' CANAL

DELTA LAKE IRRIGATION DISTRICT

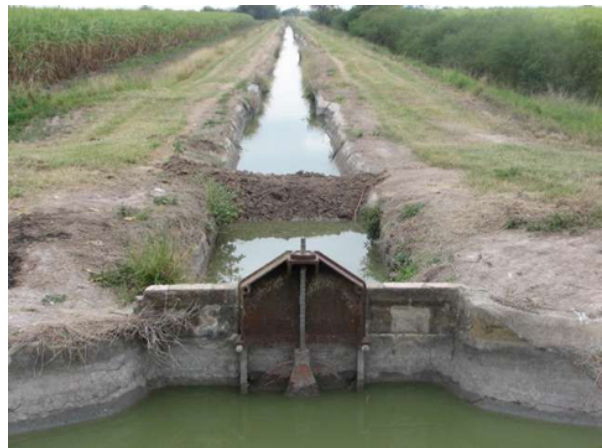
Figure 4. Lateral gate & earthen dam downstream

The test segment DL3 did contain two farm turnout valves and one small head-gate for a southbound lateral canal; thus, the total loss rate was measured. Upon the start of the test, measures were taken to limit water losses through the mentioned control structures. Pretest inspections of the farm turnout valves and the lateral head-gate were performed to check for visible signs of leakage. A small earthen dam was also constructed of just downstream of the lateral head-gate in attempt to rule out losses due to the lateral canal (Figure 4).

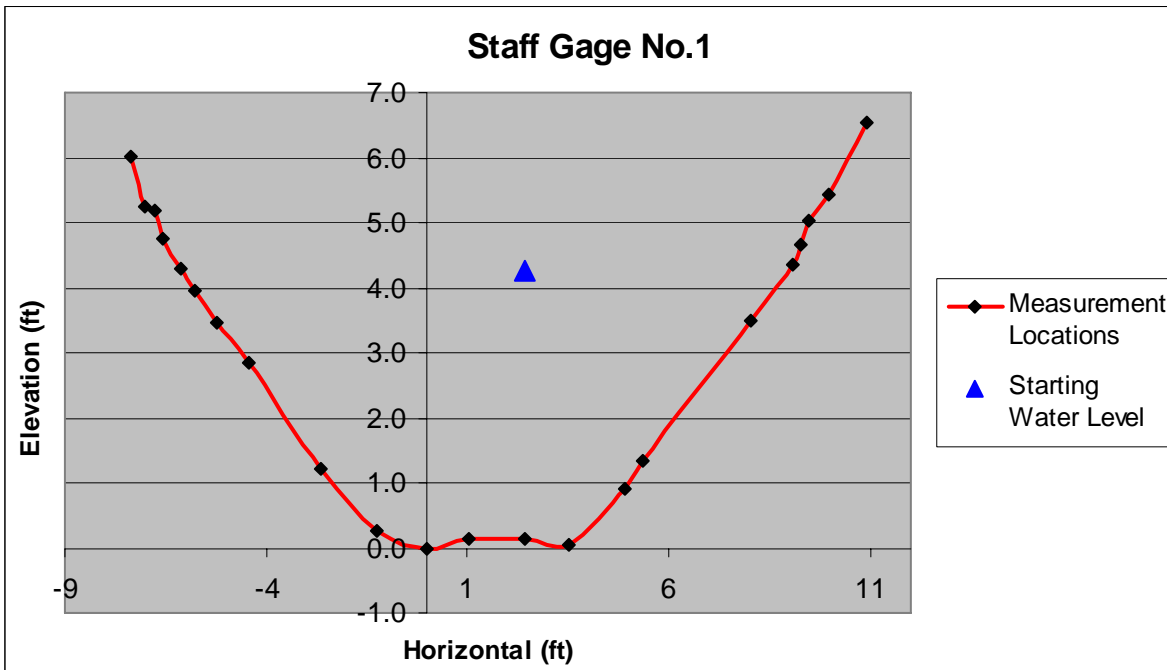
Figure 5. Cross Section at Staff Gage No.1

Table 3 provides details on test DL3 including data collected and recorded changes in water depths during the test. The canal cross sections at the four staff gages are illustrated in Figures 5 – 8. Also shown on these charts are the water depths at the beginning of the test.
