**Point-to-Point Verification of Monitored Sensors at  
Reynolds Army Clinic and Hospital  
Final Report**

**Reynolds Army Clinic and Hospital  
Fort Sill, Oklahoma**

**October 2004**

**Energy Systems Laboratory  
Texas Engineering Experiment Station  
Texas A&M University System  
College Station, Texas 77843-3581**

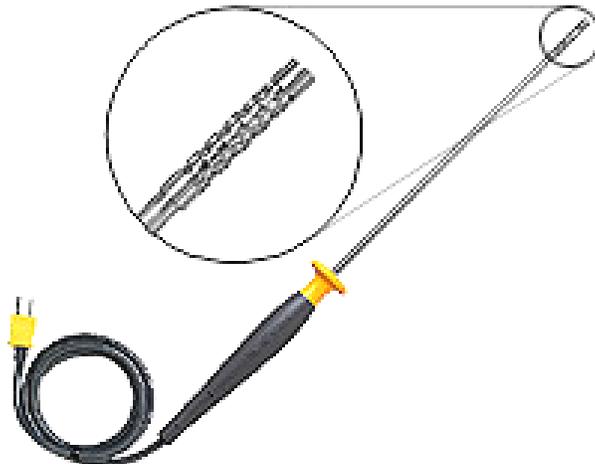
**Figure 1: Fluke 80PK-24 Probe**

The probe is 8.5” long and made from Inconel (See Figure 1). The measurement range is  $-40.0^{\circ}\text{F}$  to  $1,500.8^{\circ}\text{F}$ . This probe is compatible with K-type thermocouples. Error generated by the probe is reduced by the electronic offset function within the digital thermometer. A perforated baffle surrounds the probe to protect it during use.

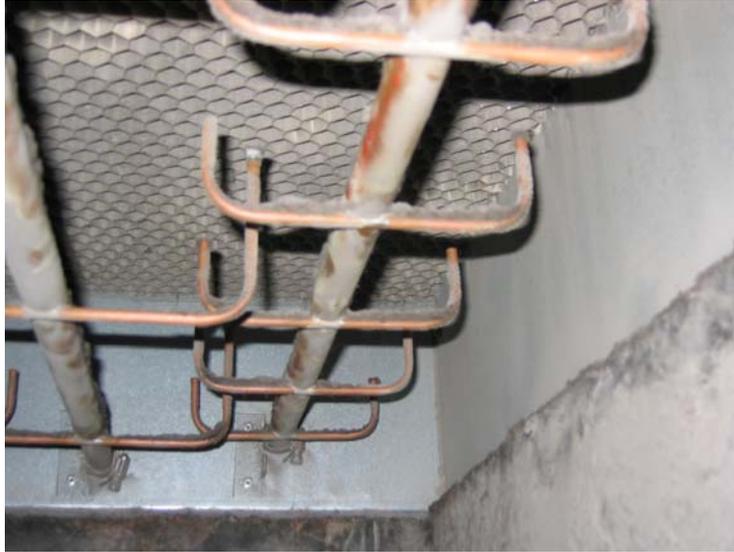
**Figure 3: Return Airflow Station for AHU-130**

Figure 3 is a photograph of a flow station located on the return airside of air handler 130. It is accessible from the return fan plenum. The flow stations used in the other air handlers are not accessible. Notice the excessive amount of dust on the tubing and that some of the tubes that measure the total pressure are completely covered with dust. The blockage is causing the averaging sensor to send a skewed signal to the transducer. In order to illustrate this further, a more detailed picture is provided (See Figure 4).

ESL recommended that each and every flow station be cleaned. Compressed air was used to back flush the tubing assembly. Pressurization of the flow station pitot tubes will force dust from the clogged ports into the ductwork. For future cleanings it is important to remember to remove the lines connecting the transducer or the high pressure will damage it. Service doors should be installed in the ductwork before and after the flow station to remove the excess debris and for preventative maintenance.
