STABILITY OF A LOW-COST SHORE PROTECTION DEVICE

Ocean Engineering

Submitted in Partial Fulfillment of the Requirements of the
University Undergraduate Fellows Program

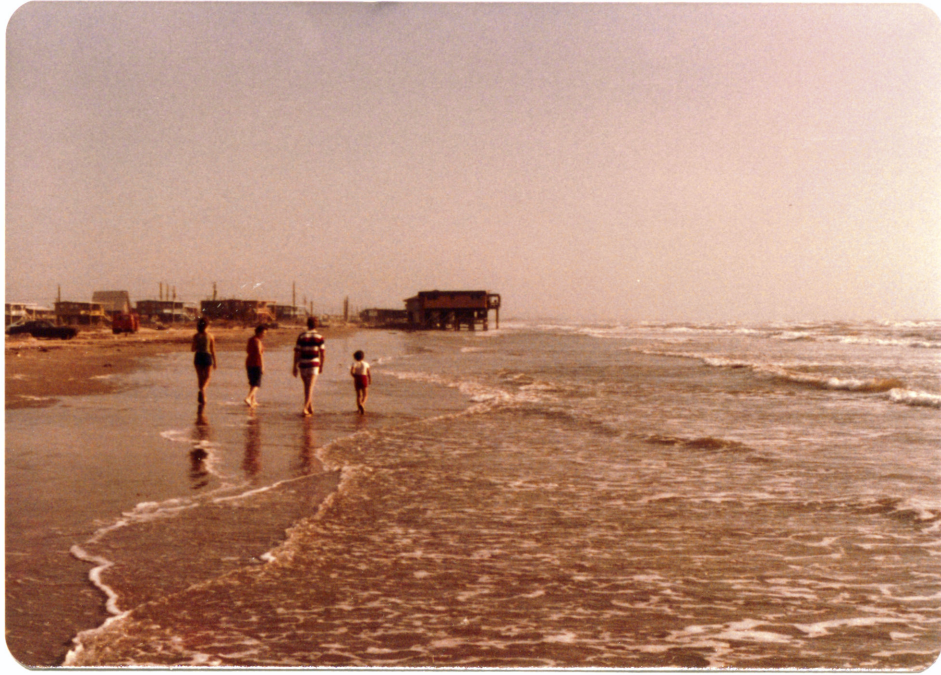
Fig. 2. Surfside Beach Looking Eastward From the Jetty

The city of Surfside, a community located forty miles southwest of Galveston and on the Texas Gulf Coast, has an erosion problem (Barnett, 1975; Dawson, 1976; Riley, 1977). The beach at Surfside has experienced rapid erosion in the last ten years resulting in the loss of several beach homes as seen in Figs. 2 and 3. The citizens of Surfside are demanding that some action be taken to prevent any further deterioration. The Galveston branch of the Corps of Engineers has looked at the Surfside erosion and determined that there is no chance of an expensive conventional solution to the dilemma there. The reason is simple, the loss of several more beach homes will not cause a large enough overall loss to justify the expenses involved in protecting the shore with some type of structure. Since a conventional structure is not feasible due to low benefits, Surfside has three alternatives. The simplest alternative is to do nothing, letting nature take its course (Brazosport Facts, 1977). The next easiest solution is to have the Federal government pay the residents for their homes and relocate the families. The only alternative which might satisfy both the citizens of Surfside and the Corps of Engineers would involve the use of a low-cost shore protection device.

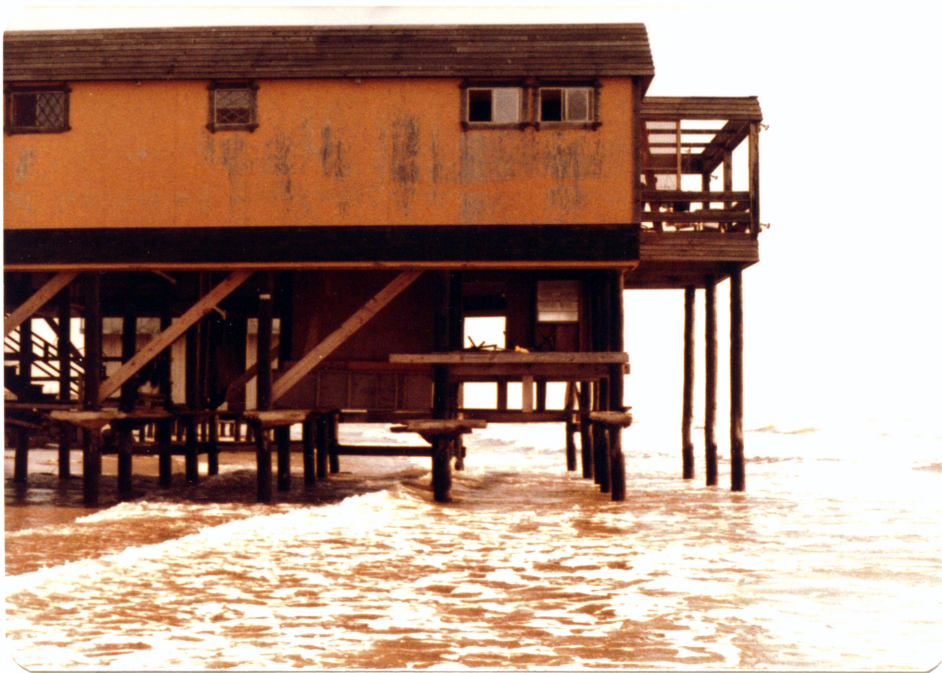
Fig. 3. Close up of Surfside Beach Home

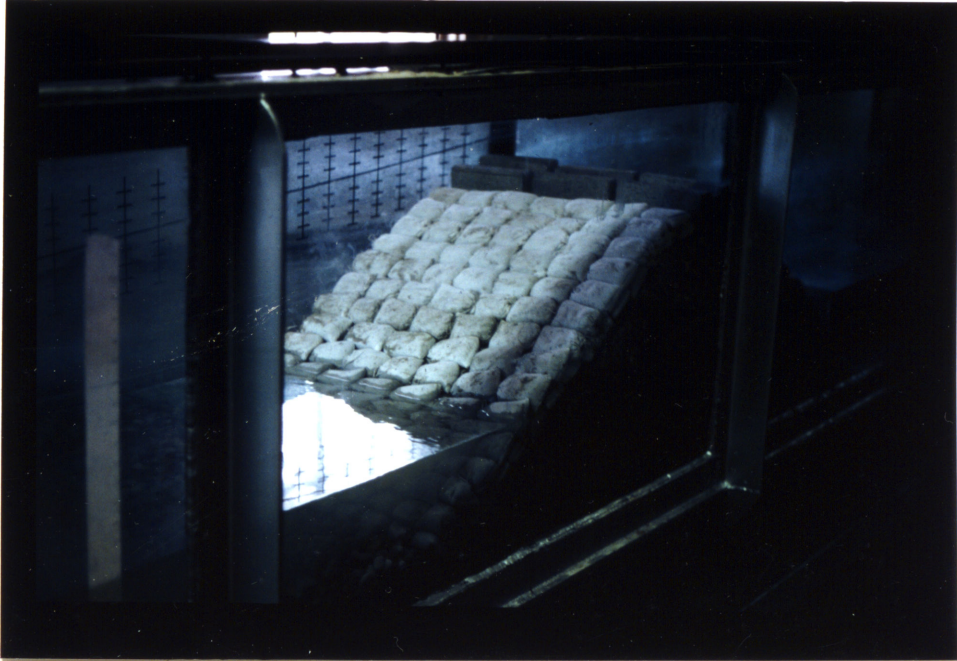
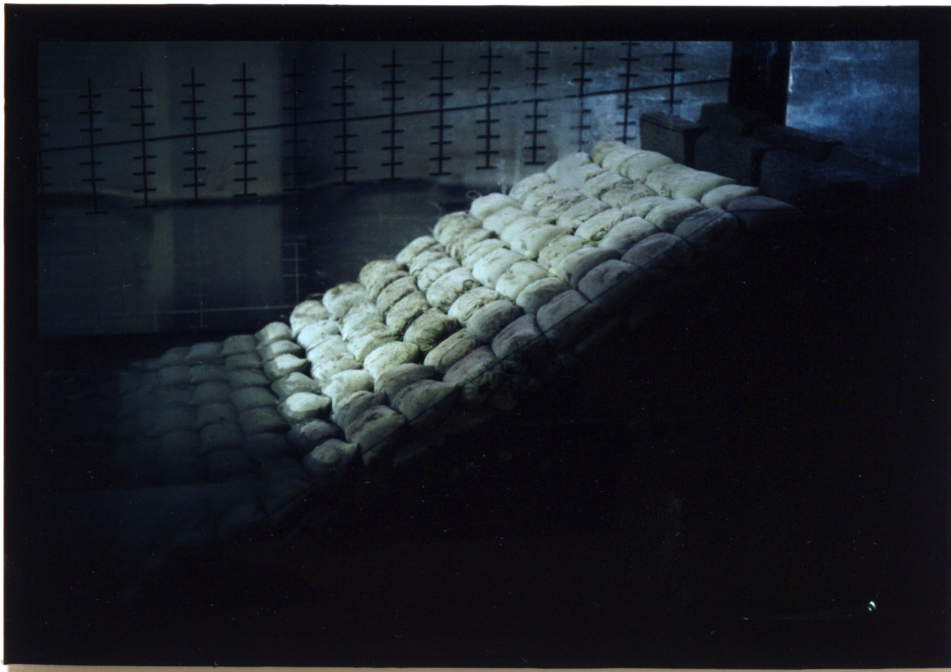
Fig. 6. Breakwater Prior to Testing

Fig. 7. Breakwater Prior to Testing

the guiding lines drawn on the side of the tank. The armor units were filled with mortar made using a sand:cement:water ratio of 3:1:1 in a portable cement mixer. The sand had a specific gravity of 2.60, the cement was Portland cement with a specific gravity of 3.15, and the water was fresh tap water. The bags were filled one at a time, the drawstring was tied closed and each bag placed immediately in the tank. The armor layer was built from the toe upward one row at a time with the long axis of the bags placed perpendicular to the length of the tank as shown in Figs. 6 and 7.

The placement of the bags while soft is probably the most important element in the stability of the breakwater as the units harden together and are difficult to pry apart. All 200 of the bags were put in place as more could have been used. However, since no more bags were readily available the tests were run with the cross section as shown in Figs. 6 and 7. The flume was then filled to the desired depth and the experiment begun.

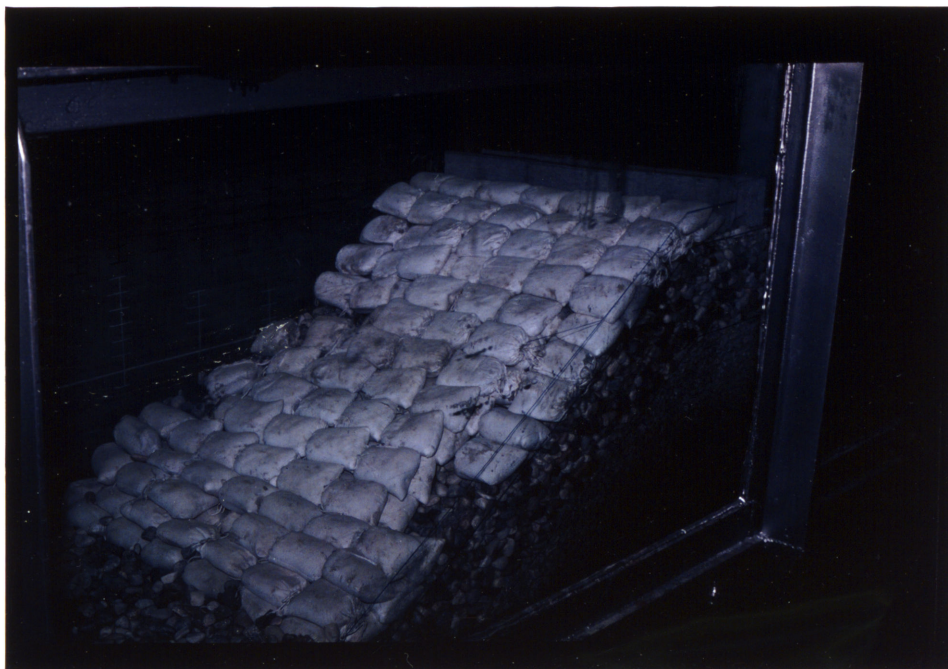
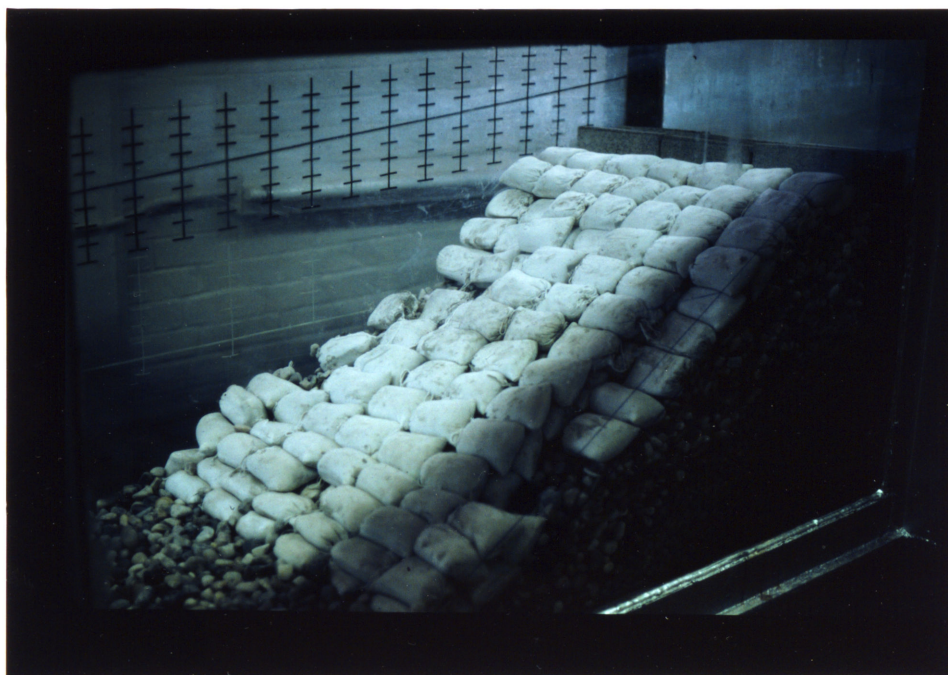
Fig. 8. Breakwater After Completion of Testing

Fig. 9. Breakwater After Completion of Testing

fallen it could be returned to its original position but not to its original strength and stability due to the placement of the bags while soft. The replaced armor units were almost sure of failing again in a subsequent test because of the difficulty in replacing the units in exactly the same orientation as before. The study was terminated after test 13, in which 17% of the armor units had failed, with a breakwater configuration as shown in Figs. 8 and 9.

Test 13. The stroke-length and the wave period were decreased in order to subject the breakwater to more of a deep water wave and to prevent the severe overtopping of the previous test. The water depth was also decreased to 16 inches. Significant damage to the armor layer occurred as 34 bags were displaced. Overtopping was still a problem causing damage to the backslope. Some of the waves broke on the structure. Failure of under-layer stones also detected.

Upon completion of this test the tank was drained and the damage was surveyed. No attempt was made to rebuild the breakwater because of the number of armor units displaced. Test sequence was complete.
