**UNUSUAL SEDIMENTATION OF A GALVESTON BAY WETLAND AT PINE  
GULLY, SEABROOK, TEXAS:  
IMPLICATIONS FOR BEACH RENOURISHMENT**

A Thesis

MASTER OF SCIENCE

Major Subject: Geology

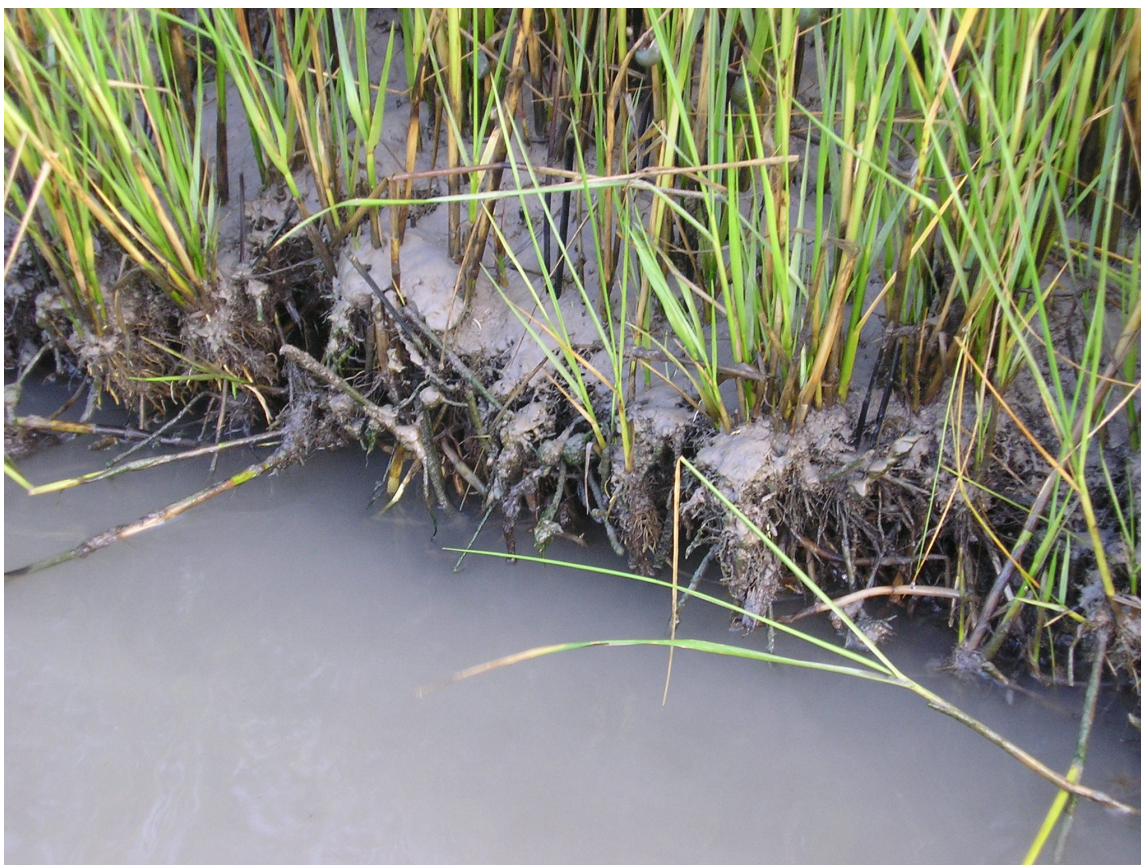
Figure 3. First dusting of sediment observed in Pine Gully, February 2004 (Antrobus, personal communication).

Problems in Pine Gully were first observed by residents in August 2004 when a light dusting of sediment was observed in the wetland grasses after high tide (Figure 3). This phenomenon was a shock even to long-standing residents of the area because they had never seen such sediment deposition in the 25+ years of residency (Sally Antrobus, Personal Communication). After the first dusting of sediment in Pine Gully, the problem continued to get worse. Deposition in Pine Gully eventually produced a sand plug at the mouth of the Gully and caused the wetland to be cut off from Galveston Bay. This has been detrimental to the dynamics of the wetland because it is no longer possible to get nutrient and oxygen rich saltwater flushing from Galveston Bay into Pine Gully. Having the plug emplaced at the mouth of Pine Gully ceased the tidal dominance and created a fresh water lens to build behind what is now effectively a dam made of sand. The source of fresh water trickles in from the small drainage basin of Pine Gully and stagnates. Dominance of this stagnant freshwater for long durations puts undue stress on the once tidally dominated wetland grasses, such as *Spartina alterniflora*. After some time, these grasses succumb to the adverse conditions, slowly dying off in patches (Figure 4). Because the sand plug acts as a dam, the water level can be six inches to a foot higher than normal. These elevated water levels in Pine Gully have killed off hardwoods that lined the margins of the wetland, such as *Ilex vomitoria*, simply because they were submerged for prolonged periods of time (Figure 5). Long durations of freshwater inundation have made it possible for *Bacopa monnieri* and *Scirpus spp.* to out-compete

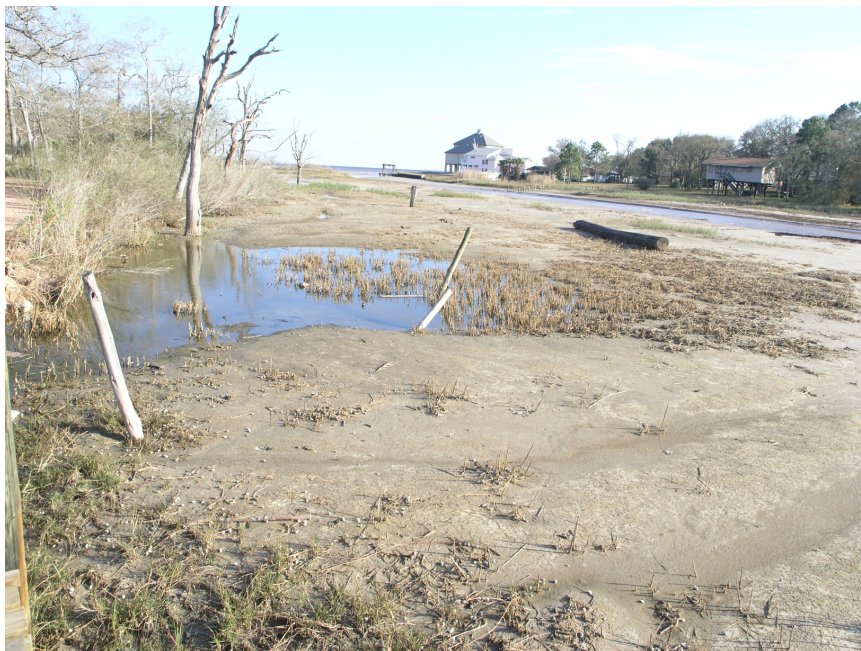
Figure 4. Patches of *Spartina alterniflora* killed by stands of anoxic freshwater and sediment choking. Picture taken March 2007.

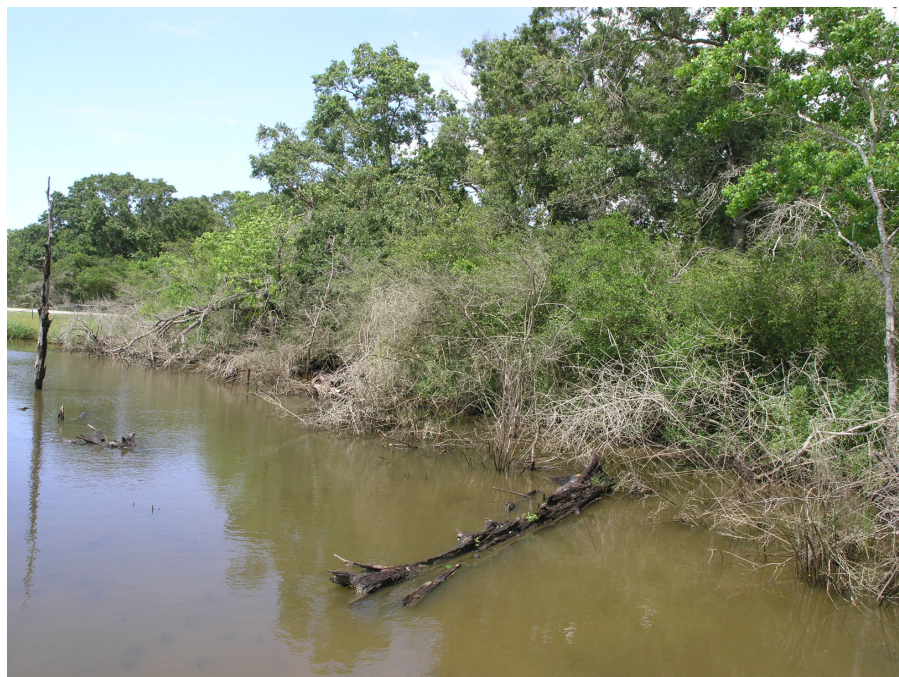
Figure 5. Hardwoods on the margins of Pine Gully killed by high stands of water. Picture taken May 2007.

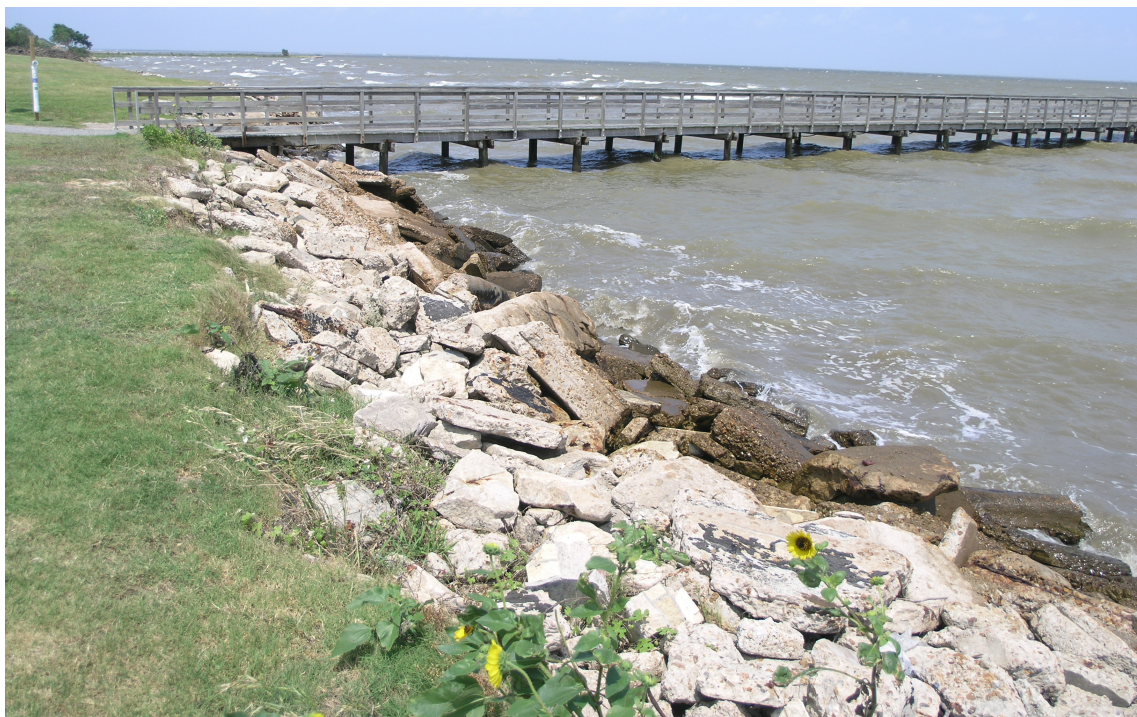
Figure 10. Shoreline armoring with concrete rip rap. Picture taken at Pine Gully Pier, March 2005.

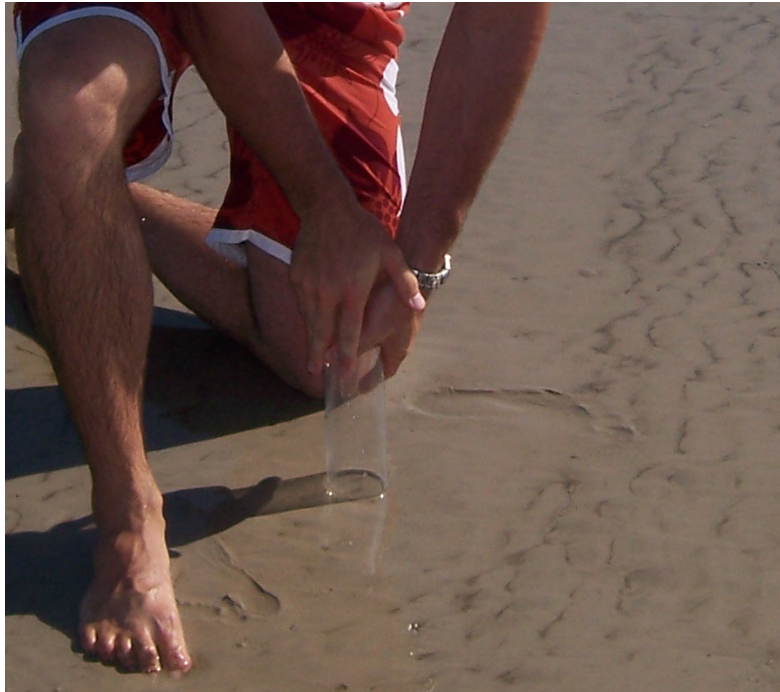
Figure 13. Extraction of core sample by hand using water filled core tube. Photo taken August 2006.

New sediments being deposited in Pine Gully are a fine, quartz rich sand, typical of a coastal environment. Cores of these sands were taken to analyze the properties. To obtain the cores, 2 inch diameter clear polyurethane pipe, 2.5 feet long, was used. These core tubes were then pushed into the ground by hand until about 4 inches above the ground or until refusal. Before extracting the core tube from the sediment, the tube was filled to the top with water. Filling the tube with water enabled a suction to be created using the palm of my hand (Figure 13). Full recovery was achieved unless the core hit refusal. The core samples were then marked for future identification and a GPS point was taken to reference the location for each core. To package the cores, wet paper towels were stuffed in the space at the top of the tube to keep the samples moist. To seal the samples, small plastic bags were used that fit snugly over both ends of the tube and then sealed with tape.

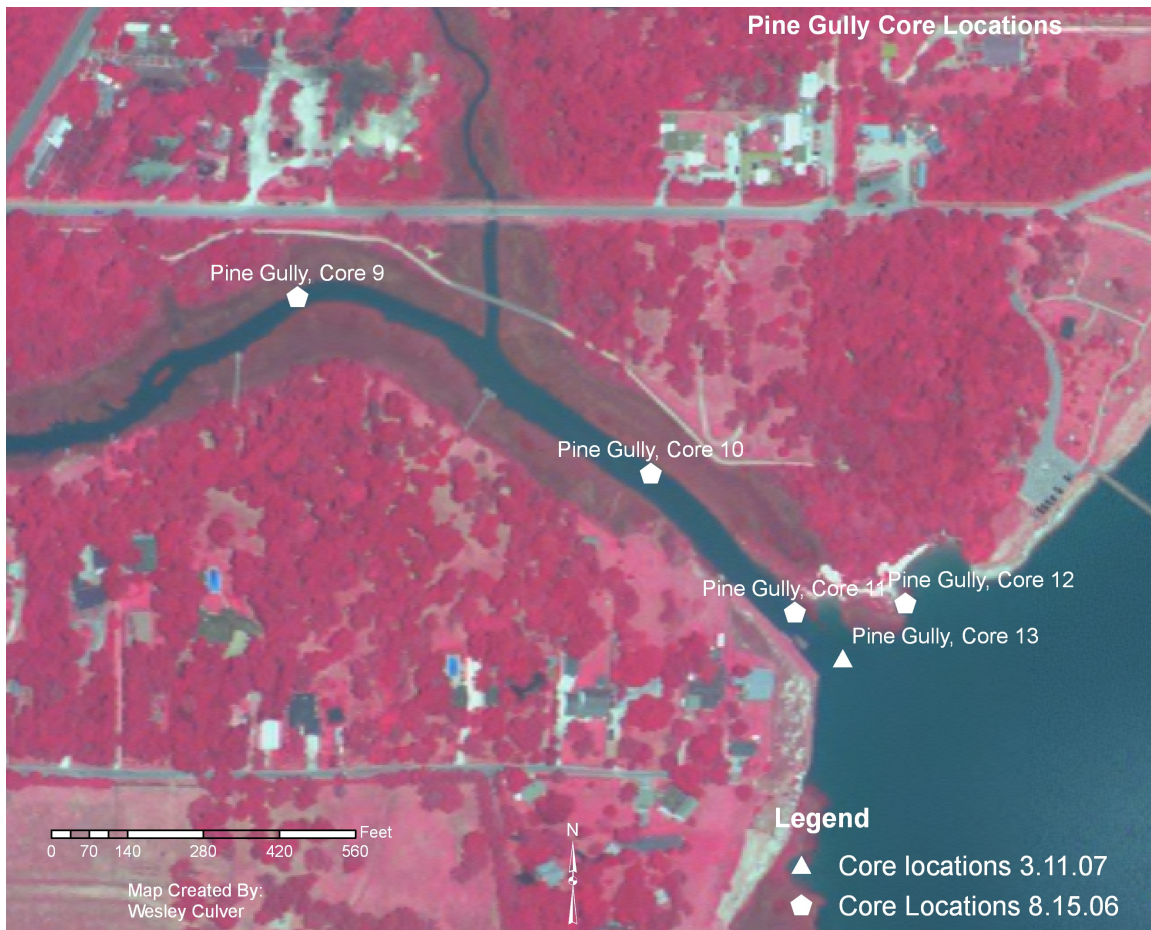
Figure 15. Location map for cores collected in Pine Gully on 15 August 2006 and 11 March 2007. Data plotted on the 2004 NAIP aerial photo from TNRIS.

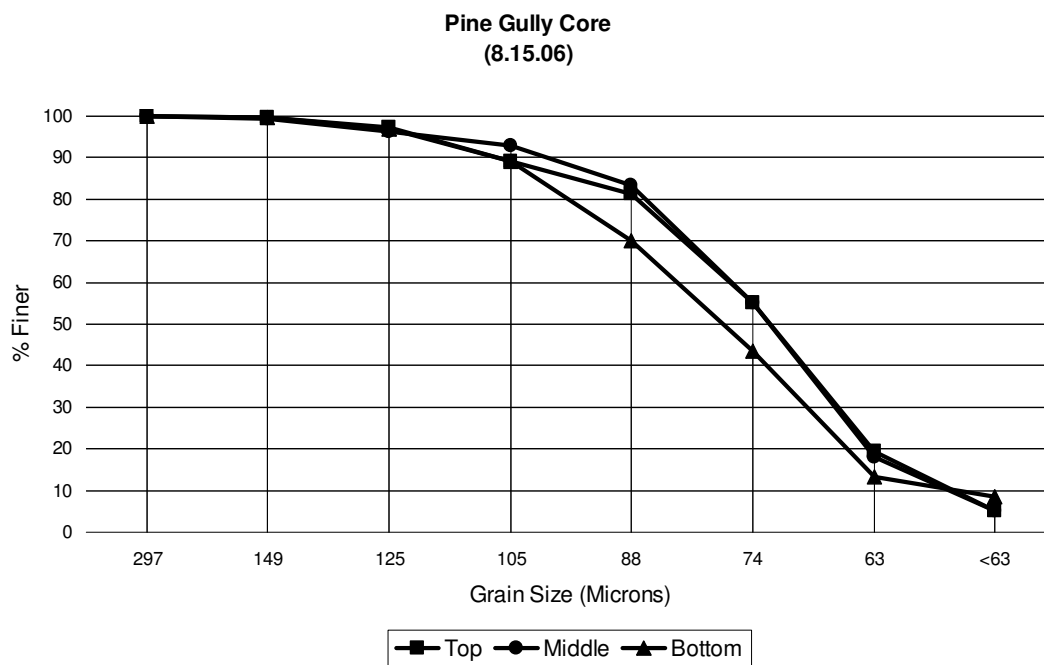
Figure 17. Percent finer curve for Pine Gully from the sampling date 15 August 2006. Notice the deviation of the bottom sediments from the middle and top sediments.

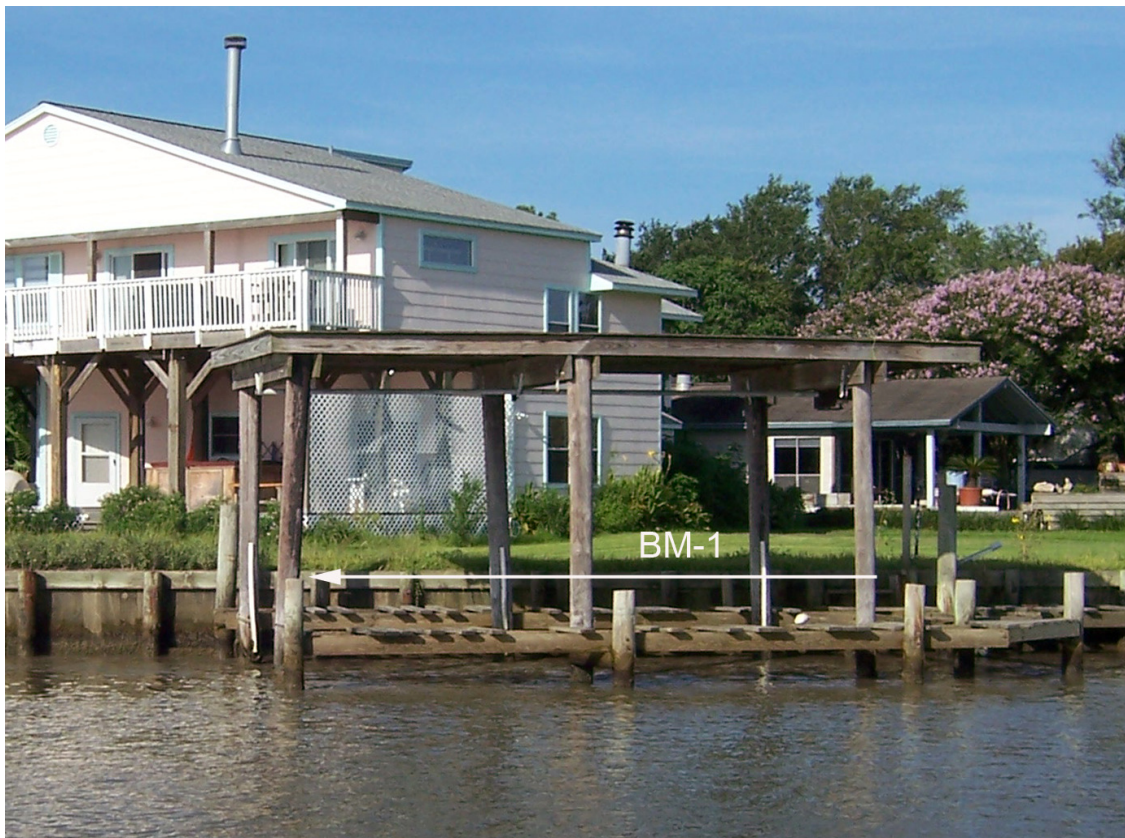
Figure 19. Picture of the boat dock used as the benchmark for the survey. Arrow labeled BM-1 shows the top of the pile used for the benchmark in this survey. Photo taken August 2006.

In an effort to look at the profile of the shoreline at Pine Gully and attempt to capture the addition of sediment, a beach survey was done at the mouth of Pine Gully. This would supply unmistakable evidence that shoreline accretion occurred at the mouth of Pine Gully. An unconventional method was used to collect the data because this method only required at most two people and was designed to be efficient. To collect the data, a Lasermark<sup>®</sup> LMH Series laser level system was used. The laser level was set atop a tripod so that line of site could be achieved for the whole survey in that location. The Universal Laser Detector included with the System was attached to a Measuremark<sup>®</sup> F/G Rod by CST/berger survey rod. The Universal Laser Detector would respond to the Lasermark unit when it was at the correct level. Once the survey rod was stabilized, the corresponding height of the rod was recorded along with the GPS position of the reading. The GPS unit used was a Garmin<sup>®</sup> GPSmap 76C, with a horizontal accuracy of plus or minus 15 feet. To be able to carry the data sheets and the GPS unit efficiently, a fitted plastic frame was purchased and hard-mounted on an extended clipboard. This system was user friendly and efficient, and many points were mapped in a short amount of time. This Pine Gully survey was tied to the northeastern most pile on the boat dock in the Pine Gully channel, Figure 19.

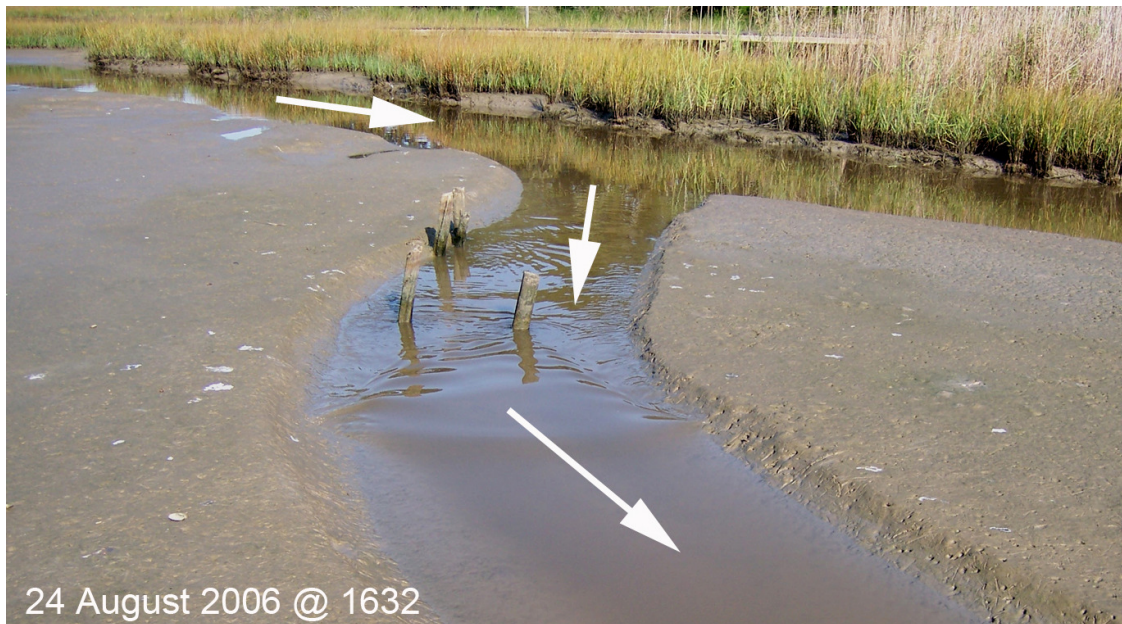
Figure 22. Picture of a marine bore wave in the upper portions of Pine Gully seen by the turbulence caused by the small piers in the picture. Arrows direction and point out pictured bore wave location.

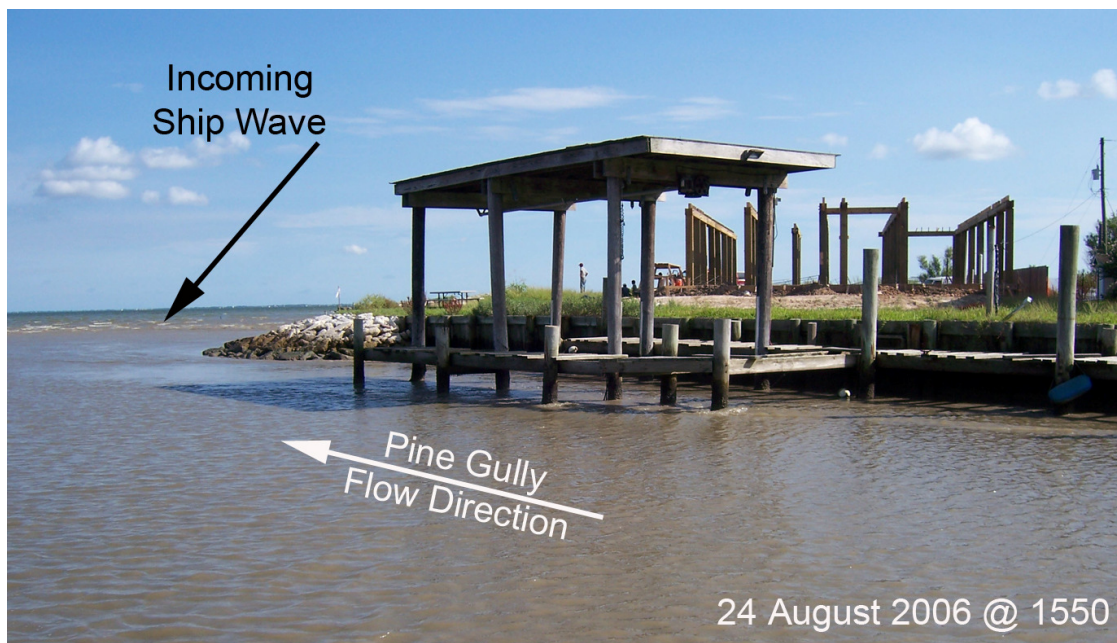
Figure 24. Photograph taken on 24 August at 1550 (3:50 PM) showing the impact of an incoming type “B wave” on the circulation in Pine Gully. Note that the arriving hull wave is visible just offshore while the current in Pine Gully is flowing toward the incoming wave. The standing wave against the right pile on the dock across Pine Gully demonstrates the significance of this outward flow. The graph below the photograph shows the wave record for the period of the photograph above. Note on the wave record that the water level dropped more than 1 foot in about 2 minutes and rose about 1.5 feet over the next 3 minutes.

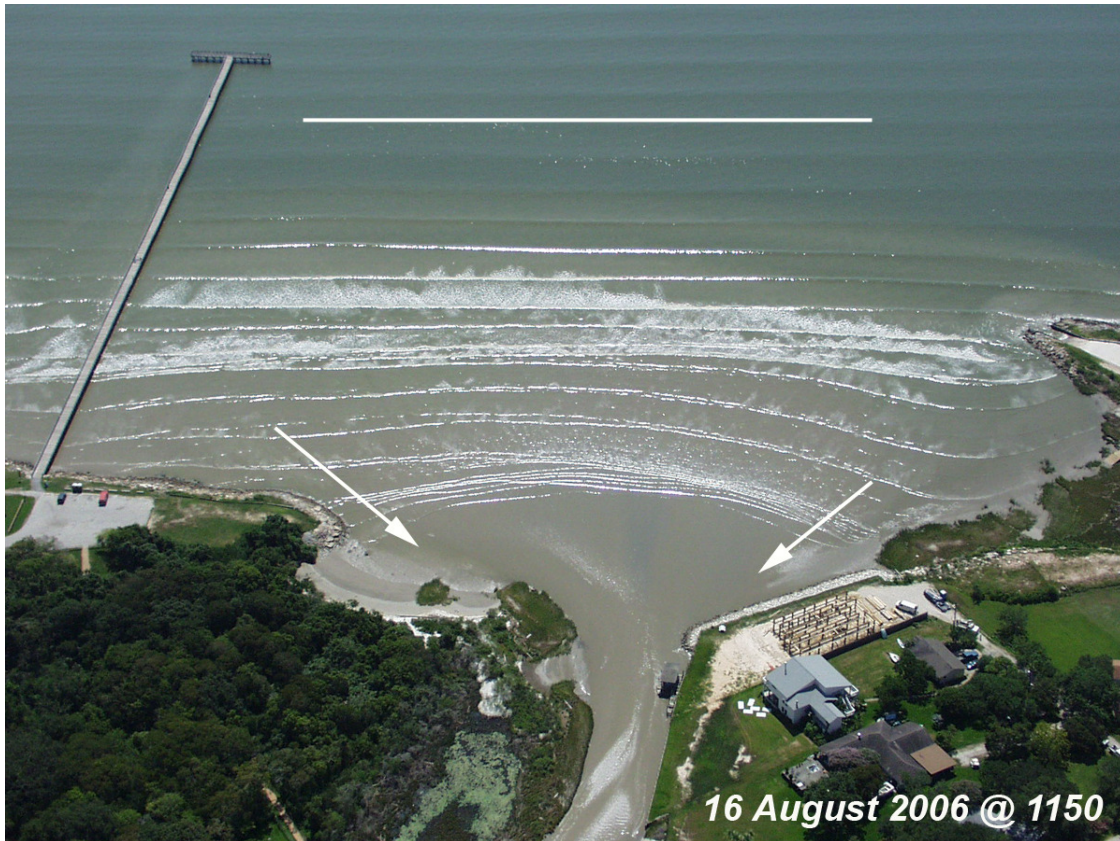
Figure 25. White line shows incoming waves are parallel offshore, then as the wave train approaches the sand bar the waves “feel bottom” and refract around the sand bar. Every train of ship waves brings in more sand to Pine Gully in this way.

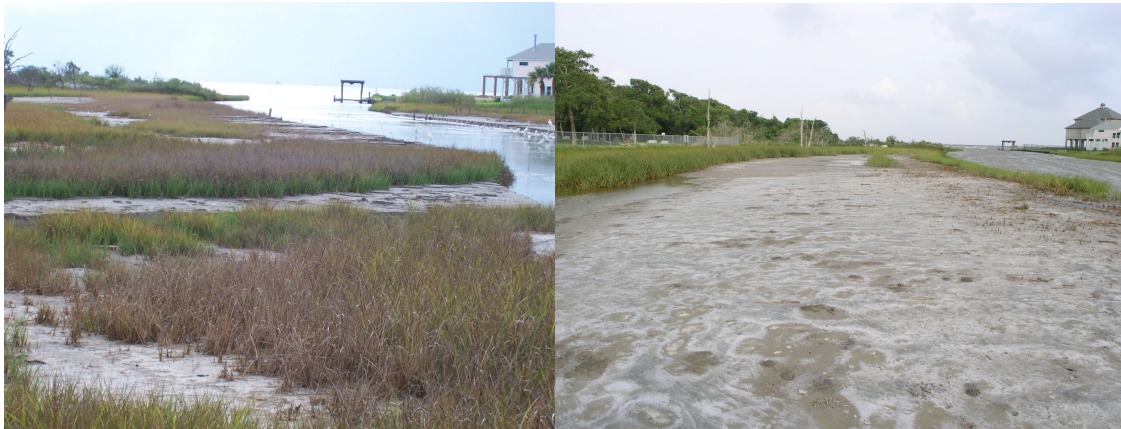
Figure 26. Left photo taken 25 August 2006, right photo taken 24 May 2007. Notice how much of the wetland grasses in similar areas of the photos have been lost and replaced by salt flat.

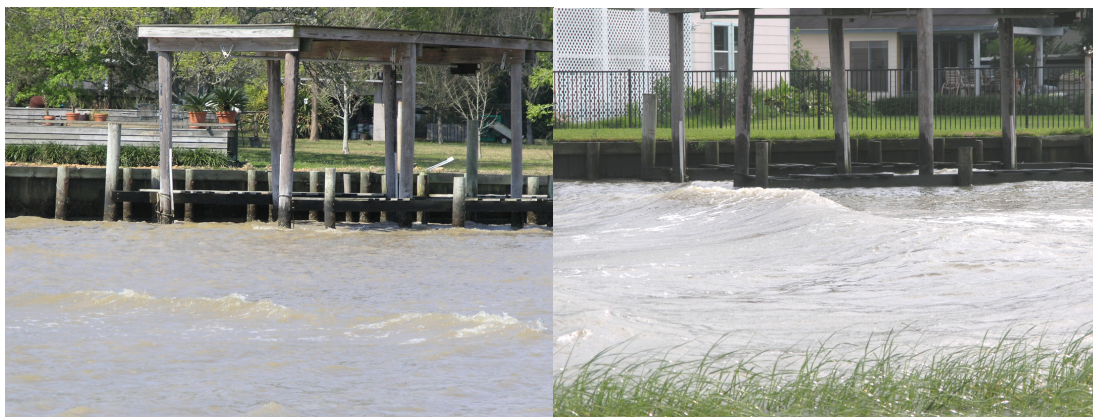
Figure 27. Picture taken 10 March 2007 on left shows lower water level at mouth of Pine Gully than in the picture taken 24 May 2007 on right where the water level is over one foot higher.

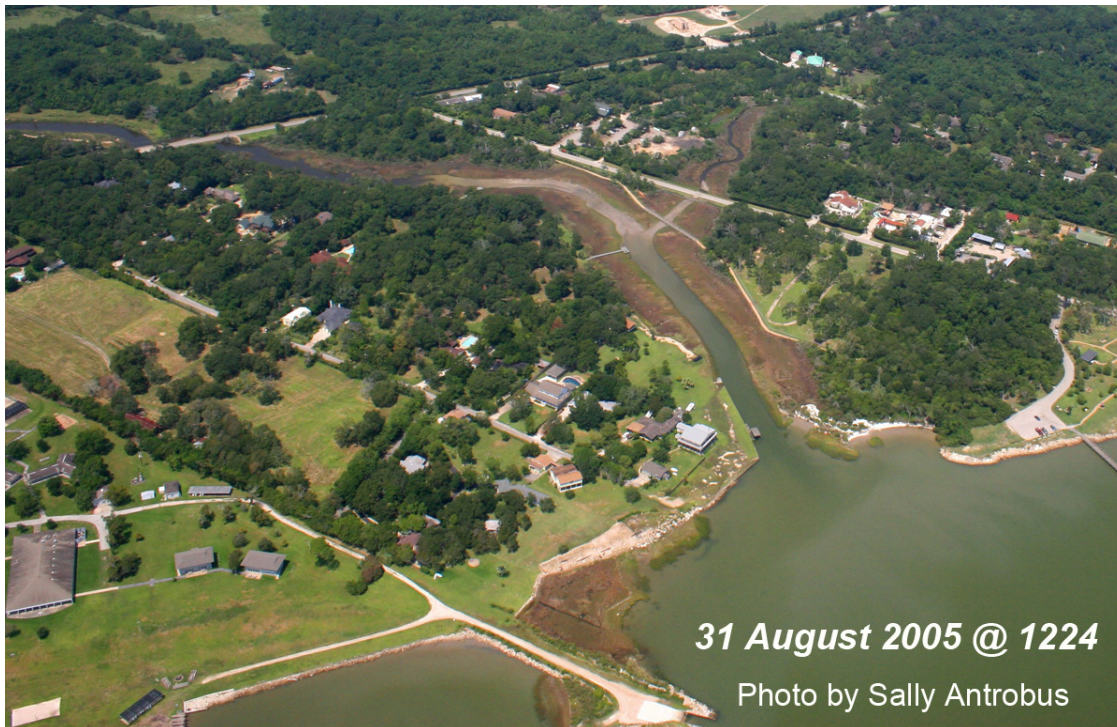
Figure 28A. Picture taken 31 August 2005 by Sally Antrobus. Note the rising tide at +0.6 feet. This marks the beginnings of sedimentation as the north tributary has been plugged and the main channel of Pine Gully has been plugged.

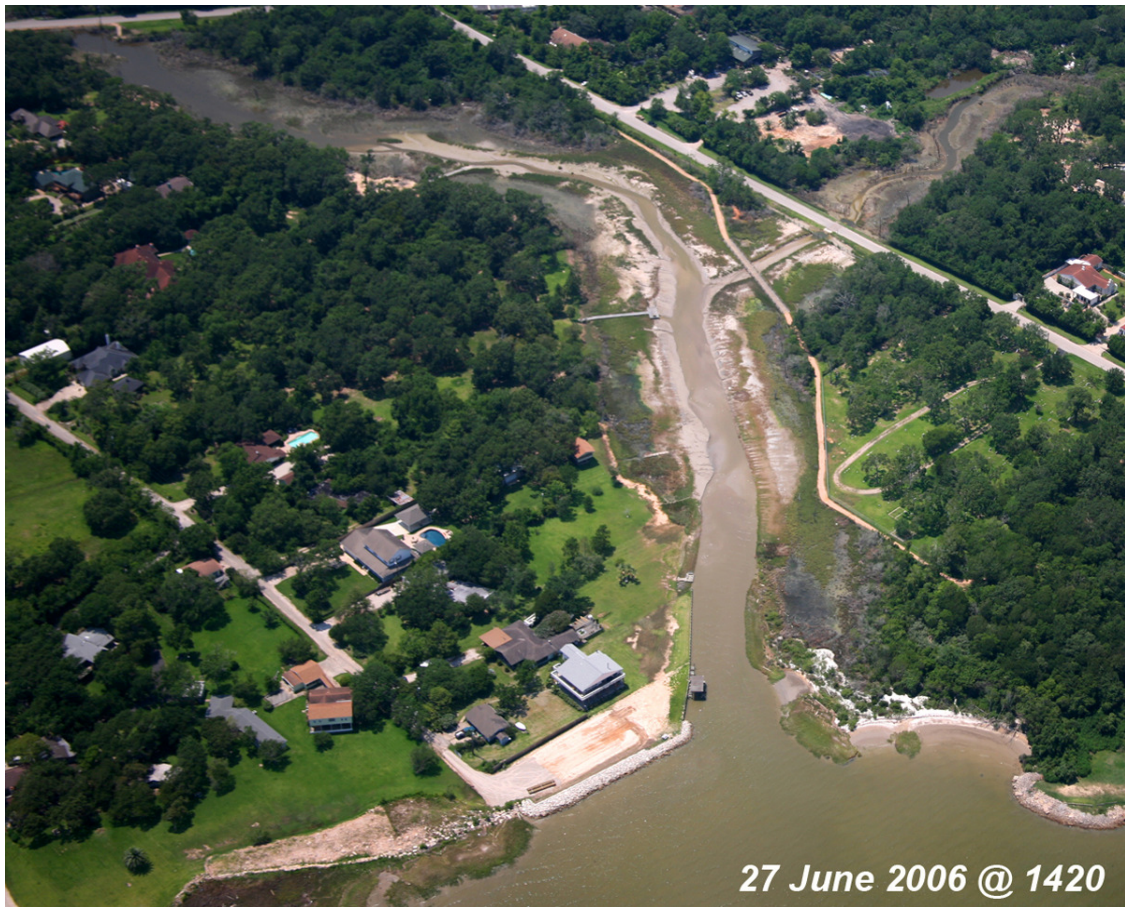
Figure 28B. Aerial view of Pine Gully sand plug on 27 June 2006 (tide level is rising currently +0.2). Note that the sand plug has advanced toward Galveston Bay and that the sand levees are clearly visible along both sides of Pine Gully.

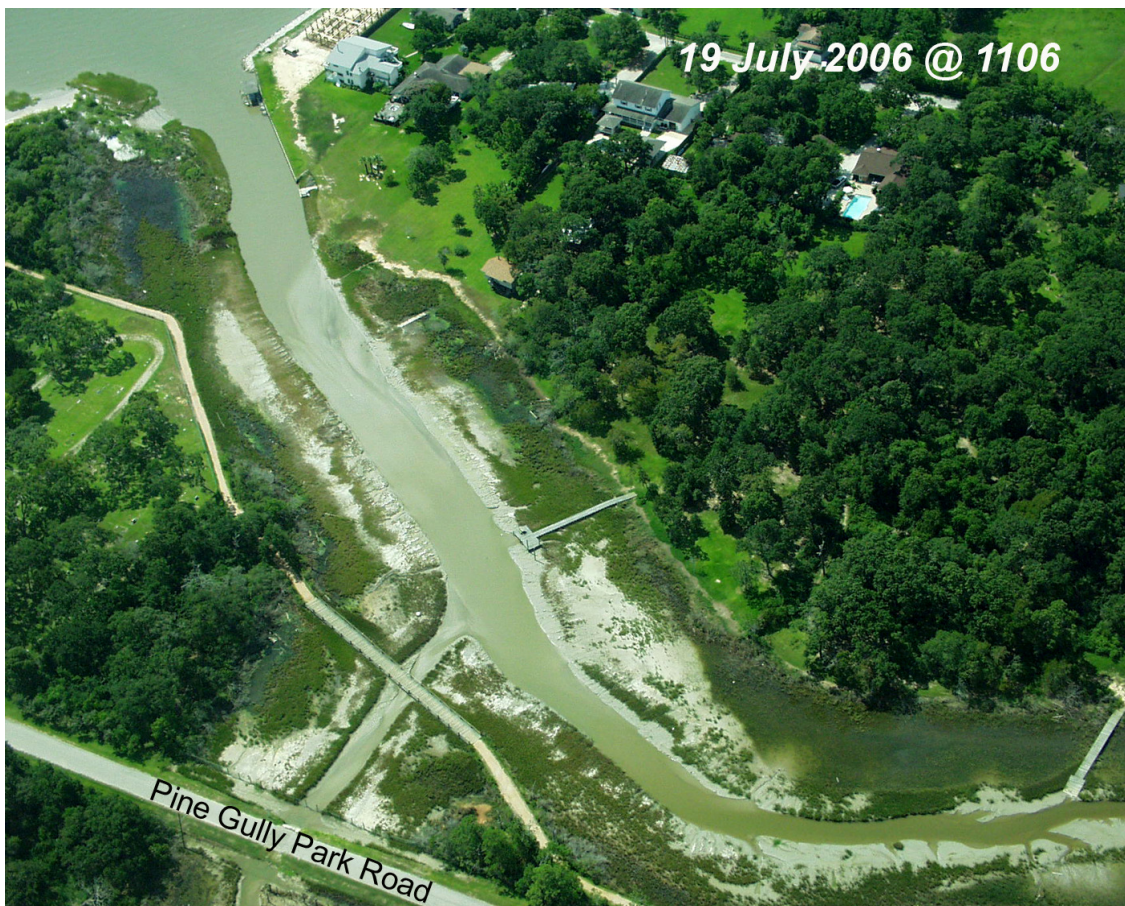
Figure 28C. Aerial View of Pine Gully on 19 June 2006 (tide is currently +0.6 feet). Note that the sand plug has advanced toward Galveston Bay in the 23 days since the previous photograph and that the sand levees are more developed.

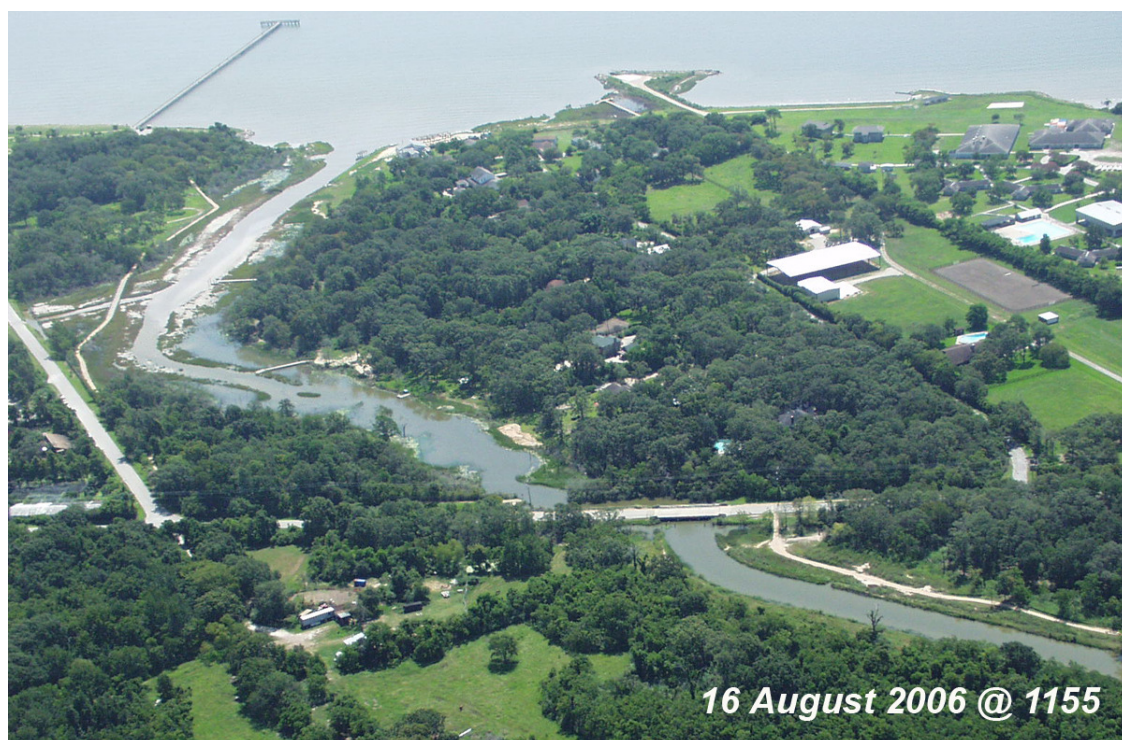
Figure 28D. Aerial view of Pine Gully on 16 August 2006 (the tide is currently at +1.1 ft). Note the ponded freshwater behind the sand plug and the extent of the plug. Sand levees are clearly visible above high tide along both banks of the Pine Gully channel.

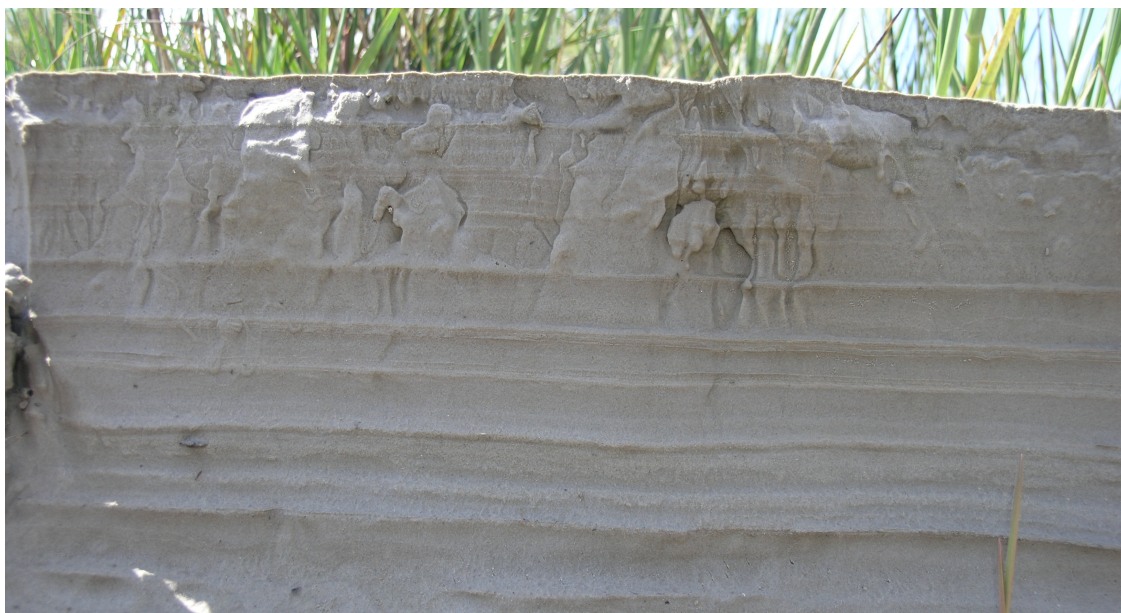
Figure 29. Laminations of sand brought into Pine Gully by bore waves. Each of the laminations marks more sedimentation from a bore wave. Photo taken March 2007.

Photography helped interpret the process of filling Pine Gully with sand. The marine bore waves carry excess sediment into Pine Gully and deposit sediment slowly over time, shown in Figure 29 as small laminations of sand. This eventually produces overbank deposits that spill out into the wetland. During a storm event, the Pine Gully channel is flushed out and levees are produced along the side of the channel. Figure 30 shows levee deposits in Pine Gully after the channel has been flushed out by a rain storm. After the flow in Pine Gully subsides, the bore waves are able to resume silting the channel. But this time the bore waves are forced to stay in the channel by the levee deposits remaining. This ultimately forces sediment further into Pine Gully each time this process begins again. Figure 31 is a schematic of this process.

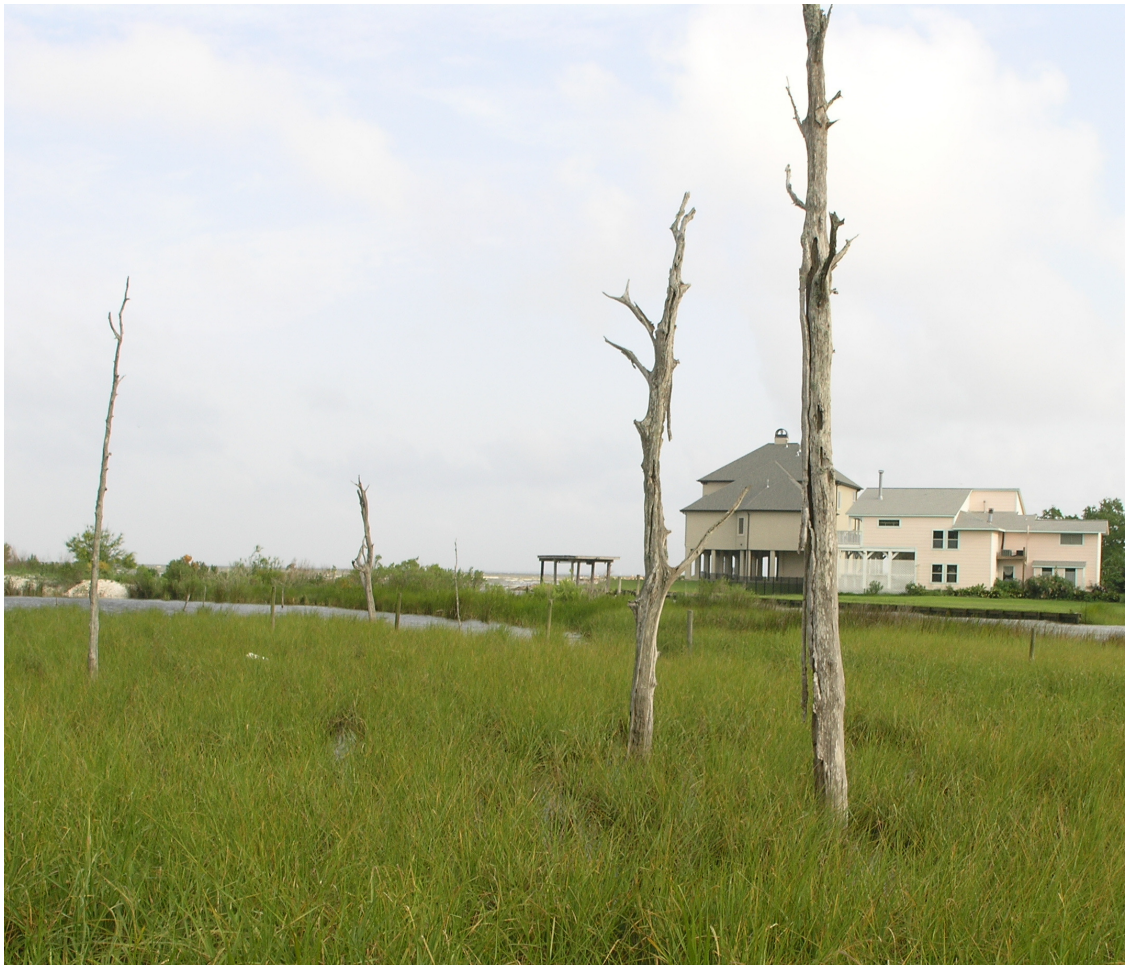
Figure 32. Dead hardwoods from an upland setting in what is now the Pine Gully wetland. Photo taken March 2007.

The hypothesis that Pine Gully is just naturally returning to its pre-subsidence state, or that nature has a “memory” of past conditions and will naturally gravitate back toward that condition, has little supporting evidence. The area where the Pine Gully wetland exists today used to be upland in the past. This is evidenced by tree trunks preserved in the wetland (Figure 32). In the introduction of this paper, I showed that over 300 meters of shoreline erosion has taken place since 1944. To return Pine Gully to historical conditions, at least some shoreline must be re-established. With the sedimentation at Pine Gully no significant shoreline addition has occurred to make the “memory” hypothesis valid. Continued sea level rise will make the situation even worse in the future for Pine Gully as the land is submerged by the bay. Evidence against a “memory” of past conditions in Pine Gully because of shoreline erosion exacerbated by sea level rise and a permanently altered shoreline environment will never allow Pine Gully to naturally return to historic conditions without human intervention.

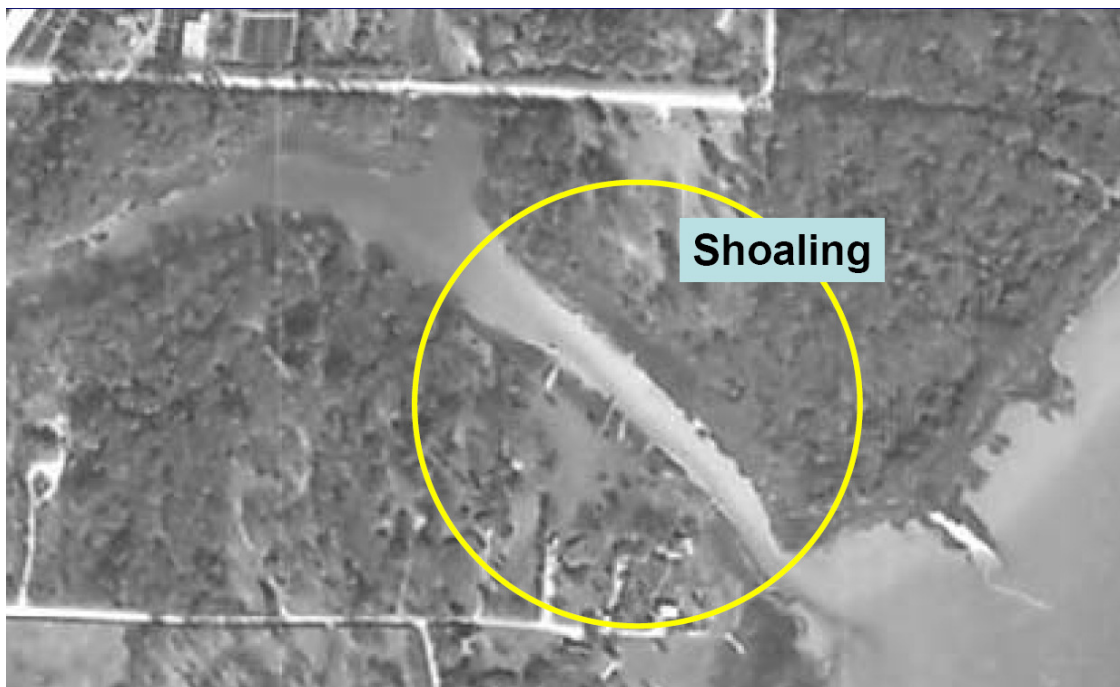
Figure 33. 1982 aerial photograph of Pine Gully report given to the City of Seabrook by Dr. Sherman. Figure is pulled directly out of presentation.

Dr. Sherman's presentation about subsidence causing a shoaling process to form, progressing up Pine Gully over time, interpreted aerial photography in a misleading way. The evidence presented for this hypothesis was a series of historical aerial photographs that show light colored areas in Pine Gully. The aerial photos Dr. Sherman used in his presentation are presented in Figures 33 through Figure 37 and Figure 39. All six of these photos are from his presentation given at the City of Seabrook meeting.

Each of the photos, starting in 1982, has an area circled in yellow that highlights the proposed shoaling locations. In each subsequent year after 1982 and up to 1990, the shoaling location appears to move up-stream in Pine Gully. The misconception with this hypothesis is that the black and white aerial photographs used for this analysis are assumed to exhibit excess sediment, or shoaling, depositing in the light colored areas of the Gully. These light colored areas are really just bare ground, or areas without vegetation. These areas should not automatically be interpreted as areas with excess sedimentation. Dr. Sherman interpreted these light colored areas as excess sediment that was part of a progressive shoaling process migrating upstream in Pine Gully. The described shoaling process is actually not shoaling at all. Freshwater wetland grasses are dying off as a response to the land being submerged with saltwater after the effects of subsidence and continued sea level rise. The aerial photos show areas that resemble shoaling once the freshwater grasses have died; yet these areas are healed in subsequent photos as the saltwater vegetation moves into the bare area, replacing the freshwater grasses. Figure 38 is an aerial photo retrieved from the TerraServer operated by

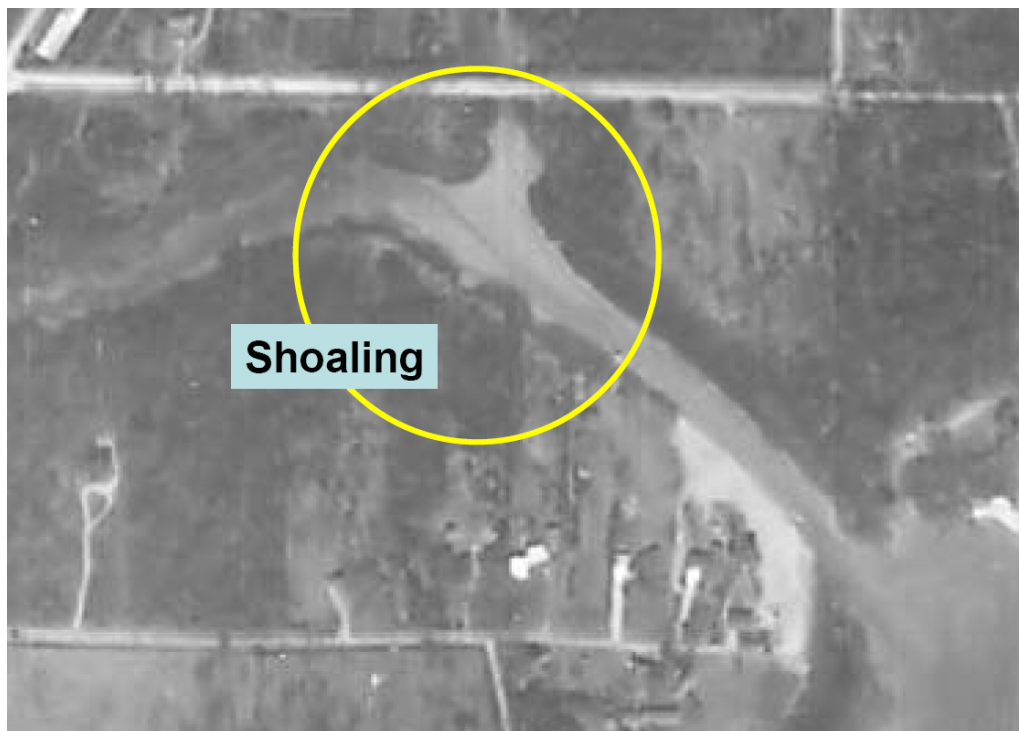
Figure 34. 1984 aerial photograph of Pine Gully report given to the City of Seabrook by Dr. Sherman. Figure is pulled directly out of presentation.

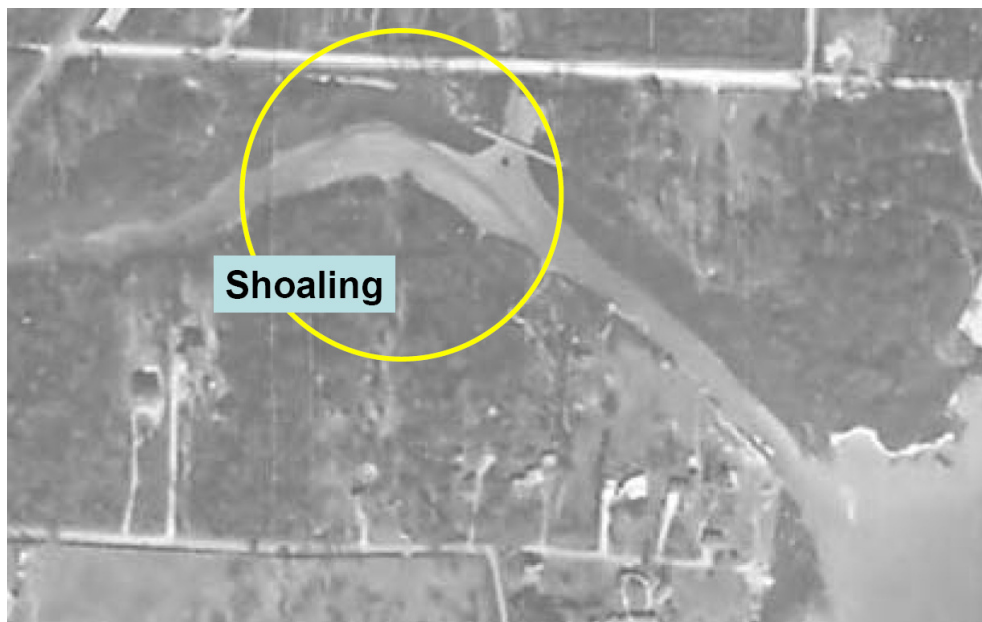
Figure 35. 1986 aerial photograph of Pine Gully report given to the City of Seabrook by Dr. Sherman. Figure is pulled directly out of presentation.

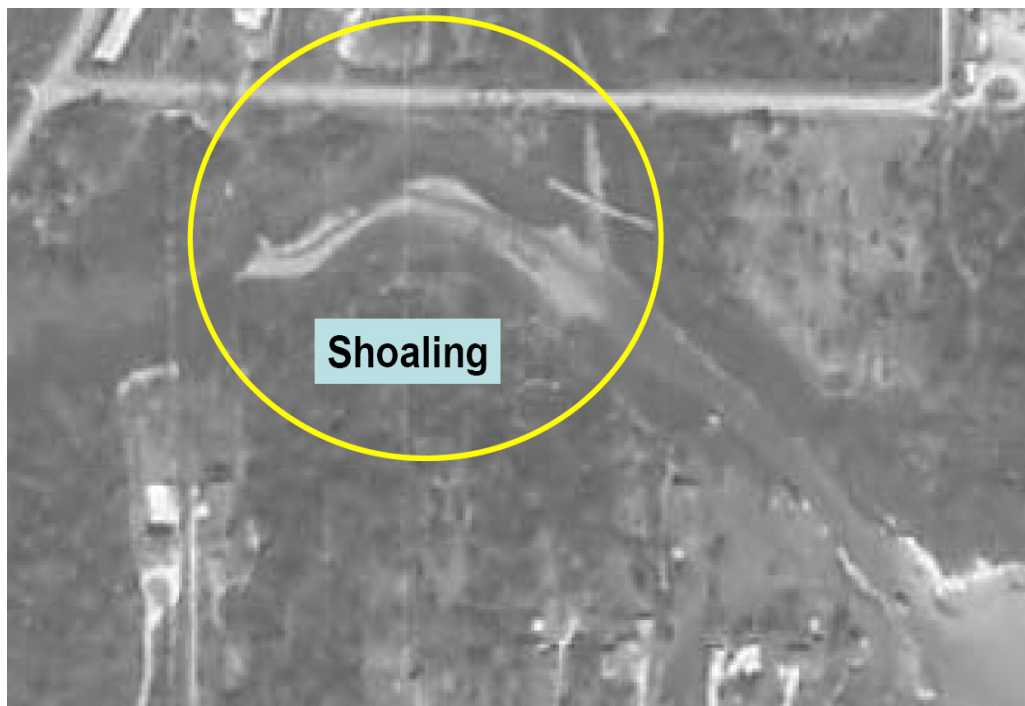
Figure 36. 1989 aerial photograph of Pine Gully report given to the City of Seabrook by Dr. Sherman. Figure is pulled directly out of presentation.

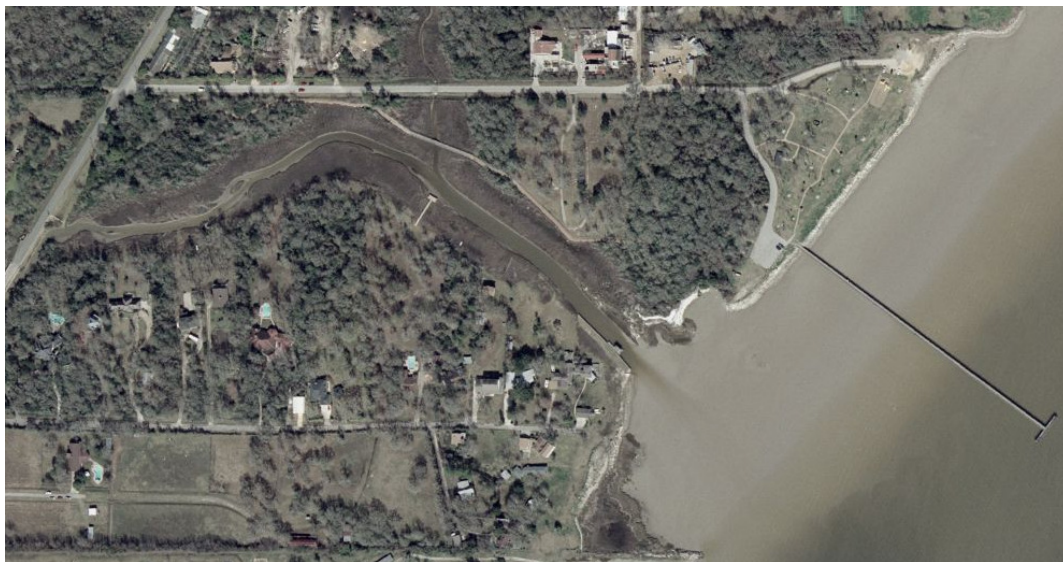
Figure 38. 2002 aerial photograph of Pine Gully collected from the TerraServer run by Microsoft. The photo was provided to the TerraServer by the USGS. Notice the lack of any sedimentation in this 2002 aerial photograph.

Microsoft. These photos are provided to the TerraServer by the USGS. The date of this photo is January 2002. There is no evidence of any shoaling in this photo, but suddenly in Figure 39 there appears to be massive amounts of sedimentation in Pine Gully. Three yellow circles exist from the mouth of Pine Gully to just past the north fork of Pine Gully. If this is part of the same shoaling process described in the past aerial photographs, and that seems to disappear in the 2002 aerial photo, the shoaling process should not have gotten closer to the mouth of Pine Gully, but should have continued its progression inland.
