**UNUSUAL SEDIMENTATION OF A GALVESTON BAY WETLAND AT PINE  
GULLY, SEABROOK, TEXAS:  
IMPLICATIONS FOR BEACH RENOURISHMENT**

A Thesis

MASTER OF SCIENCE

Major Subject: Geology

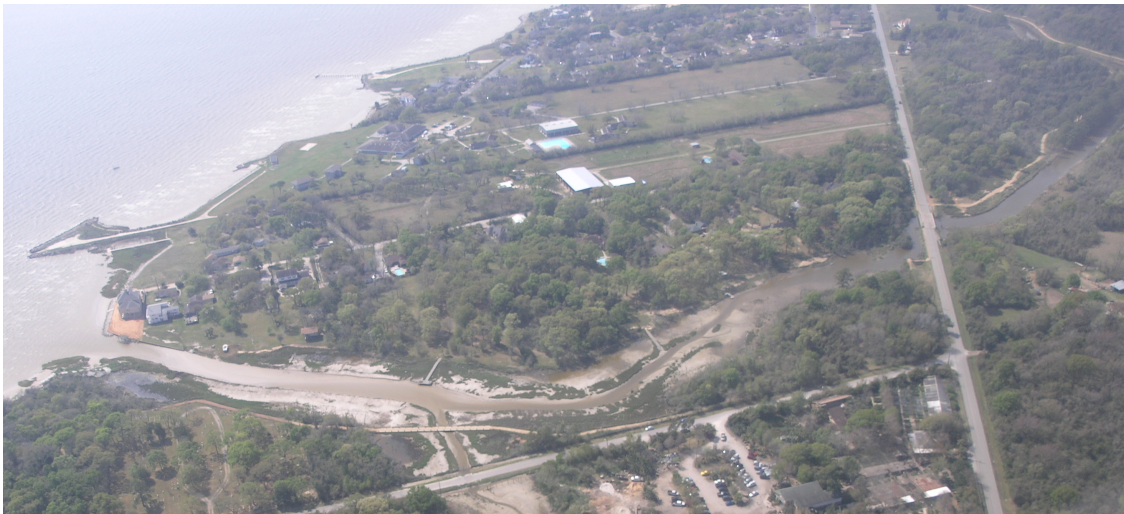
Figure 41. Aerial photo of Pine Gully taken 11 March 2007 showing limit of inland sedimentation in Pine Gully.

The most convincing evidence against a land source is the direction that the sand plug built into Pine Gully. The original sand dam in Pine Gully formed close to the mouth. Over time, the location of the plug migrated inland and deposited more sand and overbank deposits in Pine Gully. If the sediment was from a land source it would have first deposited inland and then migrated to the mouth of Pine Gully. Figure 41 shows the most recent aerial photograph taken at Pine Gully on 11 March 2007. The sedimentation is restricted to the downstream portion of Pine Gully. Ripple marks are important sedimentary features found in Pine Gully and again confirm a bay source of sand and not a landward source. The direction of sand transport, seen in Figure 42, shows the ripple marks and the dominant direction of sand transport from the bay. As waves from ships wash into Pine Gully they carry sediment into the channel and produce the ripple marks in Figure 42. The wave then disperses into the wetland once it passes the levee structures formed on the banks of Pine Gully. If the sediments were coming from a land source, none of these features should be present. Because no significant source of sand is available from a landward source to Pine Gully, rainfall data is unsupportive and the sedimentary structures contradict a land source, a landward source of sediment can be rejected as a viable hypothesis.

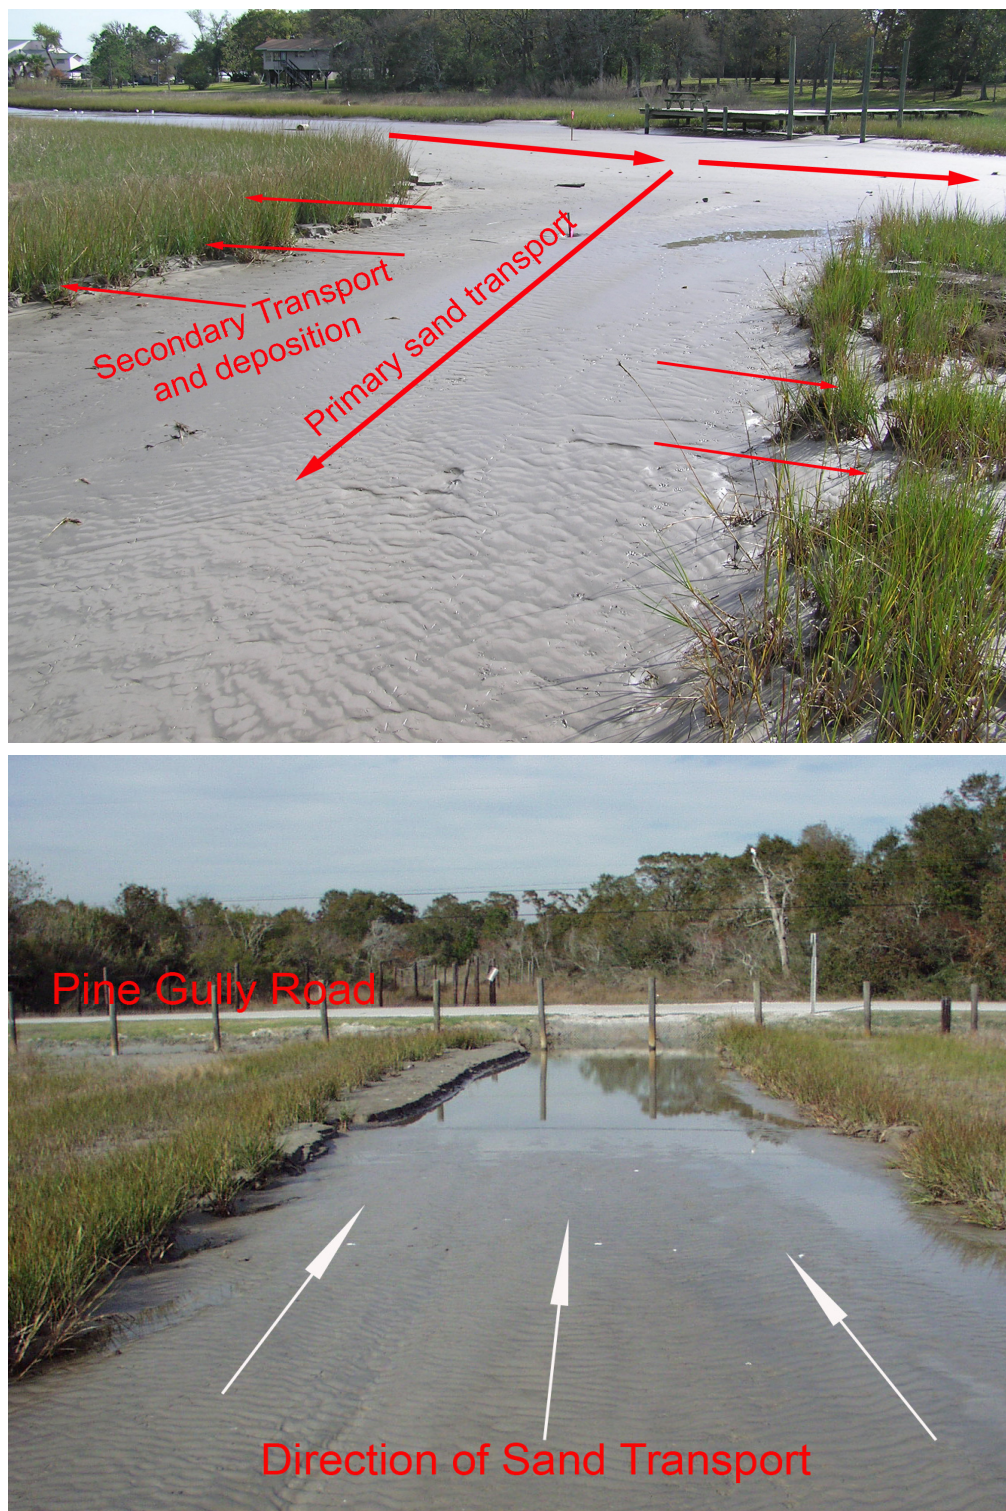
Figure 42. Views of the sedimentary structures preserved on the sand plug in Pine Gully, confirming that the dominant direction of sand transport is from Galveston Bay. Photos taken August 2006.

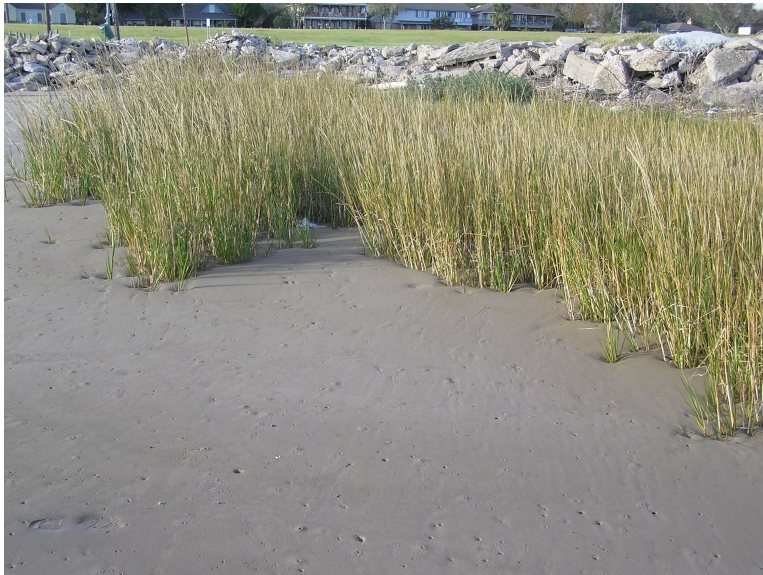
Figure 44. Sedimentation in marine grasses on the back of Wright Beach. Picture taken 10 August 2006.

The search for a possible sediment source north of Pine Gully led to Wright Beach, a public beach maintained by the City of El Jardin. This site had experienced significant beach renourishment concurrent with the sedimentation problems in Pine Gully. Preliminary evidence of sedimentation was the presence of fresh sand deposition existing in the marine grasses on the back of the beach (Figure 44). This sediment appeared to be consistent with the sediment in Pine Gully. Residents confirmed suspicions that Wright Beach had undergone beach accretion.

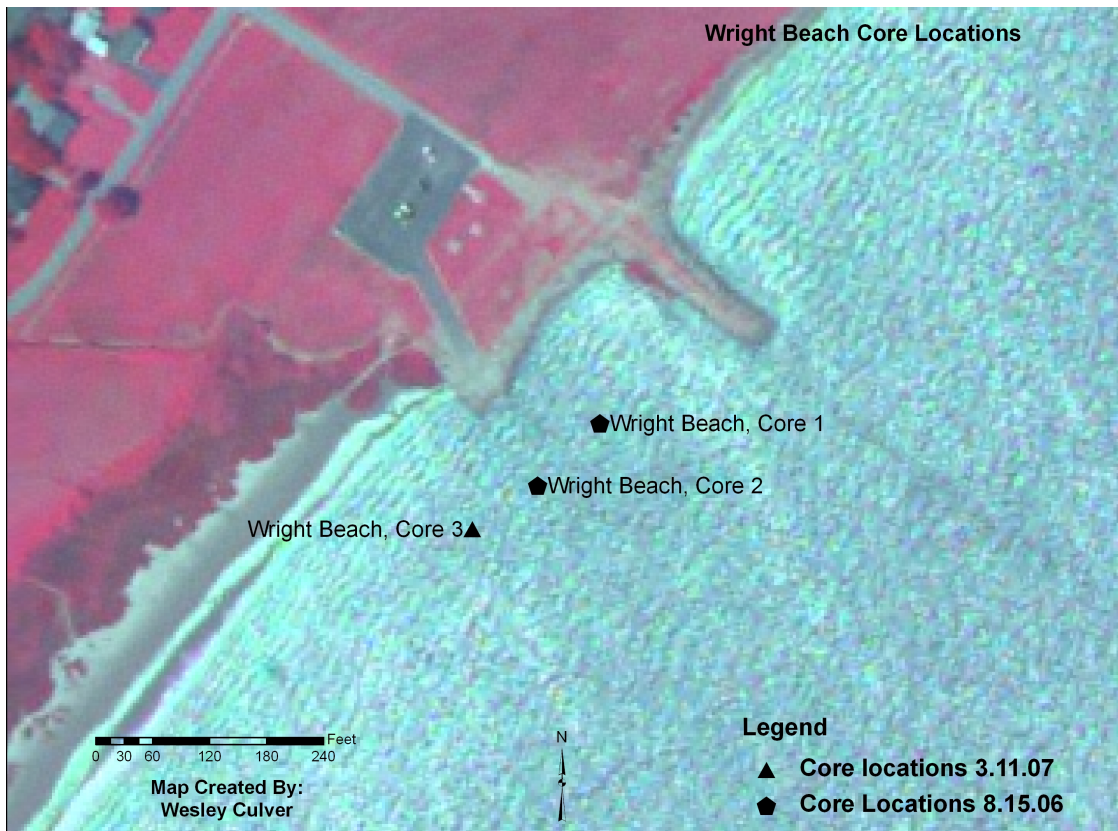
Figure 46. Core locations at Wright Beach for both sampling dates of 15 August 2006 and 11 March 2007. Data plotted on the 2004 NAIP aerial photo from TNRIS.

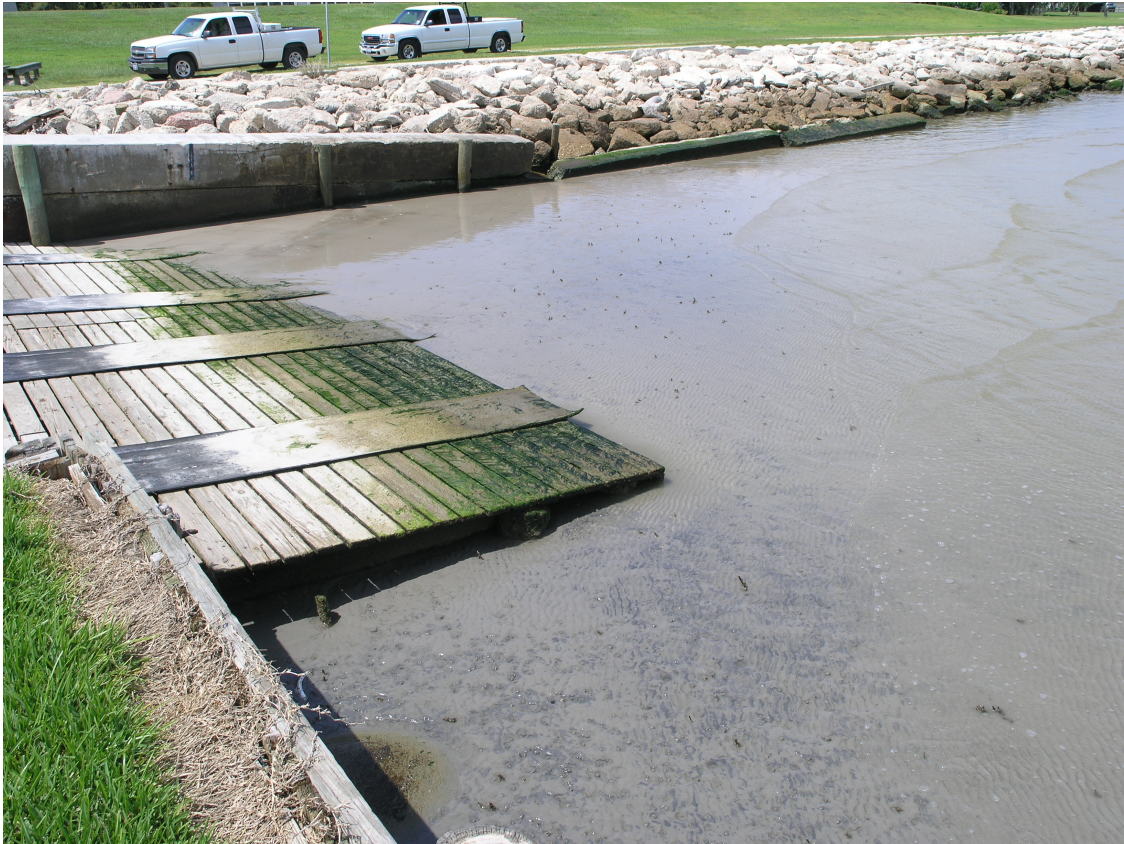
Figure 50. Sediment building up at the Camp Casa Mare marina. Picture taken on 14 August 2006.

With the counterclockwise circulation of Galveston Bay, a considerable amount of sediment should exist south of Pine Gully. Sedimentation was found adjacent to Pine Gully in the marina of the Girl Scout Camp, Camp Casa Mare, and even further south at First Street Beach. During field work in August 2006, the Director of the camp confirmed that the sediments in the marina at Camp Casa Mare were new and sedimentation had never been an issue during his term at the camp. He also added the sedimentation was severe enough that launching of the small Sunfish© used by the girls at the camp had become difficult. The girls now have to carry these small boats out by hand to deeper water, a difficult task for the young girls that attend the camp. Figure 50 shows the sedimentation found building up in the Camp Casa Mare Girl Scout Camp Marina.

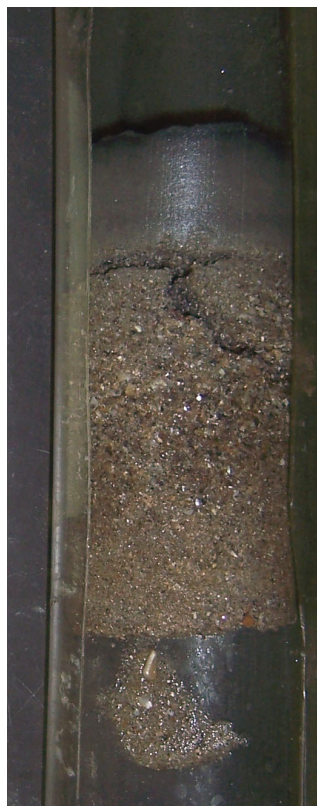
Figure 53. Core of Original First Street Beach sediments overlain by newly deposited sediments. Core collected on 15 August 2007.

Cores from First Street Beach were also compared to the cores from other locations. Figure 53 is a core from First Street Beach that contains the original sediments from First Street Beach on the bottom and the new sediments being deposited on the top. The original First Street Beach sediments are just crushed up shells and road fragments from Todville Road. This provides evidence the sediments from Wright Beach South to First Street Beach are similar. Figure 54 is the other three cores collected 15 August 2006 and 11 March 2007. Core collection locations are plotted in Figure 55 and Figure 56 for Camp Casa Mare and First Street Beach, respectively.

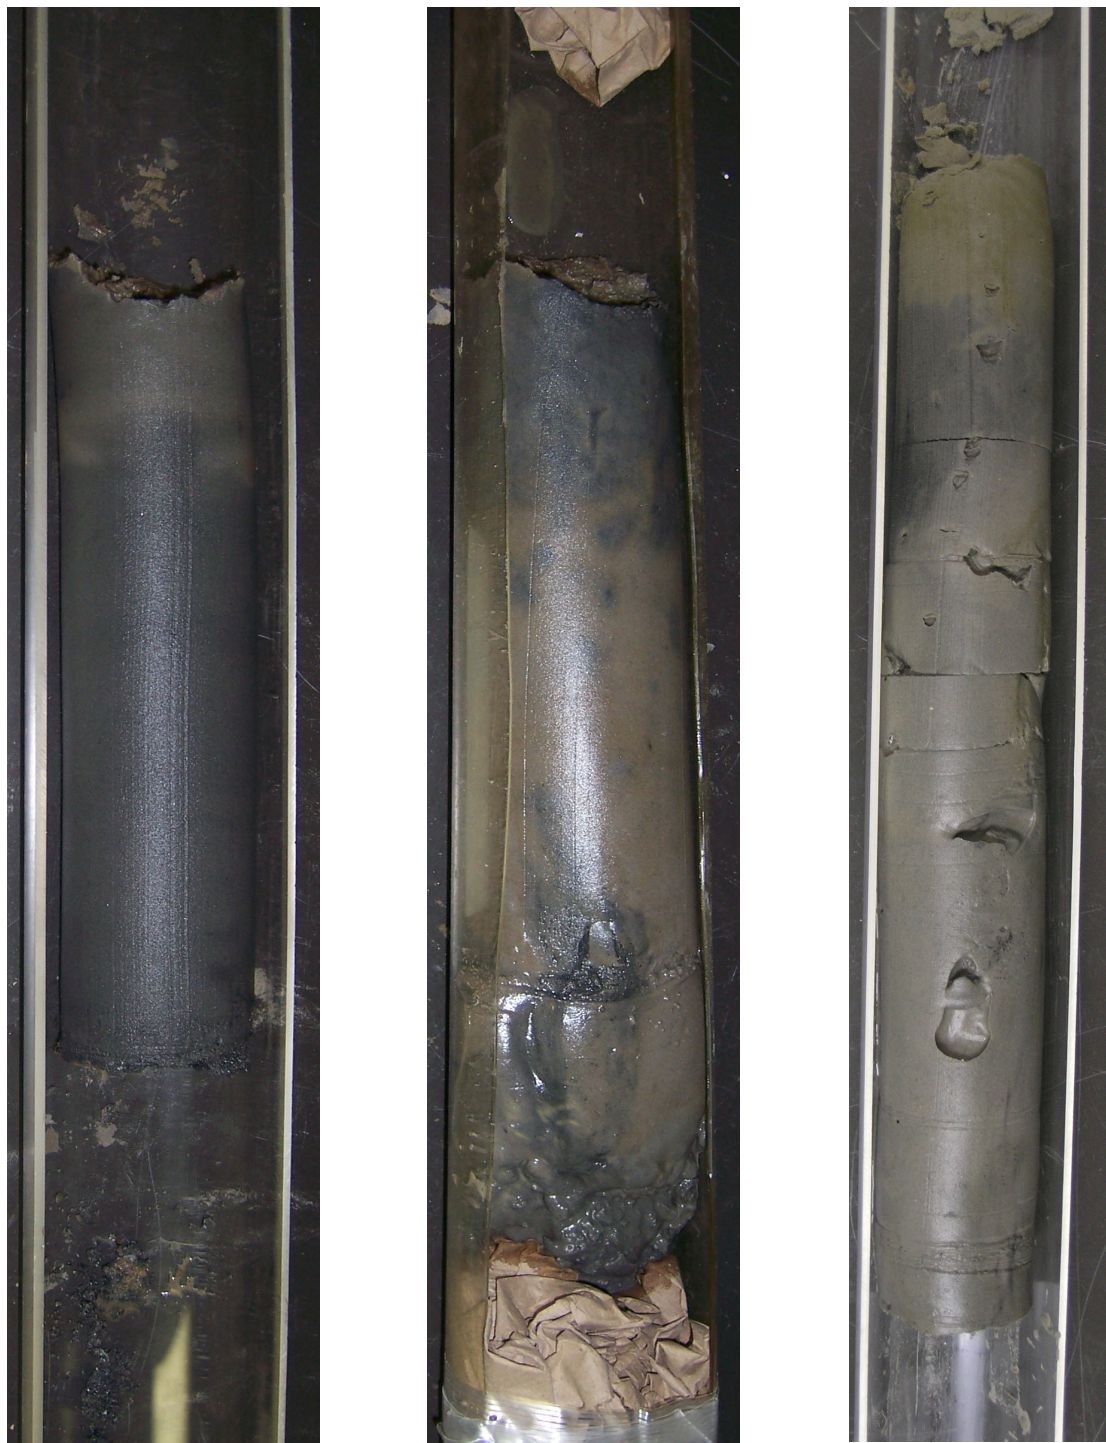
Figure 54. Cores collected from First Street Beach. Two cores on left are from the collection date 15 August 2007. Again, notice the rich black color of the sediments from the first core collection as opposed to the color of the core on the right taken on 11 March 2007.

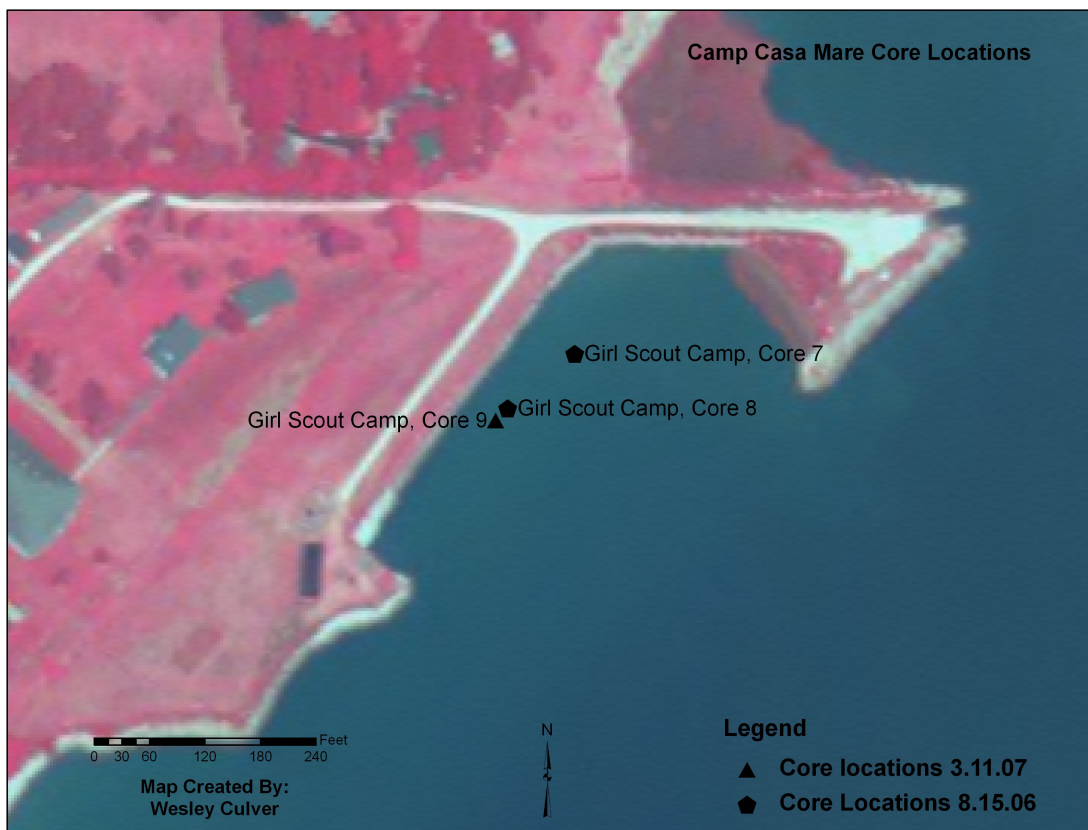
Figure 55. Core Locations for cores taken at Camp Casa Mare Girl Scout Camp on 15 August 2006 and 11 March 2007. Data plotted on a 2004 aerial photo from TNRIIS.

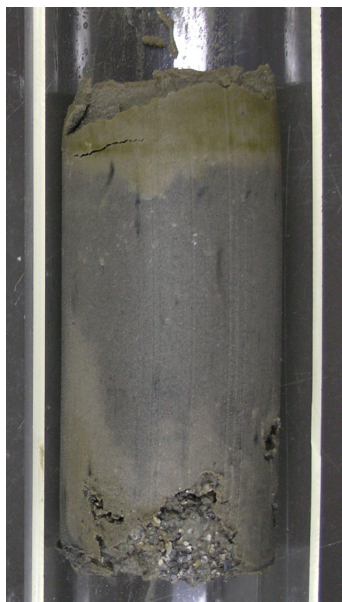
Figure 61. Clear Lake Inlet Core collected on 11 March 2007. Notice the original sediments consisting of shell hash on the bottom and new sandy sediments on top.

Sediments had already been observed as far south as First Street Beach and after that point there was no active search for sediment. One core sample of the sediment, shown in Figure 61, was collected for sand sieve analyses. A small amount of shell hash is visible at the bottom of the core. As with First Street Beach, these are the original sediments at Clear Lake Inlet. The sandy sediments above the shell hash represent new sediment that had been observed and are consistent with the sediments found at Wright Beach. Sand sieve analyses were done on this core but only one analysis was completed because insufficient sediment existed in the core to do an analysis similar to those done at the other locations. Figure 62 shows the results of the sieve analysis of the Clear Lake Inlet Core. The sand sieve analysis confirms that the sand sizes from Clear Lake Inlet are consistent with the other locations in this study located up-drift.

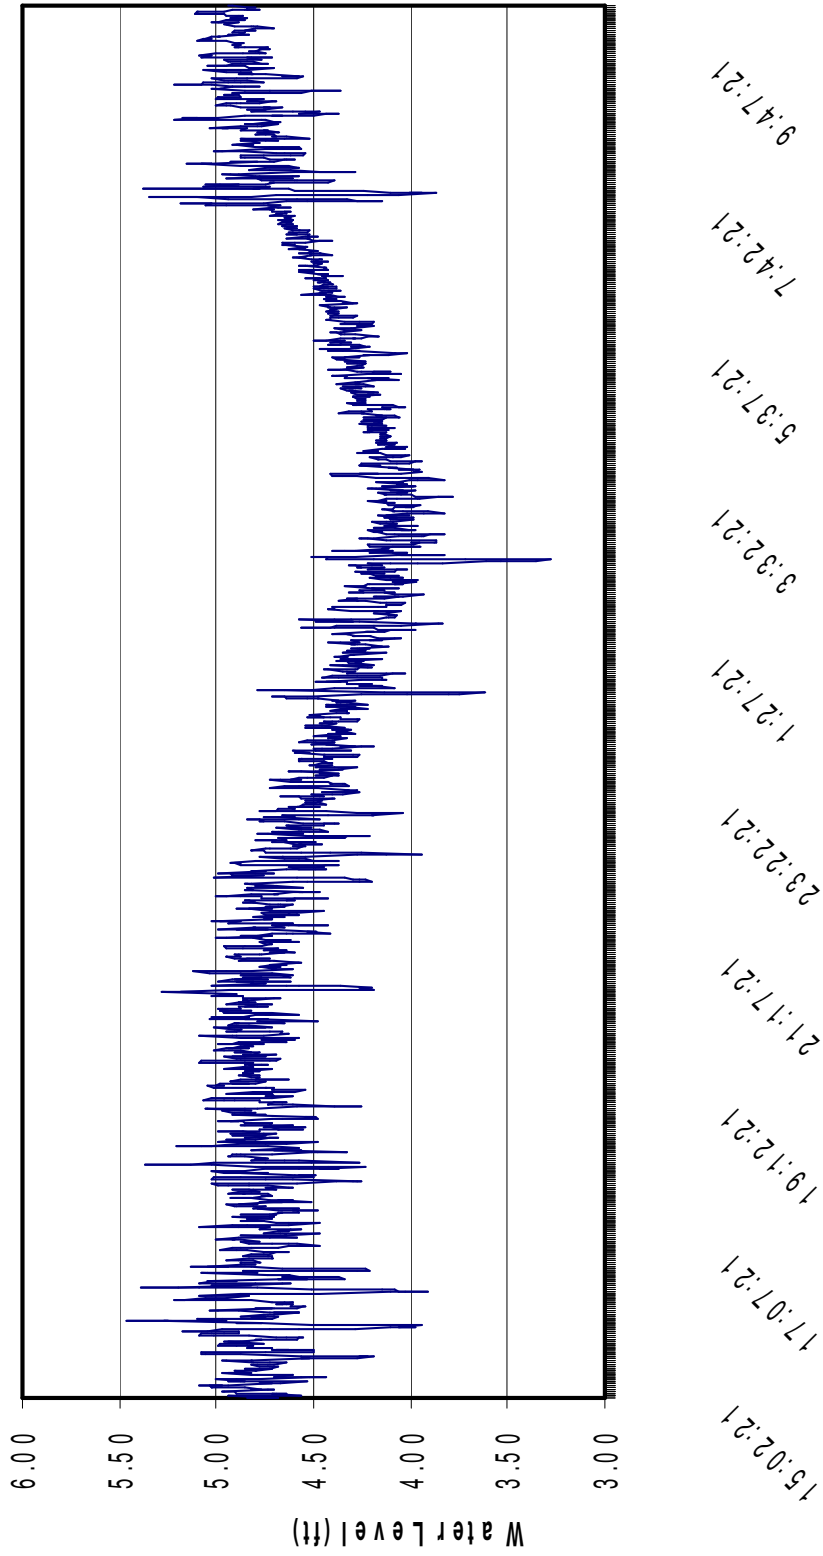
Pine Gully Wave Record, PG-3  
30 Second Interval

Time - Start 8/24/1502:21 -- End 8/25/1028:51
