**SIMPLIFIED METHOD FOR ESTIMATING FUTURE SCOUR  
DEPTH AT EXISTING BRIDGES**

A Dissertation

ANAND V GOVINDASAMY

Submitted to the Office of Graduate Studies of  
Texas A&M University  
in partial fulfillment of the requirements for the degree of

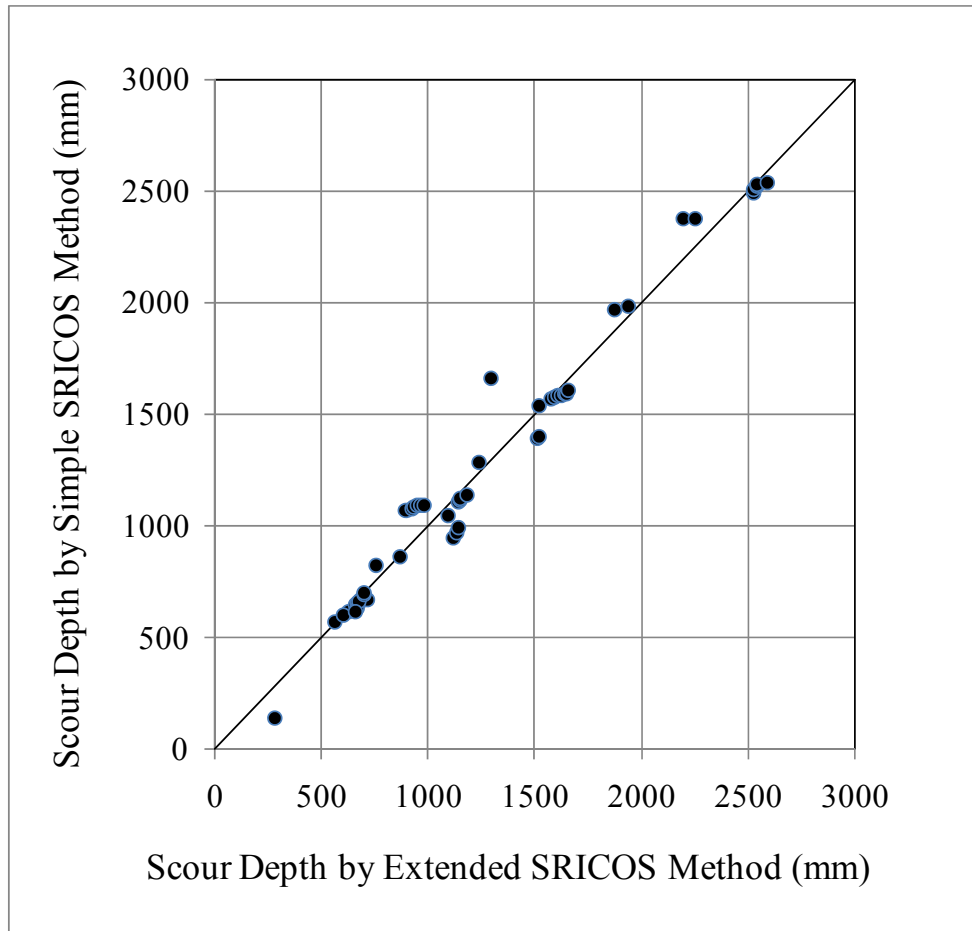
**Figure 2-12. Comparison of pier scour depth using Extended-SRICOS and Simple-SRICOS Methods (after Briaud et al. 2001).**

Equation (2.7) had a regression coefficient of 0.77. A comparison between the pier scour depth using the complete hydrograph input (termed Extended-SRICOS) and the pier scour depth obtained from the equivalent time method (Simple-SRICOS) was compared and is presented in Figure 2-12.

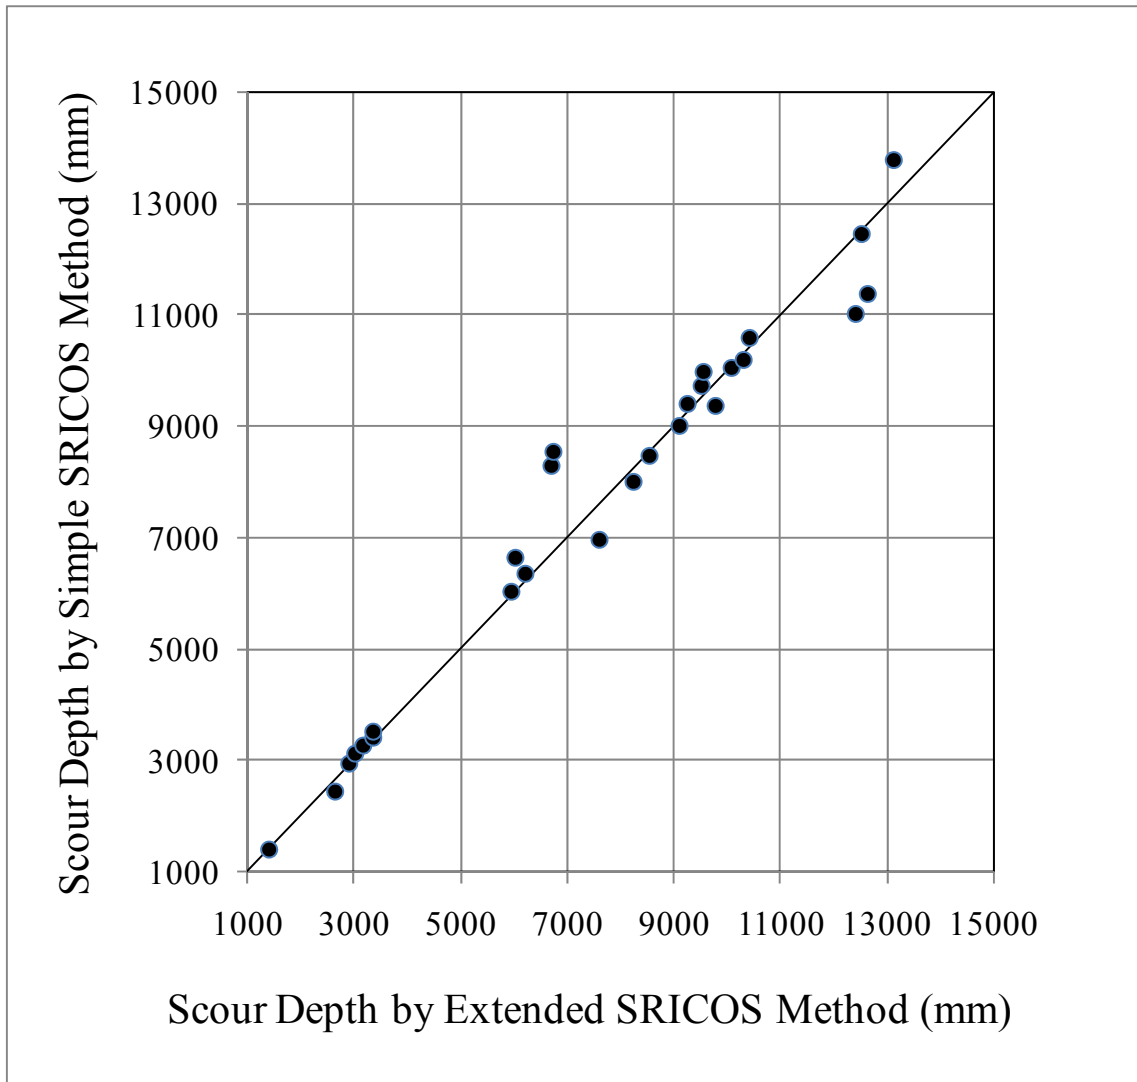
**Figure 2-13. Comparison of contraction scour depth using SRICOS-EFA and Simple SRICOS-EFA Methods (after Wang 2004).**

The equivalent time as presented in Equation (2.8) can be used to calculate the contraction scour depth at the end of a given hydrograph just by applying the maximum velocity and initial scour rate and hydrograph duration.

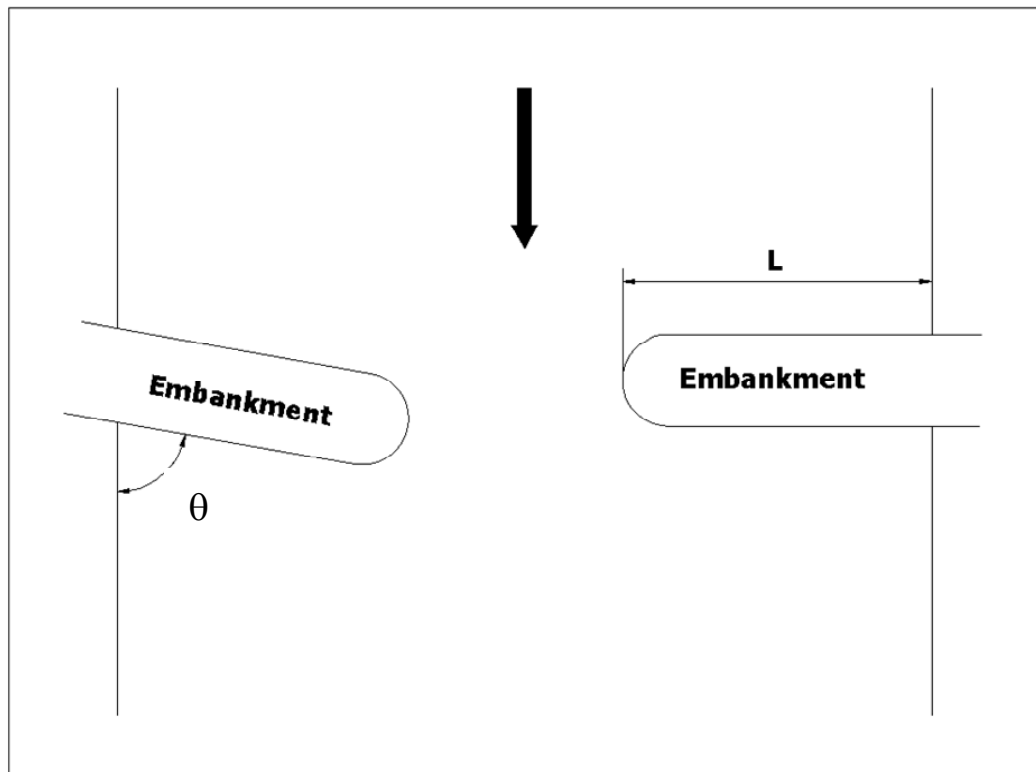
**Figure 2-14. Some abutment scour parameters.**

where  $L'$  is the length of active flow obstructed by the embankment,  $y_a$  is the average depth of flow on the floodplain and is defined as  $A_e/L$ ,  $A_e$  is the flow area of the approach cross section obstructed by the embankment,  $L$  is the length of embankment projected normal to the flow (Figure 2-14) and  $F$  is the Froude number of approach flow upstream of the abutment.  $K_1$  is the abutment shape coefficient (Figure 2-15 and Table 2-4) and  $K_2$  is the coefficient for angle of embankment to flow and is defined as  $(\theta/90)^{0.13}$  (Figure 2-14).

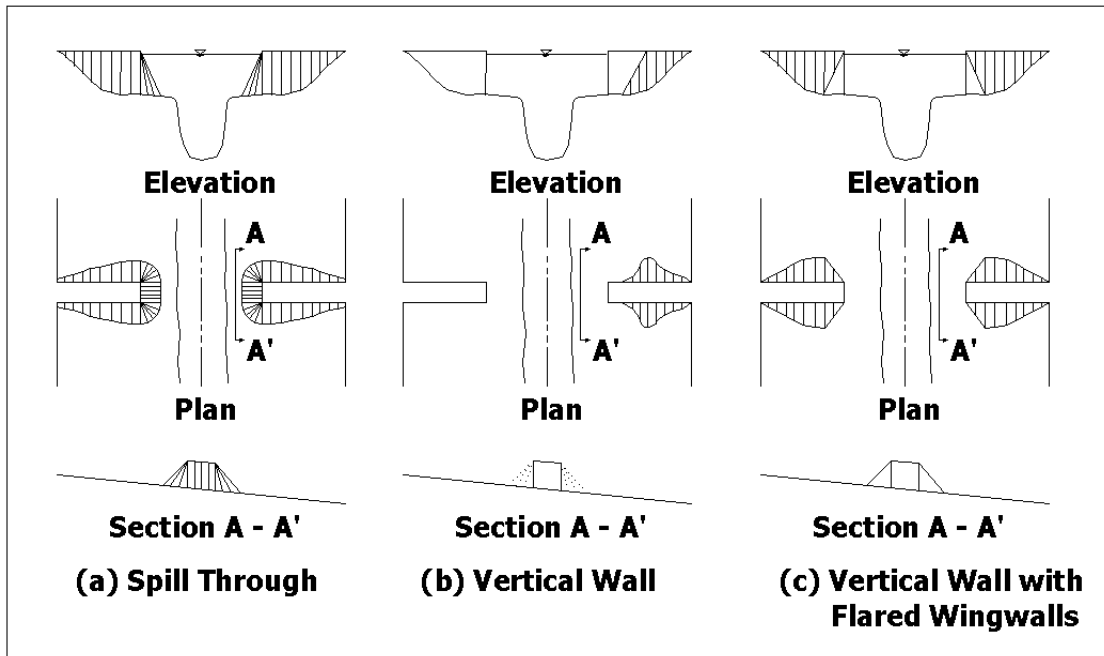
Figure 2-15. Abutment shapes (after Richardson and Davis 2001).

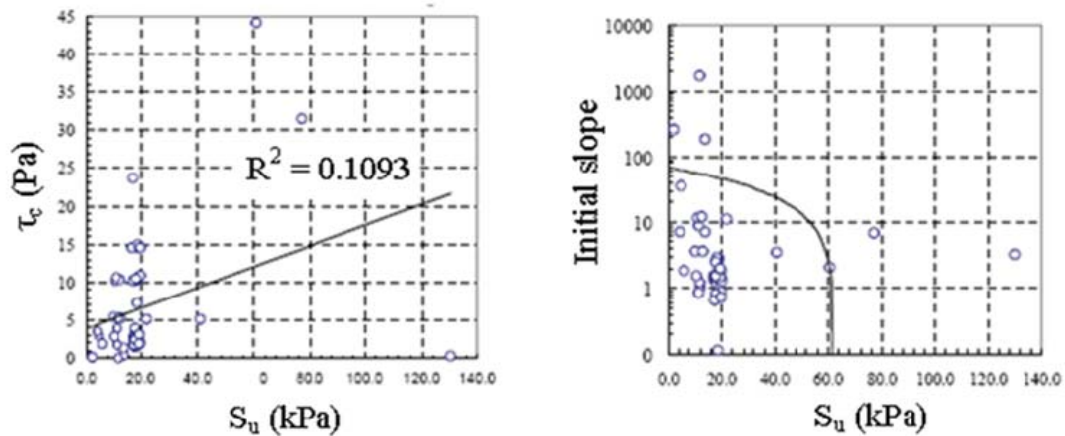
**Figure 3-2. Failed attempts at correlating the critical shear stress and initial slope with undrained shear strength (Cao et al. 2002).**

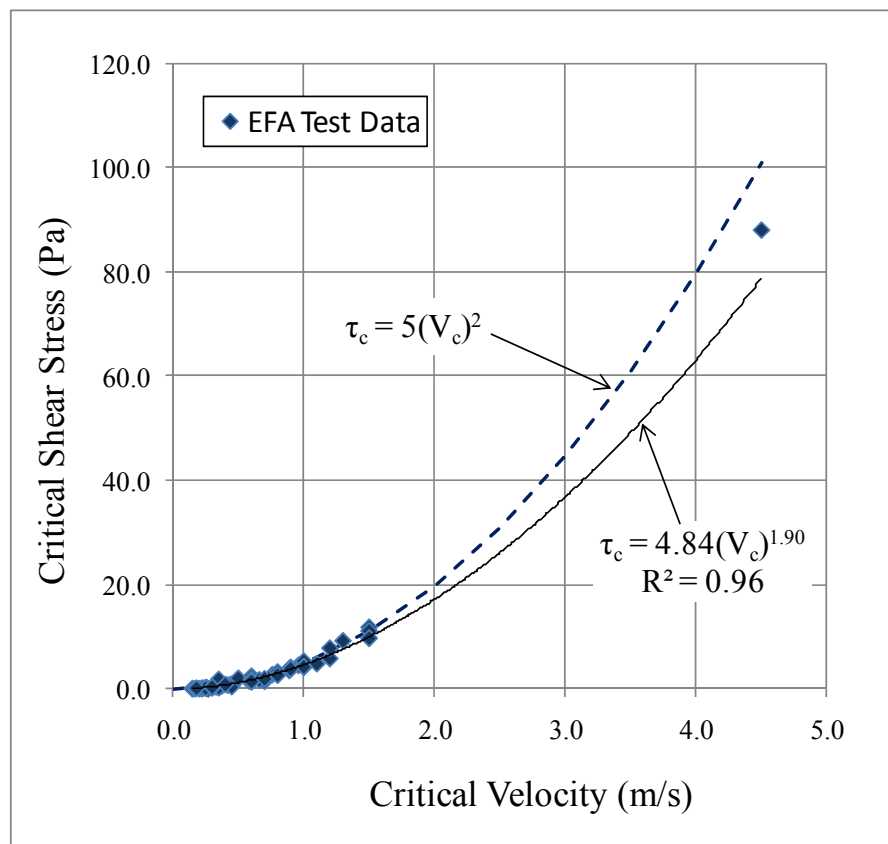
**Figure 3-3. Critical shear stress – critical velocity relationship.**

While  $\tau_c$  depends mostly on the soil properties,  $V_c$  depends also on the water depth in an open channel. The above equation comes from tests in the EFA which creates a pipe flow. In this case, the water depth is not involved. Calculations using the US Army Corps of Engineers EM 1601 Equation show that ignoring the water depth in calculating the critical velocity may create a  $\pm 20\%$  error for common values of water depth (1 m to 25 m).

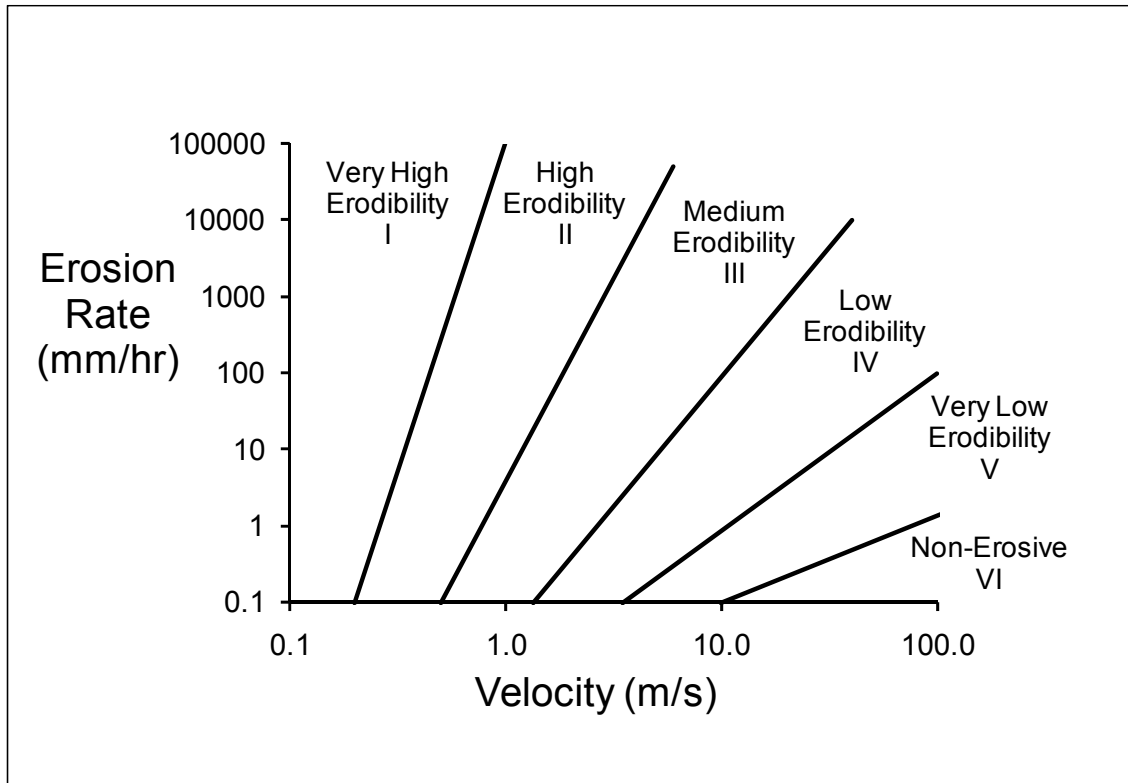
**Figure 3-4. Erosion categories based on velocity.**

The Erosion Function charts are charts that show erosion categories demarcated on the  $\dot{Z} - \tau$  and  $\dot{Z} - V$  charts (Figure 3-4 and Figure 3-5). The erosion categories are shown in Table 3-2. These charts were developed on the basis of EFA tests and the experience of the authors. The Erosion Function Charts essentially eliminate the need for site specific erosion testing for preliminary investigation (Govindasamy et al. 2008). Based on the material category in question, the user can use the boundaries of these erosion categories to determine the critical velocity,  $\tau_c$  or critical velocity  $V_c$  of the material. The definition of  $\tau_c$  is the hydraulic shear stress corresponding to an erosion rate of 0.1 mm/hour and the definition of  $V_c$  is the water velocity corresponding to an erosion rate of 0.1 mm/hour. The user can also use these boundaries or the space between them to arbitrarily determine the erosion function of a geomaterial based on engineering judgment. Table 3-2 also shows the values of  $\tau_c$  and  $V_c$  according to erosion categories.

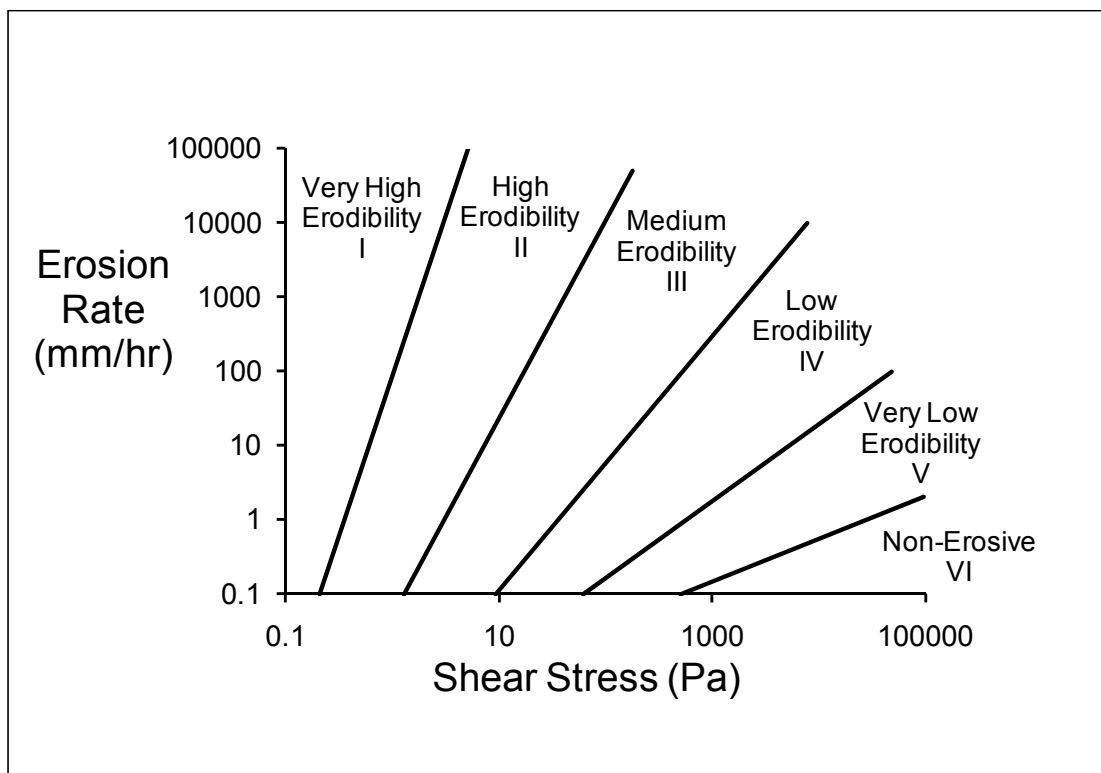
Figure 3-5. Erosion categories based on shear stress.

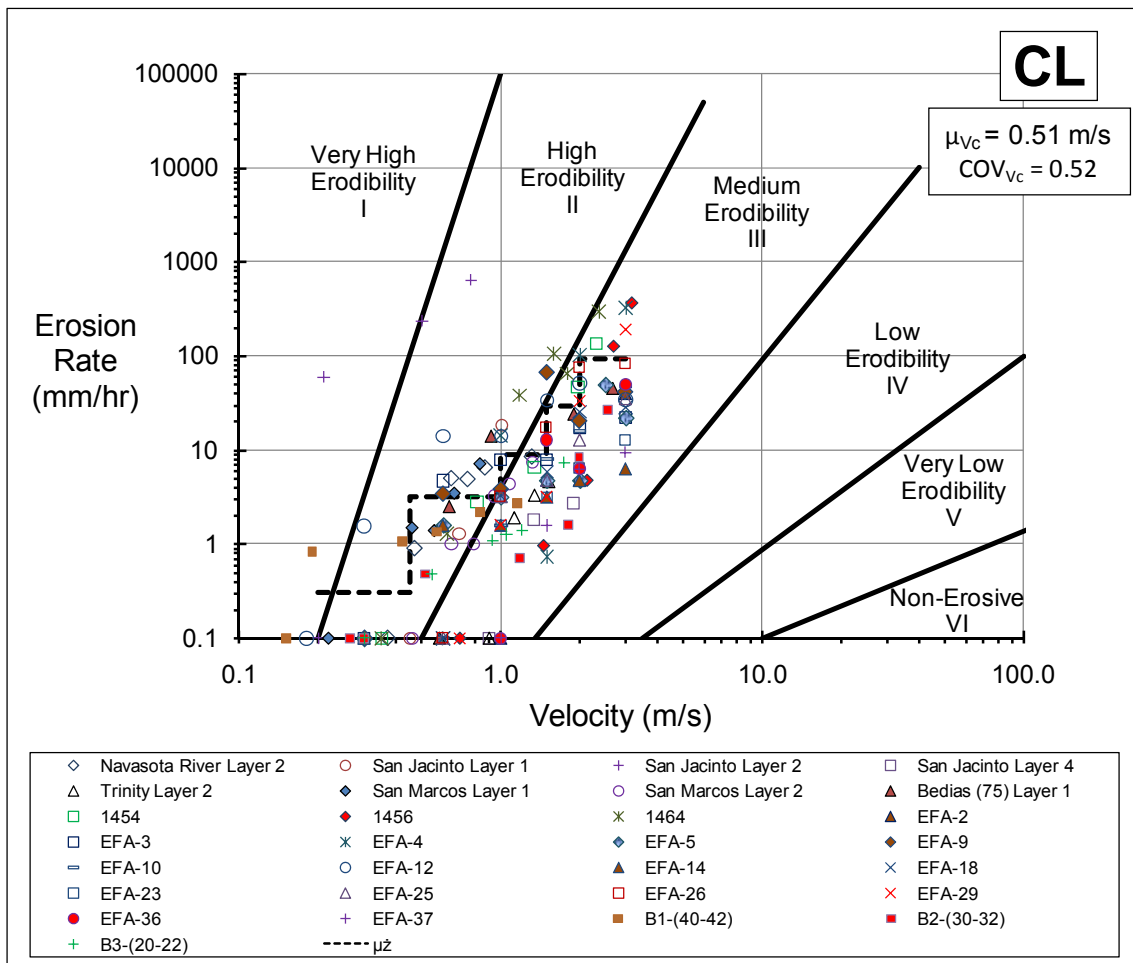
**Figure 3-6. EFA test data on low plasticity clays plotted on the Erosion Function Chart.**

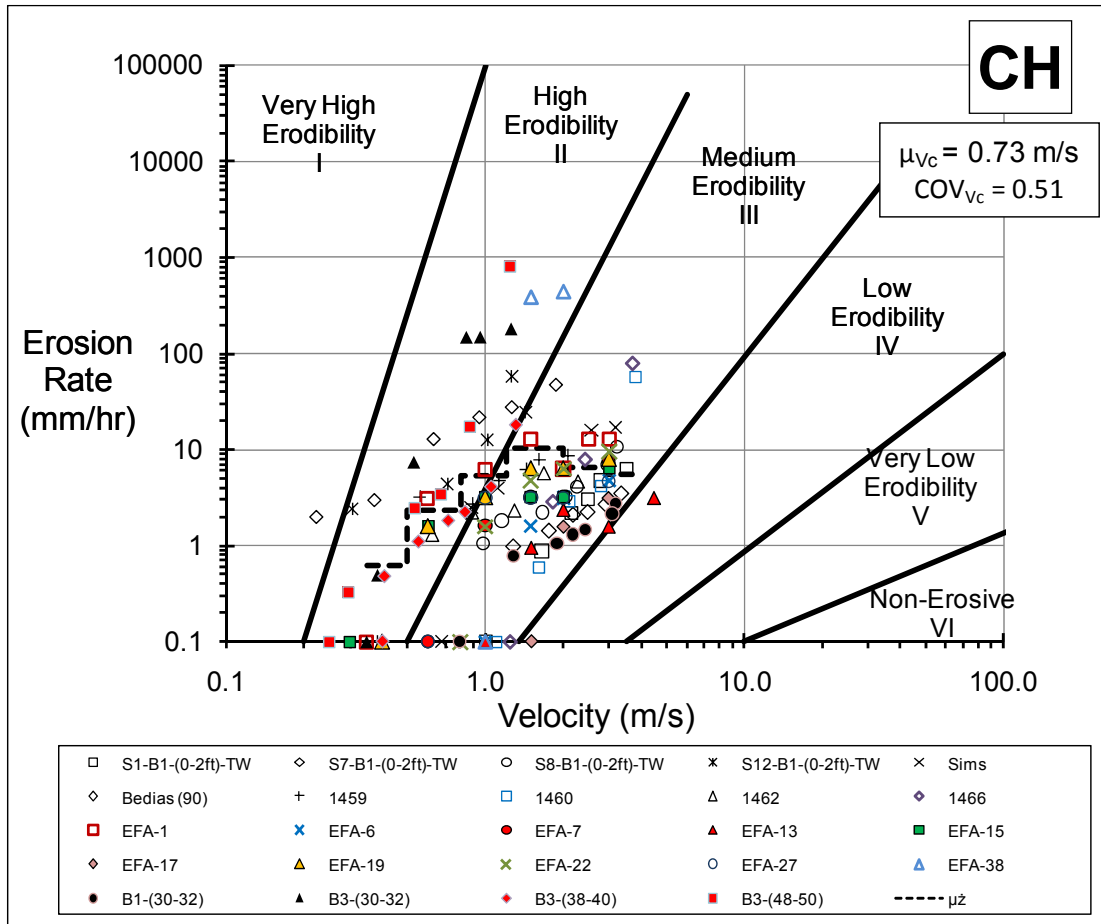
**Figure 3-7. EFA test data on high plasticity clays plotted on the Erosion Function Chart.**

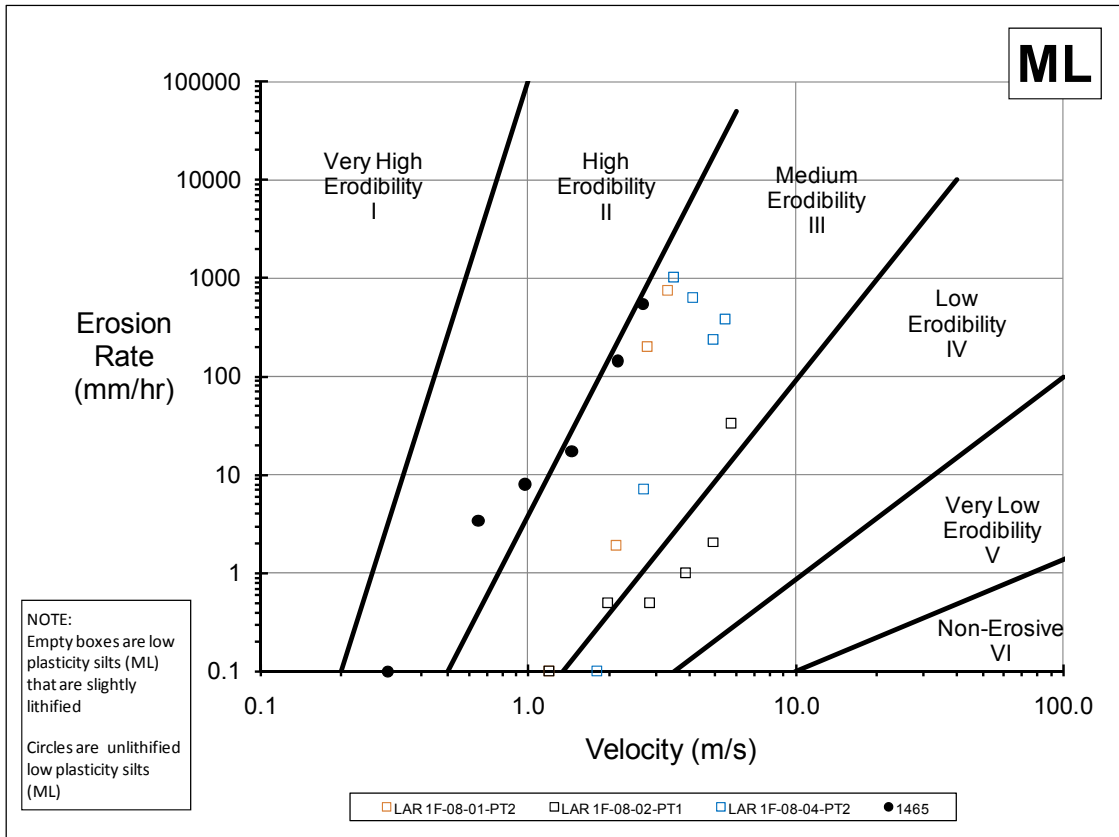
**Figure 3-8. EFA test data on low plasticity silts plotted on the Erosion Function Chart.**

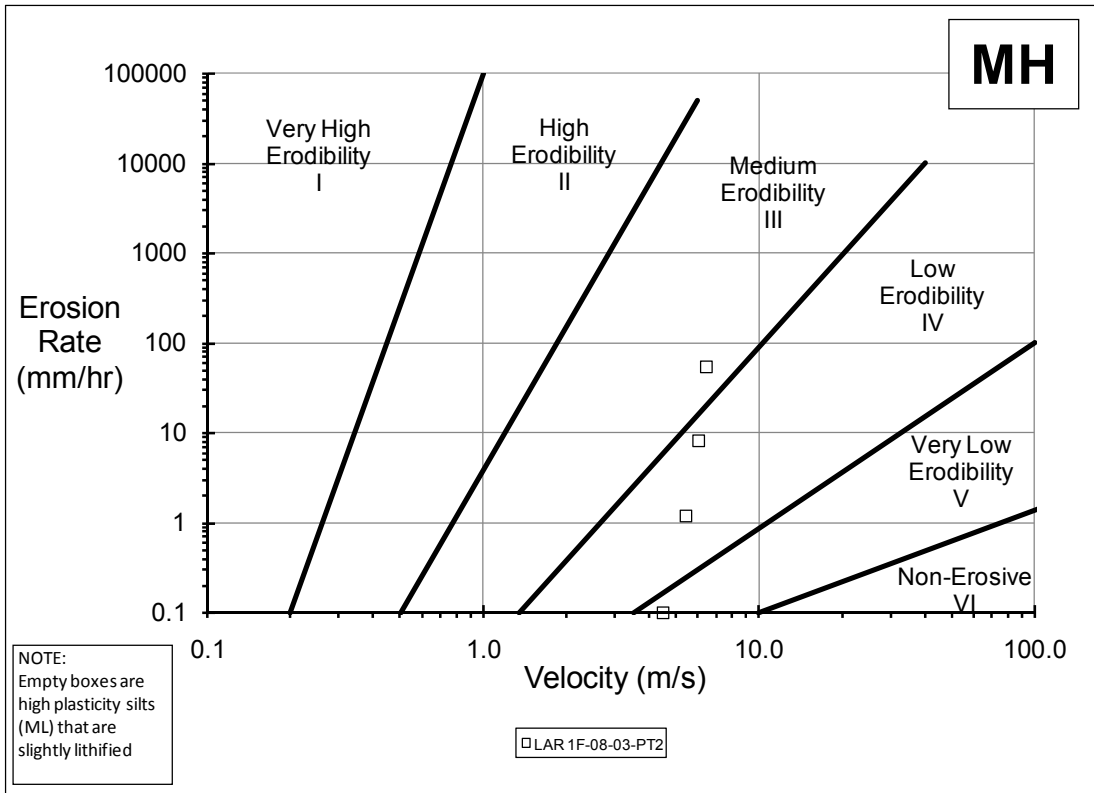
**Figure 3-9. EFA test data on high plasticity silt plotted on the Erosion Function Chart.**

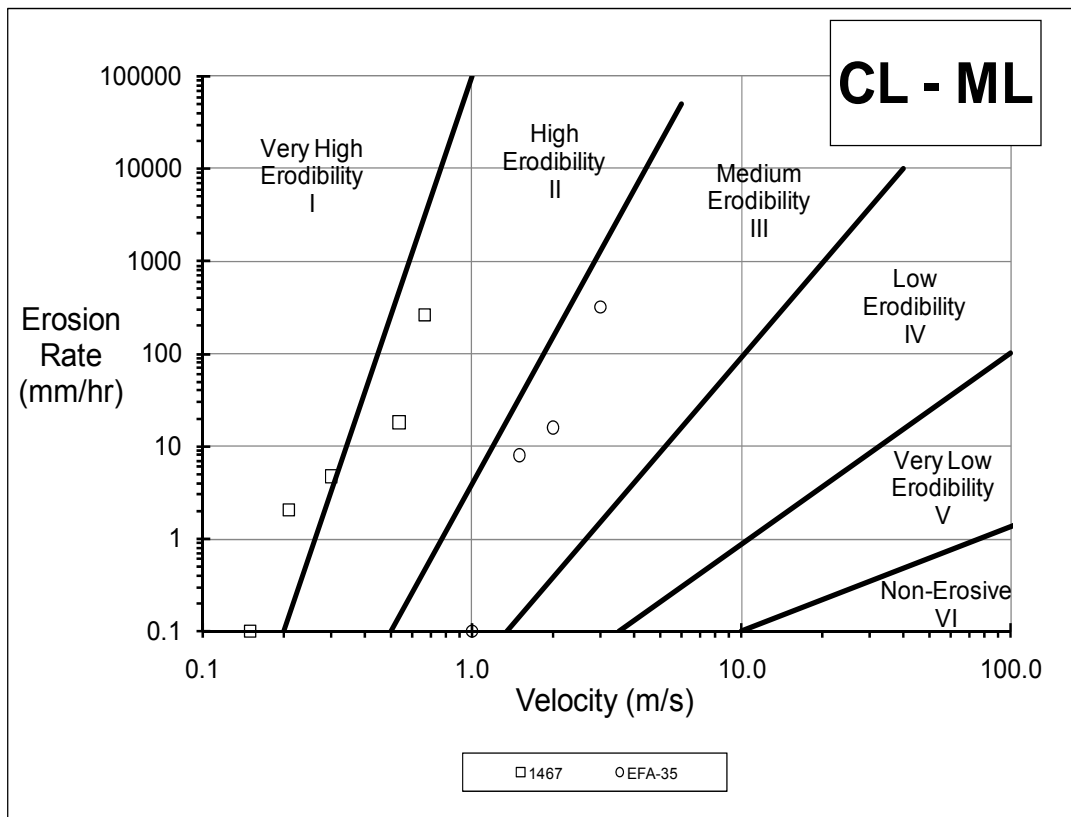
**Figure 3-10. EFA test data on samples intermediate between low plasticity clay and low plasticity silt plotted on the Erosion Function Chart.**

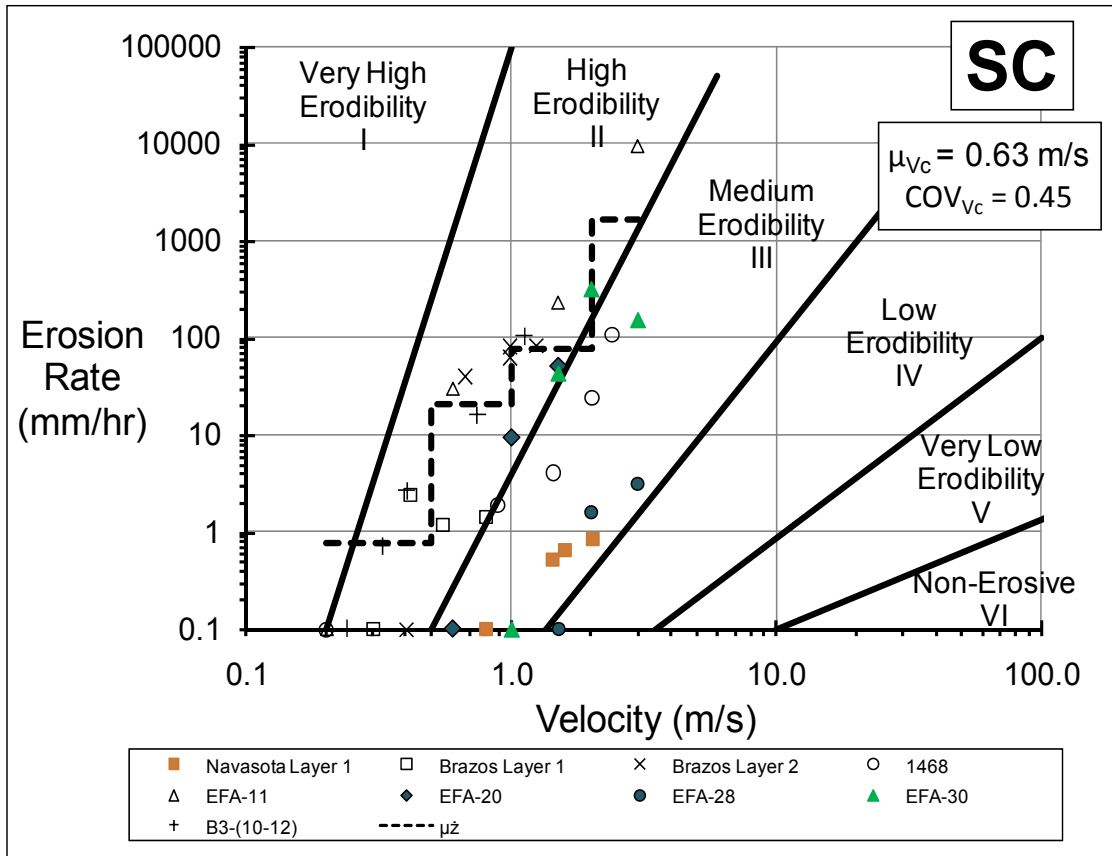
Figure 3-11. EFA test data on clayey sands plotted on the Erosion Function Chart.

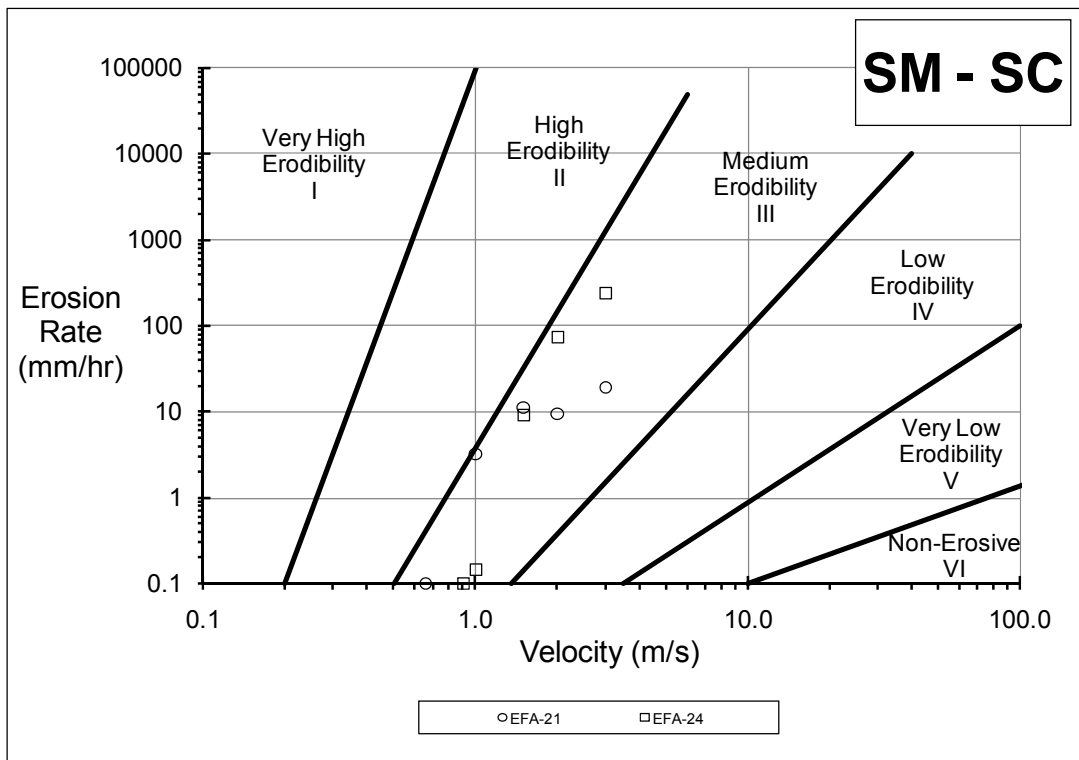
**Figure 3-12. EFA test data on samples intermediate between silty sand and clayey sand plotted on the Erosion Function Chart.**

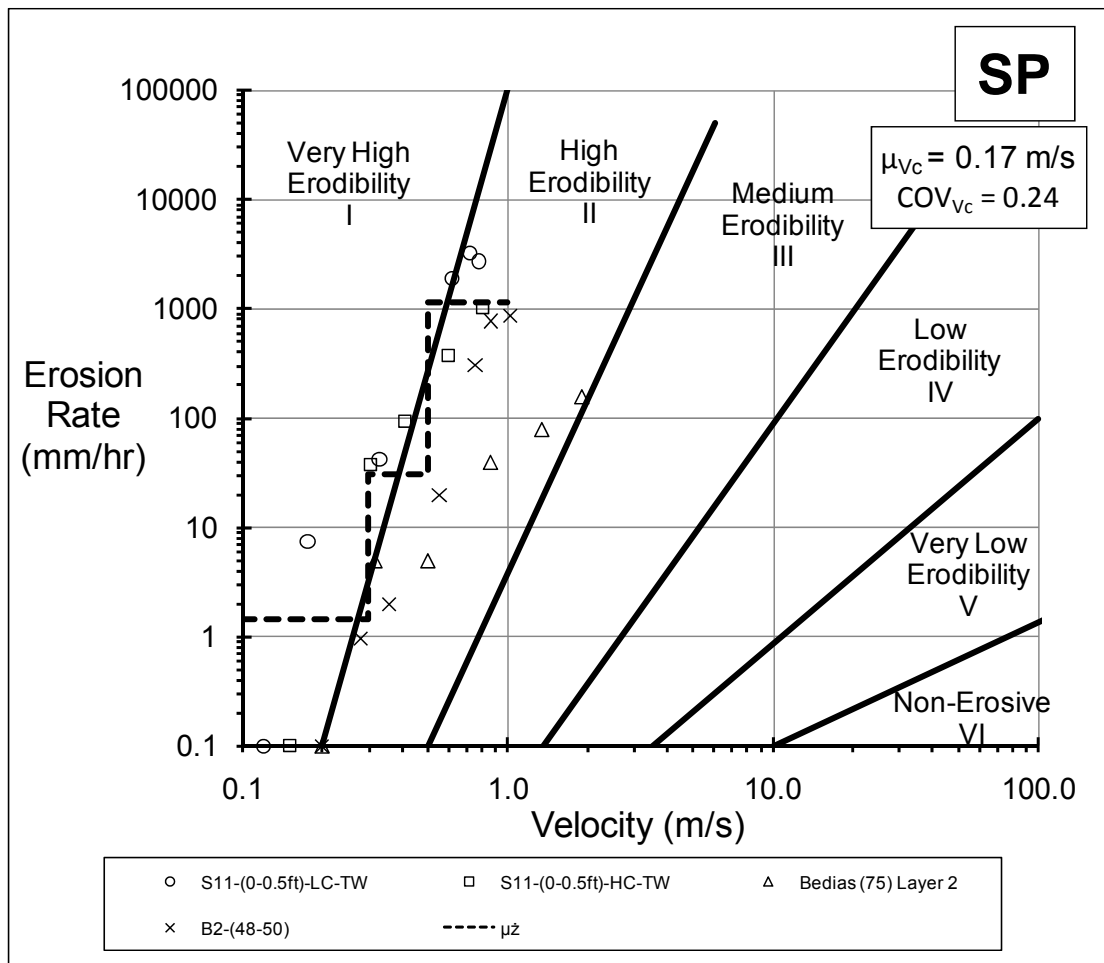
**Figure 3-13. EFA test data on poorly graded sands plotted on the Erosion Function Chart.**

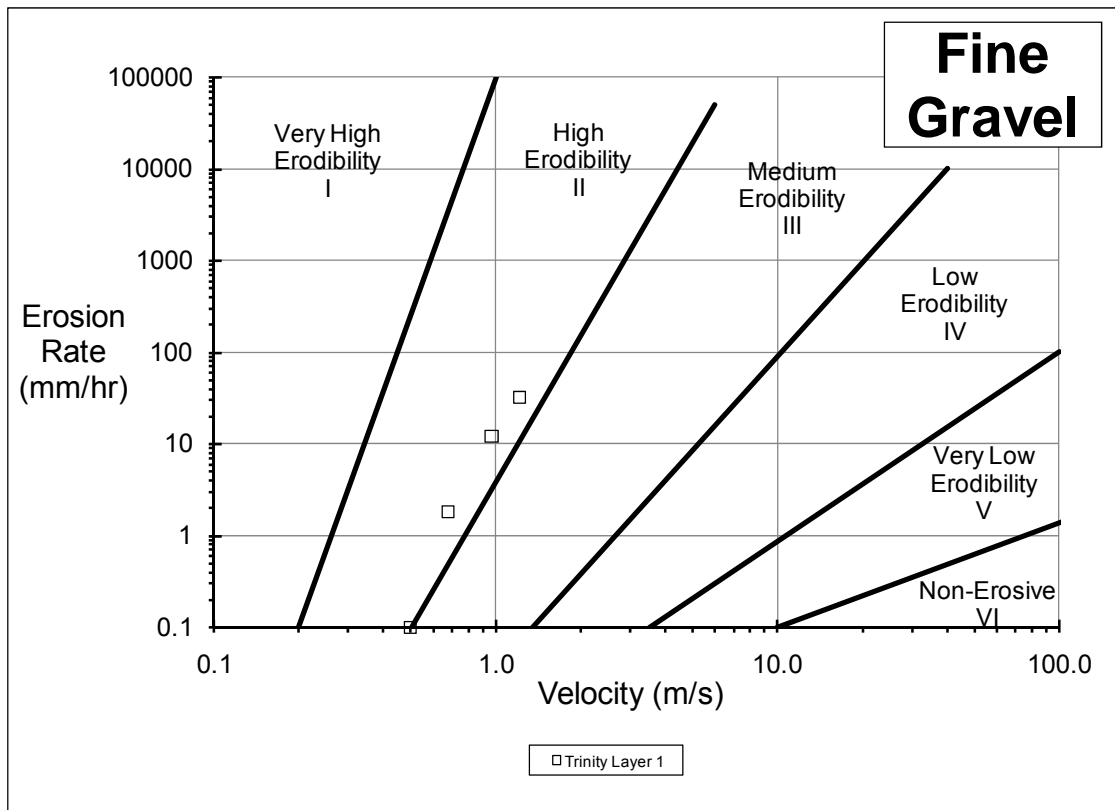
**Figure 3-14. EFA test data on gravel plotted on the Erosion Function Chart.**

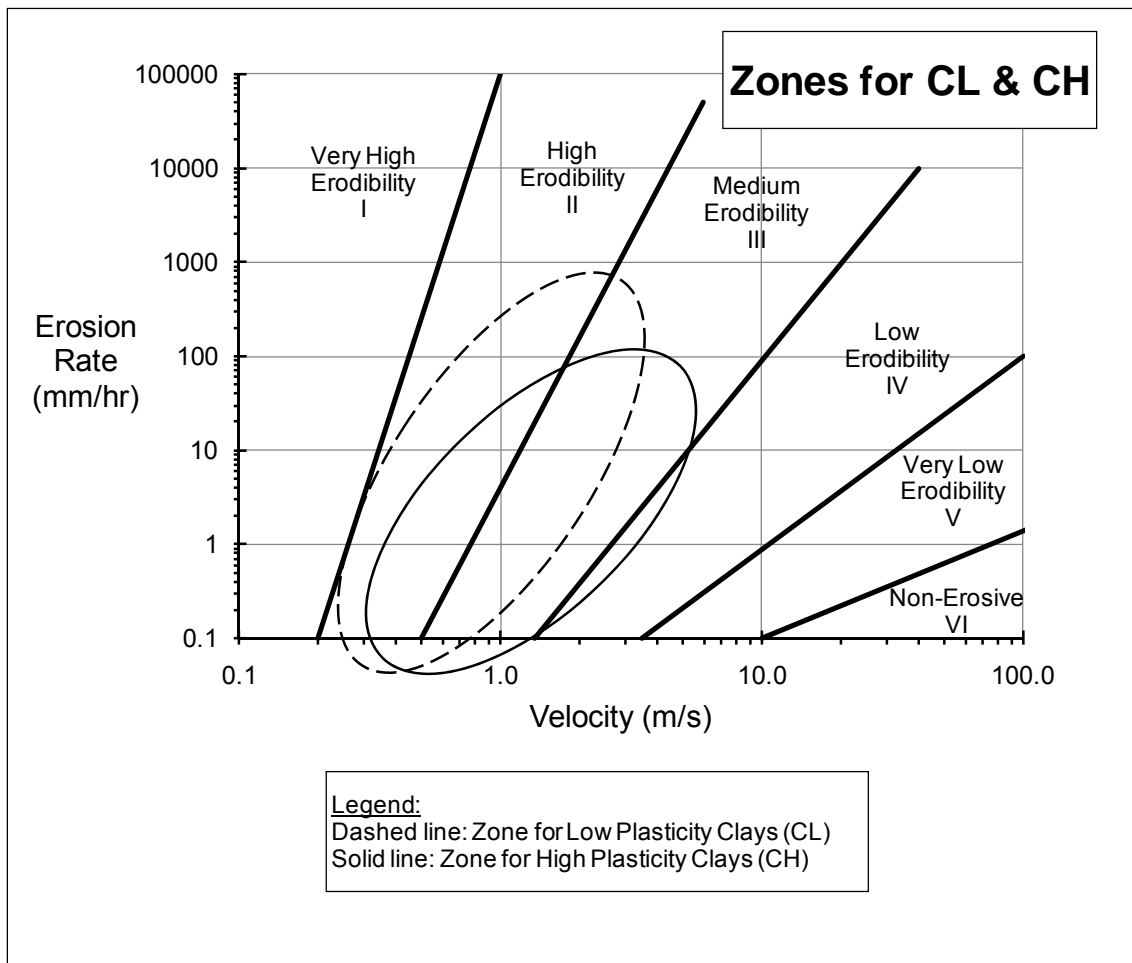
**Figure 3-15. Zones for low plasticity and high plasticity clays.**

Figure 3-15 through Figure 3-17 show the approximate zones for CL, CH, SM, SC, SM-SC and SP materials. These zones are based on the EFA test data that were presented in Figure 3-6, Figure 3-7, Figure 3-10, Figure 3-11, Figure 3-12 and Figure 3-13. The rest of the materials were not zoned on the erosion function charts due to lack of test data.

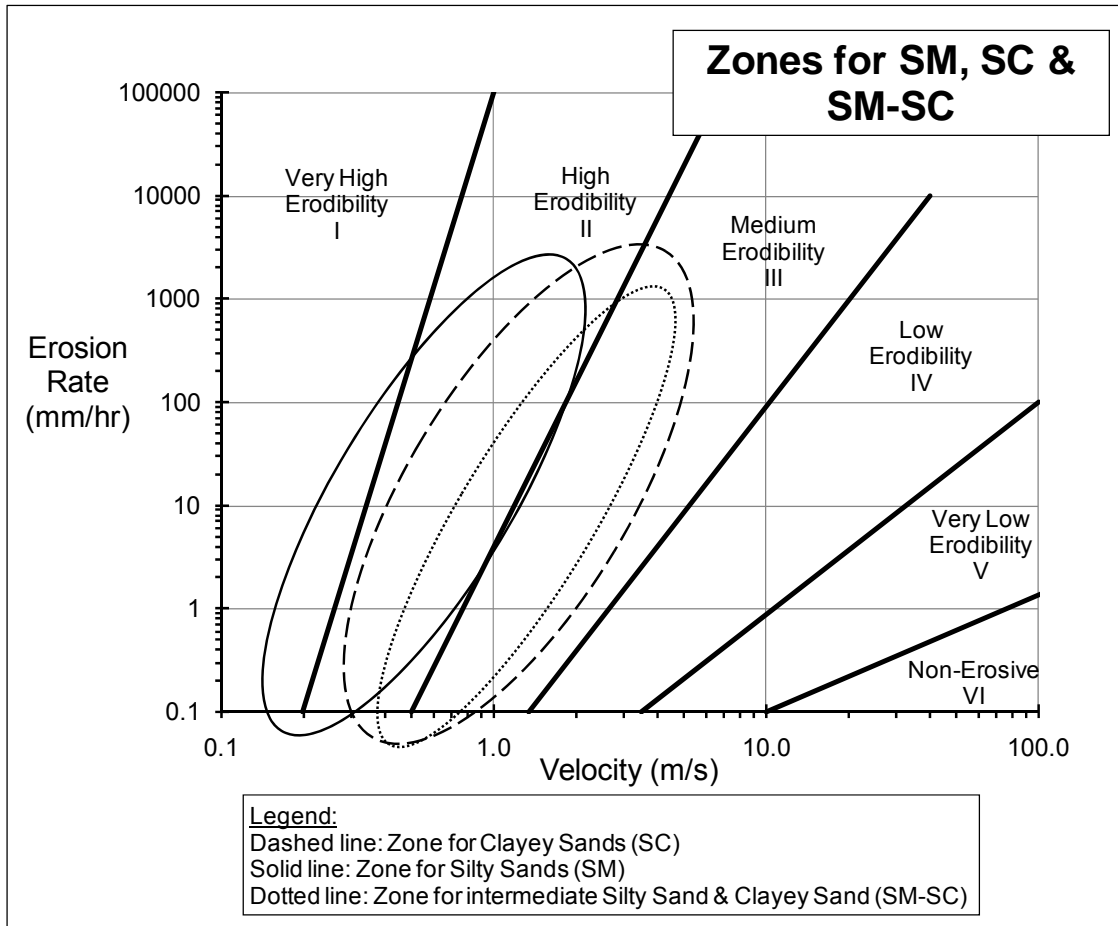
**Figure 3-16. Zones for clayey sands, silty sands and intermediate silty sands and silty clays.**

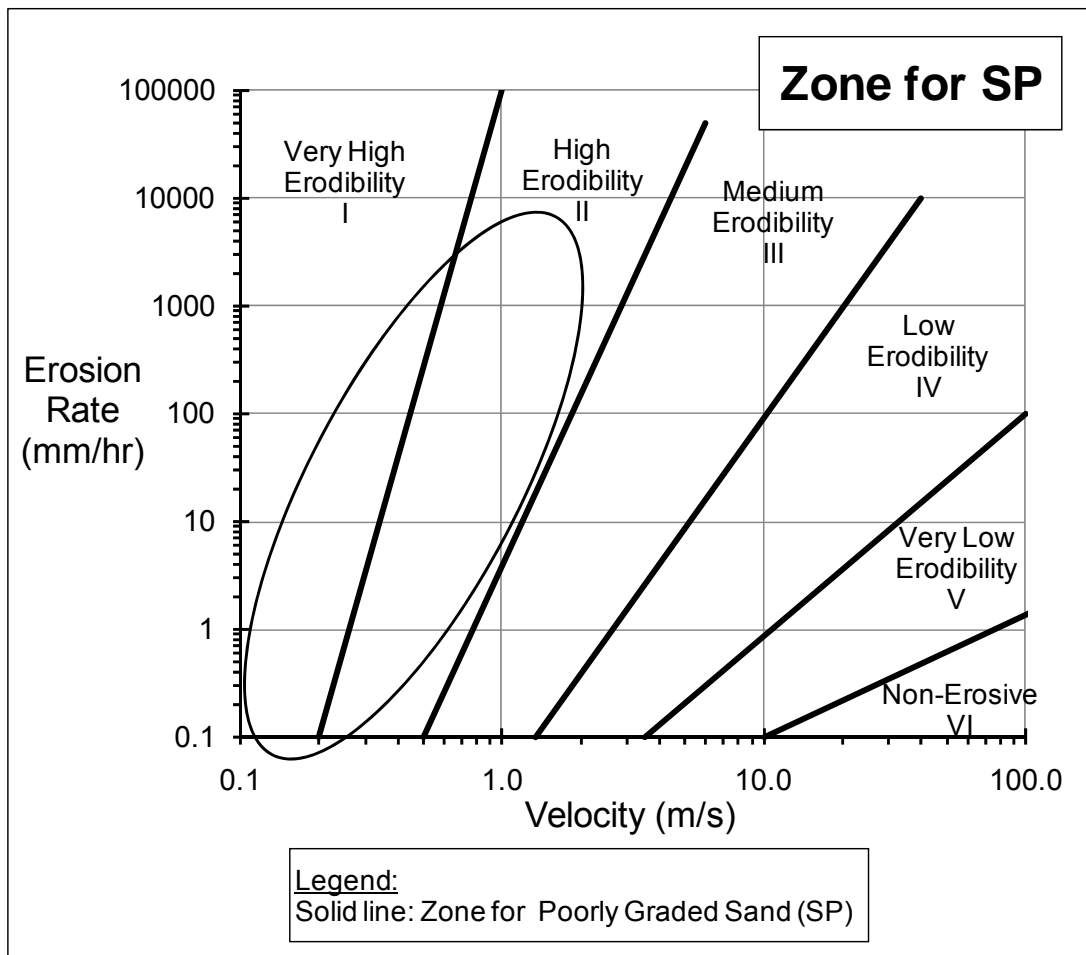
Figure 3-17. Zone for poorly graded sand.

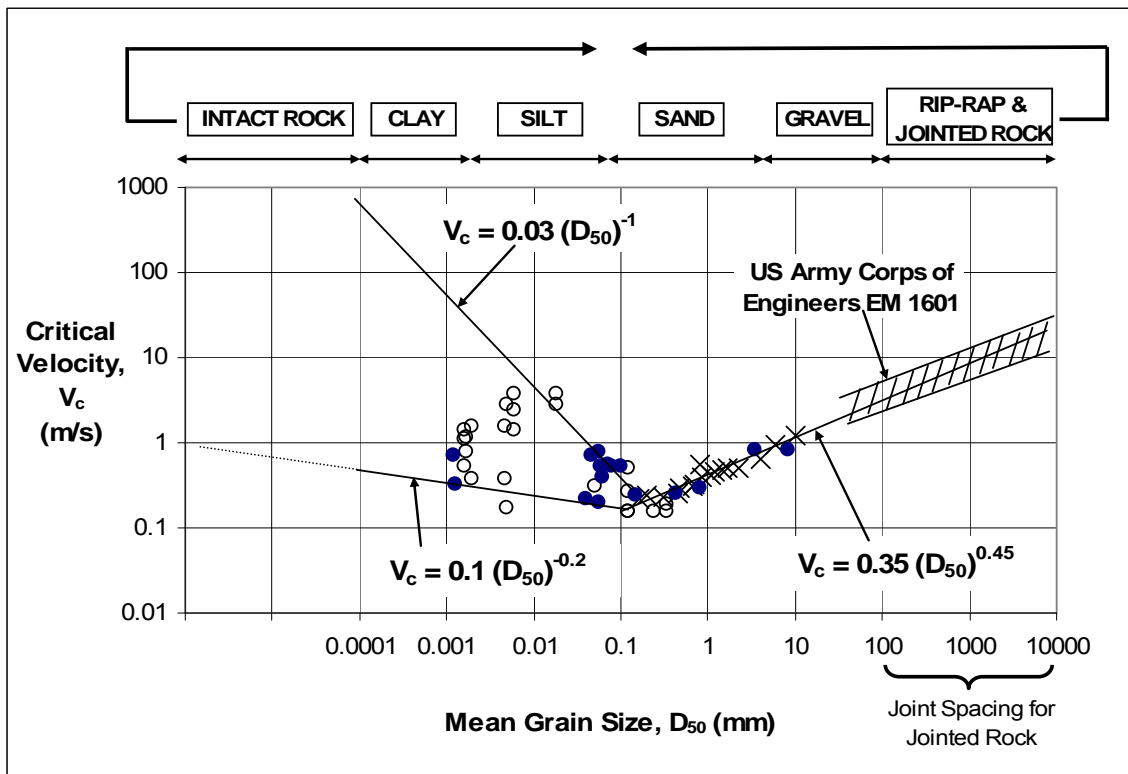
**Figure 3-18. Critical velocity as a function of mean grain size.**

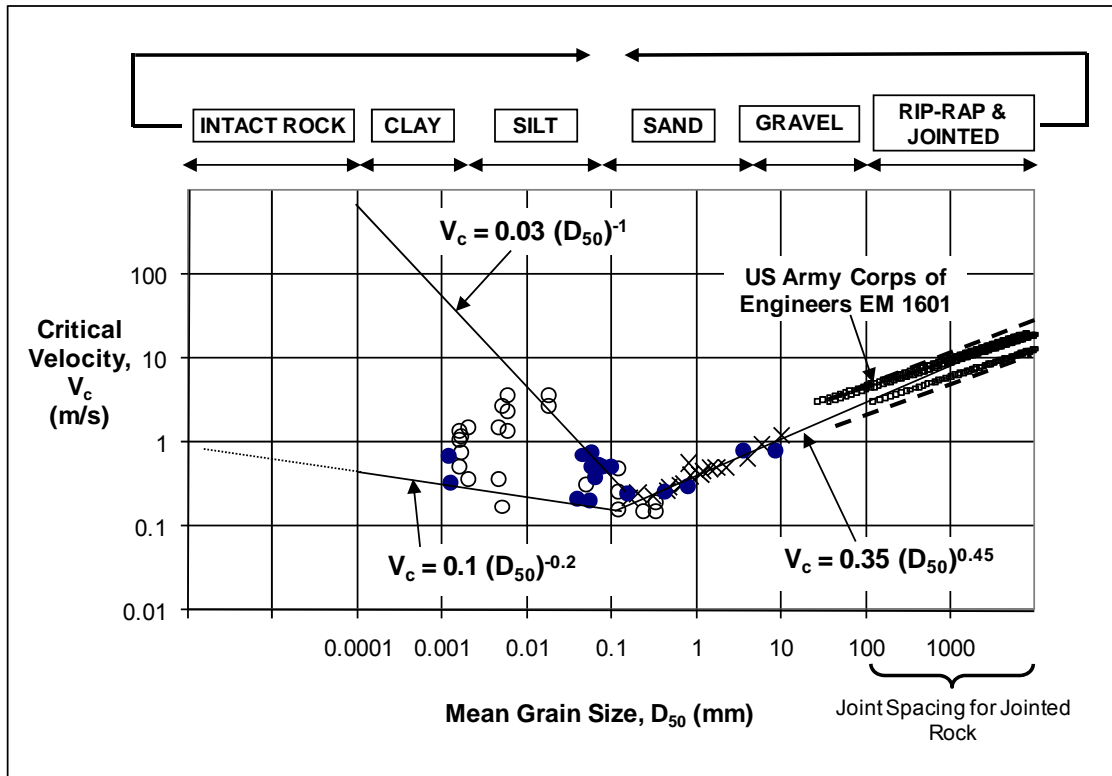
**Figure 3-19. Critical velocity as a function of mean grain size including data points from simulation using U.S. Army Corps of Engineers EM 1601 Riprap Design Equation.**

The range of threshold velocities  $V_c$  obtained using the riprap design (Equation (3.4)) is shown in Figure 3-19. Note that for fractured rock, the particle diameter is assumed to be the rock fracture spacing which seems to be a reasonable assumption because one can expect a piece of fractured rock with a certain fracture spacing to have similar critical erosion properties as a piece of riprap with a diameter that is equal to the fracture spacing.

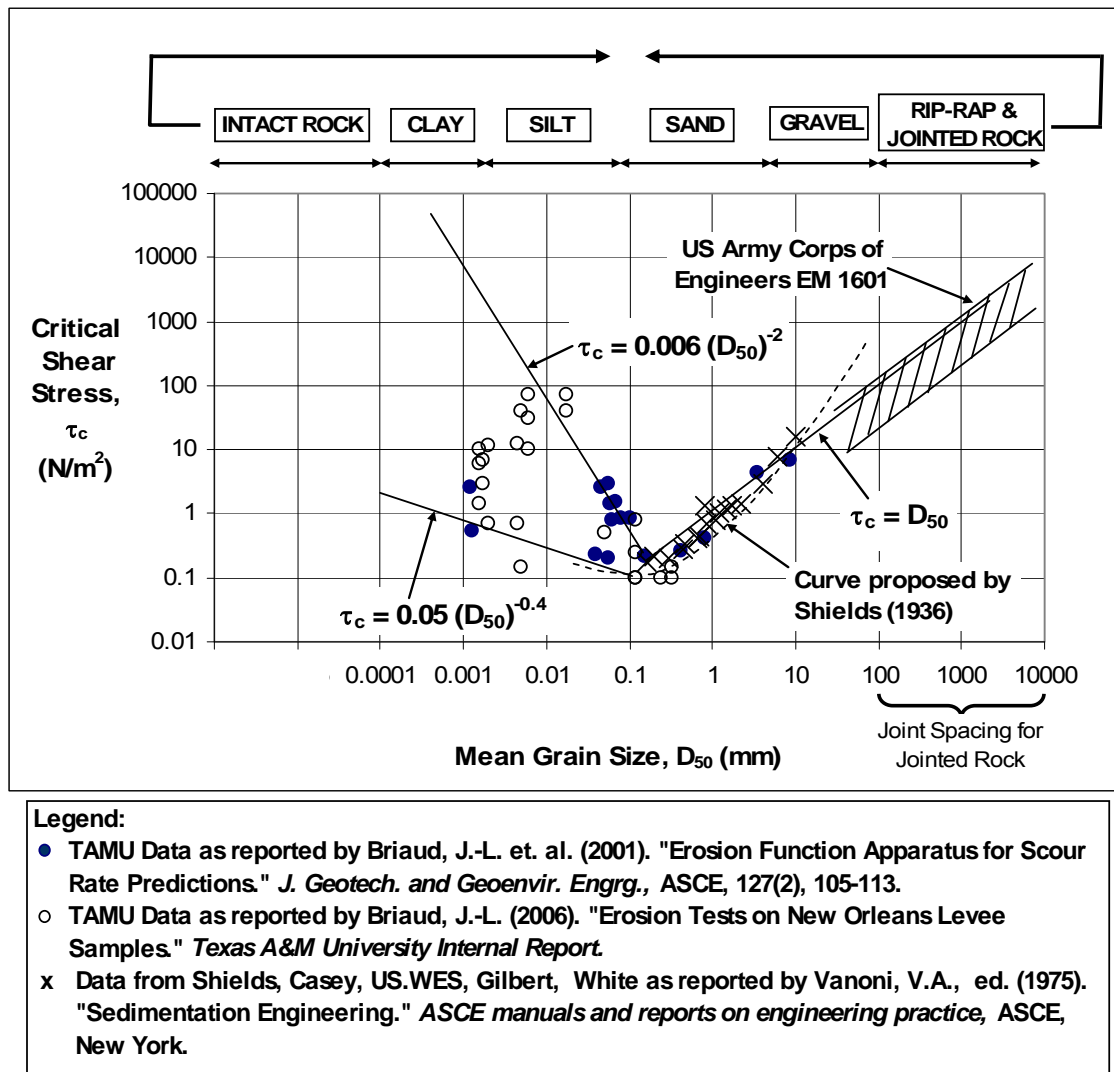
Figure 3-20. Critical shear stress as a function of mean grain size.
