**SIMPLIFIED METHOD FOR ESTIMATING FUTURE SCOUR  
DEPTH AT EXISTING BRIDGES**

A Dissertation

ANAND V GOVINDASAMY

Submitted to the Office of Graduate Studies of  
Texas A&M University  
in partial fulfillment of the requirements for the degree of

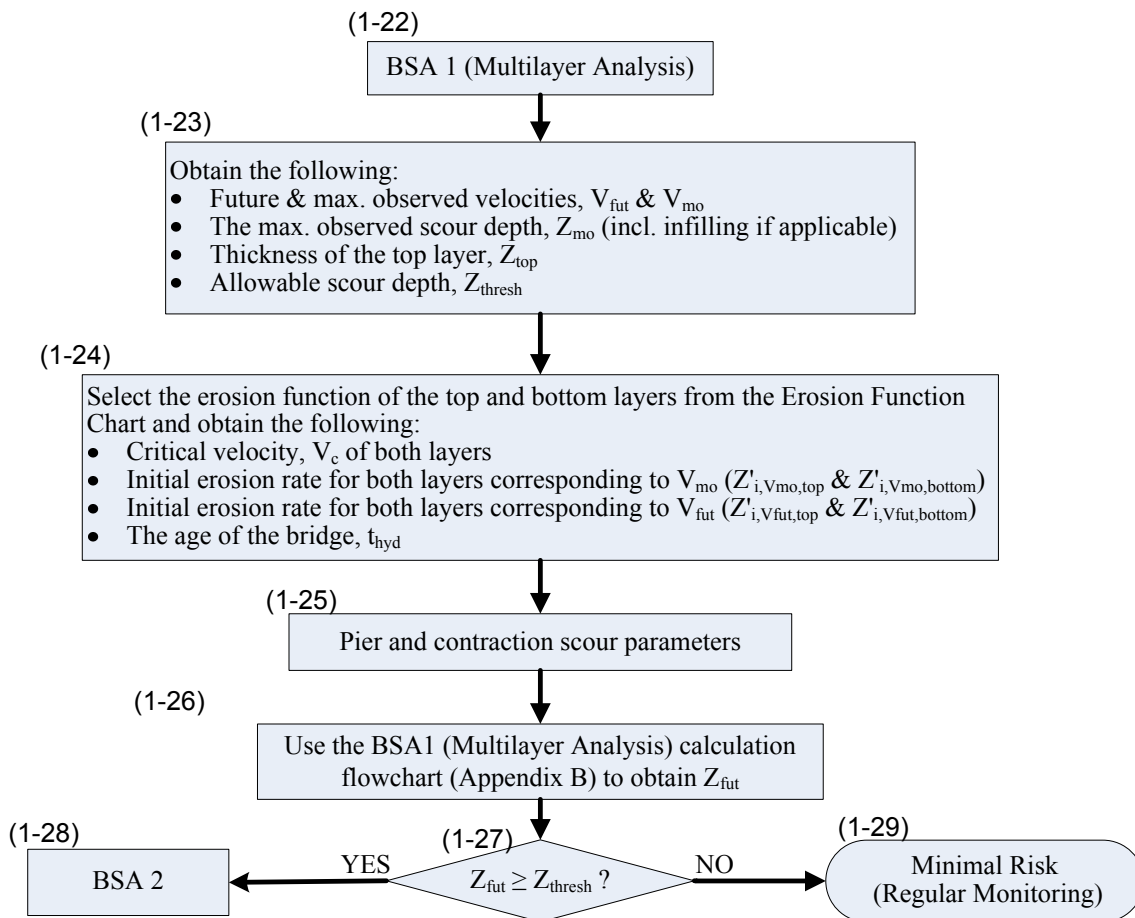
**Figure 4-2. BSA 1 (Multilayer Analysis) flowchart.**

depth being investigated extends beyond the top layer. The BSA 1 (Multilayer Analysis) flowchart is shown in Figure 4-2. Both analyses are explained in detail in this Section.

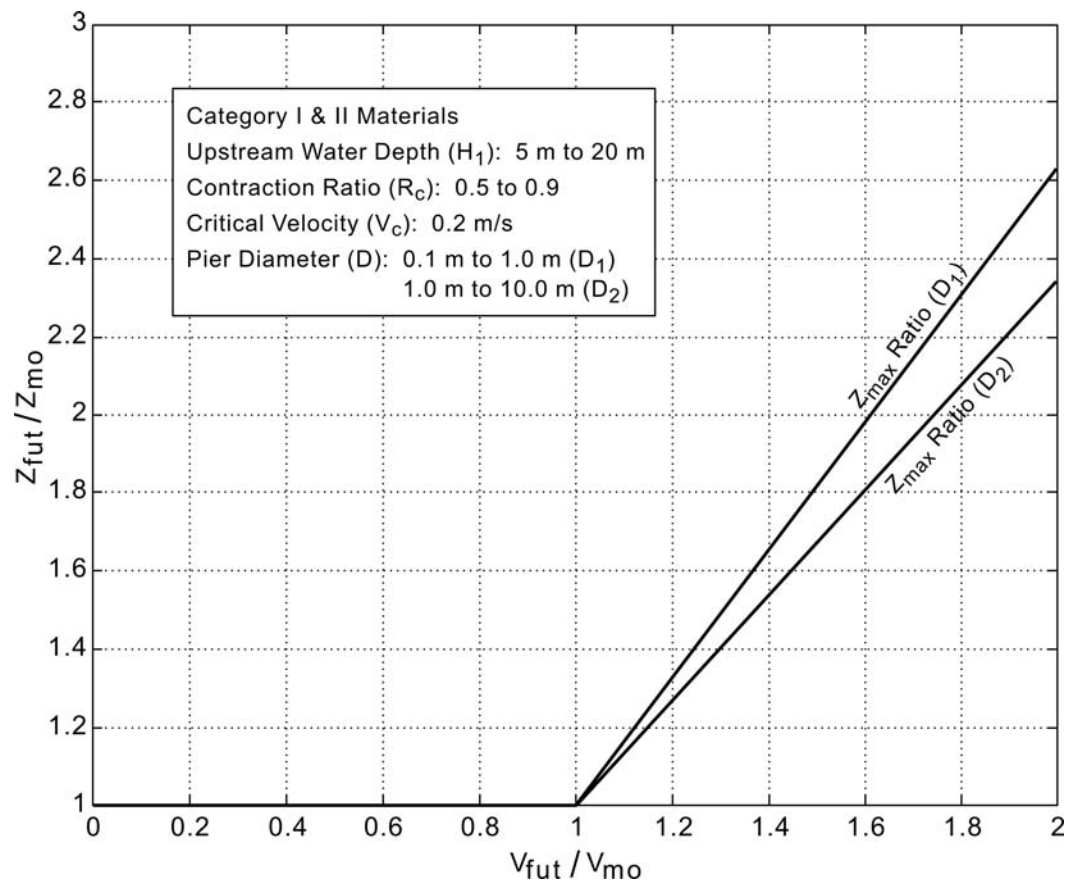
**Figure 4-3. Z-Future Chart for Category I & II materials.**

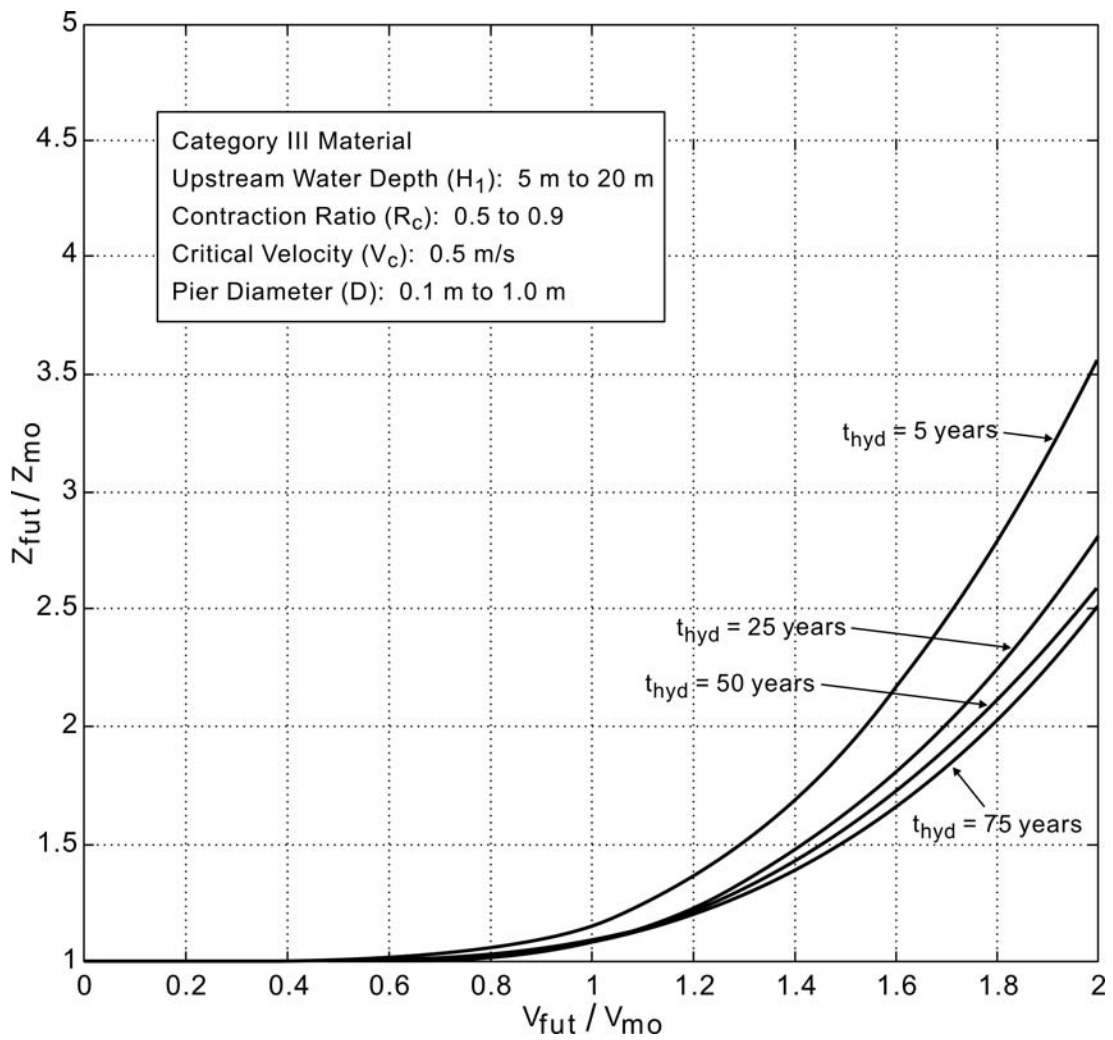
**Figure 4-4. Z-Future Chart for Category III materials  
(Pier diameter: 0.1 m to 1.0 m).**

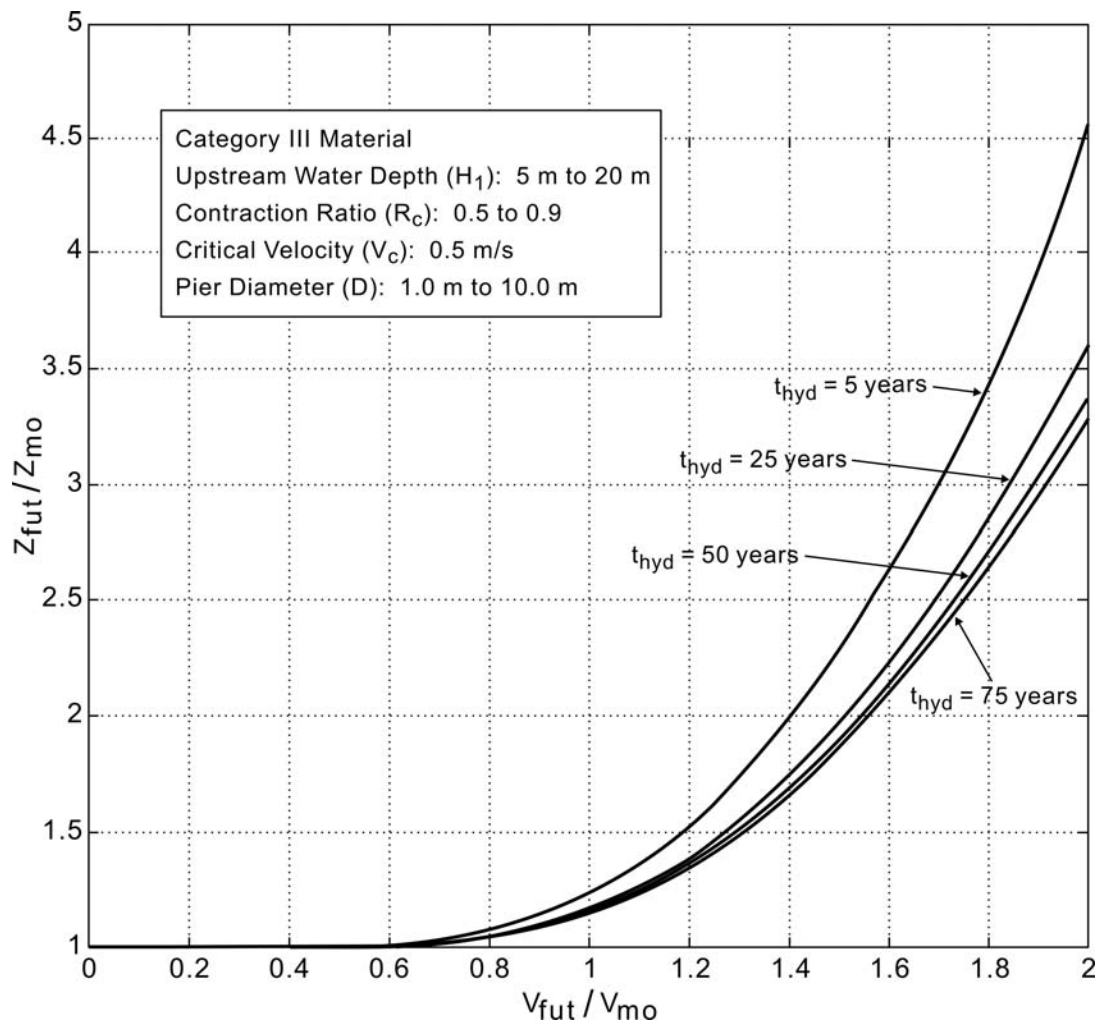
**Figure 4-5. Z-Future Chart for Category III materials  
(Pier diameter: 1 m to 10 m).**

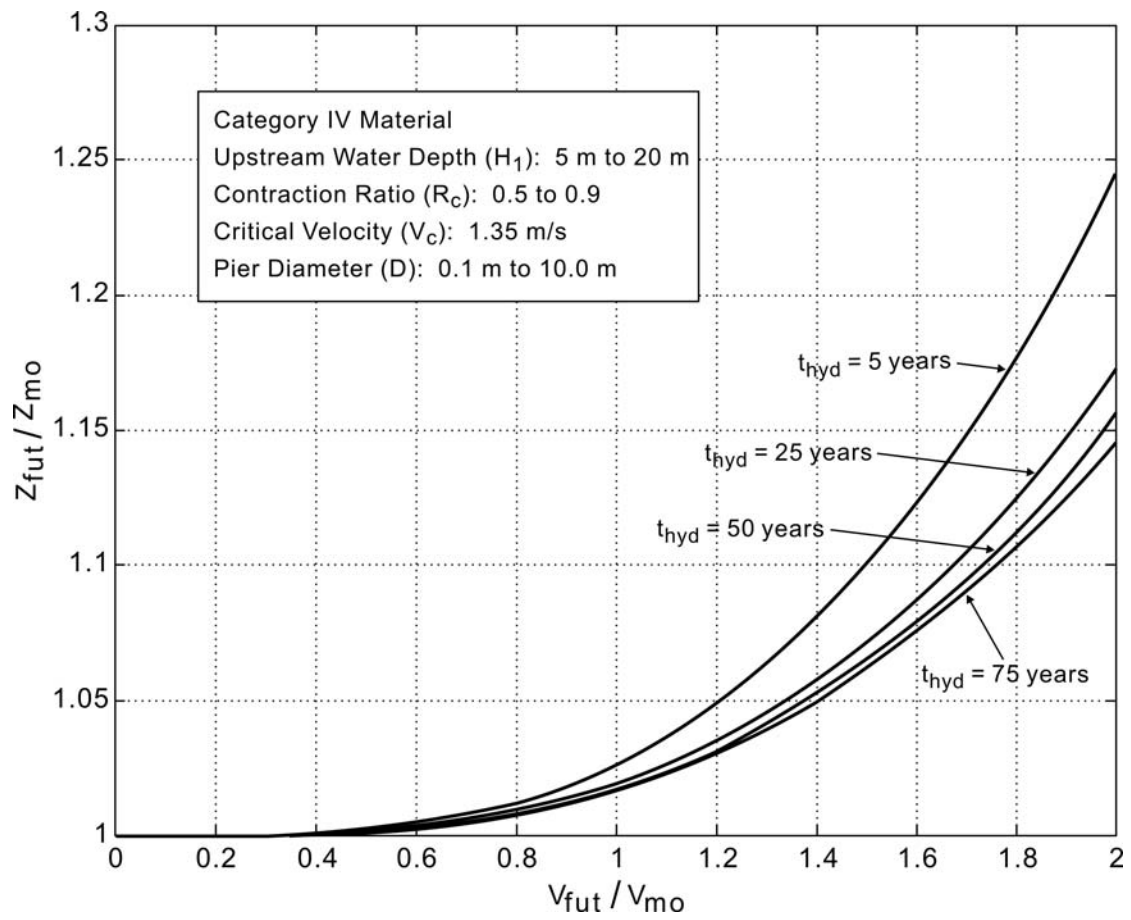
**Figure 4-6. Z-Future Chart for Category IV materials.**

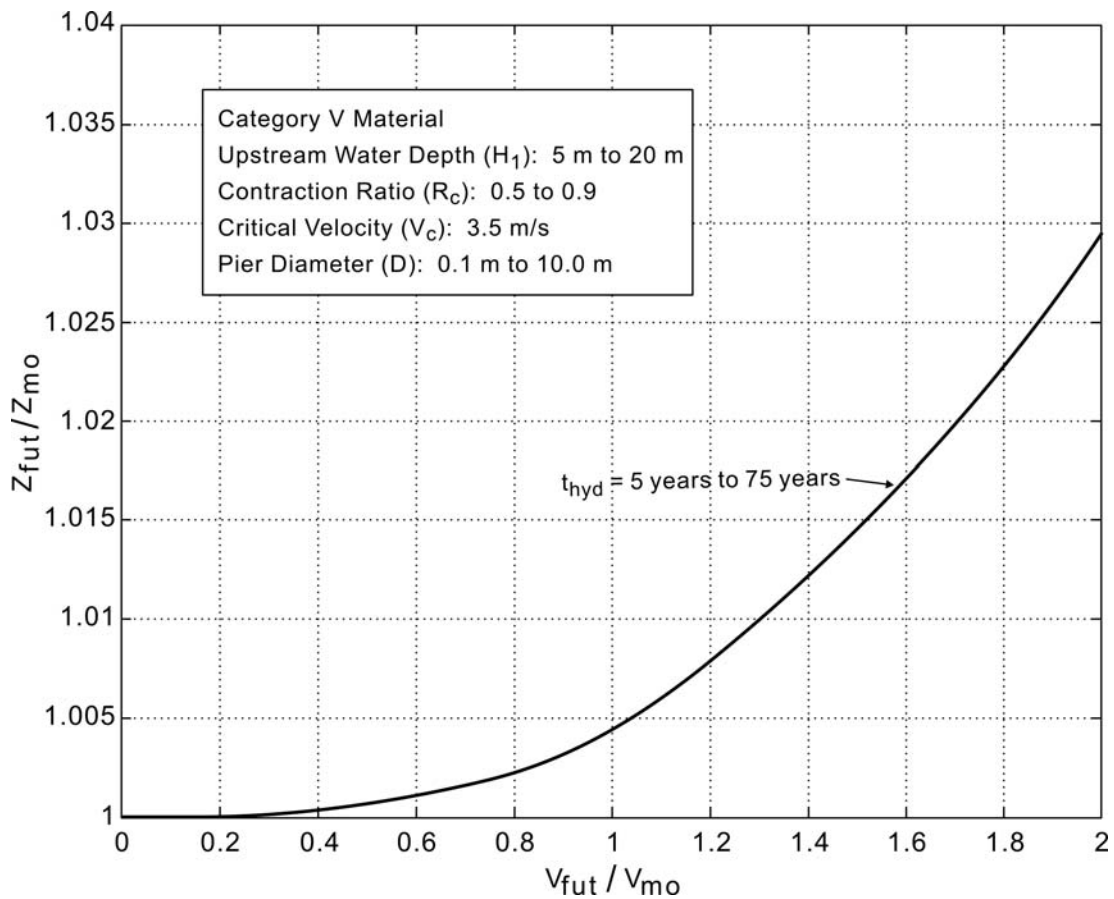
**Figure 4-7. Z-Future Chart for Category V materials.**

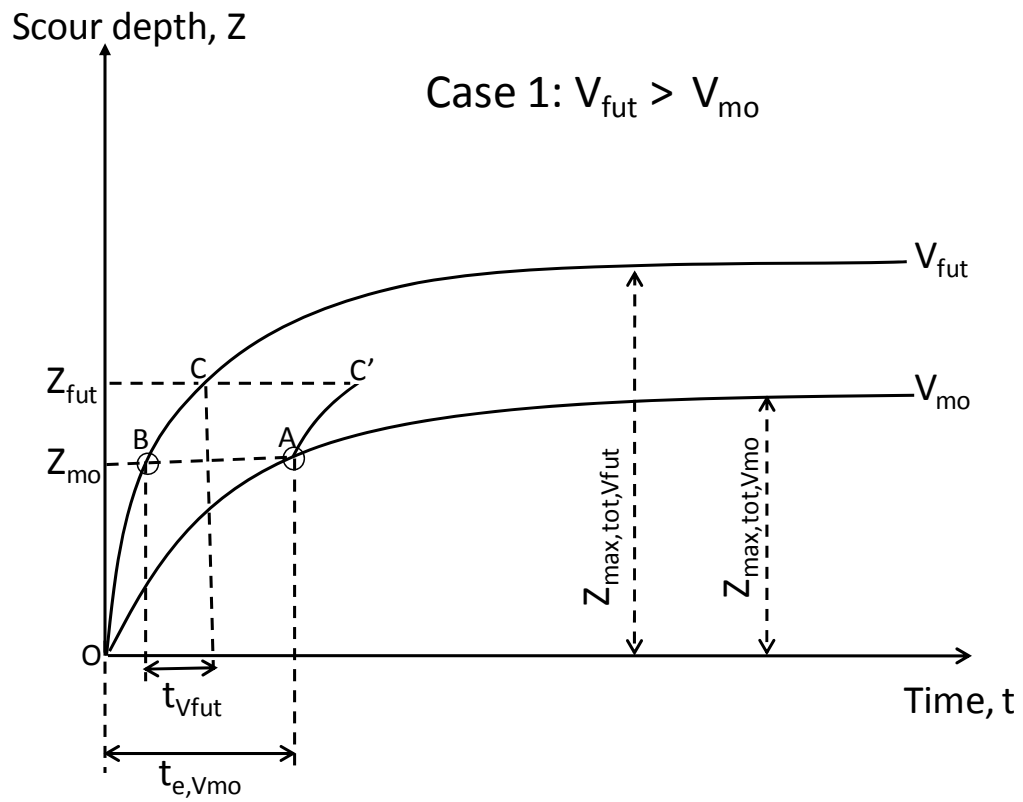
**Figure 4-8. Scour caused by sequence of two flood events:  $V_{fut} > V_{mo}$  (after Briaud et al. 2001).**

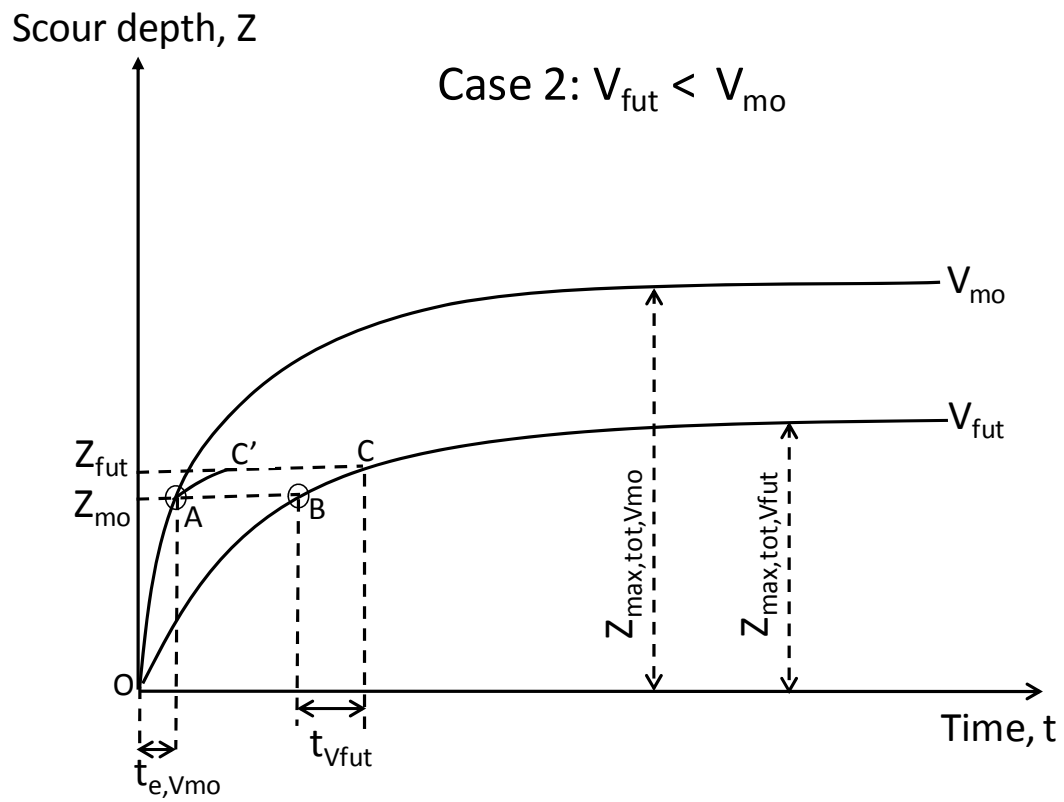
**Figure 4-9. Scour caused by sequence of two flood events:  $V_{fut} < V_{mo}$  (after Briaud et al. 2001).**

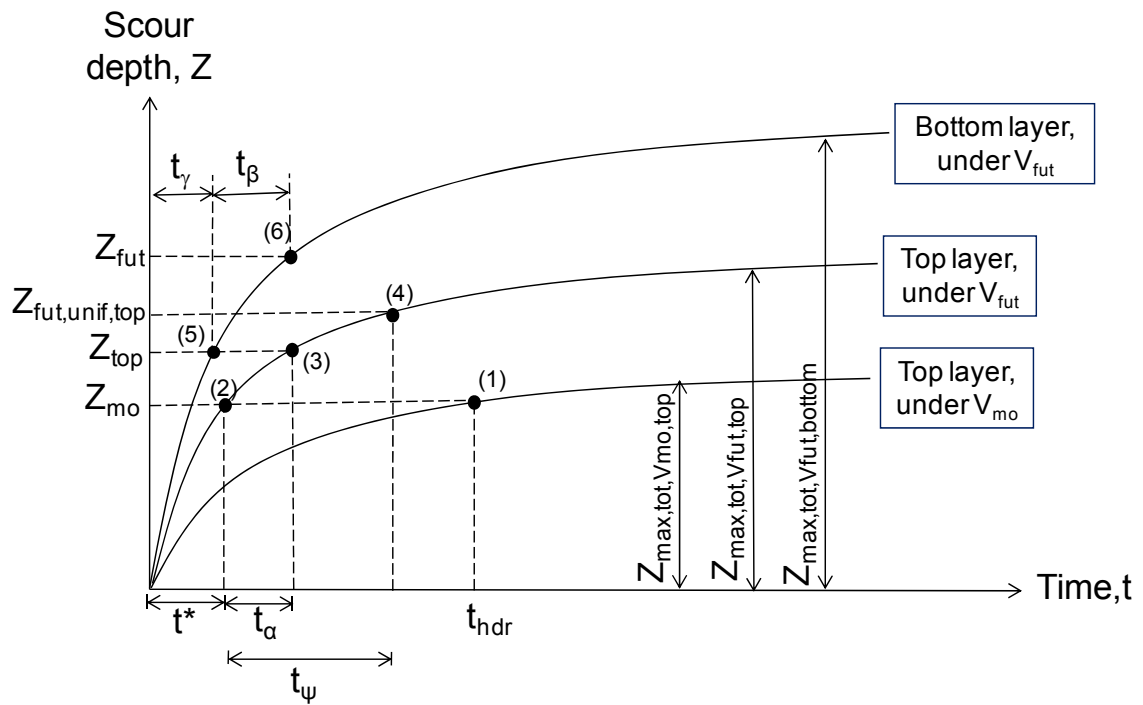
Figure 4-10. A general illustration for BSA 1 (Multilayer Analysis).

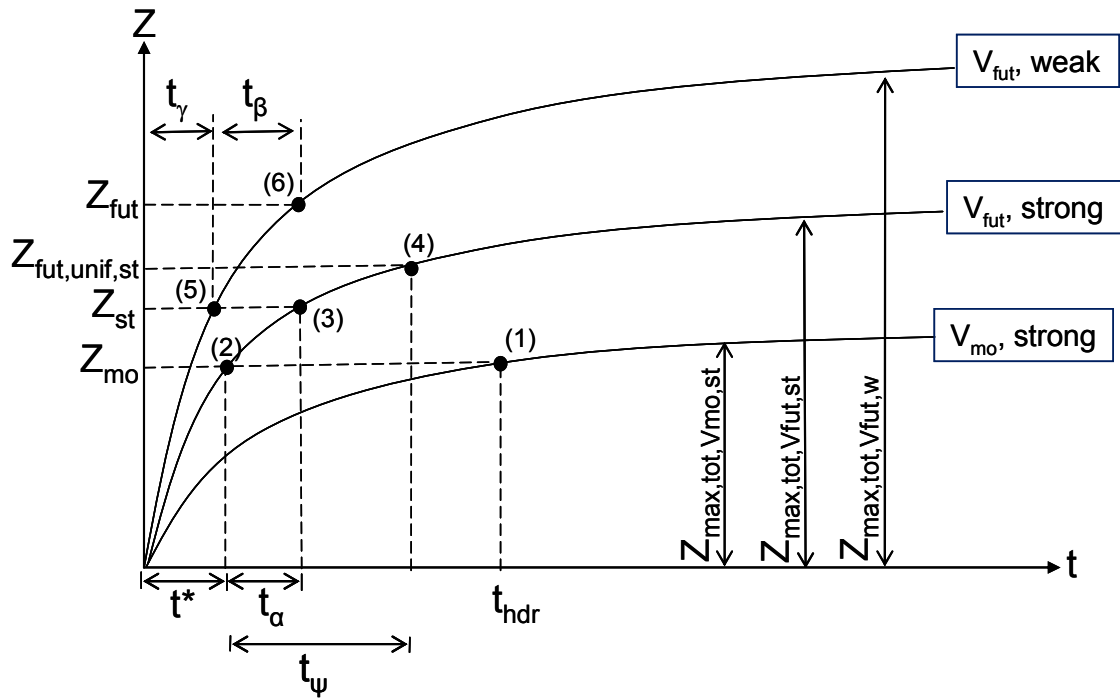
Figure 4-11. Case 1(a) for BSA 1 (Multilayer Analysis).

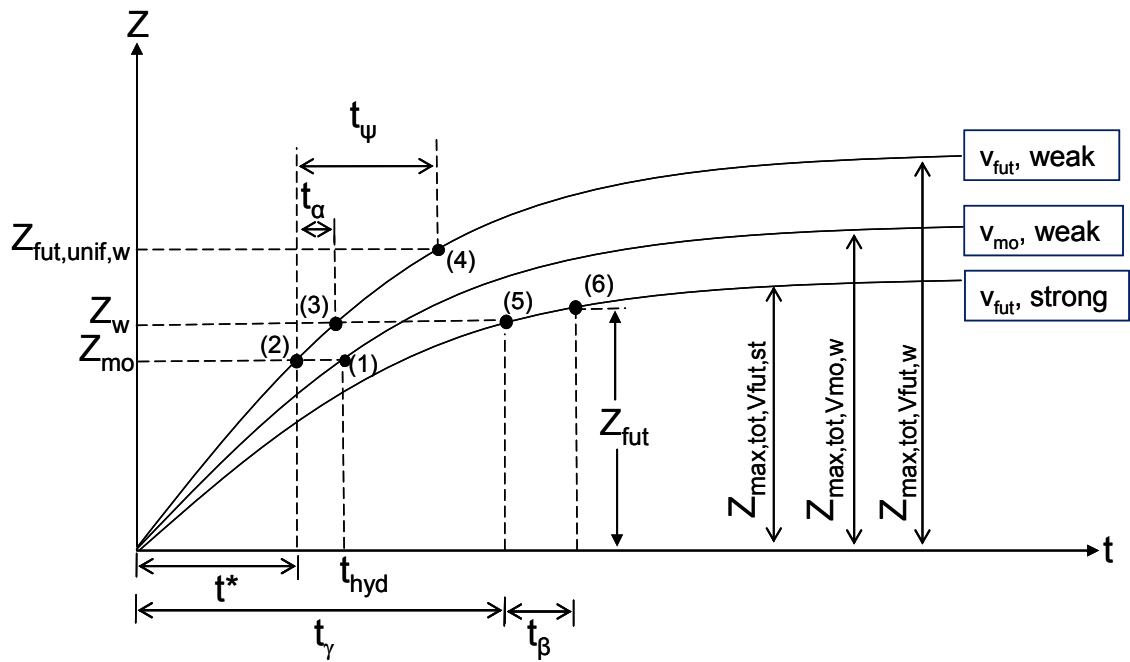
Figure 4-13. Case 1(c) for BSA 1 (Multilayer Analysis).

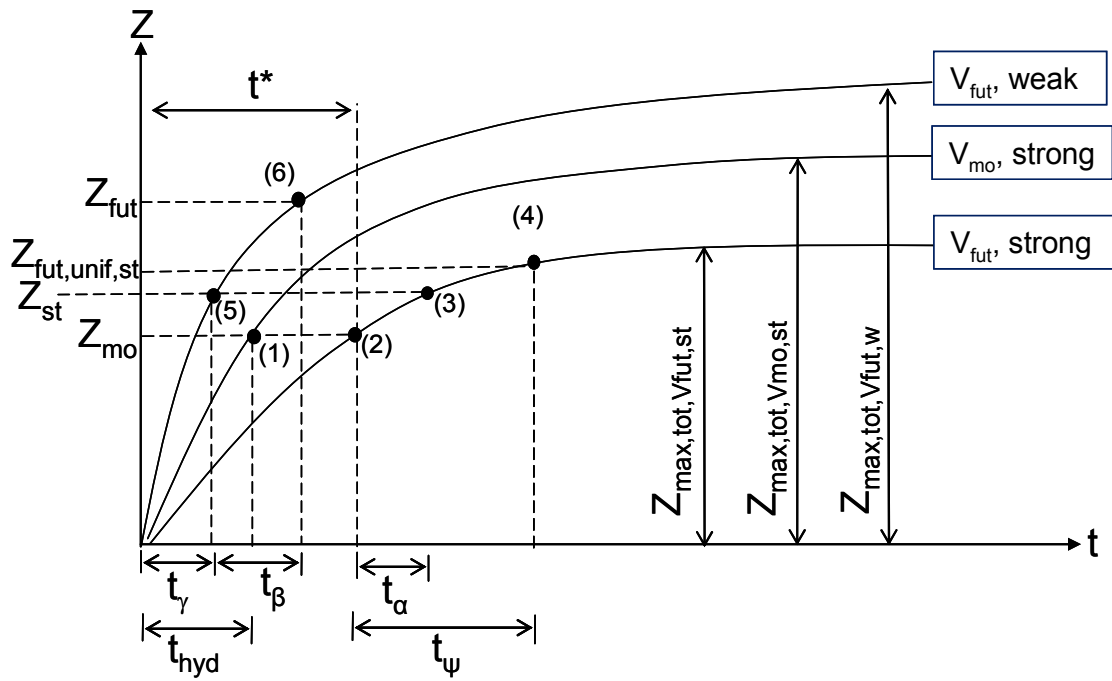
Figure 4-14. Case 2(a) for BSA 1 (Multilayer Analysis).

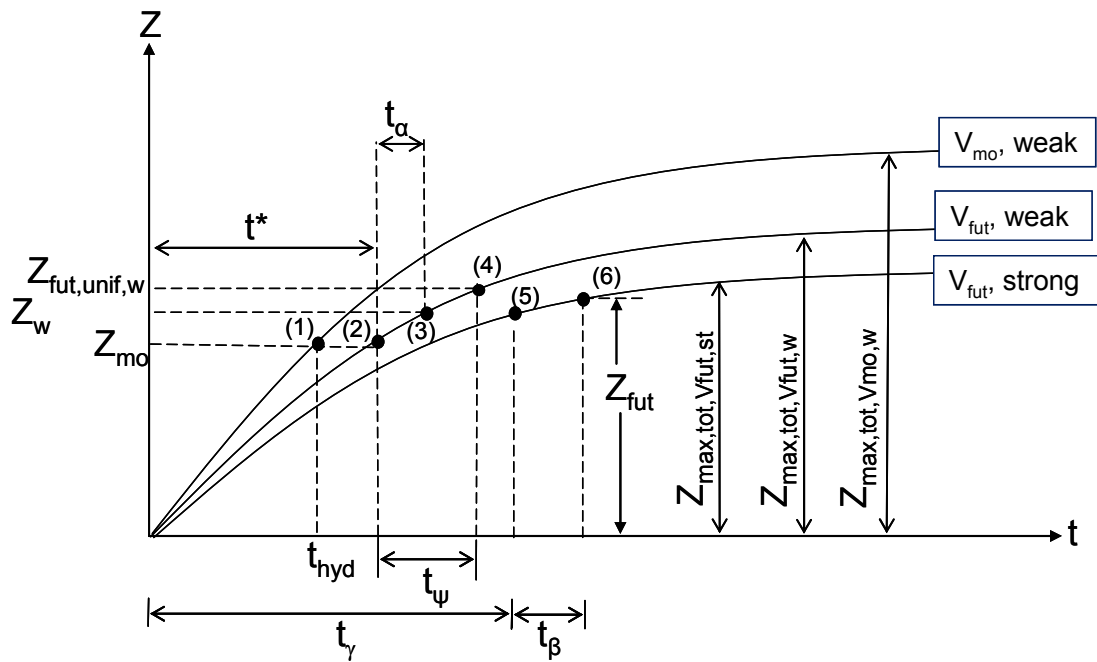
Figure 4-16. Case 2(c) for BSA 1 (Multilayer Analysis).

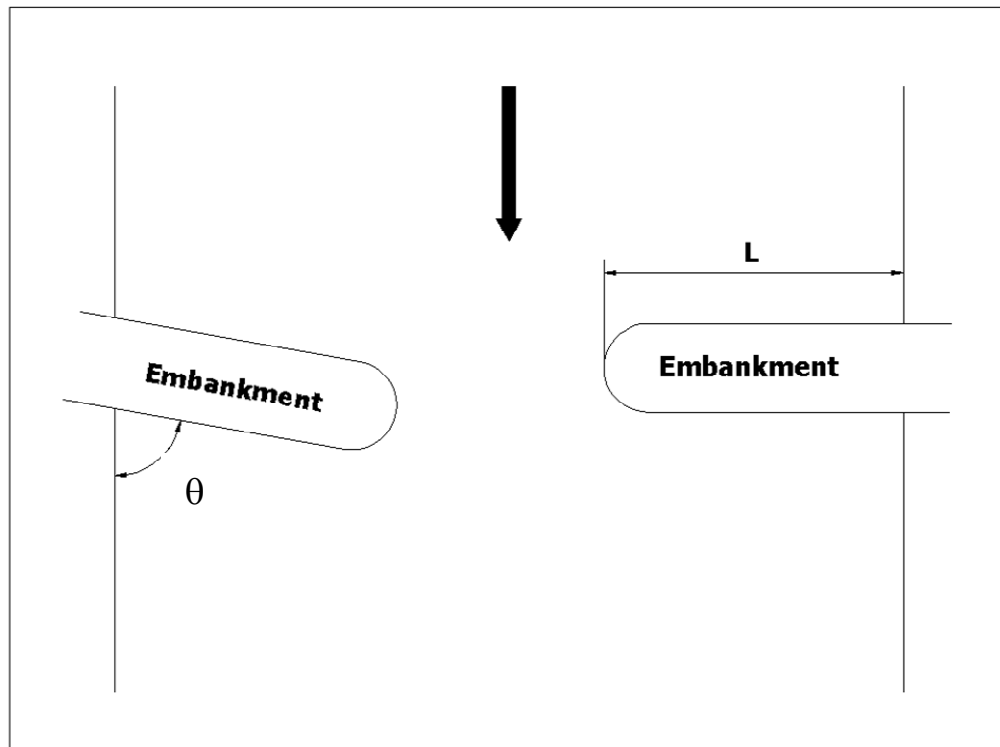
**Figure 5-2. Definition of length of active flow obstructed by the abutment and angle of embankment flow.**

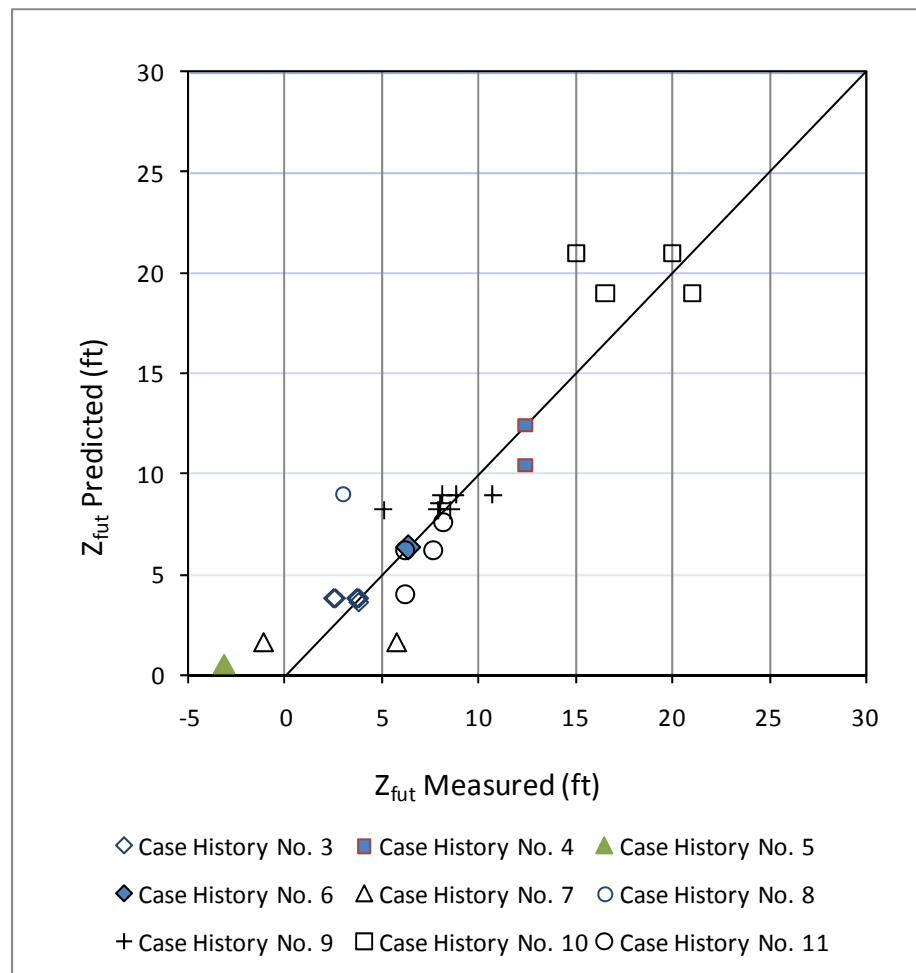
**Figure 7-2. Comparison between  $Z_{fut}$  values predicted by BSA 1 and corresponding field measurements.**

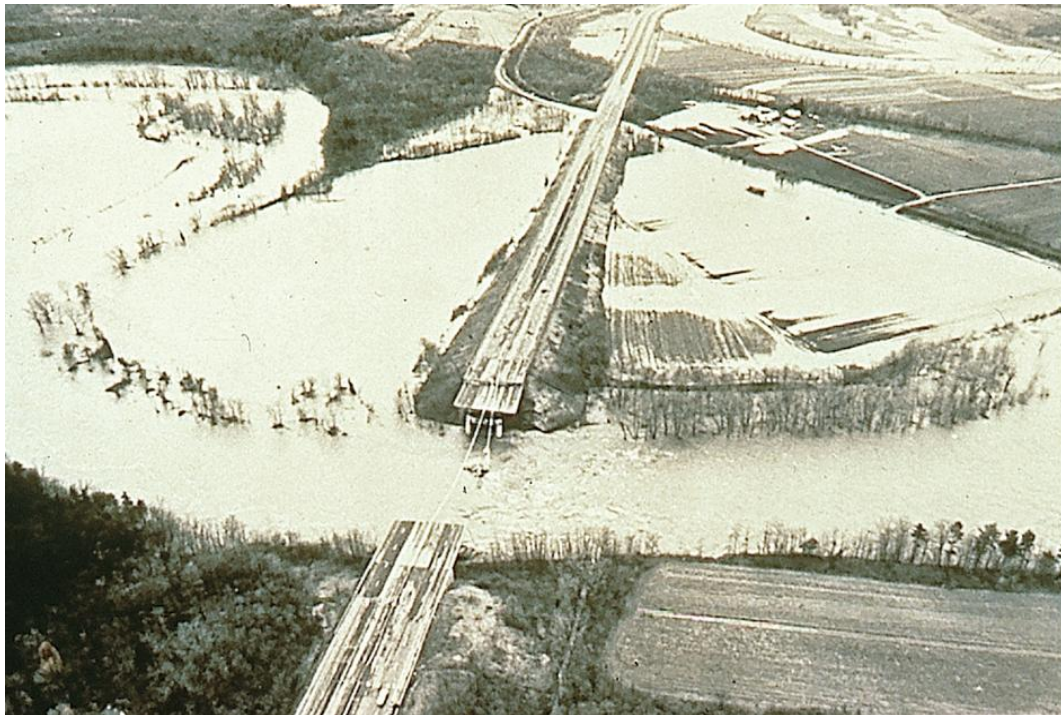
**Figure 7-4. The 1987 Schoharie Creek Bridge failure.**

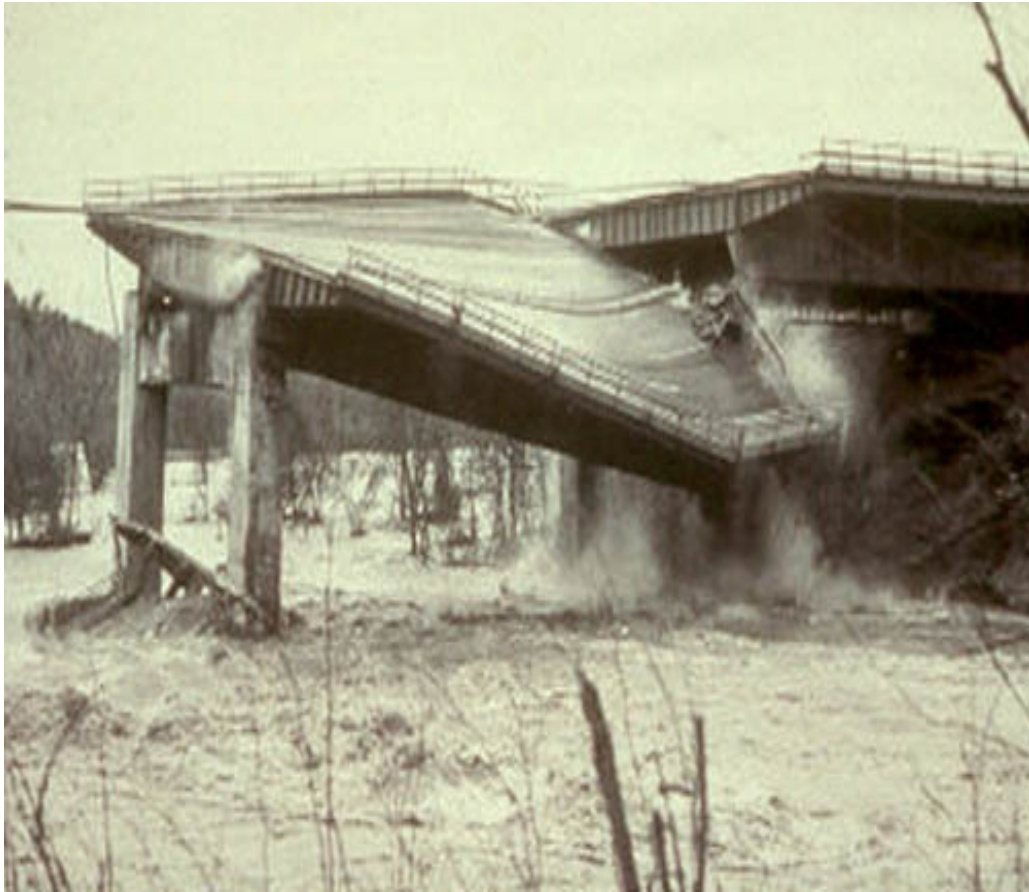
**Figure 7-5. One of the Schoharie Creek Bridge spans plunging into the river.**

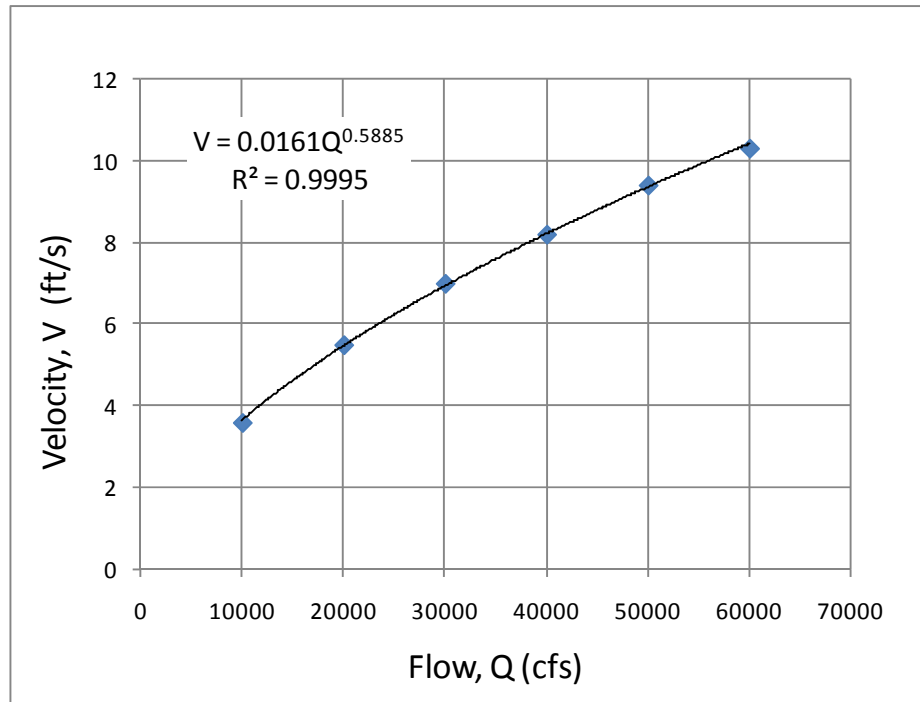
**Figure 7-6. Flow-velocity relationship for Schoharie Creek Pier 3.**

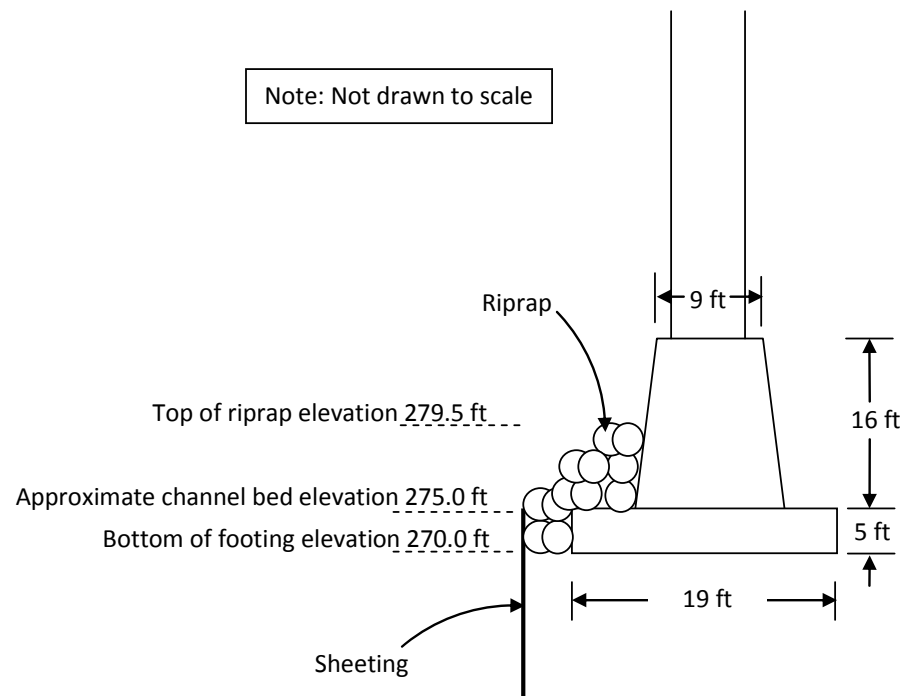
**Figure 7-7. Schoharie Creek Pier 3 (after NTSB 1987).**

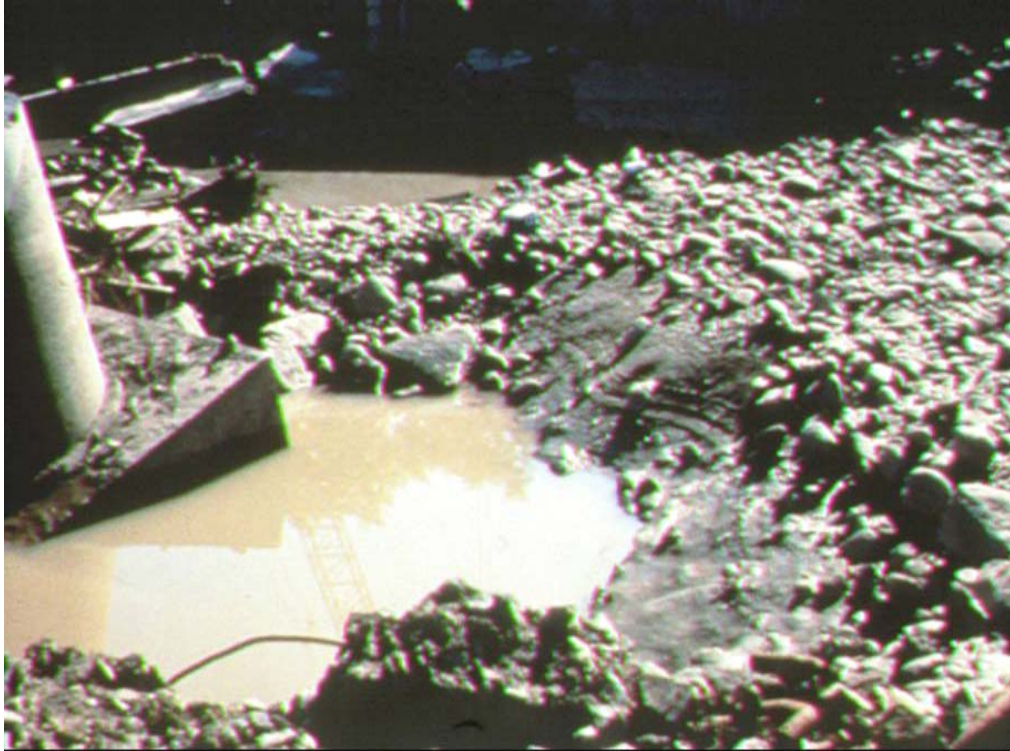
**Figure 7-10. Photo of Pier 2 taken in 1987 after the failure.**

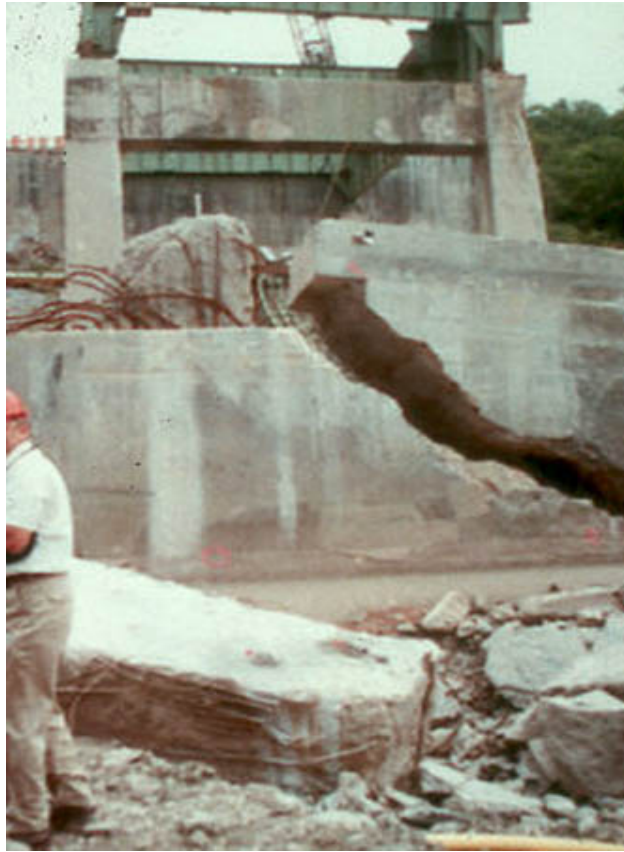
**Figure 7-11. Photo of Pier 3 taken in 1987 after the failure.**

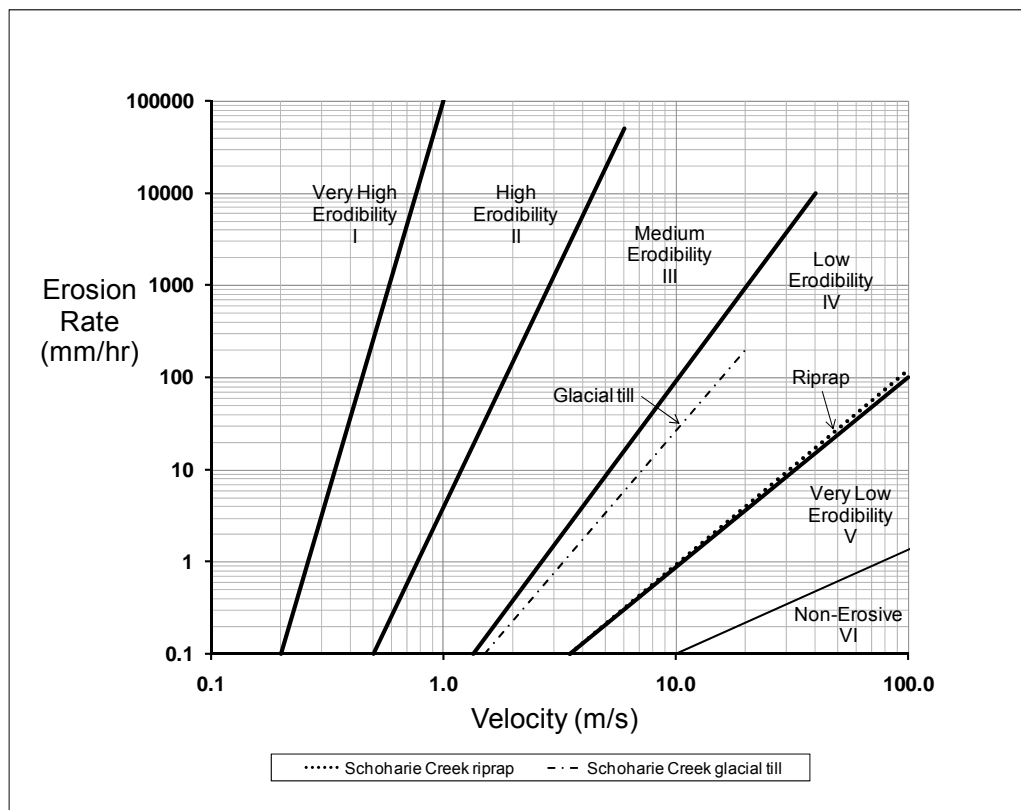
**Figure 7-12. Estimated erosion functions for the Schoharie Creek riprap and glacial till.**

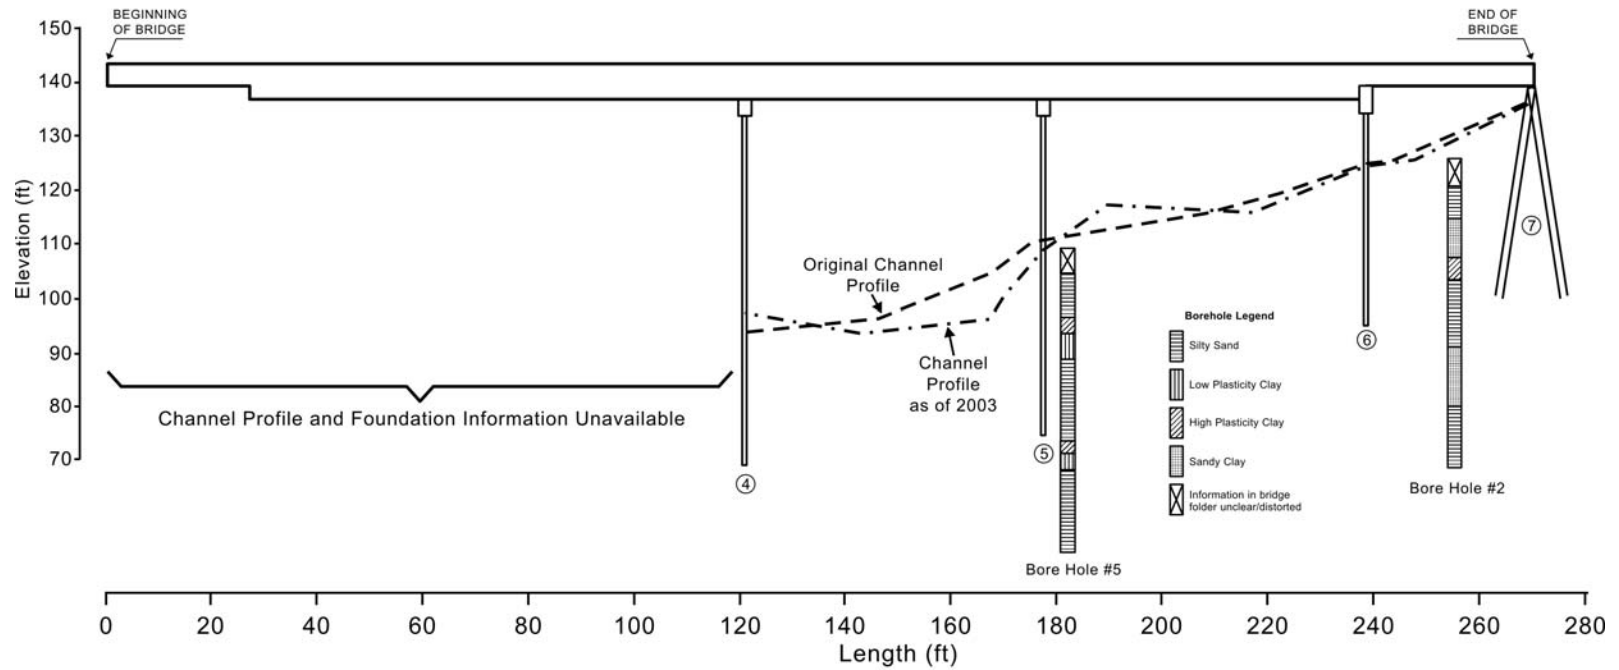
Figure C-5. Case History No.5 – Bridge Cross-Section.

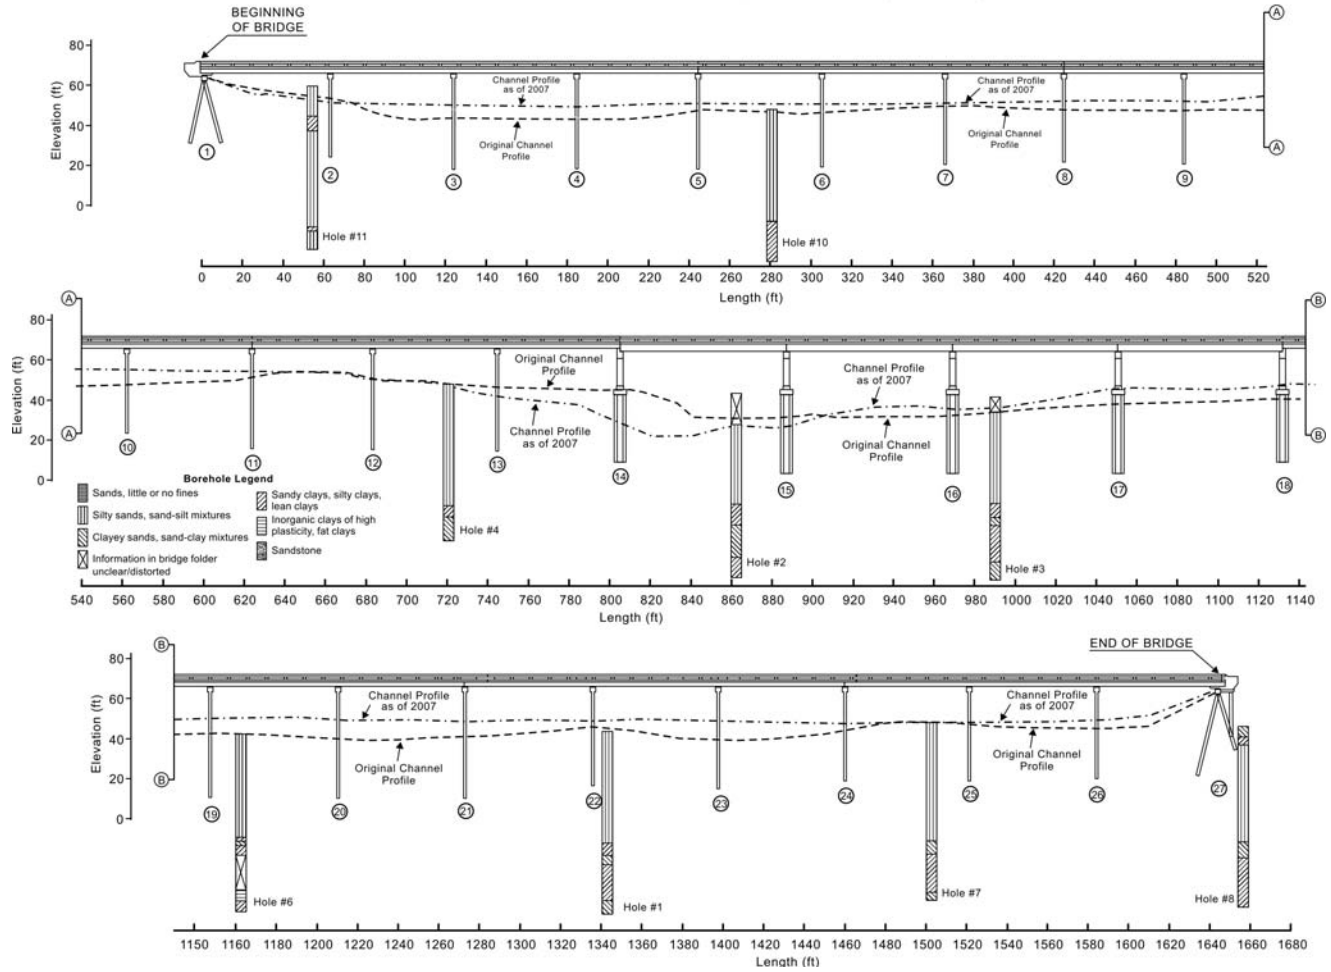
Figure C-7. Case History No. 7 – Bridge Cross-Section.

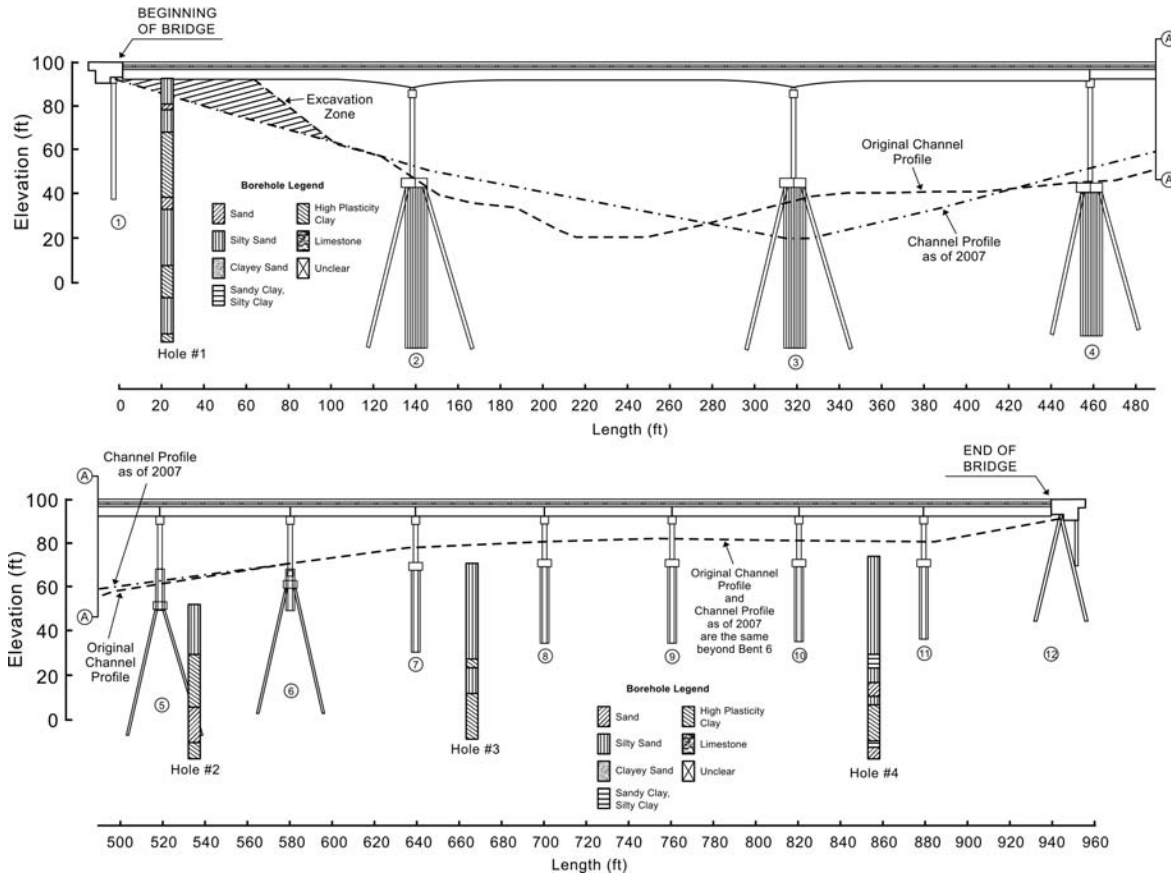
Figure C-10. Case History No.10 – Bridge Cross-Section.
