**SIMPLIFIED METHOD FOR ESTIMATING FUTURE SCOUR  
DEPTH AT EXISTING BRIDGES**

A Dissertation

ANAND V GOVINDASAMY

Submitted to the Office of Graduate Studies of  
Texas A&M University  
in partial fulfillment of the requirements for the degree of

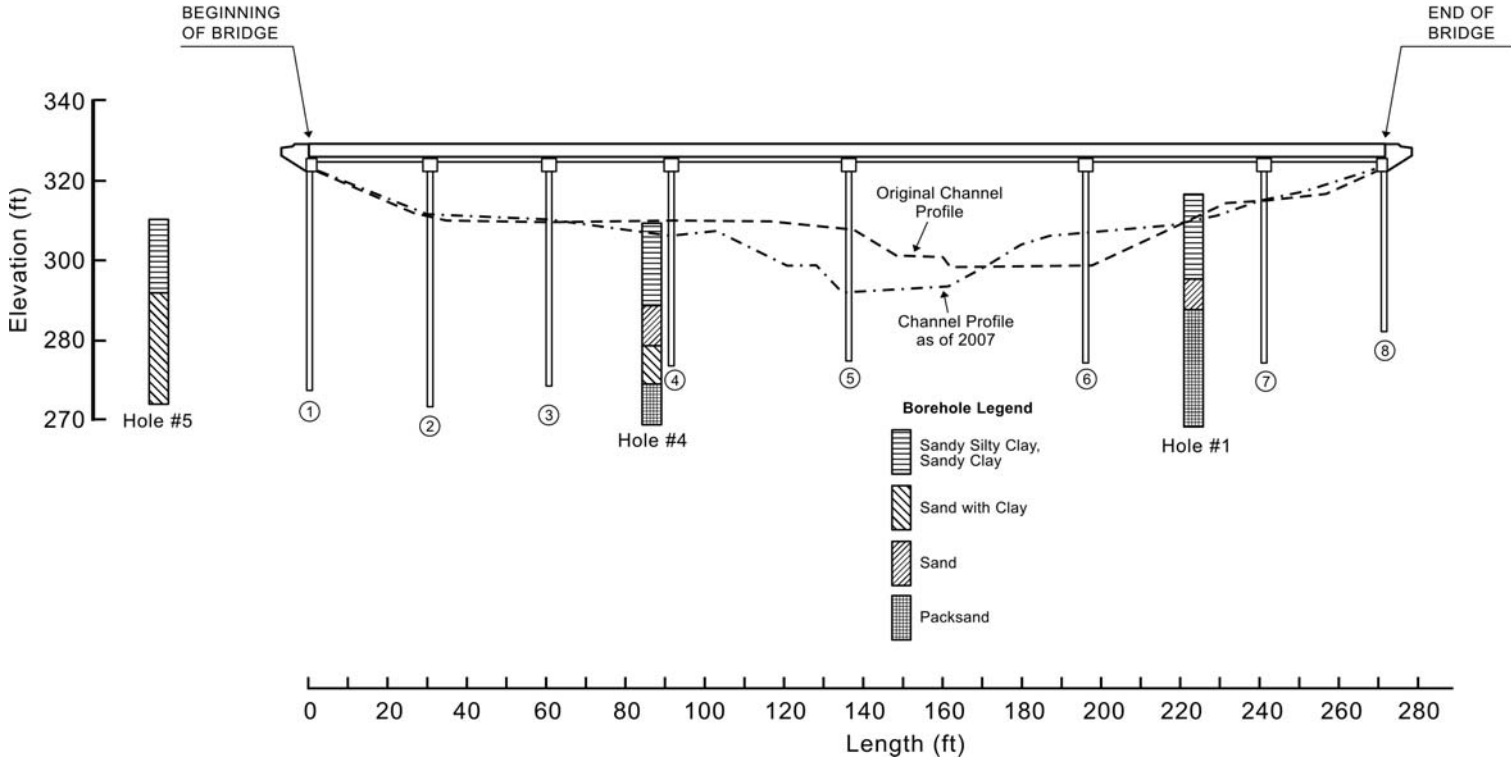
Figure C-11. Case History No.11 – Bridge Cross-Section.
