**CORROSION OF ALUMINUM ALLOY 2024 BELONGING TO THE  
1930s IN SEAWATER ENVIRONMENT**

A Thesis

Major Subject: Mechanical Engineering

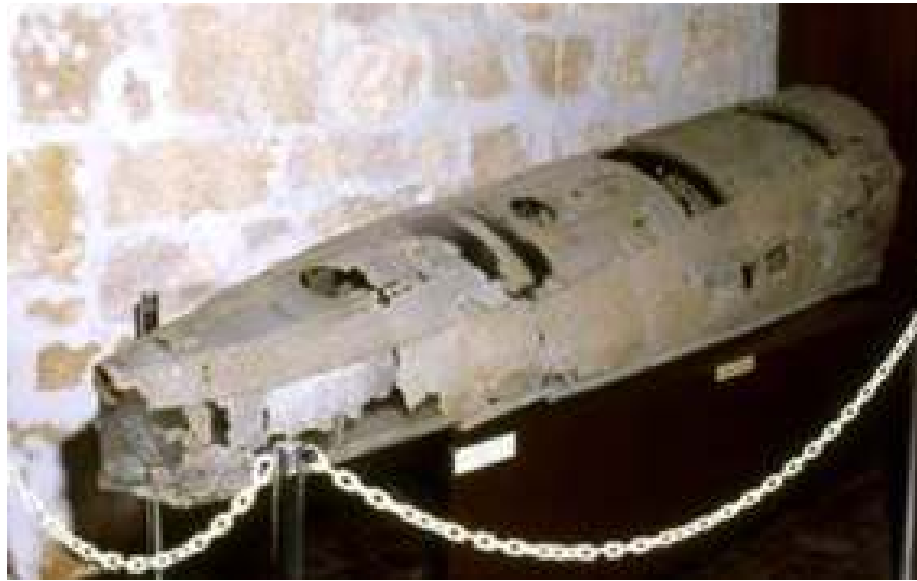
*Figure 1.3 The Junker's W33 showing extensive pitting corrosion on the skin.*

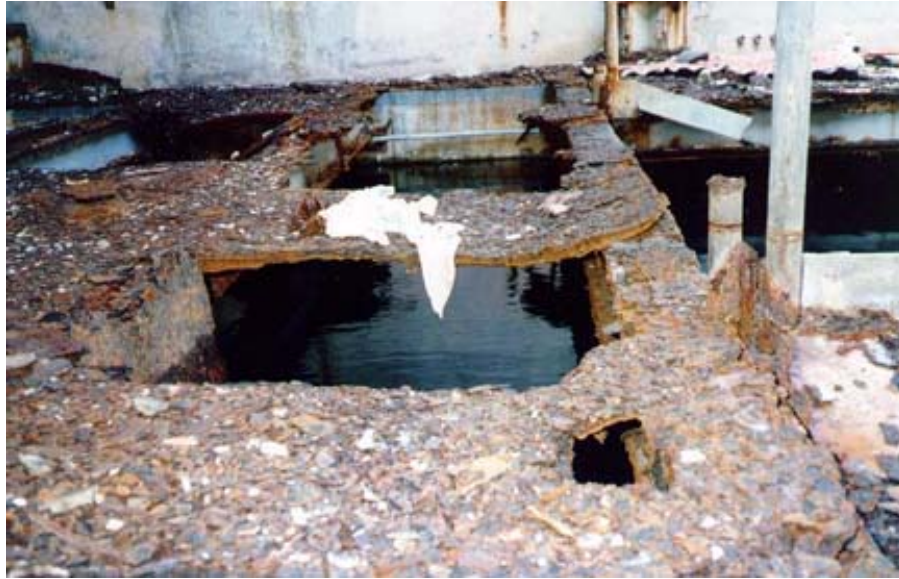
*Figure 2.7 Uniform corrosion attack on structural steel [16].*

Depiction of uniform corrosion is by corrosive attack proceeding evenly over the entire surface area, or a large fraction of the total area. General thinning takes place until failure. This is the most important form of corrosion in terms of tonnage wasted. Measurement and prediction of uniform corrosion is relatively easily, making disastrous failures rare. In many cases, it is objectionable only from an appearance standpoint. As corrosion occurs uniformly over the entire surface of the metal, it can be controlled by cathodic protection, use of coatings or paints, or simply by specifying a corrosion allowance. Thus, uniform corrosion is preferred from a technical standpoint because it is predictable and thus acceptable for design [11]. Figure 2.7 shows a uniform corrosion of part of a structure made from steel.

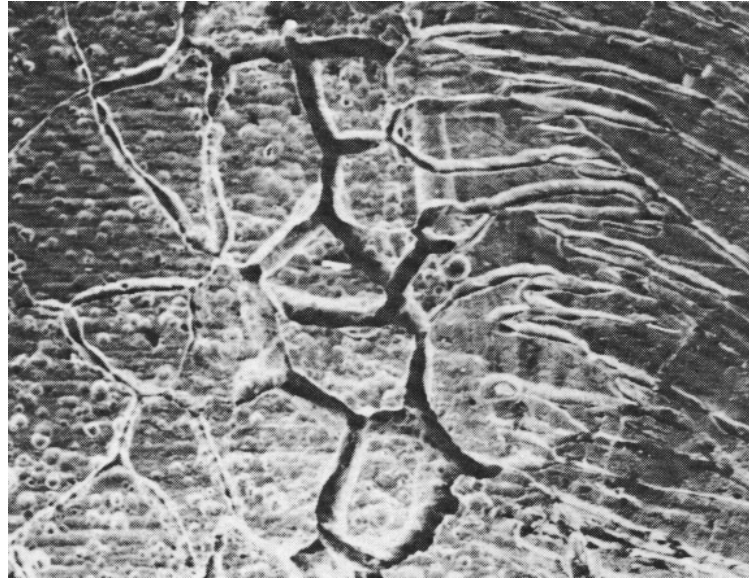
*Figure 2.11 Intergranular corrosion in austenitic stainless steel [20].*

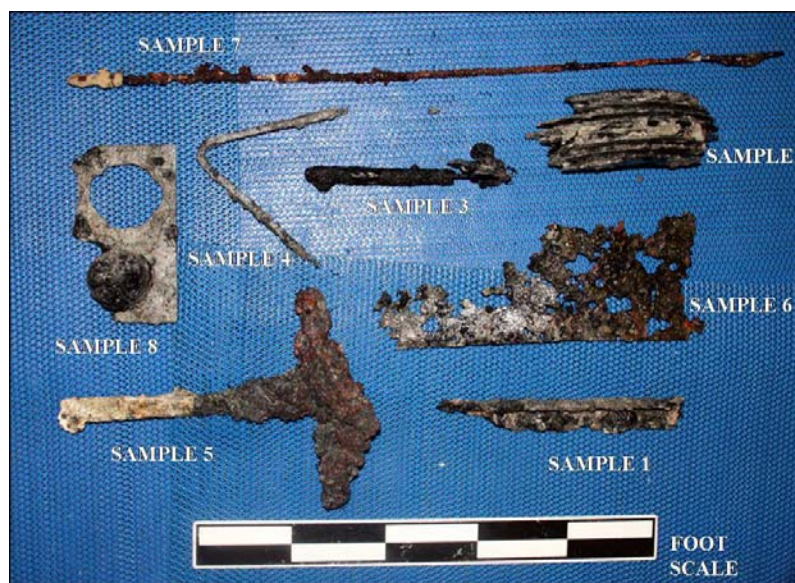
*Figure 3.2 The assemblage of the collected Carnauba samples before packaging for transport and storage.*

On site, the sample materials were photographed as shown in Figure 3.2 and its provenance recorded before collection. All samples were found in front of the aircraft or along the port wing and all but one was either lying on the surface or under a slight cover of sediment. Only the instrument (Sample #8), as already mentioned, was discovered buried in the sediment 6.5 feet off the front of the plane along the centerline.

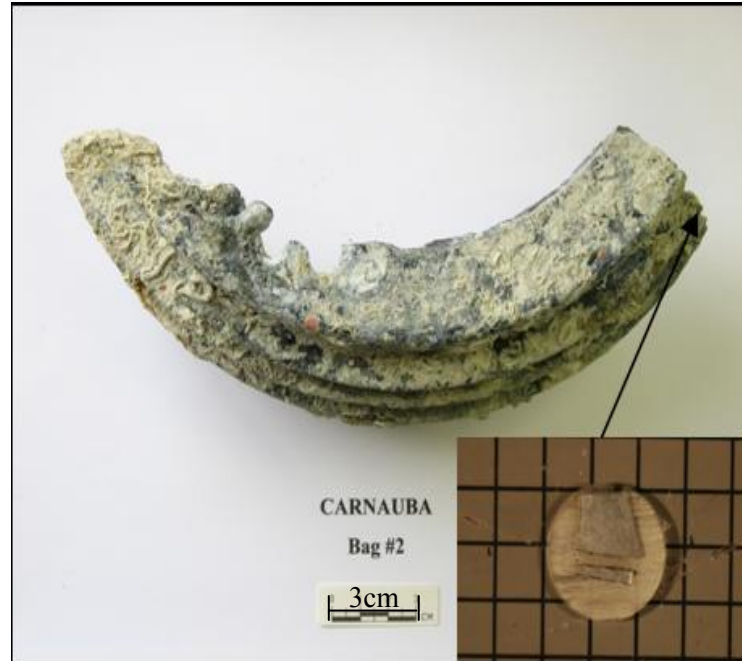
Figure 4.3 Photograph of sample 2.

This component was a part of the engine cylinder as shown in Figure 4.3. The chemical analysis shows that this is an aluminum alloy with approximately 6.5 wt% copper as the primary alloying element. The elemental composition is as shown on page 52. Due to the intricate shape of the component, the manufacturing process used was casting. This composition does not match with any of the modern day cast aluminum alloys and hence is specific to its period. The average hardness values for transverse and longitudinal direction were found to be 85 HV and 89 HV. Figure 4.4 shows a microstructure of the cast alloy. Figure 4.5 shows a microstructure of an area where exfoliation had occurred and delaminations are observed growing horizontally. The top portion of the figure shows the epoxy in which the specimen was set and the bright portion represents the metal aluminum.

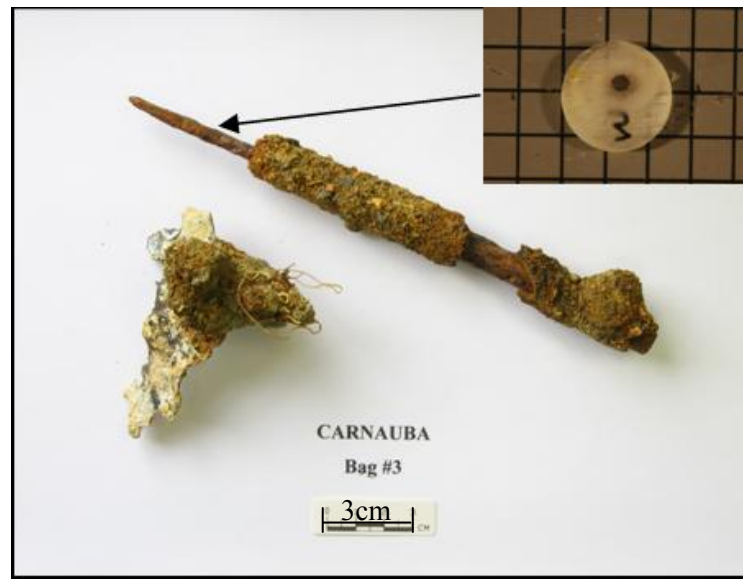
Figure 4.7 Photograph of sample 3.

This component was a steel shaft which can easily be confirmed by the rust accumulated over the years as shown in Figure 4.7. The chemical composition shows a carbon percentage of 0.11%. The elemental composition is as shown on page 52. The microstructure shows a typical low carbon steel structure as indicated in Figure 4.8 with ferrite and pearlite as the main phases. The composition matches with a typical AISI 10XX series. The average value of hardness in the transverse direction was found out to be 143 HV.

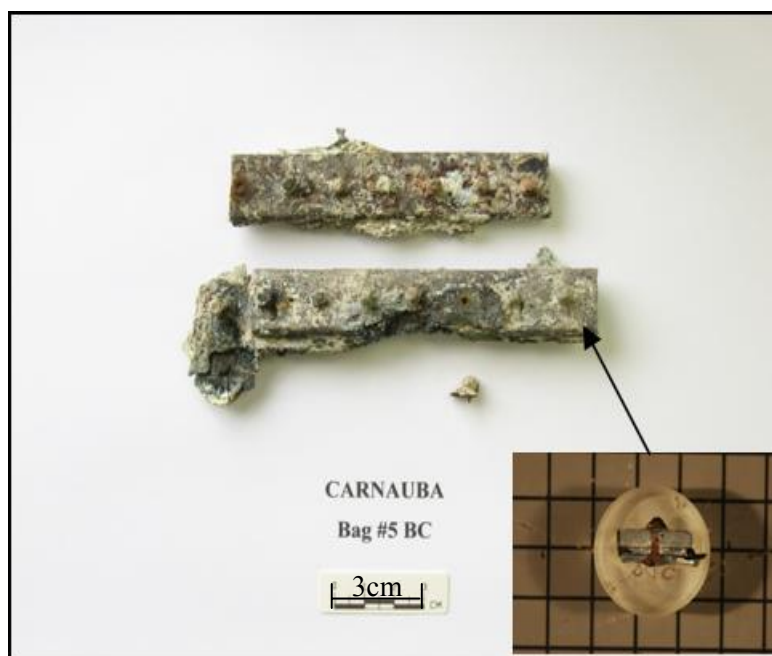
Figure 4.12 Photograph of sample 5.

This component was a part of a “T” piece as shown in Figure 4.12. The cross section of this component shows that it is a composite of three sheets. The chemical composition of all the three sheets shows 3.5% copper as a primary alloying element. The elemental composition is as shown on page 52. The elemental composition of this material matches with modern day aluminum alloy 2017. Figure 4.13 shows the microstructure of the alloy. The average hardness value across the transverse direction was found to be 143 HV.

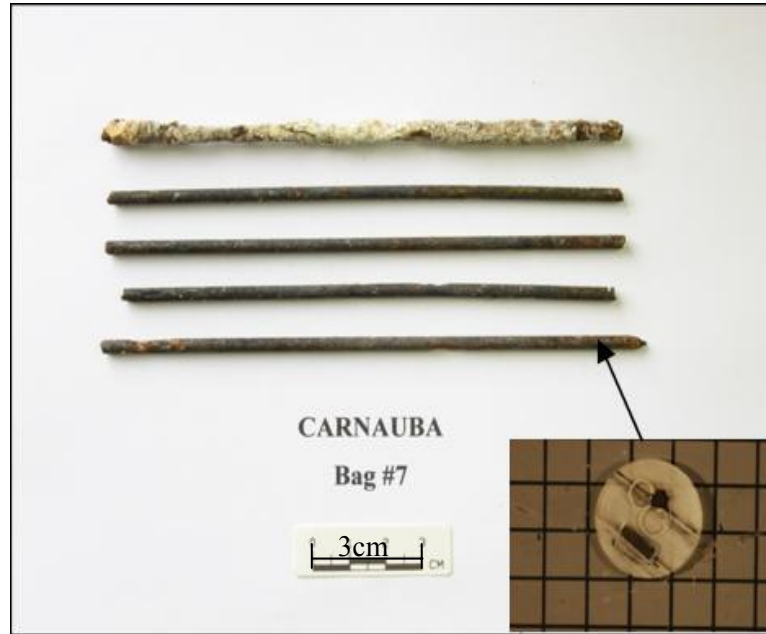
Figure 4.16 Photograph of sample 7.

The slender long rod shown in Figure 4.16 was one of the cross rod providing support to the wings. The chemical composition shows that it is a hypoeutectoid steel with 0.6% carbon. The elemental composition is as shown on page 52. The average values of hardness in transverse and longitudinal directions are 281 HV and 320 HV which is equivalent to 28 HRC to 30HRC respectively. Figure 4.17 shows a presence of pearlite, in which alternate layers of ferrite and cementite can be seen.

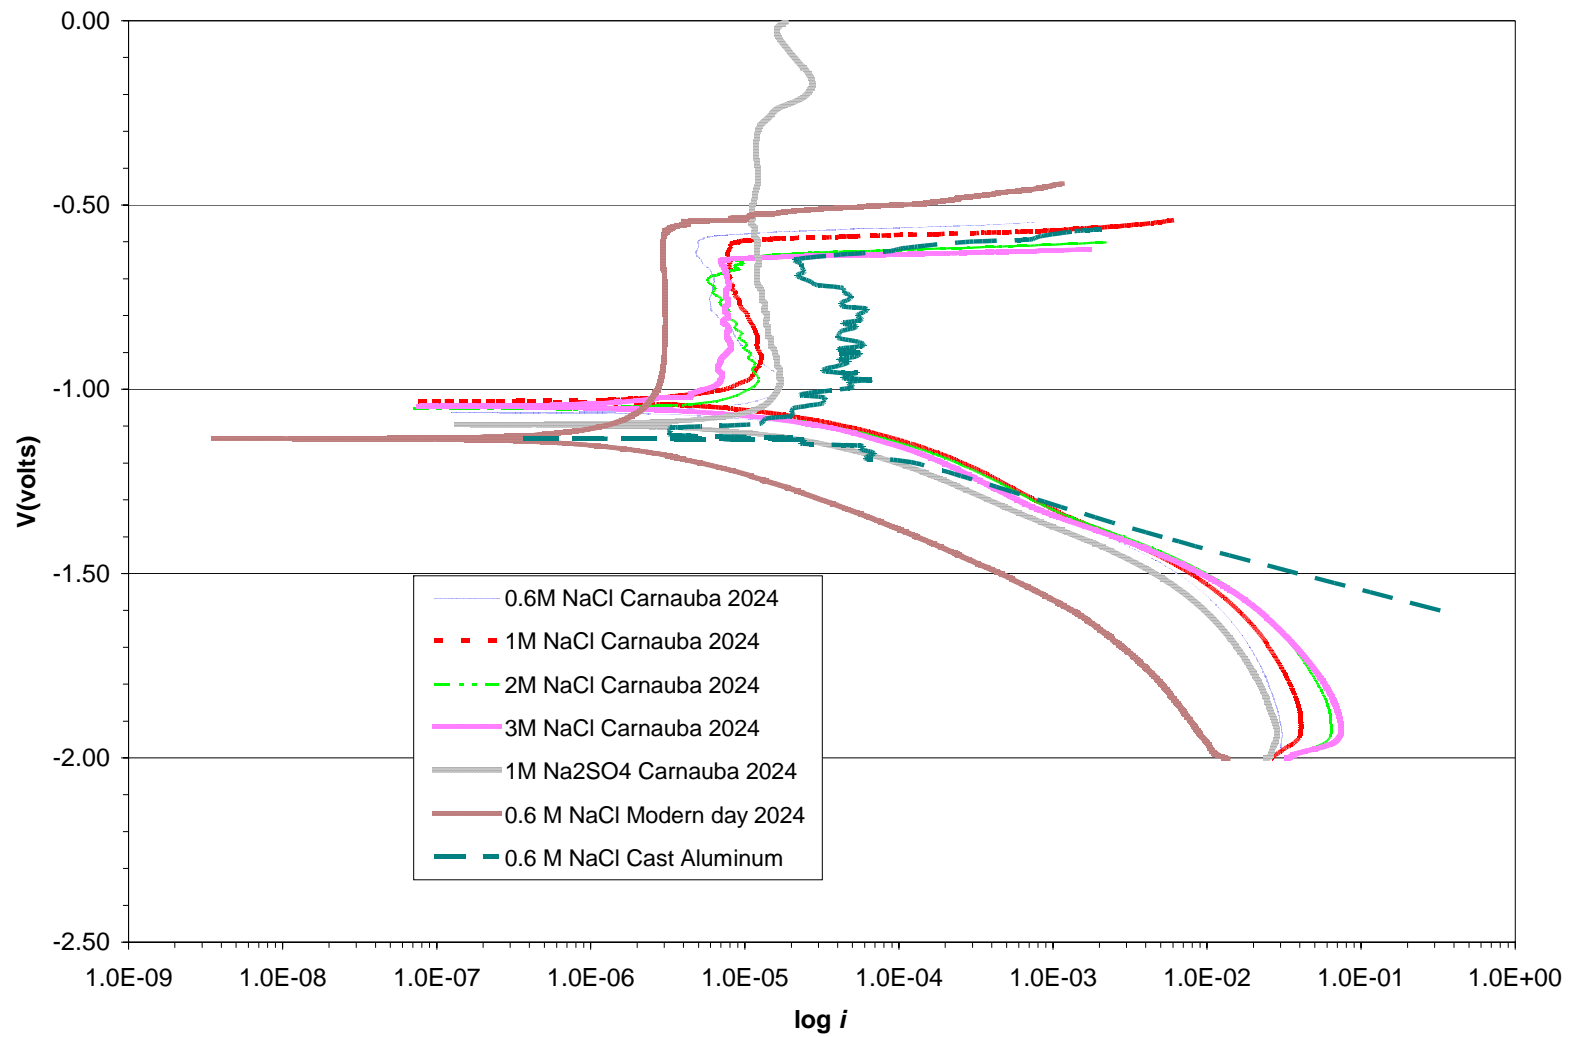
Figure 4.18 Potentiodynamic plots for aluminum alloy 2024 with sodium chloride and sodium sulfate used as electrolytes.

Although one might be tempted to think that higher the chloride content, the faster material is consumed. However, the potentiodynamic plots in Figure 4.18 show that even by increasing the concentration of chloride ions from 0.6M to 3M the critical pitting potential does not show much variation. Four samples tested in 0.6M, 1M, 2M and 3M sodium chloride solutions showed approximately the same pitting potential. This indicates that the chloride ion concentration has no effect on the rate at which pitting occurs. Figure 5.9 shows a plot of pitting potentials against the chloride ion concentration. Although, it would not be safe to assume that pitting occurs at all chloride ion concentrations and there is no threshold concentration at which pitting initiates.
