ESL-TR-17-09-01

TAMU Project

Energy Consumption Data Quality Assurance/Quality Control Assessment Report for the

Month of August 2017

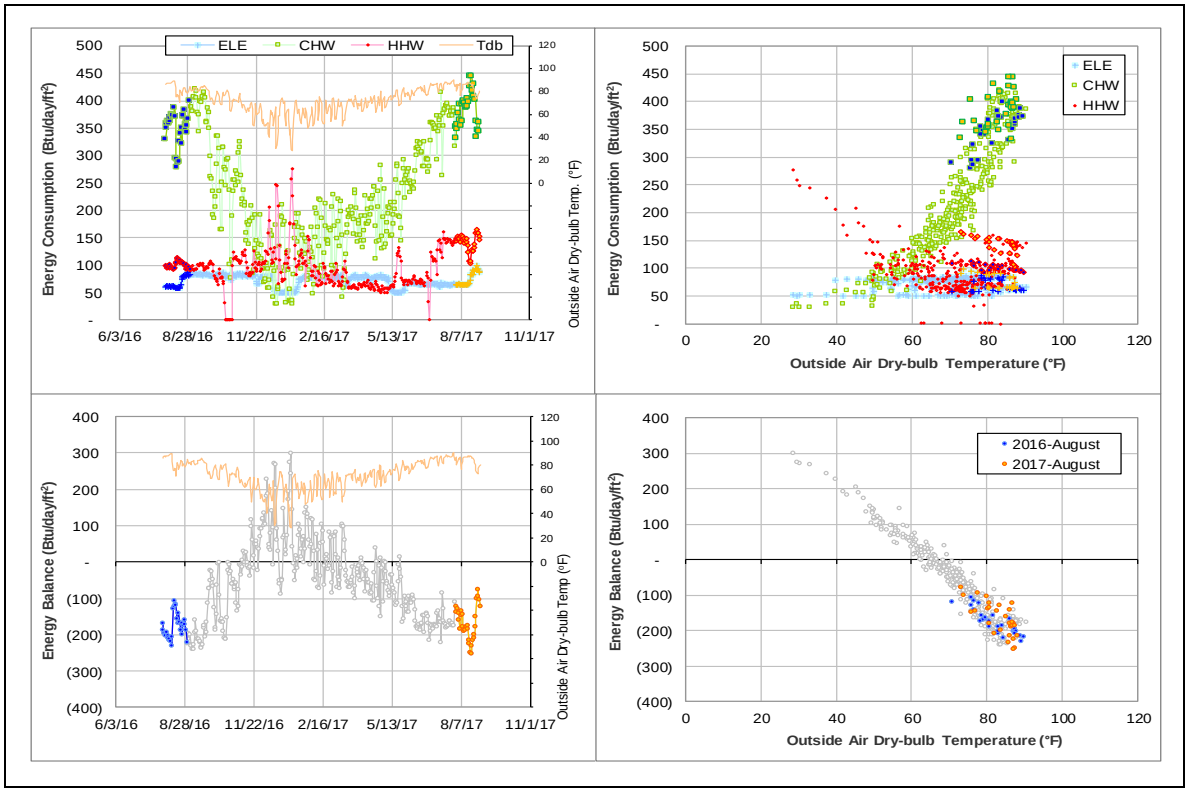
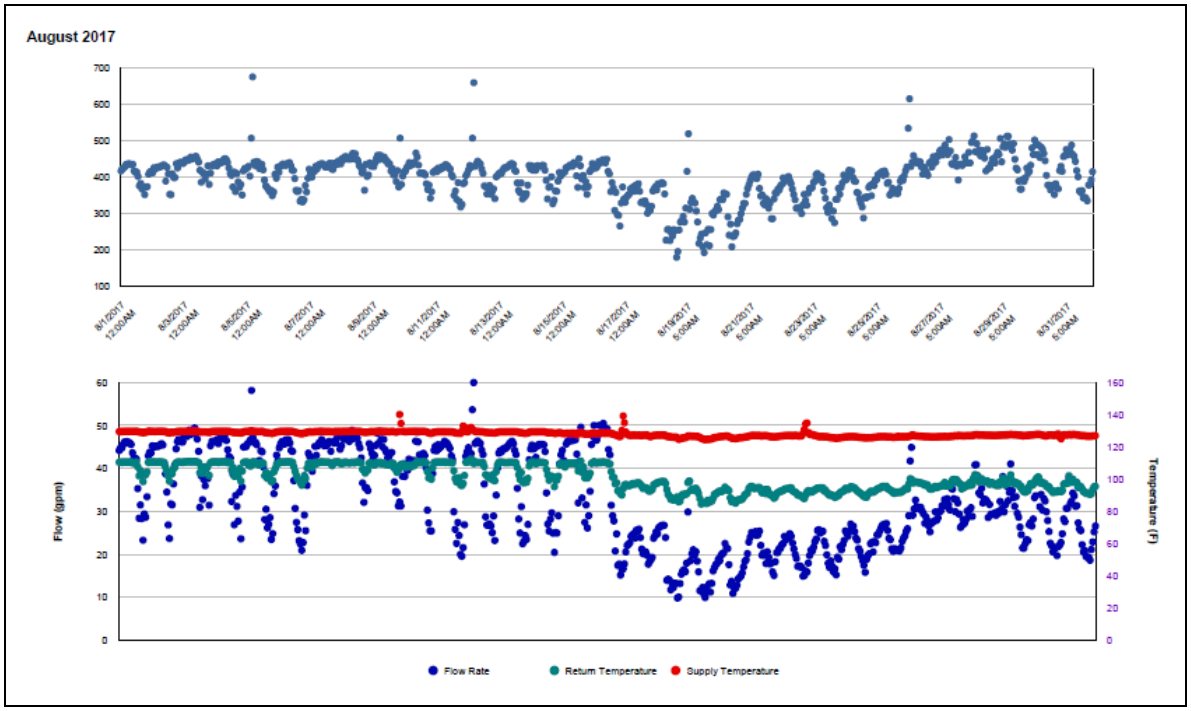
The HHW consumption was about 60 Btu/day/ft^2 higher than the previous year starting around 7/15/2017. The consumption was estimated by a model.

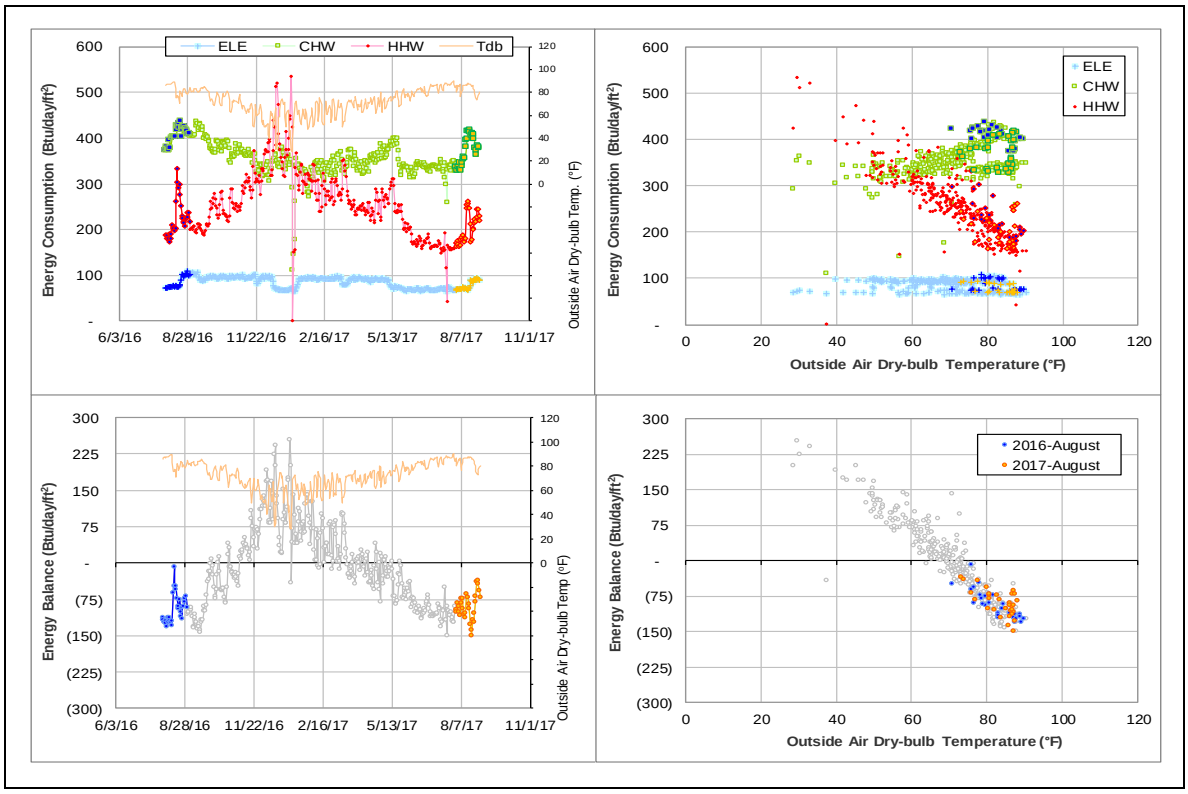
CHW consumption seemed have a different pattern during summer.

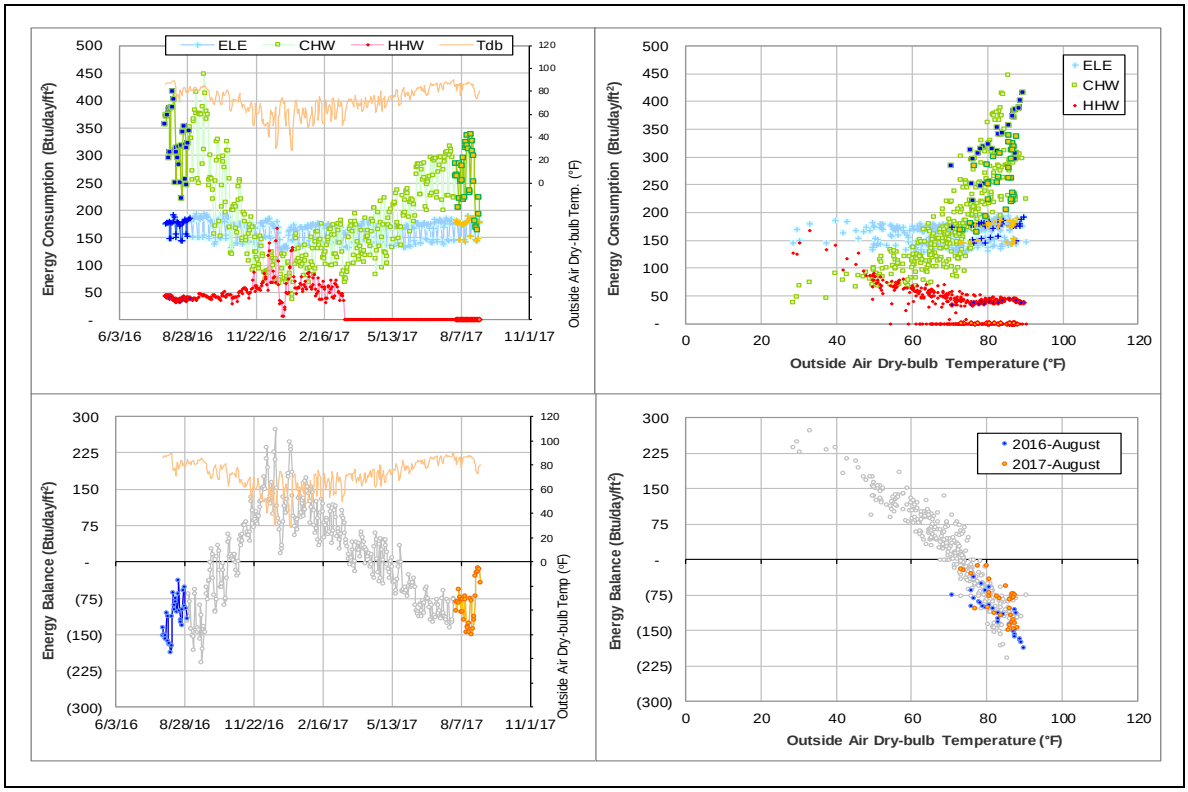
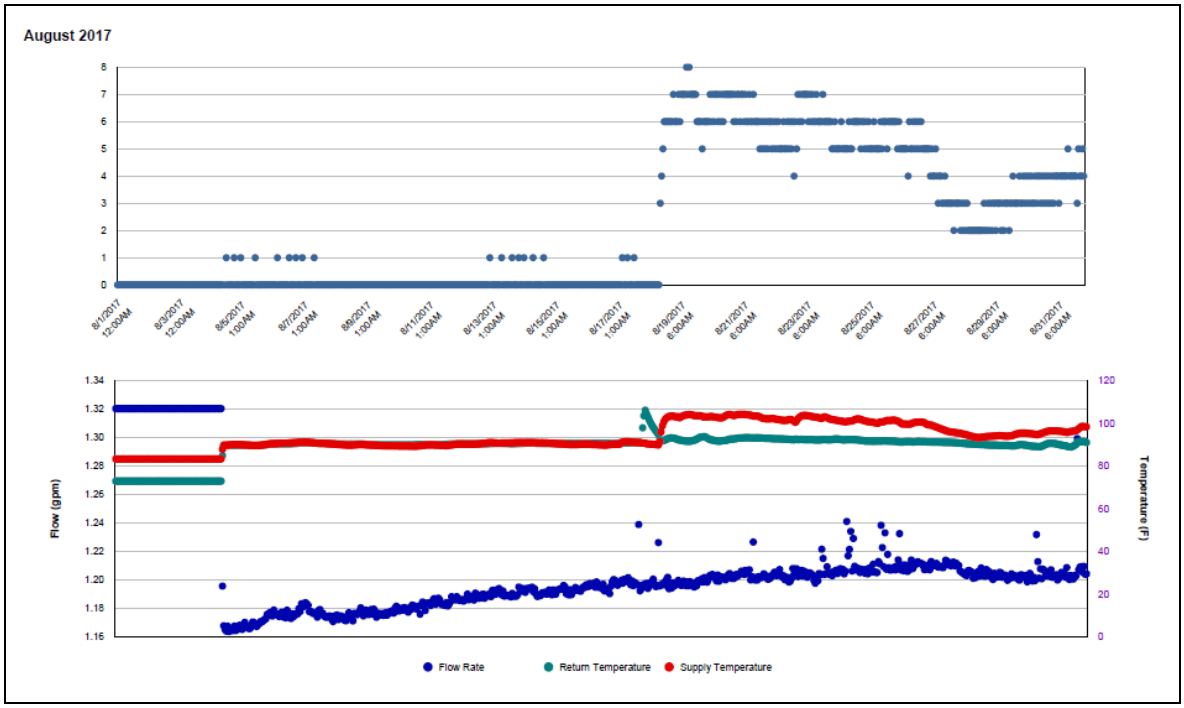
Koldus Building (TAMU Bldg #383)

The HHW consumption dropped to zero since 3/12/2017 due to a flow rate near zero. The consumption was estimated by a model.

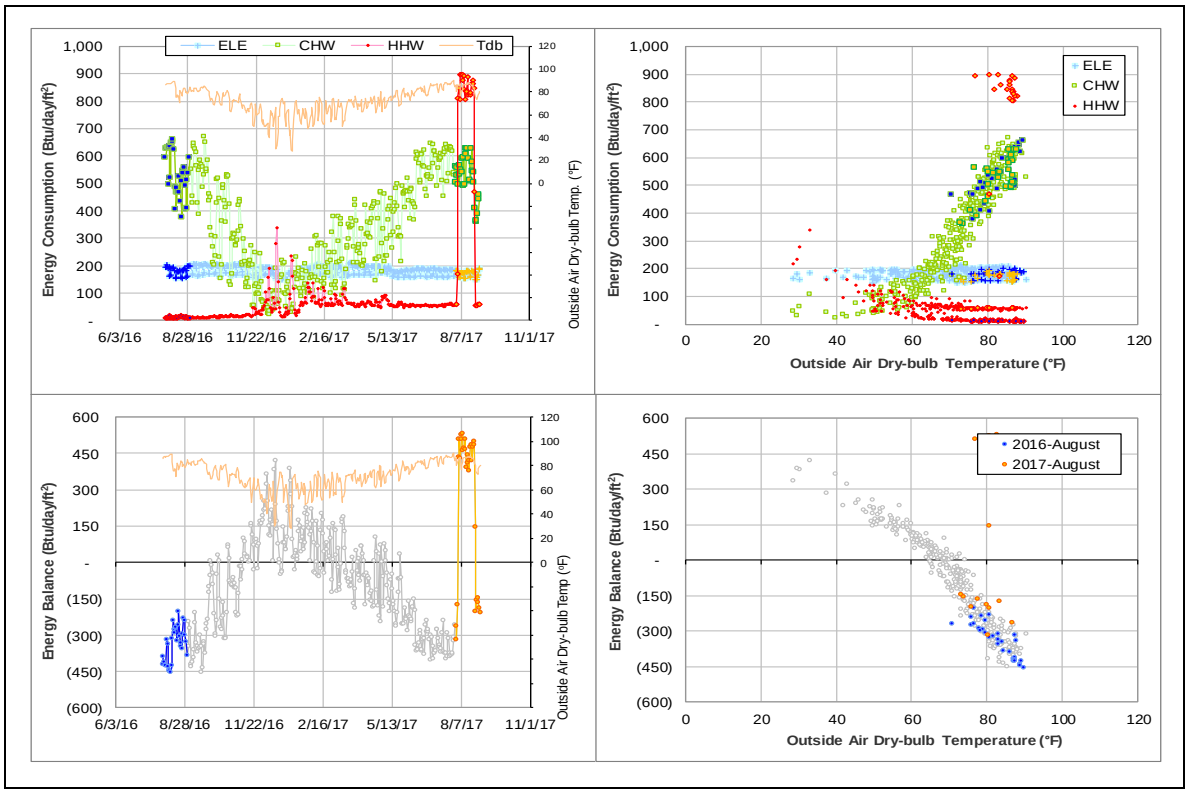
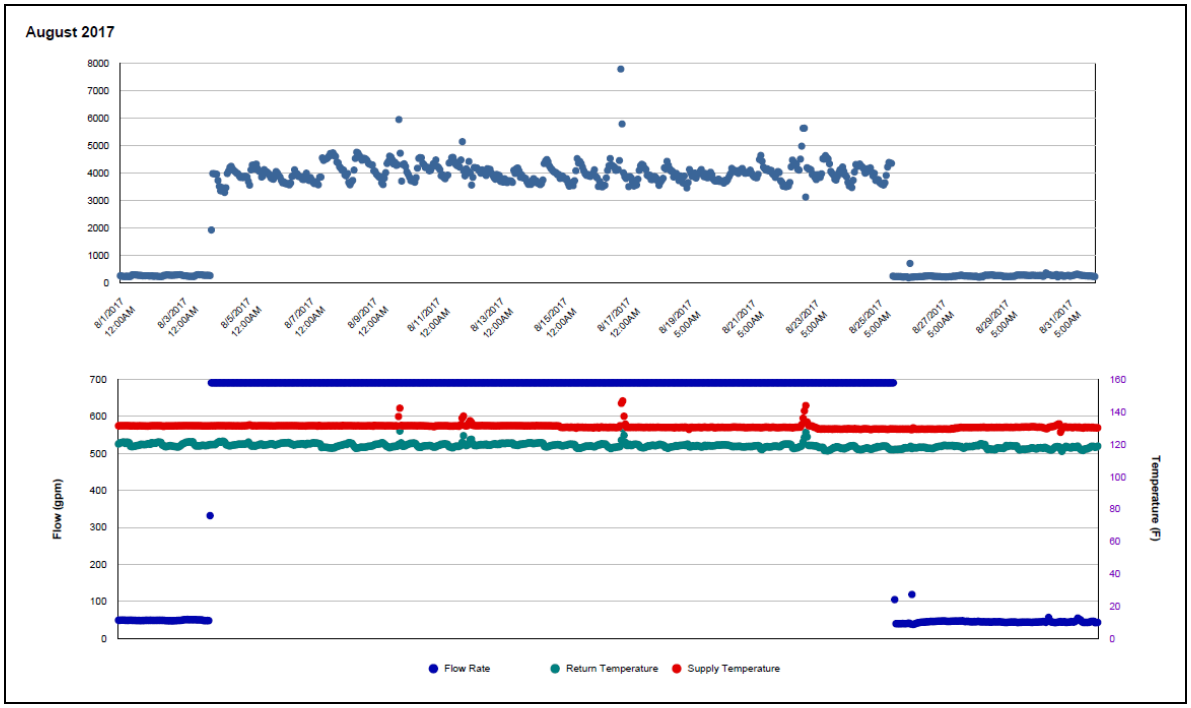
Richardson Petroleum Engineering Building (TAMU Bldg #387)

The HHW consumption increased to extremely high and metered values were faulty during 8/3/2017 – 8/25/2017. The consumption was estimated by a model.

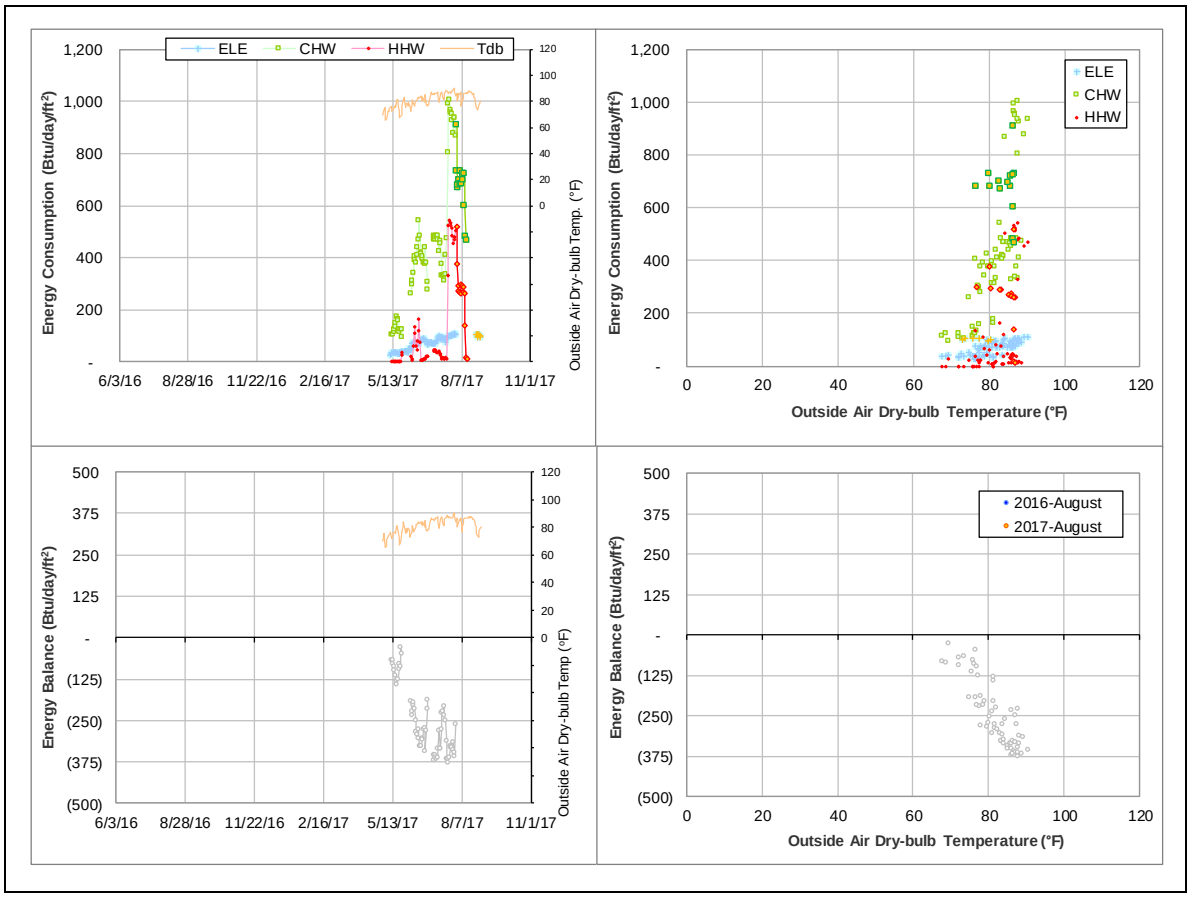
The CHW and HHW consumption was abnormally high since 7/21/2017. The consumption decreased back to a normal range on 8/12/2017 and the data after 8/14/2017 was missing. These days are estimated by a model for CHW and an average for HHW.

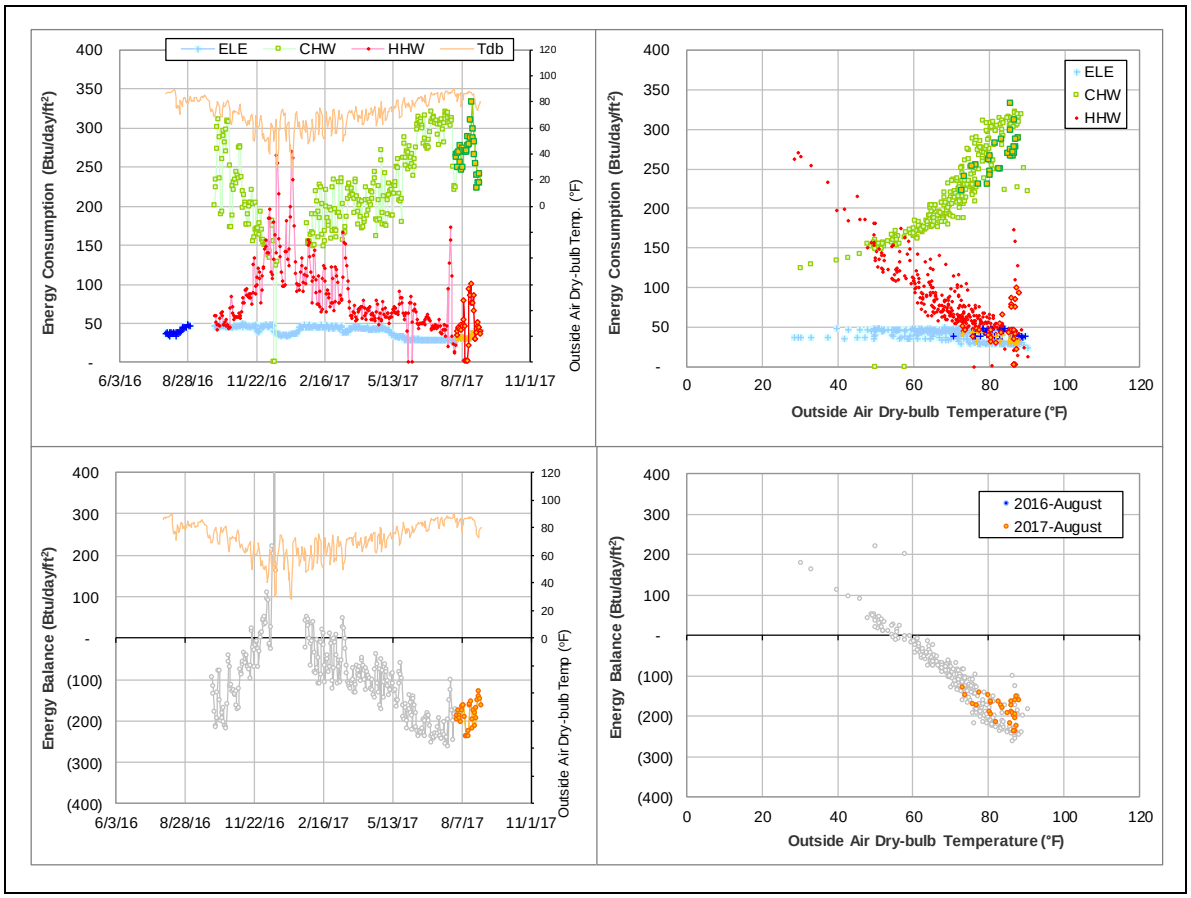
The HHW consumption fluctuate widely during 8/10/2017 – 8/23/2017 majorly caused by the change of the flow rate. These days are estimated using a model.

Explanatory Figure: 13 months energy balance plot with original data. (The plot is rescaled to remove the spikes.)

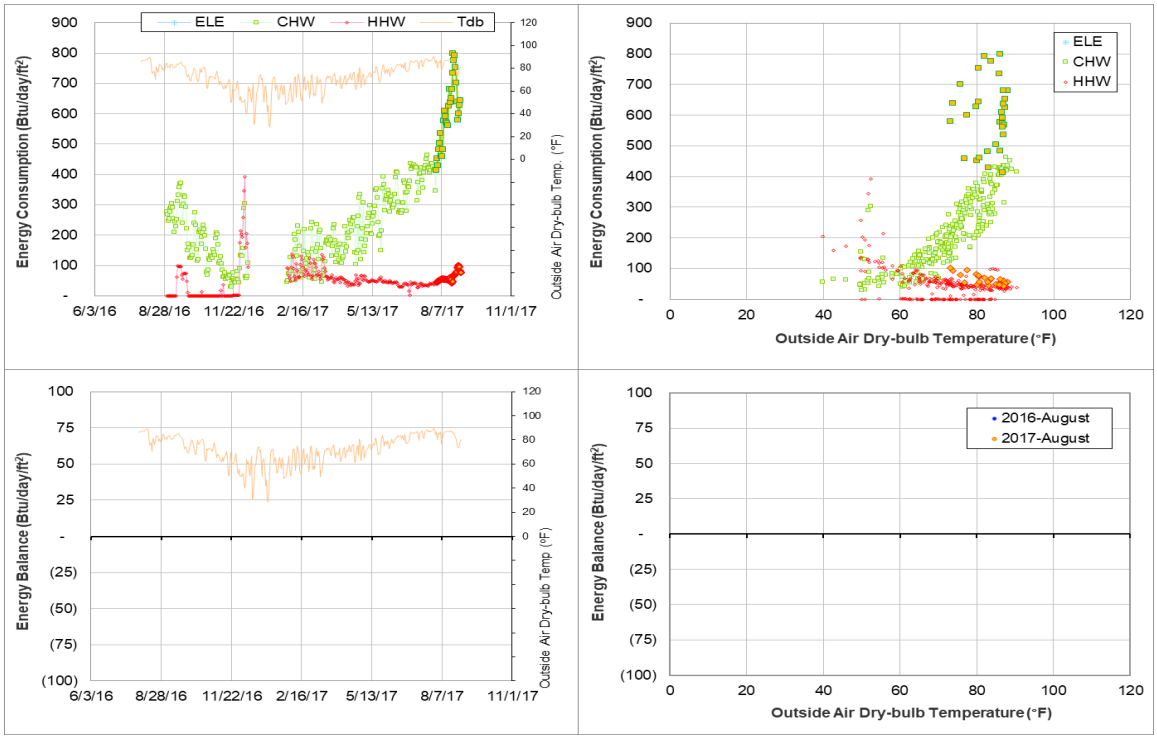
Commons Hall (TAMU Bldg #440)

The CHW consumption pattern is higher than the past year by up to 50% (approx. 360 Btu/day/ft^2 increase). This increase seems related to an increase in CHW flow rate. The consumption for this period was estimated by model. Similar to CHW, HHW consumption pattern is higher than the past year by 10 - 45 Btu/day/ft^2 with the greater increase during the cooler outside temperatures. This increase seems related to an increase in HHW flow rate. The consumption for this period was estimated by model.

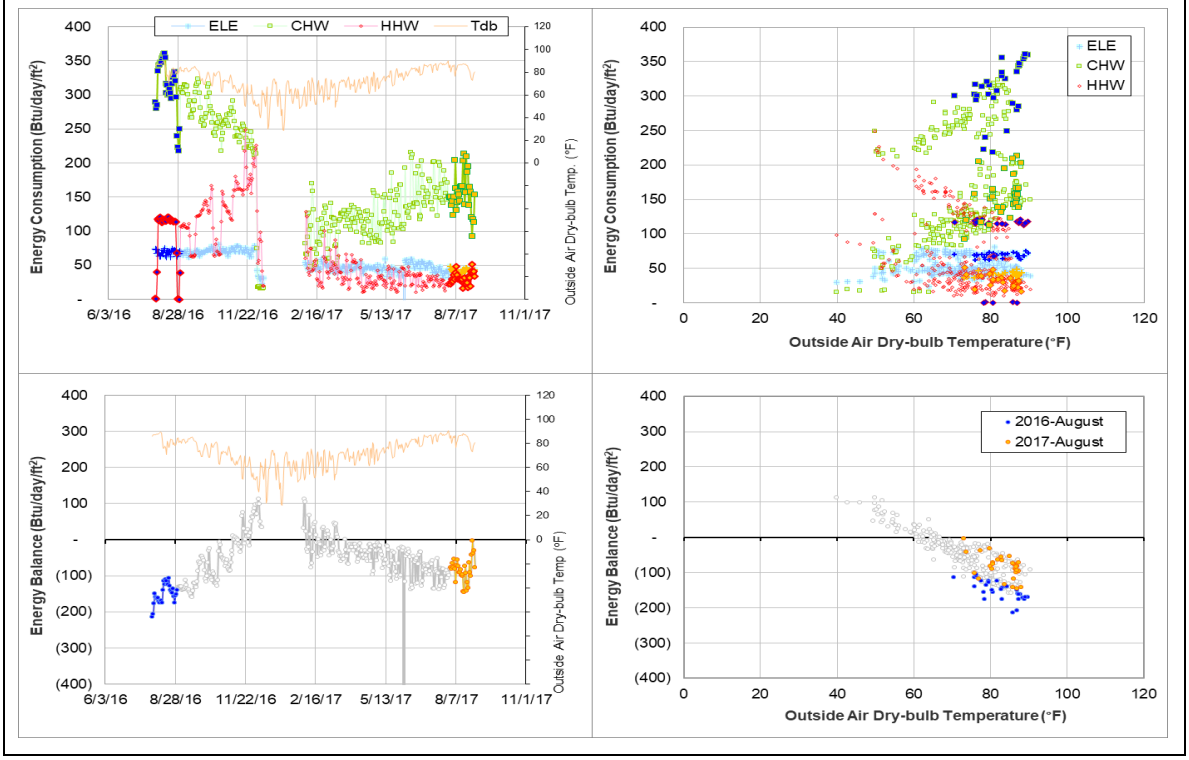
Rudder Theatre Complex (TAMU Bldg # 446)

ELE, CHW, and HHW consumption dropped during the winter break of last year (2016-2017) and again during the winter break in 2015-2016. This drop is not suspected to be a meter malfunction since a decrease would be expected during break periods and that the data from 2015-2016 winter suggests that the consumption went back to the normal level around 1/25/2016. However, the data following 2016-2017 winter has not yet returned to the normal level. The energy balance of this building does not show separate patterns for these two levels. The whole month is estimated using a model for ELE, CHW, and HHW.

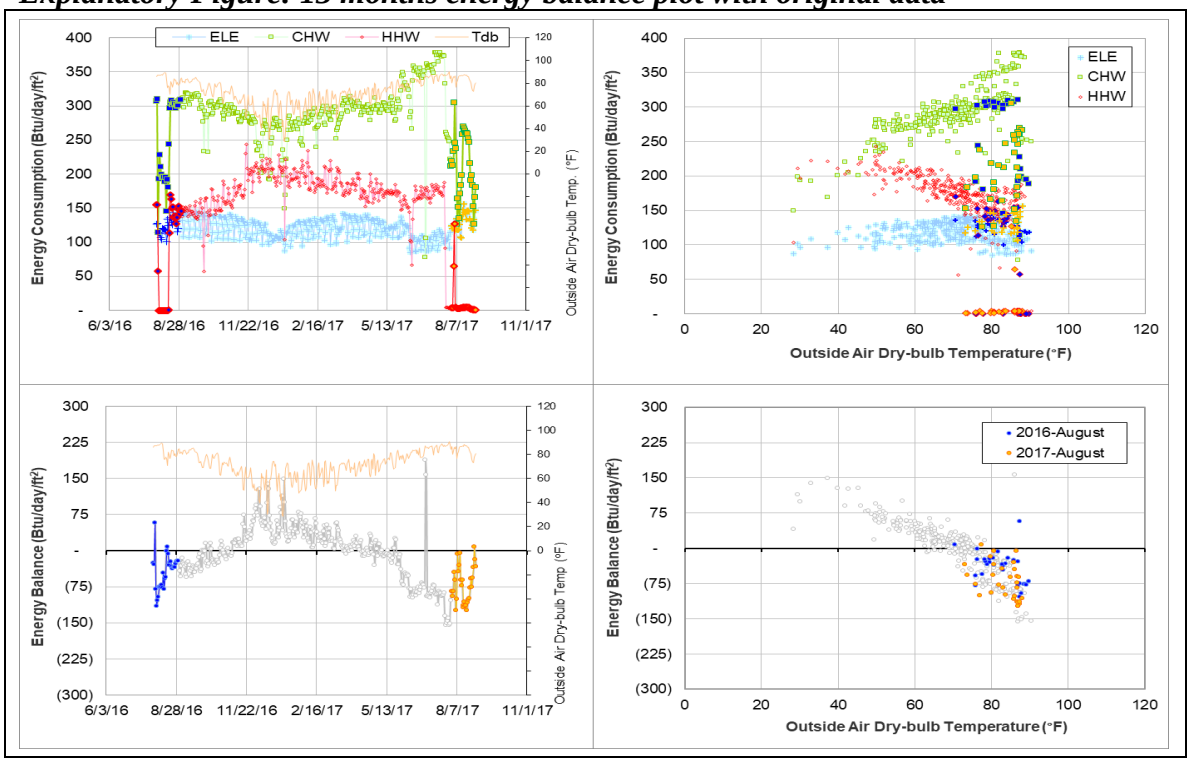
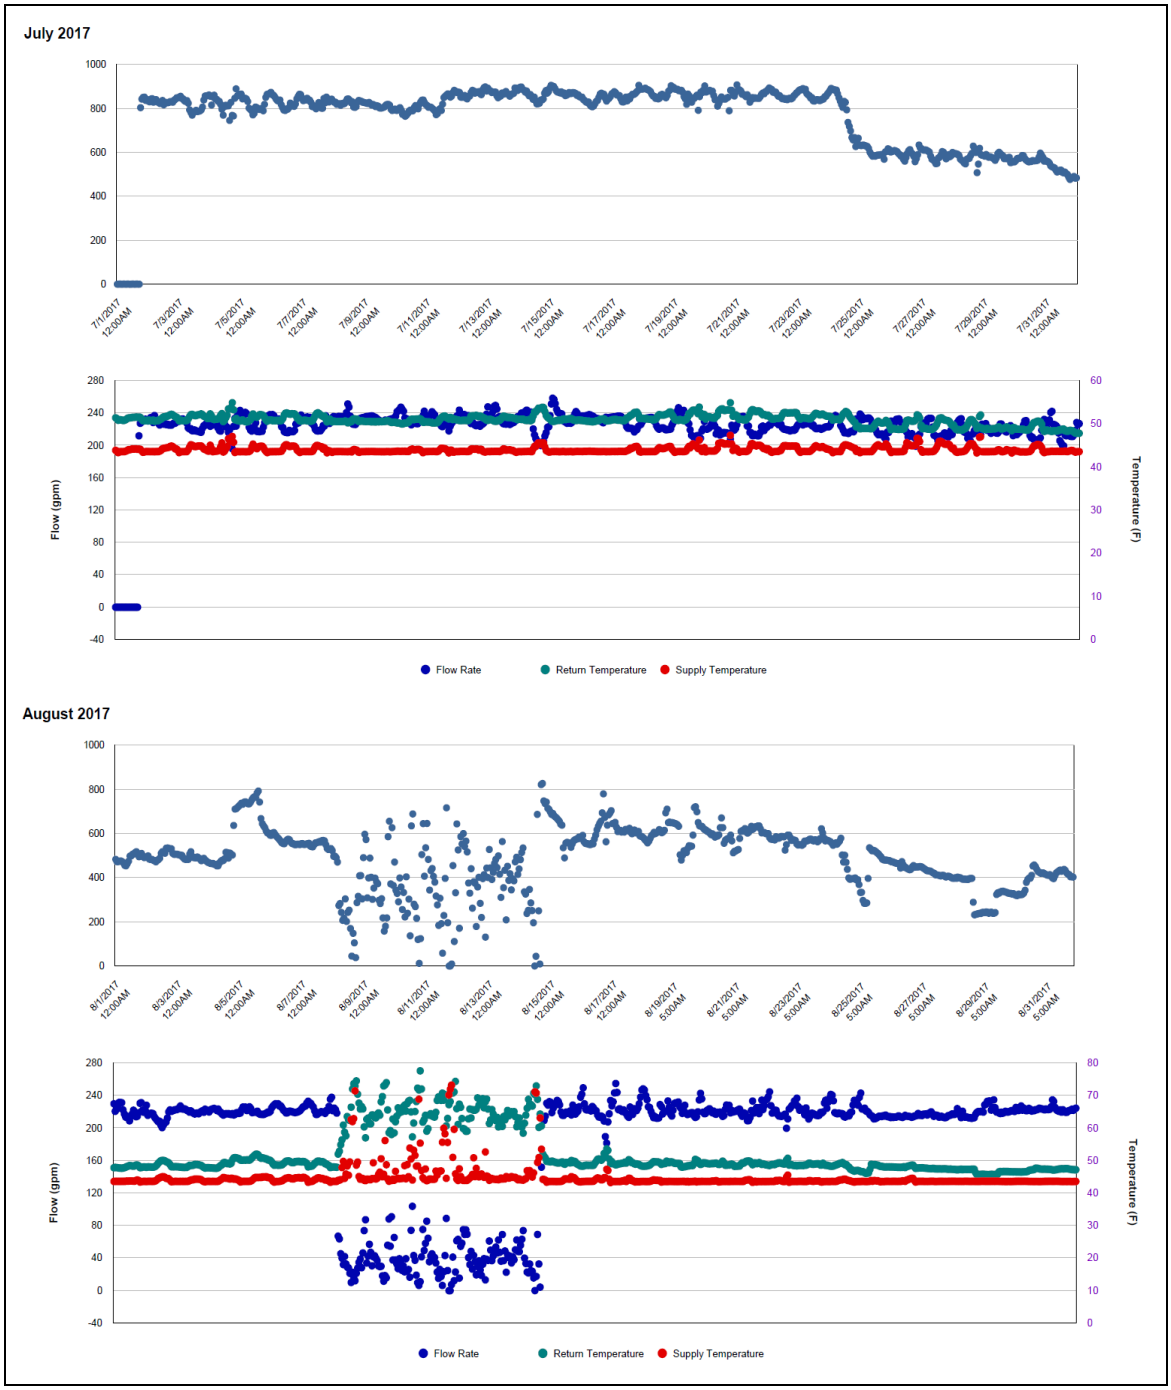
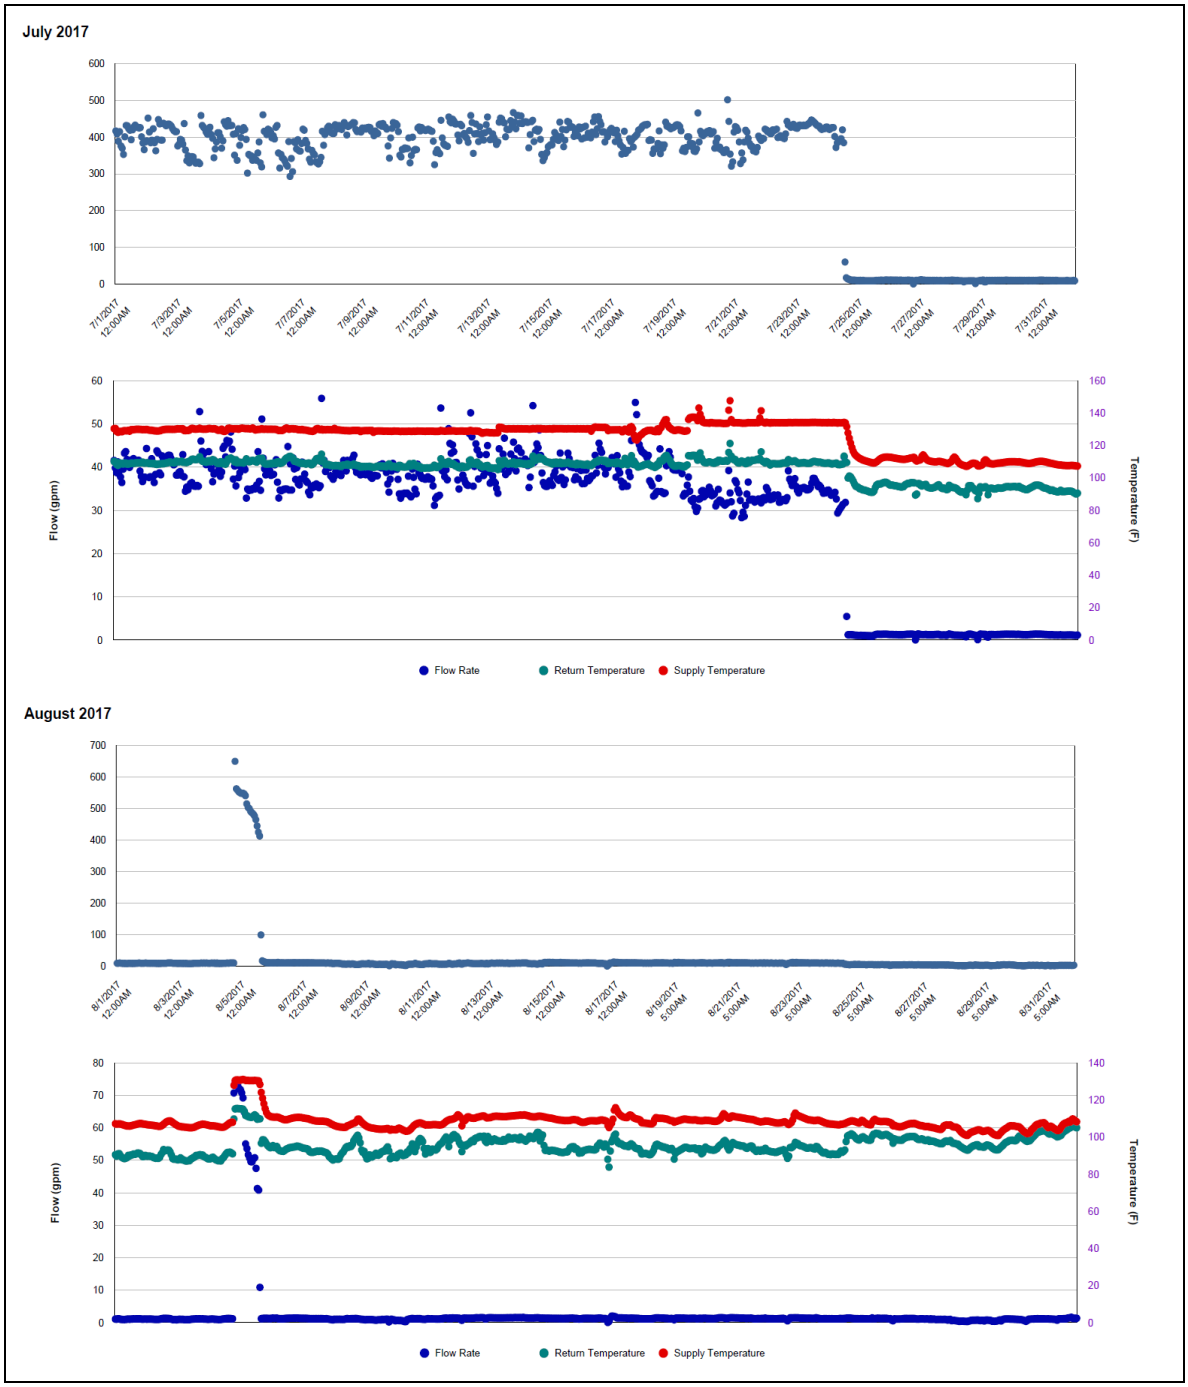
Adams Band Hall (TAMU Bldg #448)

The CHW consumption pattern for June 2017 is 50 Btu/day/ft^2 higher than June 2016. The CHW flow rate appears to be at a consistent level in June 2017 where in the previous year, the flow rate varied throughout the day. For a short period during 6/30/2017-7/1/2017, the flow rate decreased to near zero value. Starting on 7/24/2017, the return temperature decreased resulting in a consumption level 60 Btu/day/ft^2 lower than July 2016 The CHW consumption was estimated by model. The HHW consumption decreased starting 7/24/2017 and continues. During this period the HHW flow rate appears to decrease to zero or near zero values. The HHW consumption was estimated by model for this period.

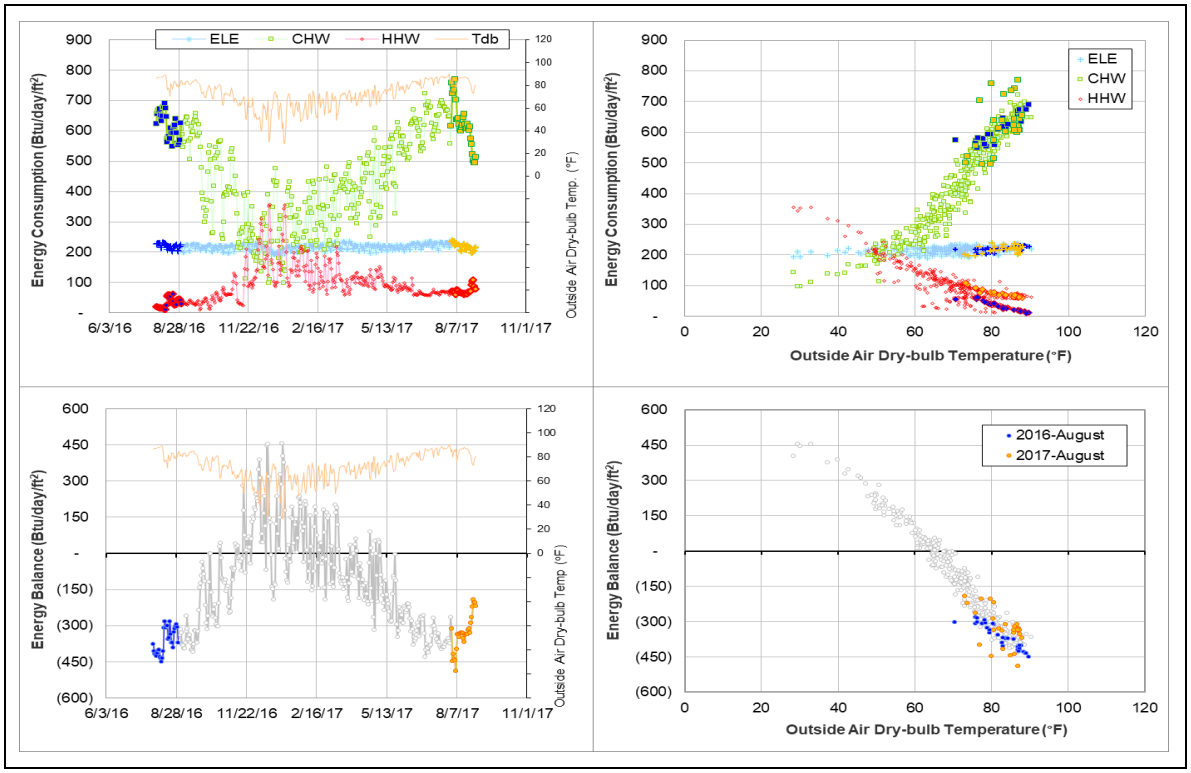
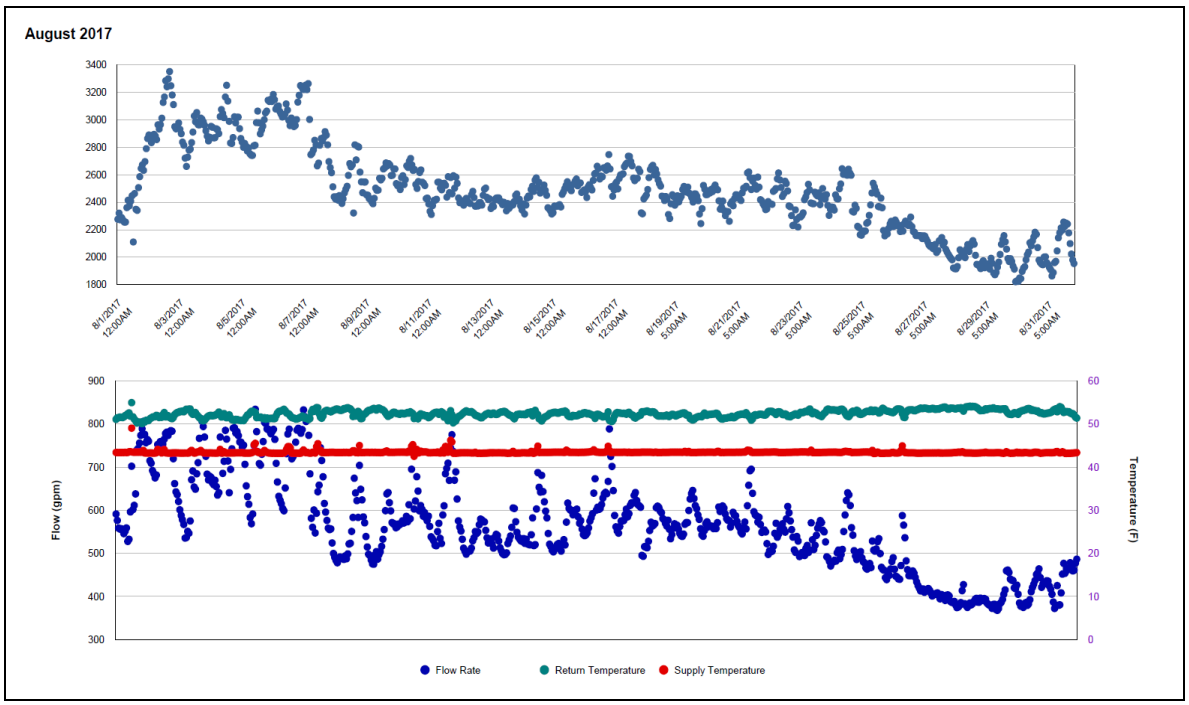
Biological Sciences Building - West (TAMU Bldg #449)

The CHW pattern is higher than the level of the past year by approx. 100 Btu/day/ft^2 (14%). The increase in consumption appears related to an increase in CHW flow rate. The CHW consumption for this period was estimated by model.

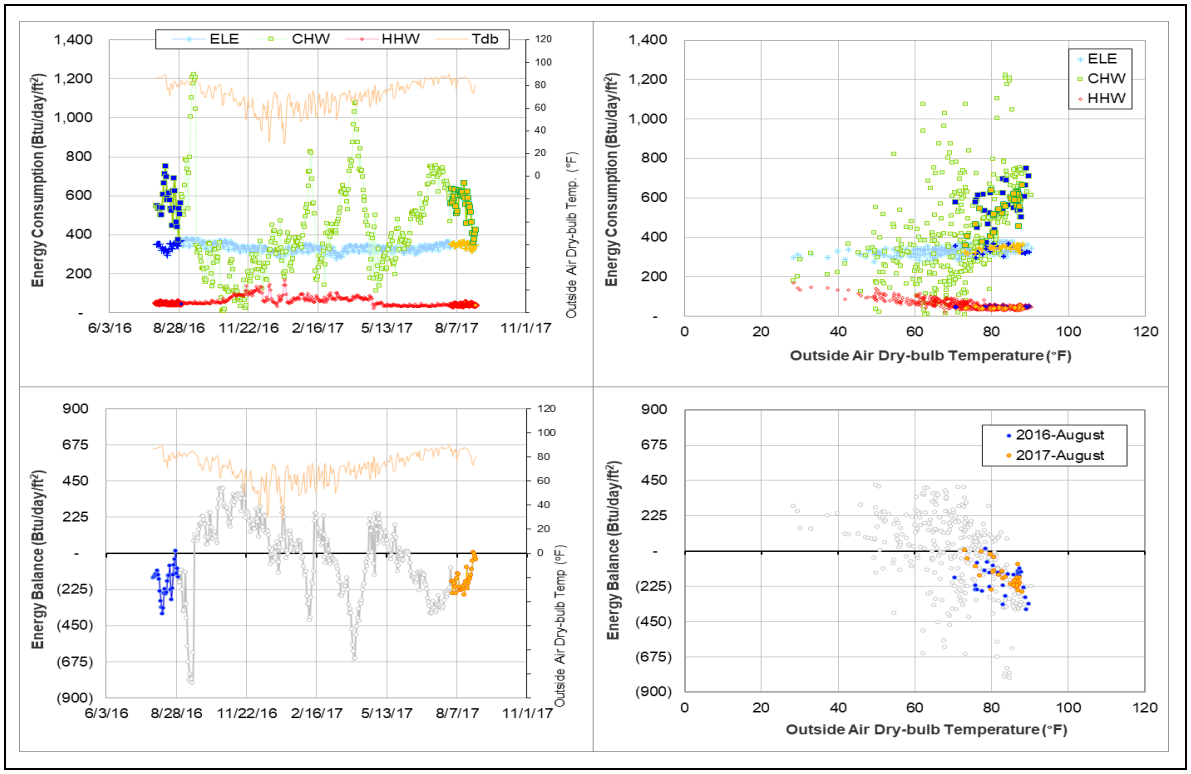
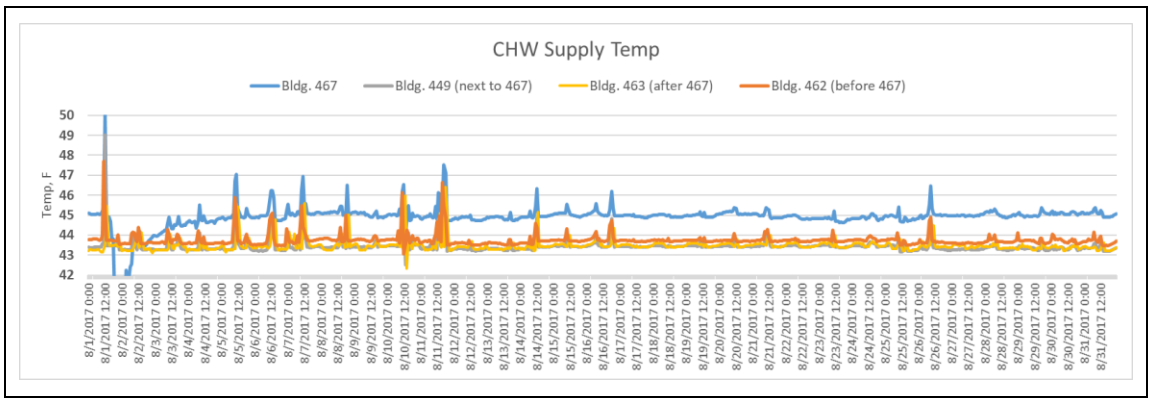
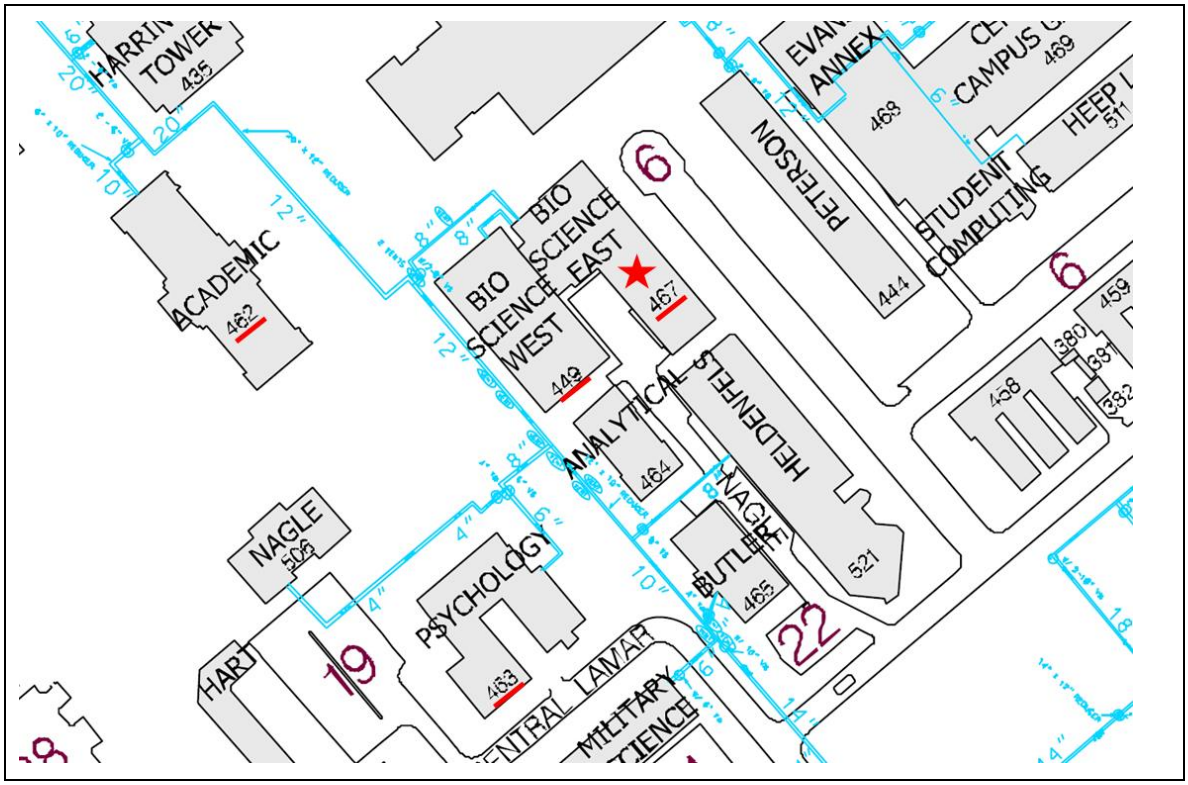
Biological Sciences Building - East (TAMU Bldg #467)

The CHW supply temp readings for this building started to decrease on 8/6/2016 while all adjacent buildings have stable supply temperature at around 42°F. The supply temperature had a period of obviously erroneous values of 20°F during 9/10 – 9/20/2016, and then increased to 45°F range. The explanatory figure below shows the supply temperature for Bldg. #467 and the surrounding Bldgs. #462, #449, and #463. The temperature sensor for Bldg. #467 shows to be almost two degrees higher than its neighboring buildings. The CHW consumption was estimated for this period by model.

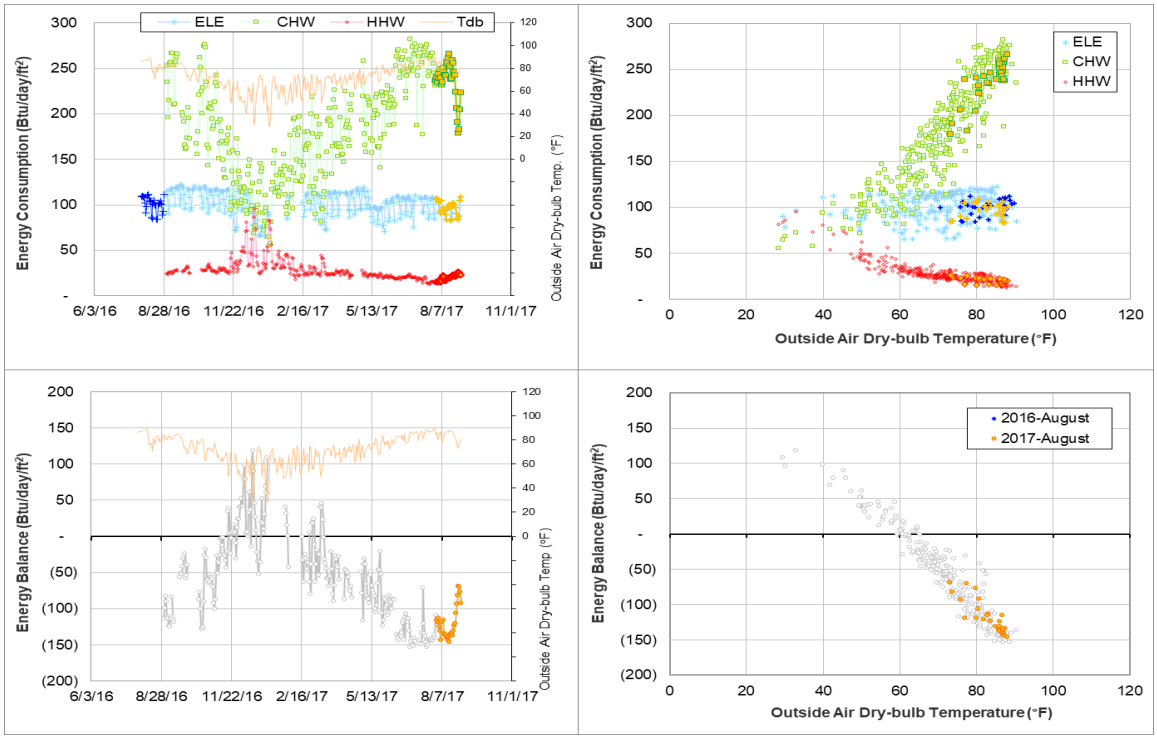
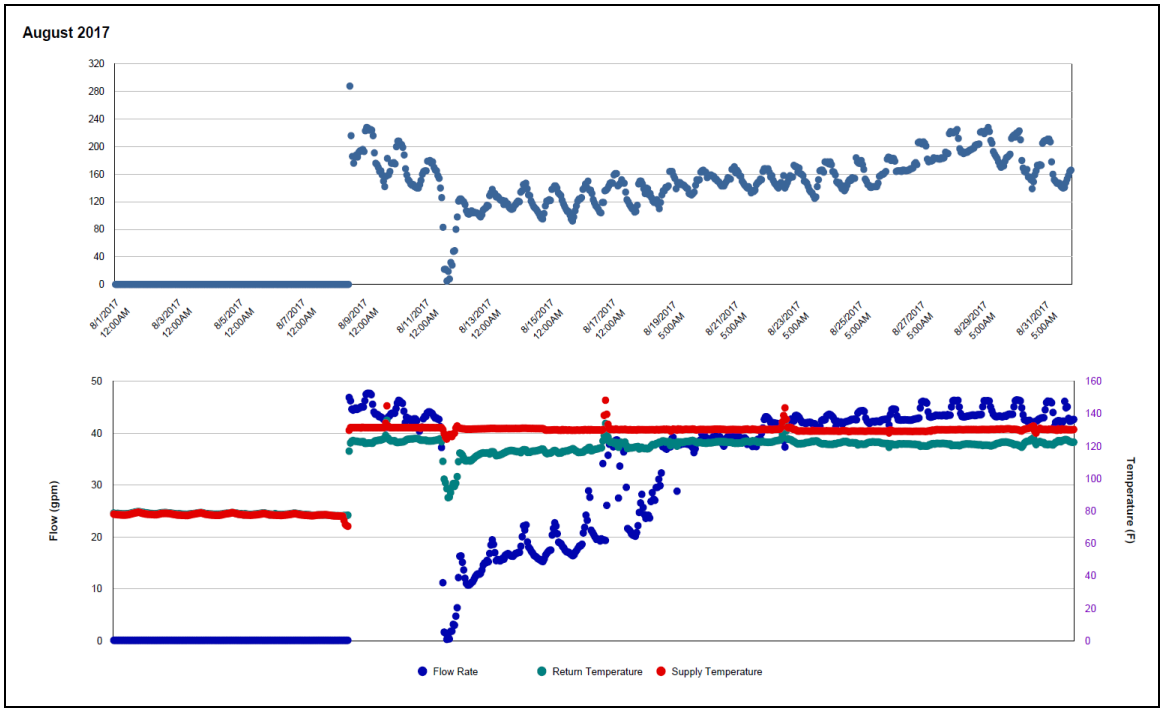
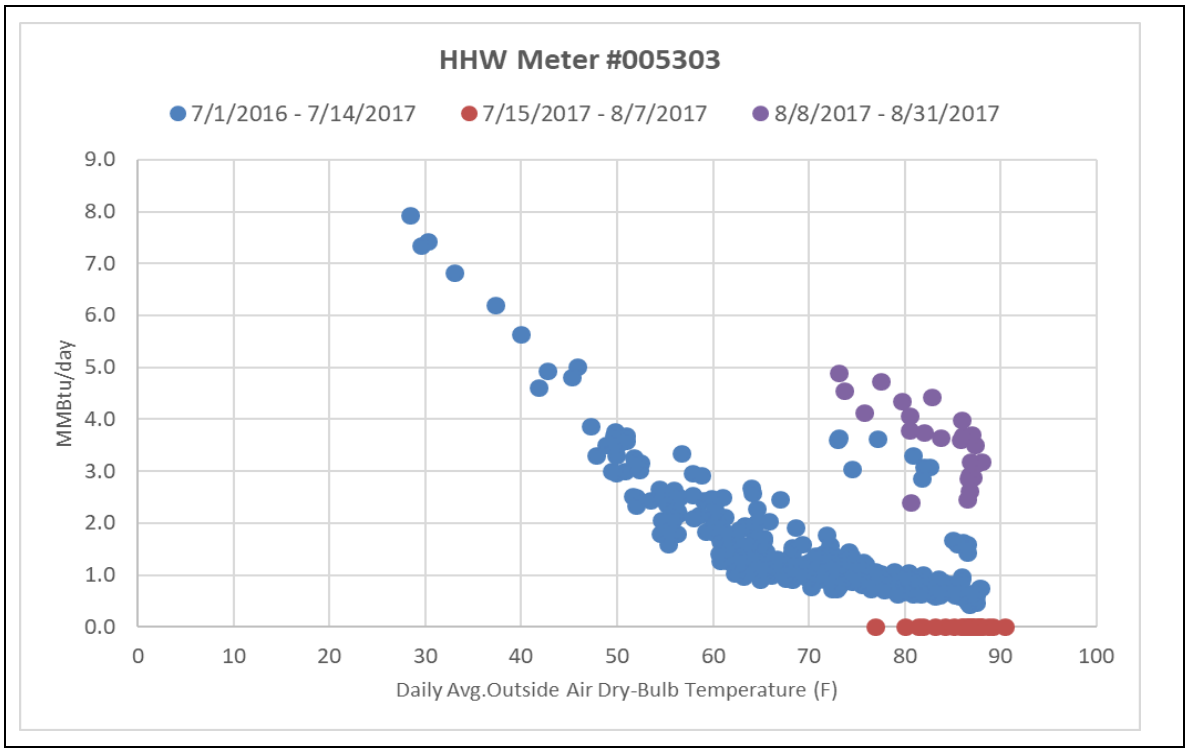
Evans Library (TAMU Bldg #468)

Evans Library has five HHW meters. HHW meter #005303 experienced a decrease in flow rate and Delta-T from 7/15/2017 – 8/7/2017. On 8/8/2017, the flow rate and Delta-T returned, however the flow rate is at an increased level causing the consumed energy to be up to four times larger than the normal pattern (an overall increase of 3-4 mmBtu/day/ft^2). The HHW consumption for this meter was estimated by model for these periods.
