ESL-TR-17-09-01

TAMU Project

Energy Consumption Data Quality Assurance/Quality Control Assessment Report for the

Month of August 2017

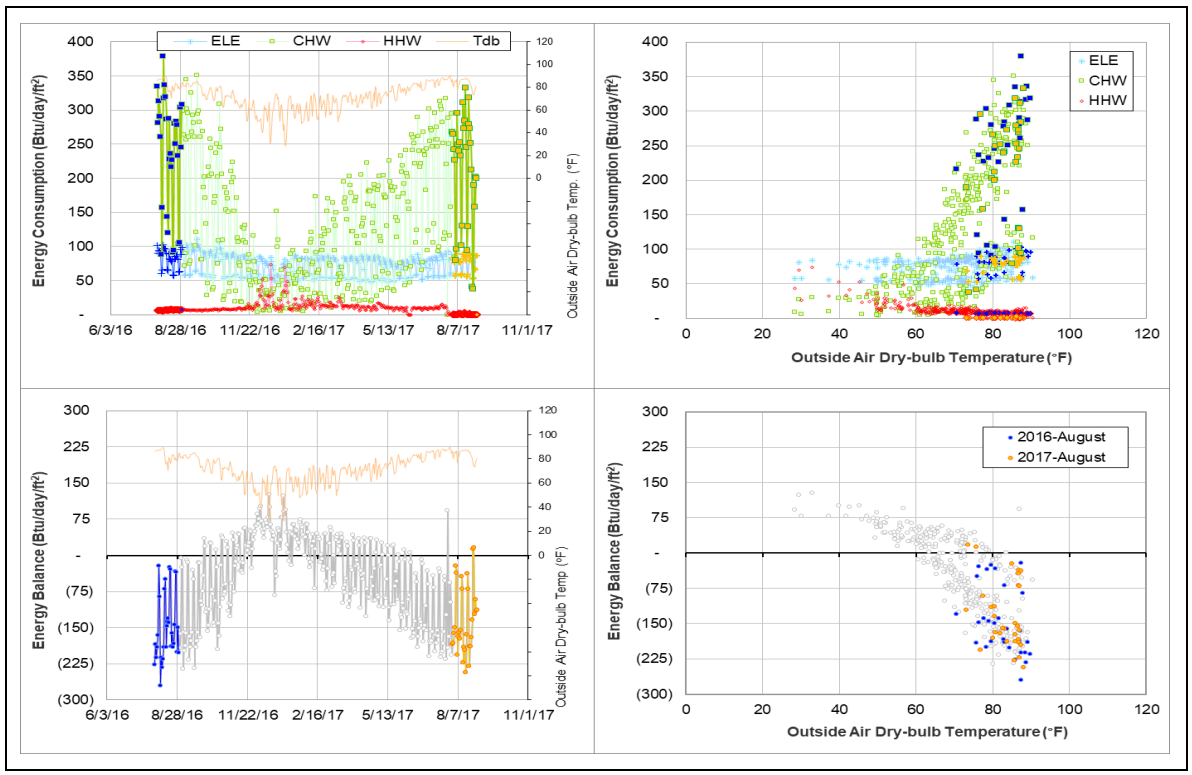
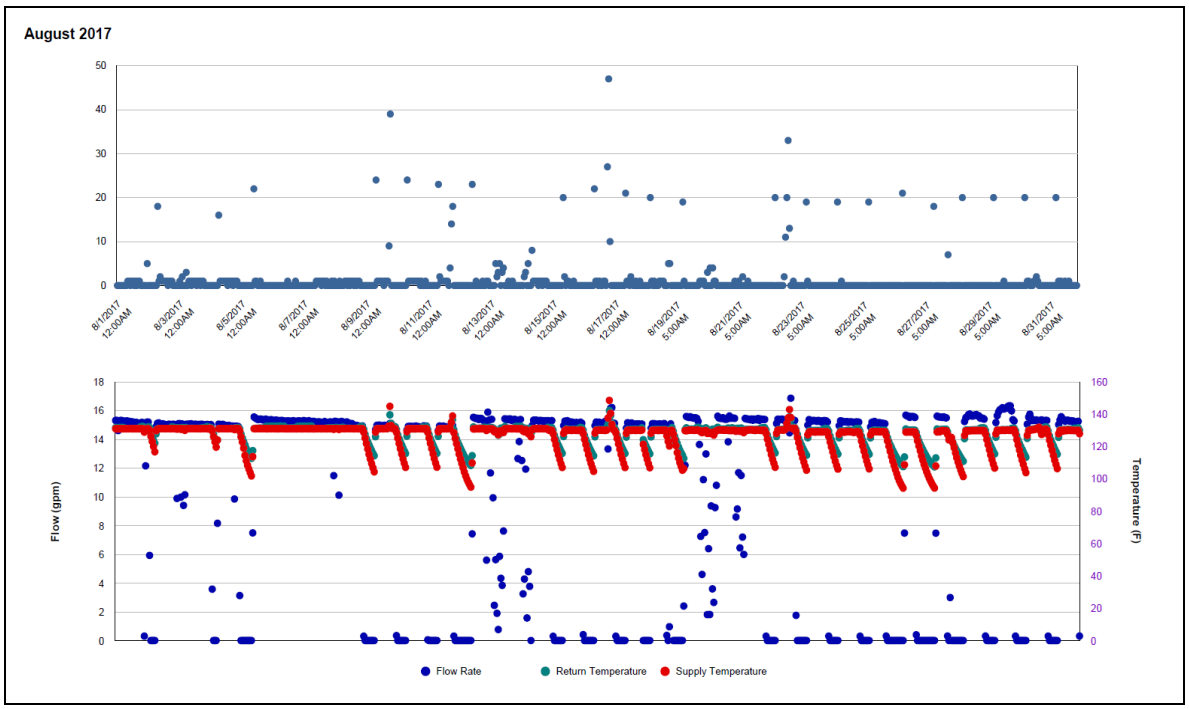
YMCA Building - West (TAMU Bldg #474)

The HHW consumption pattern is zero or near zero for the month. The flow rate is at a similar range as previous months, but the Delta-T appears to be zero or near zero with occasionally turning negative since end of July 2017. The HHW consumption for the month was estimated by model.

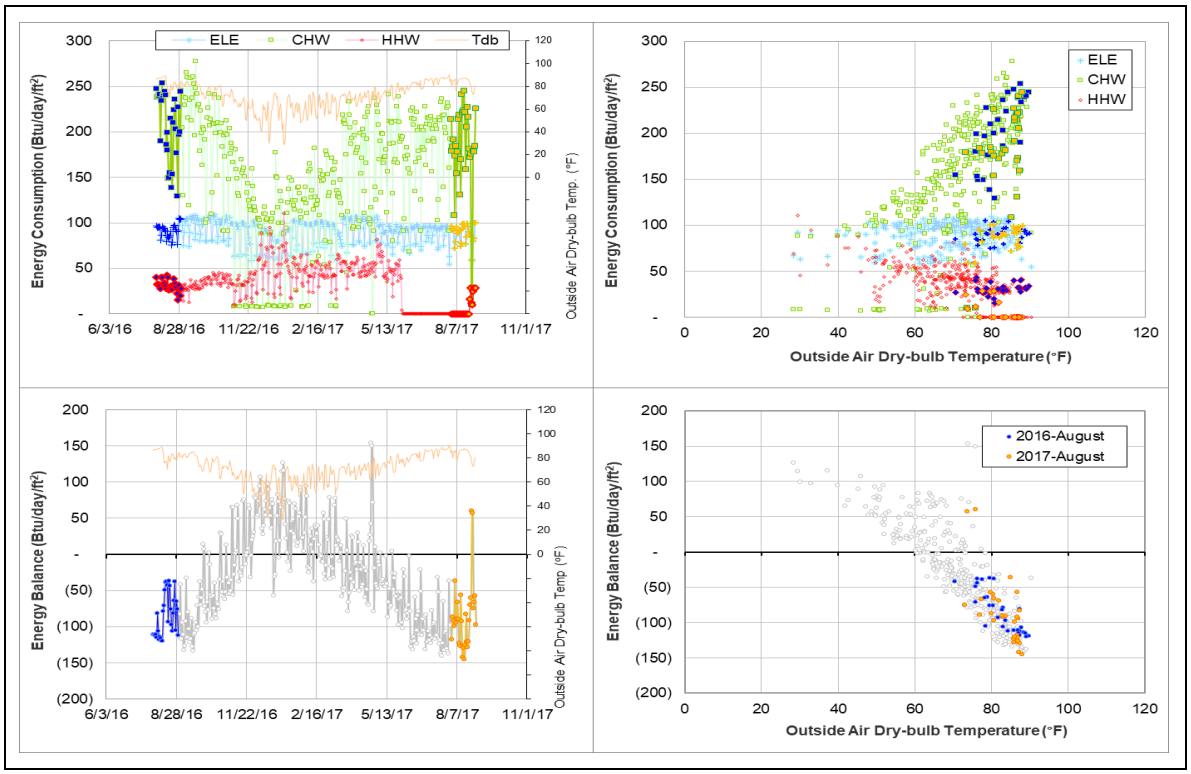
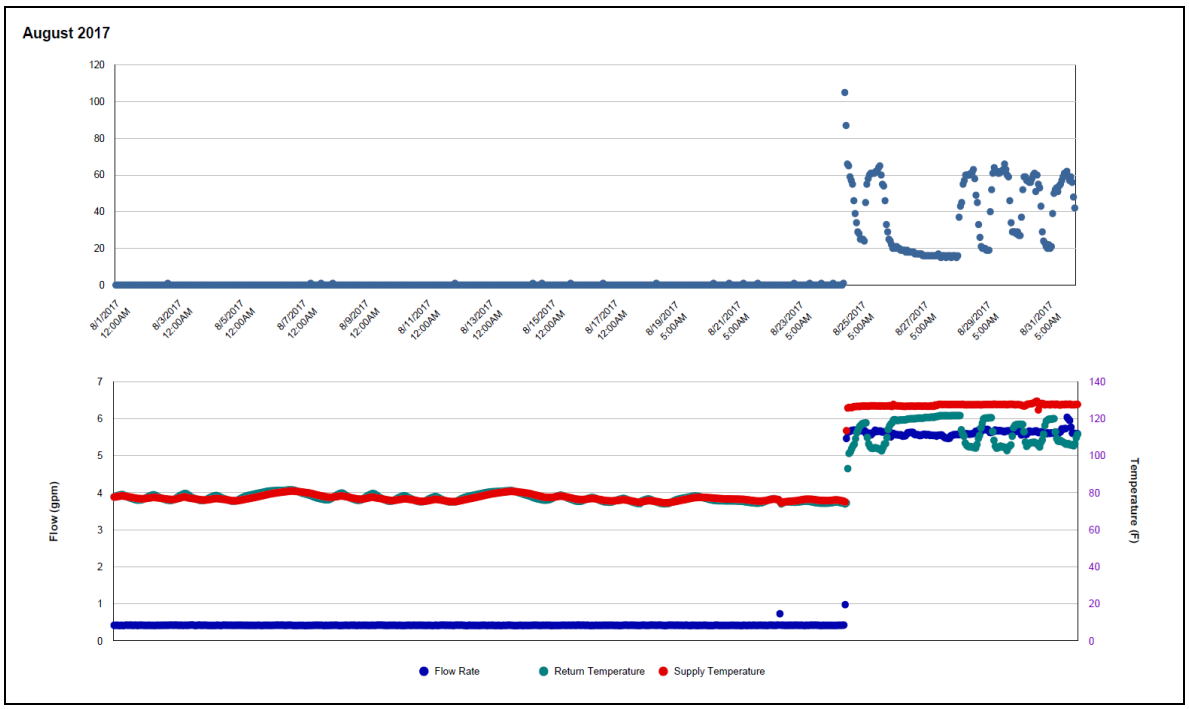
Bolton Hall (TAMU Bldg #480)

On 6/1/2017, the HHW flow rate and Delta-T decreased to near zero value and returned on 8/24/2017. The HHW consumption was estimated by model.

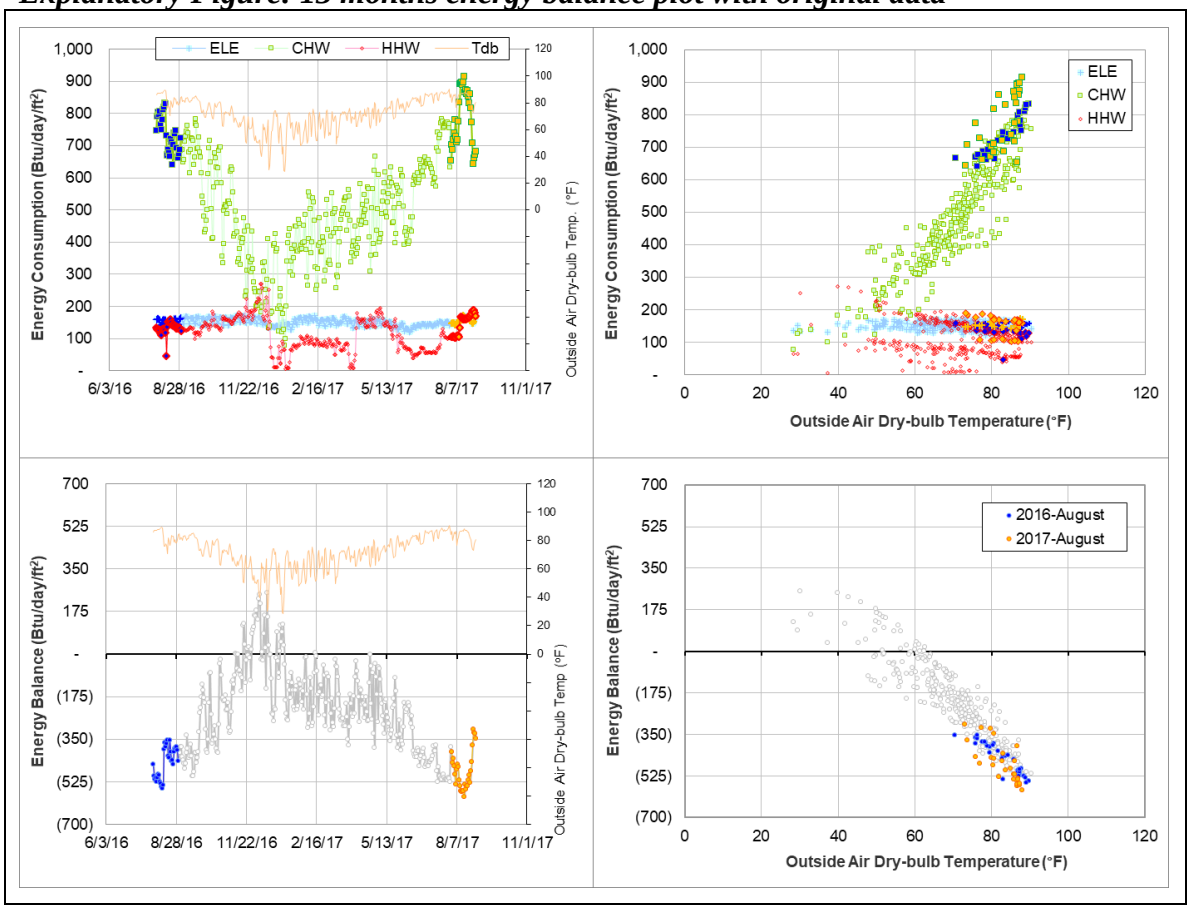
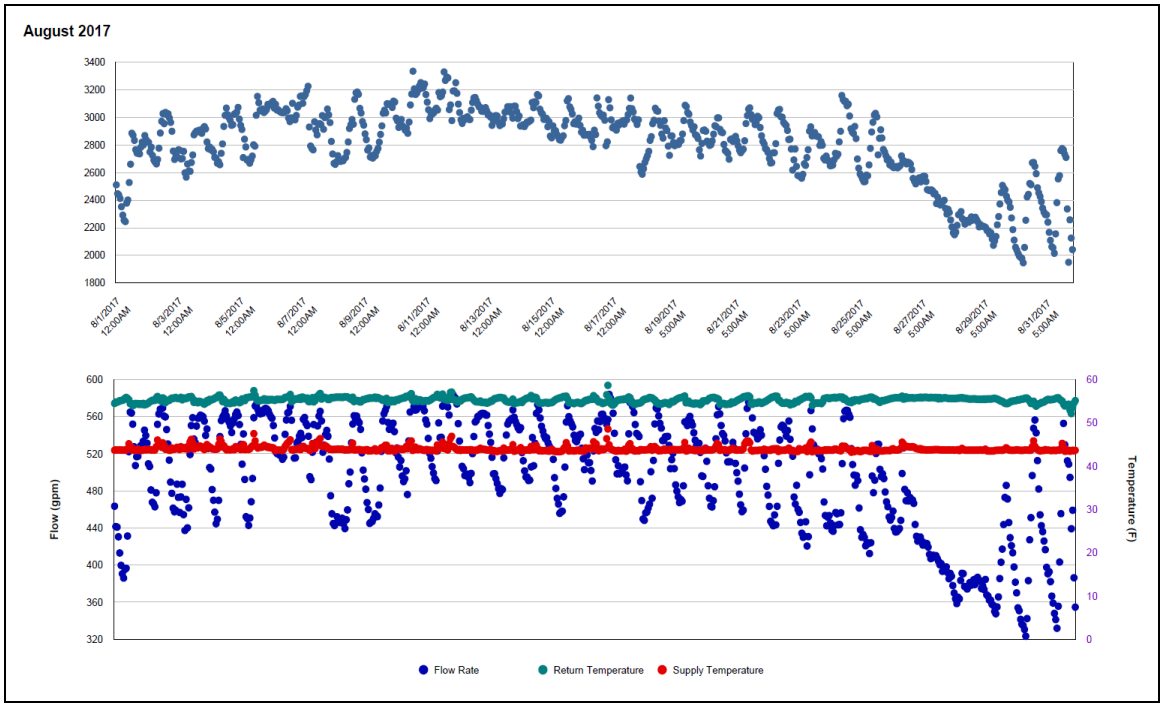
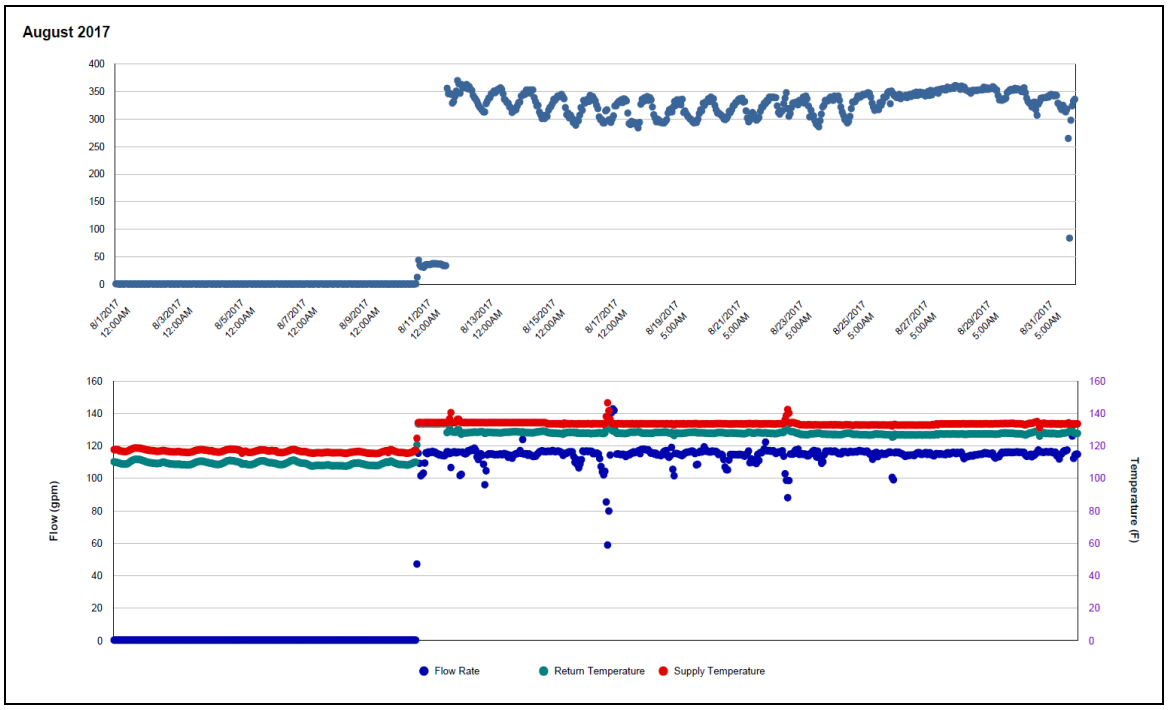
Halbouty Geosciences Building (TAMU Bldg # 490)

There are two HHW meters for this building. HHW meter #006917 experienced a decrease to near zero Delta-T for the period 5/30/2017 – 6/15/2017 and then a decrease in flow rate to zero or near zero for the period 6/15/2017 – 7/31/2017. On 8/11/2017, the flow rate returned. The HHW consumption was estimated for this meter by model.

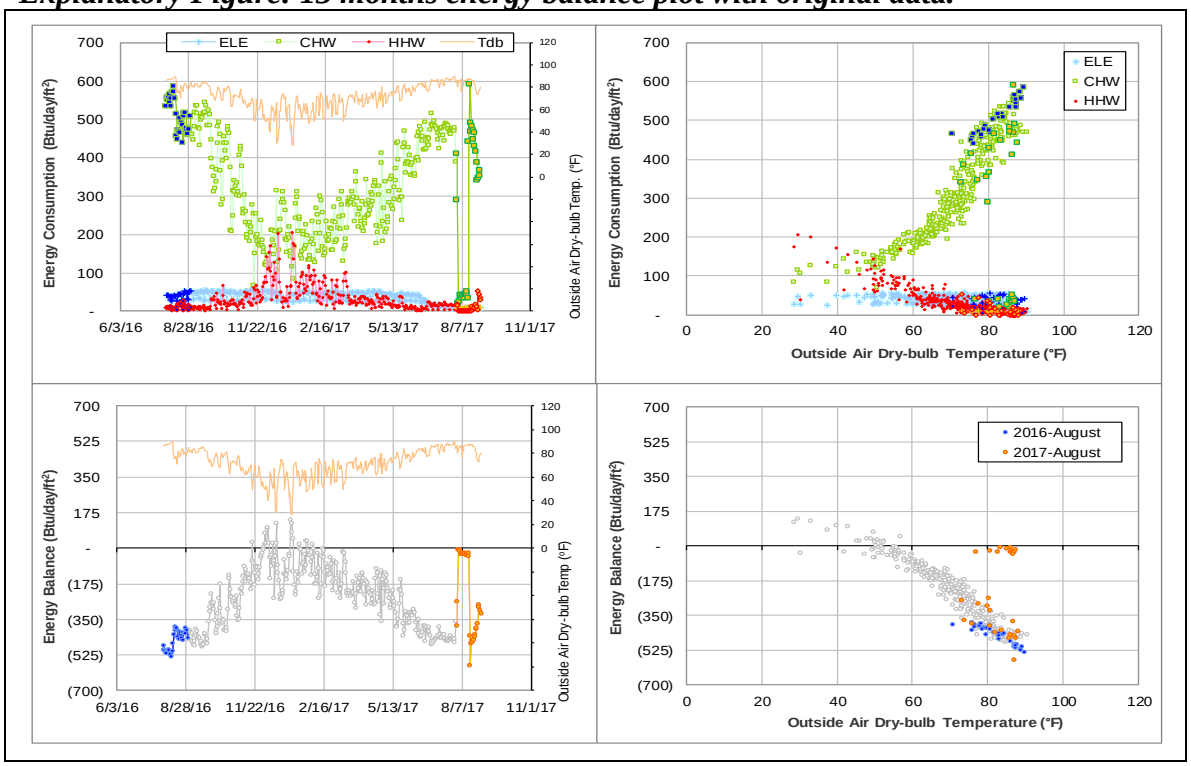
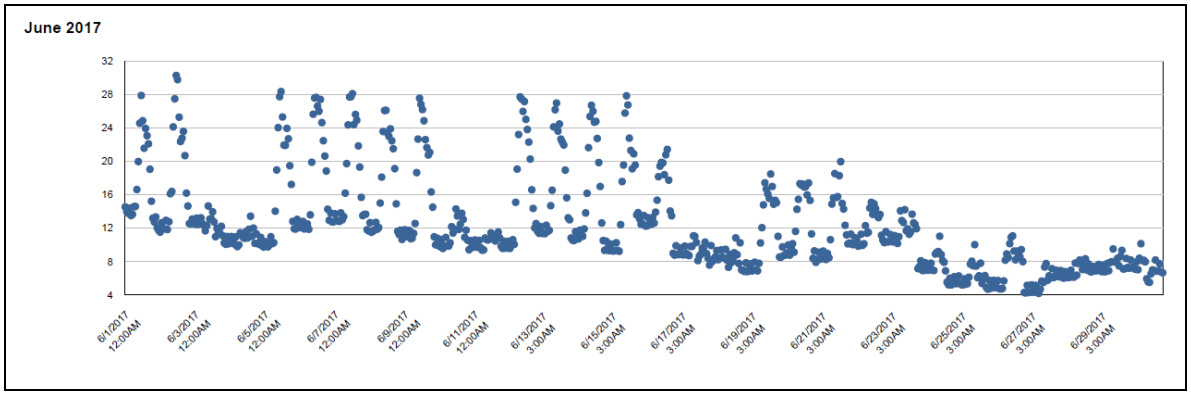
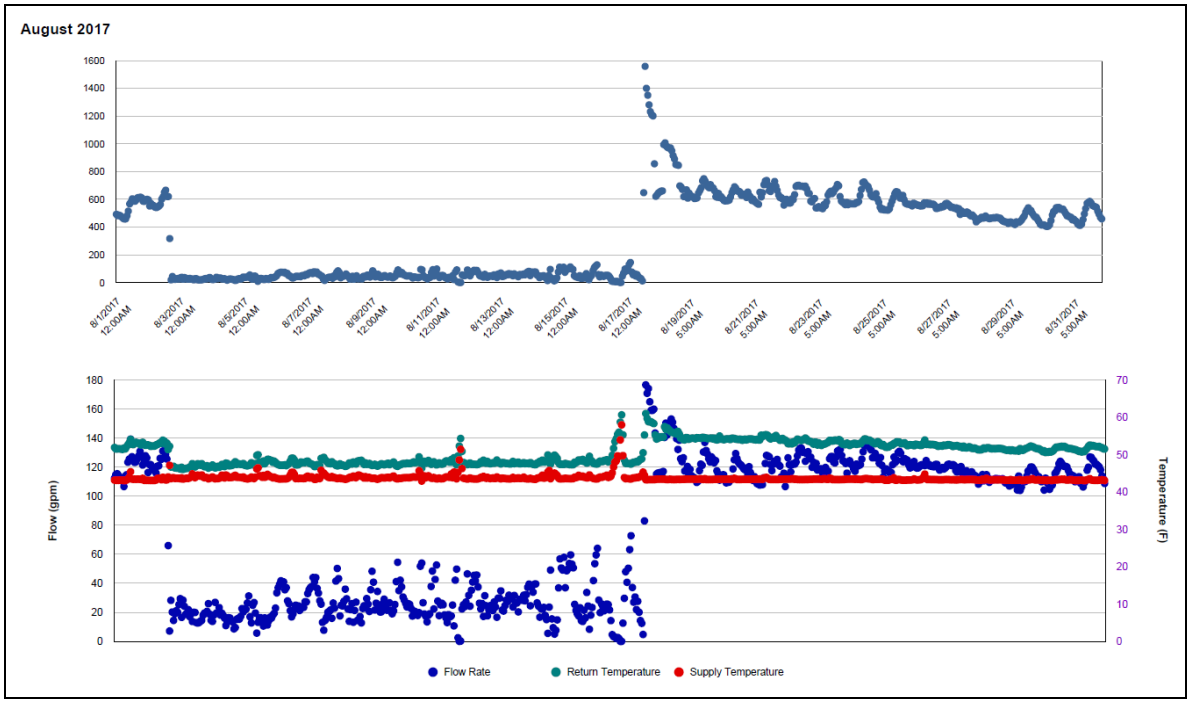
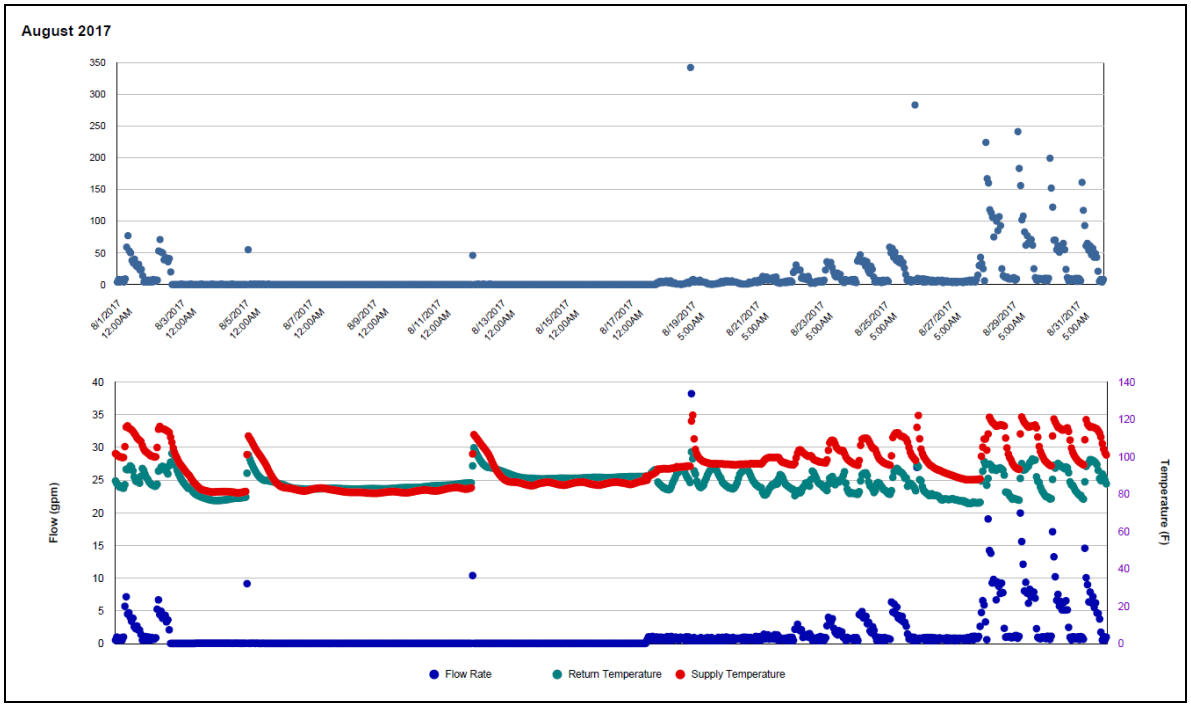
Nagle Hall (TAMU Bldg #506)

CHW and HHW of this buildings seem to have been closed during 8/2/2017 – 8/17/2017. CHW had very low flow rate and small Delta-T during this period. HHW had zero flow rate and both temperatures approached room temperature. This is not suspected to be a metering problem. This period is estimated by model.

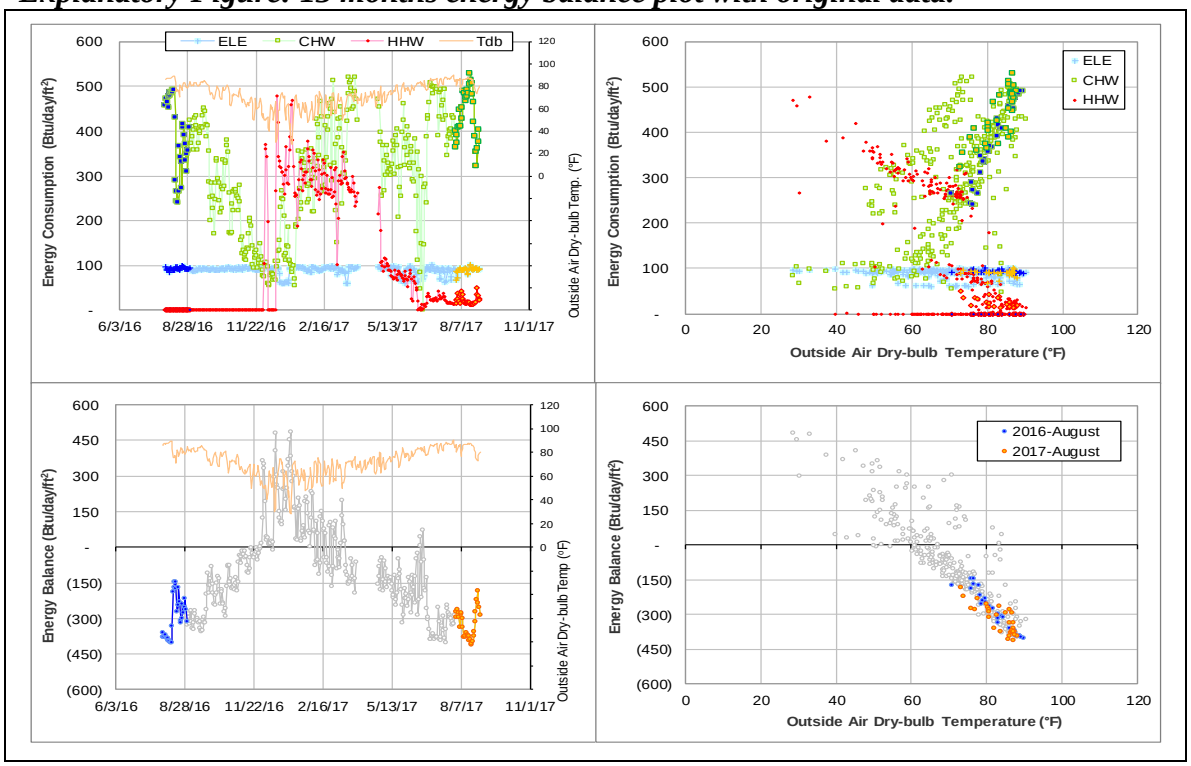
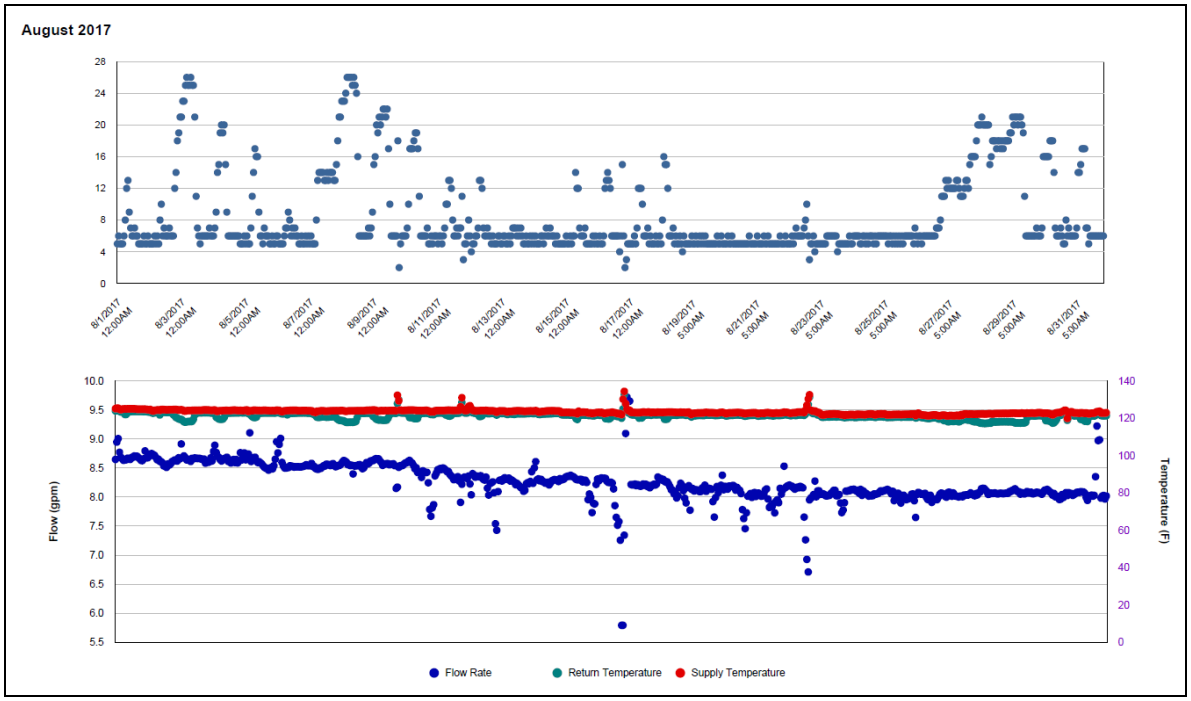
All Faiths Chapel (TAMU Bldg #512)

Data Type	Description of data behaviors	Period
HHW	The consumption level has decreased suddenly.	4/26/2017 – Ongoing
	Scattering data are observed.	6/1/2017 – Ongoing

HHW flow rate and both temperatures had been very unstable and have had multiple periods of anomaly since June 2017. The Delta-T became very small since 6/16/2017. The HHW of the whole month is estimated by model.

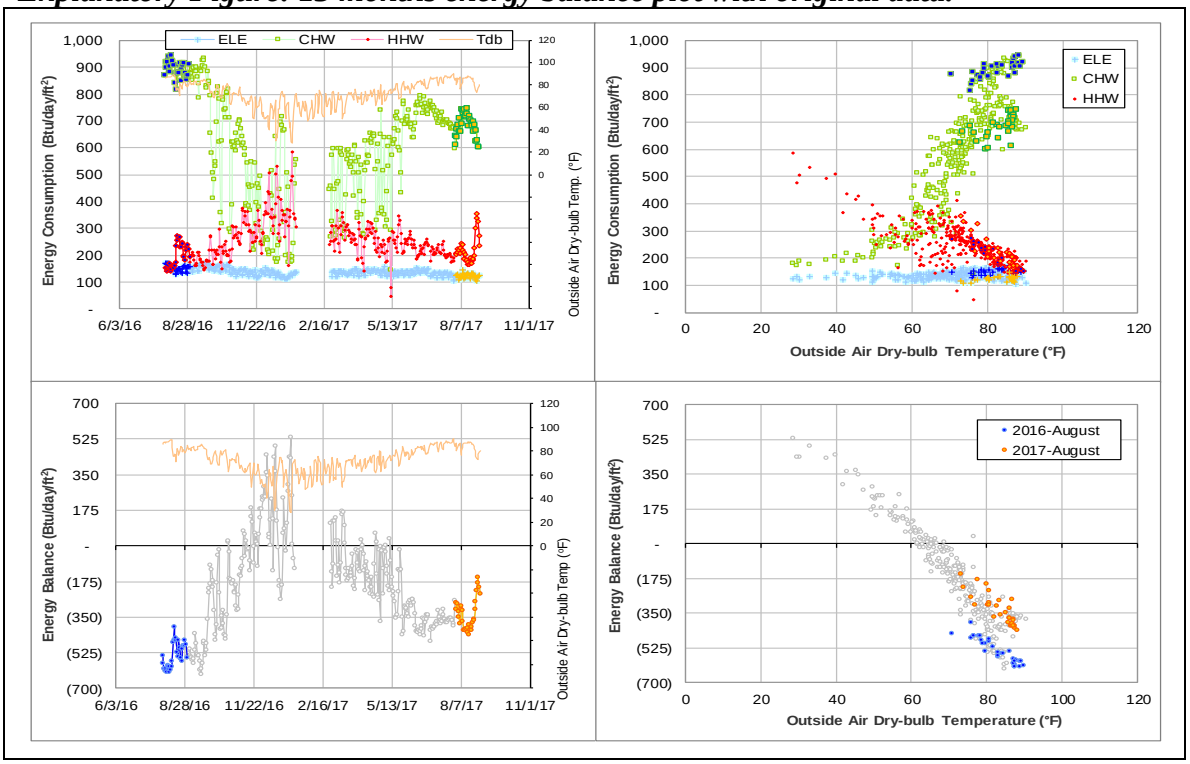
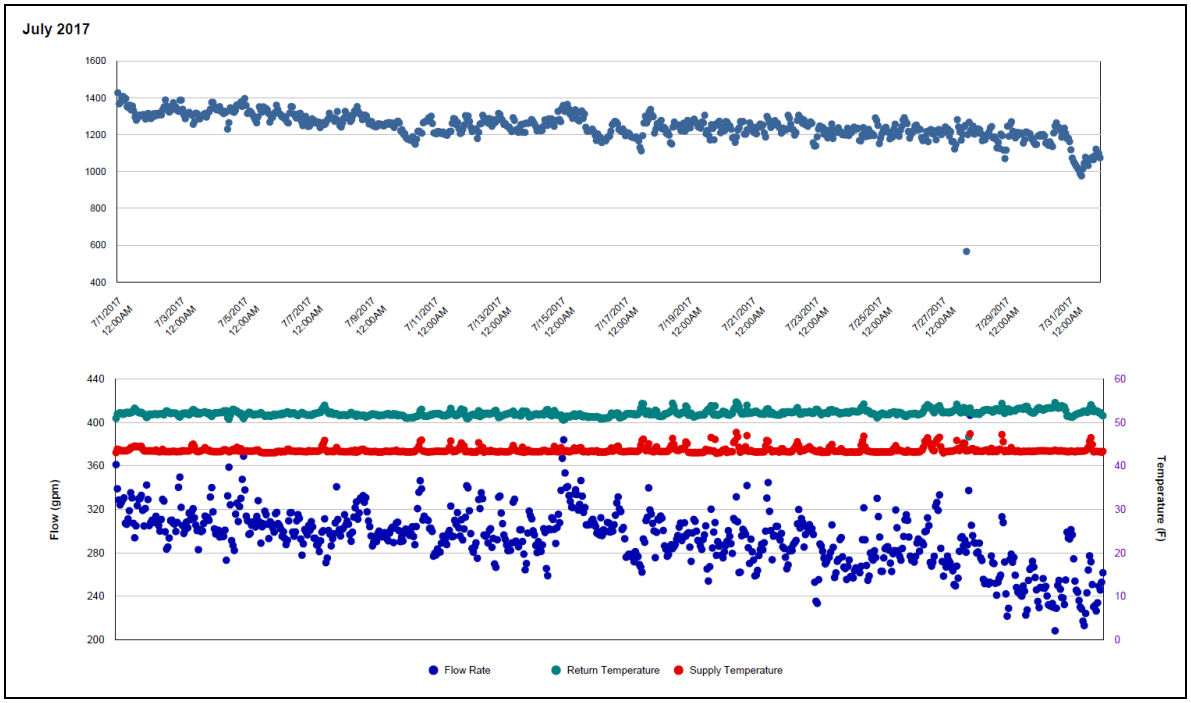
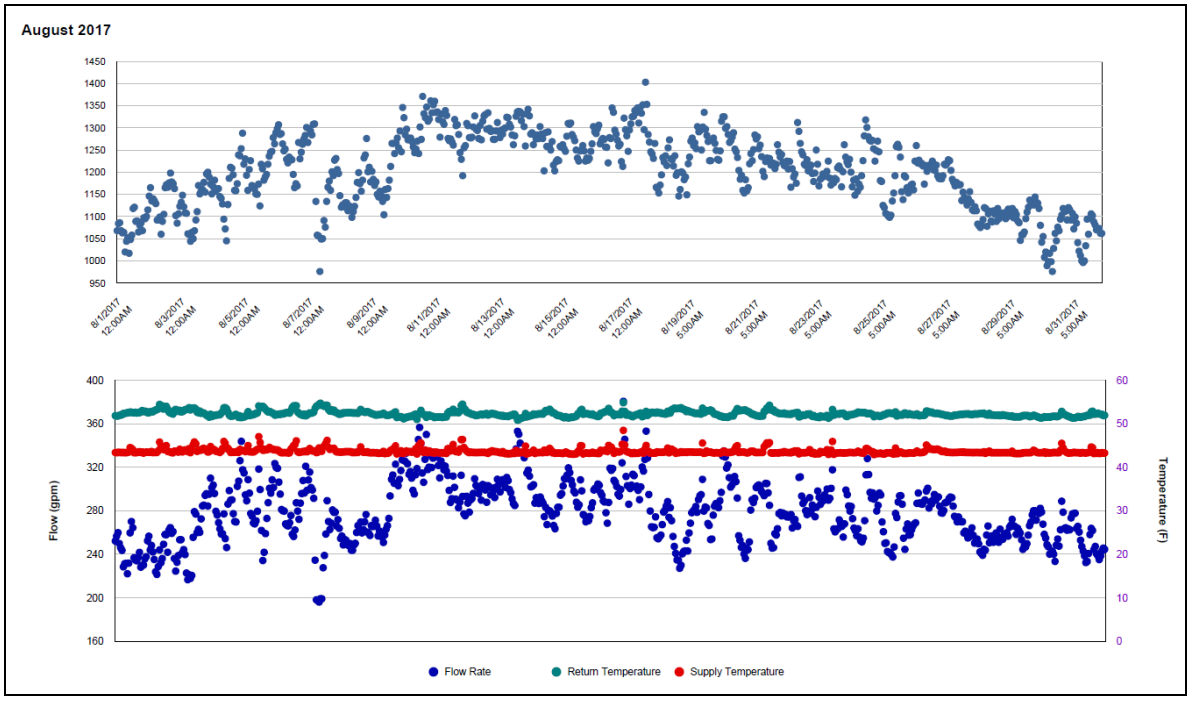
Doherty Building (TAMU Bldg #513)

CHW flow rate started to slide down slowly since 7/1/2017 from 300 – 340 gpm at the beginning of the July 2017 to 240 – 280 gpm at the end of August 2017. The consumption level is seen about 200 Btu/day-ft^2 lower than the previous year. The whole month is estimated by model.

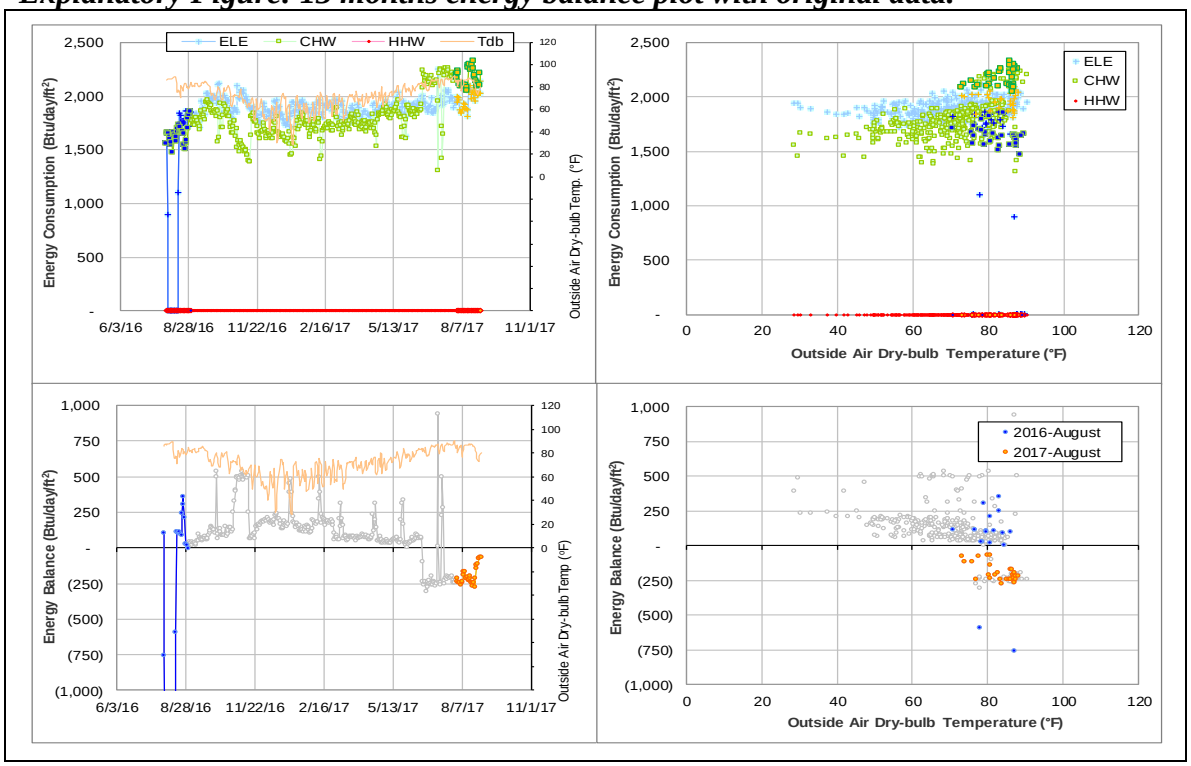
CHW flow rate increased from the range of 400 – 520 gpm to 480 – 560 gpm since 6/19/2017 resulting in a significant increase in CHW consumption. As CHW consumption of this building has only weak dependence on temperature, the estimation is made by taking average over the 6/1/2016 – 5/31/2017 when the consumption was stable and mostly independent of outdoor air temperature.

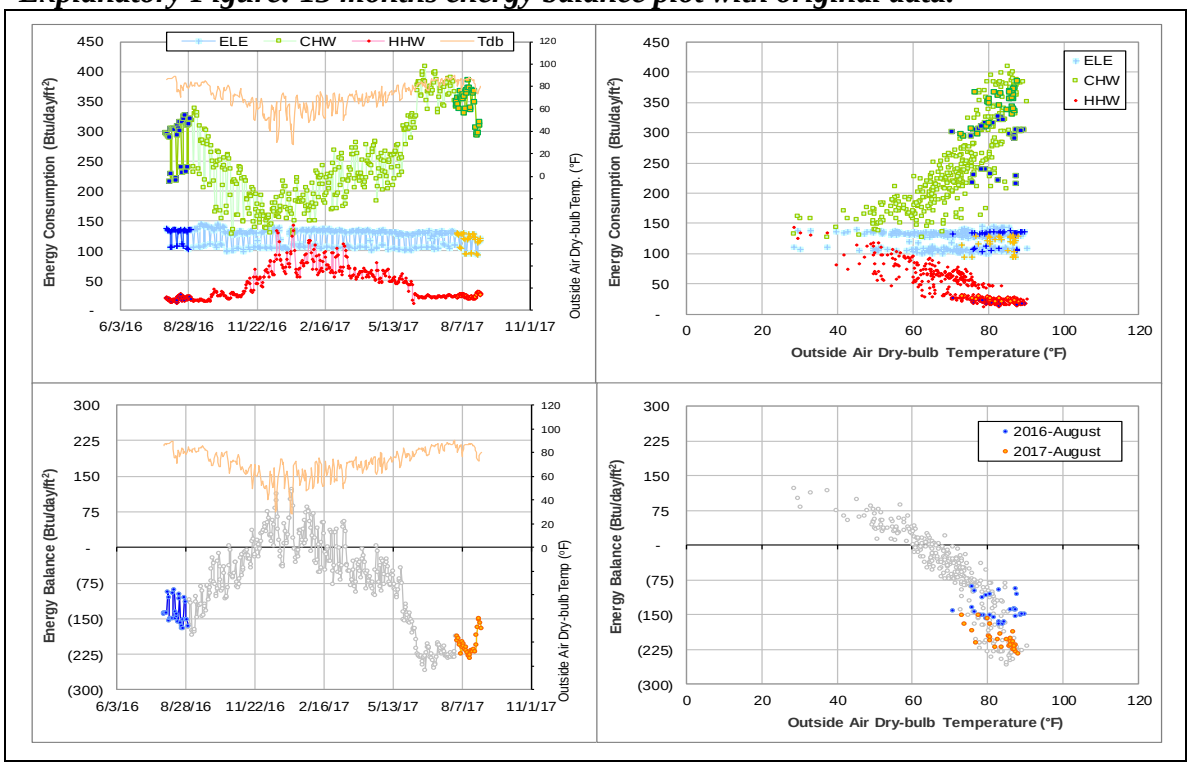
CHW consumption increased to 50 – 100 Btu/day-ft² higher than the previous year in June 2017 and stayed high. The consumption pattern of CHW no longer has a weekday/weekend difference. There is no obvious meter reading anomaly observed. The consumption of this month is estimated by model.

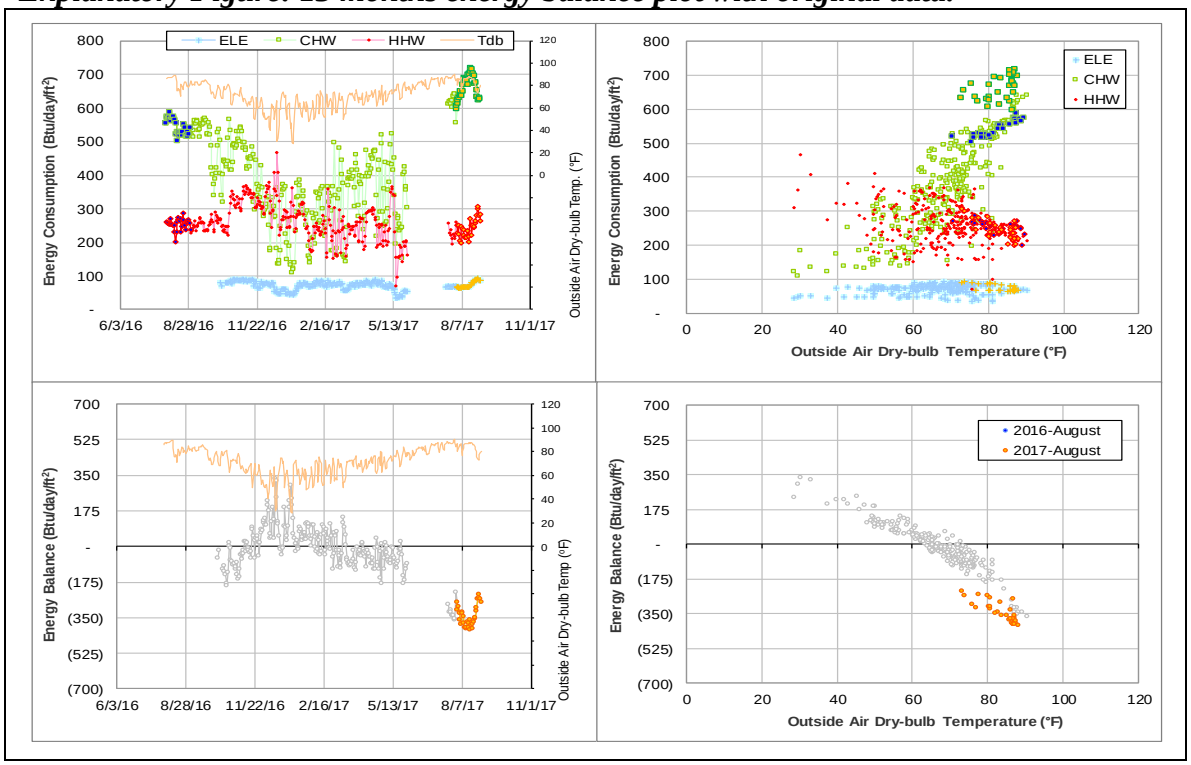
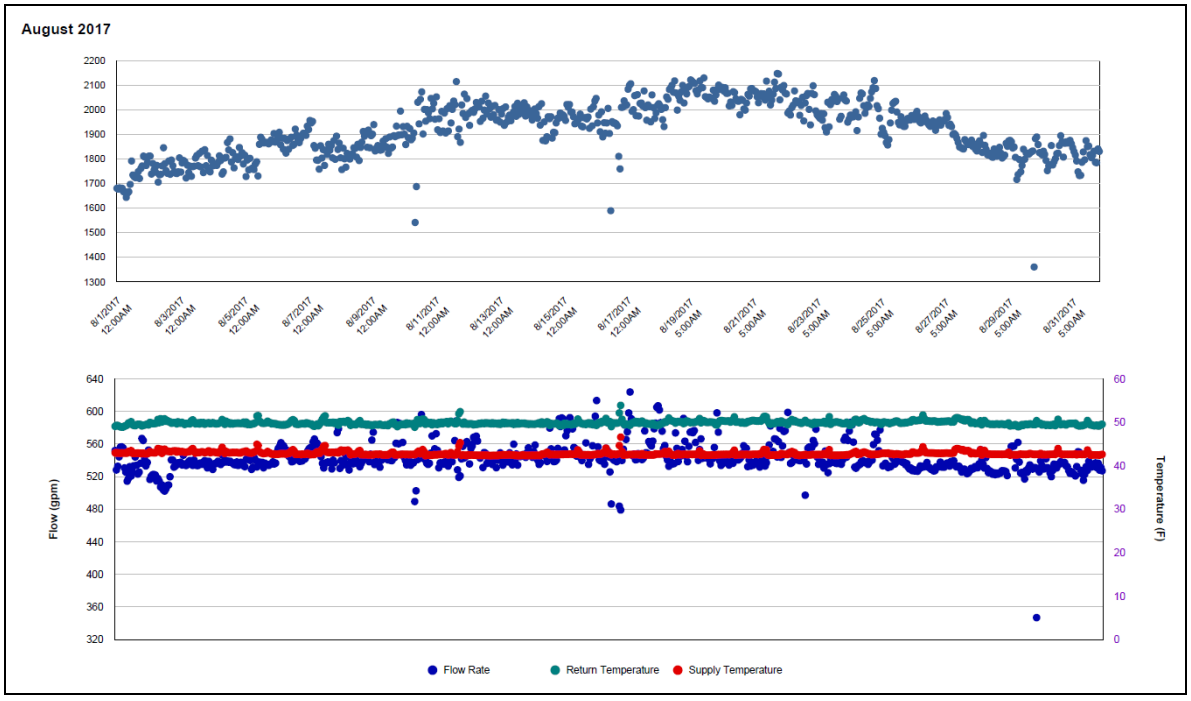
The data of this building were missing during 6/1/2017 – 7/21/2017. After the missing period, Delta-T of CHW became larger and the CHW seems to scatter in the recent period. However, the flow rate becomes more stable compared. This consumption of this month is estimated by model.

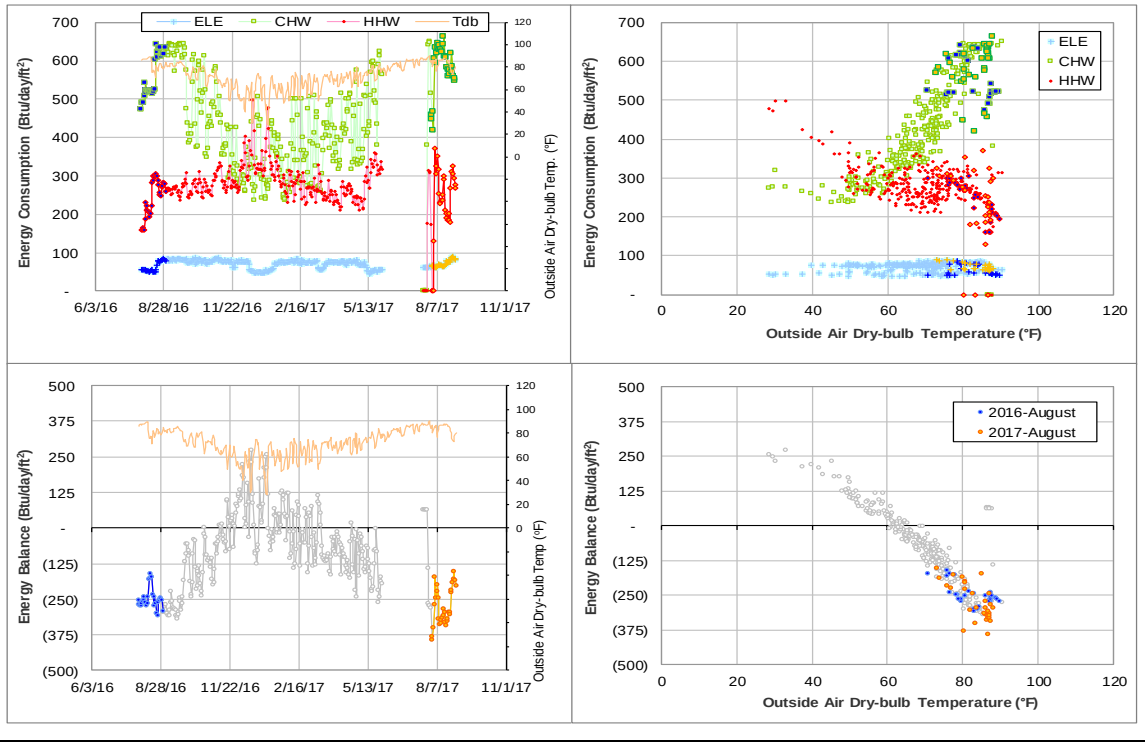
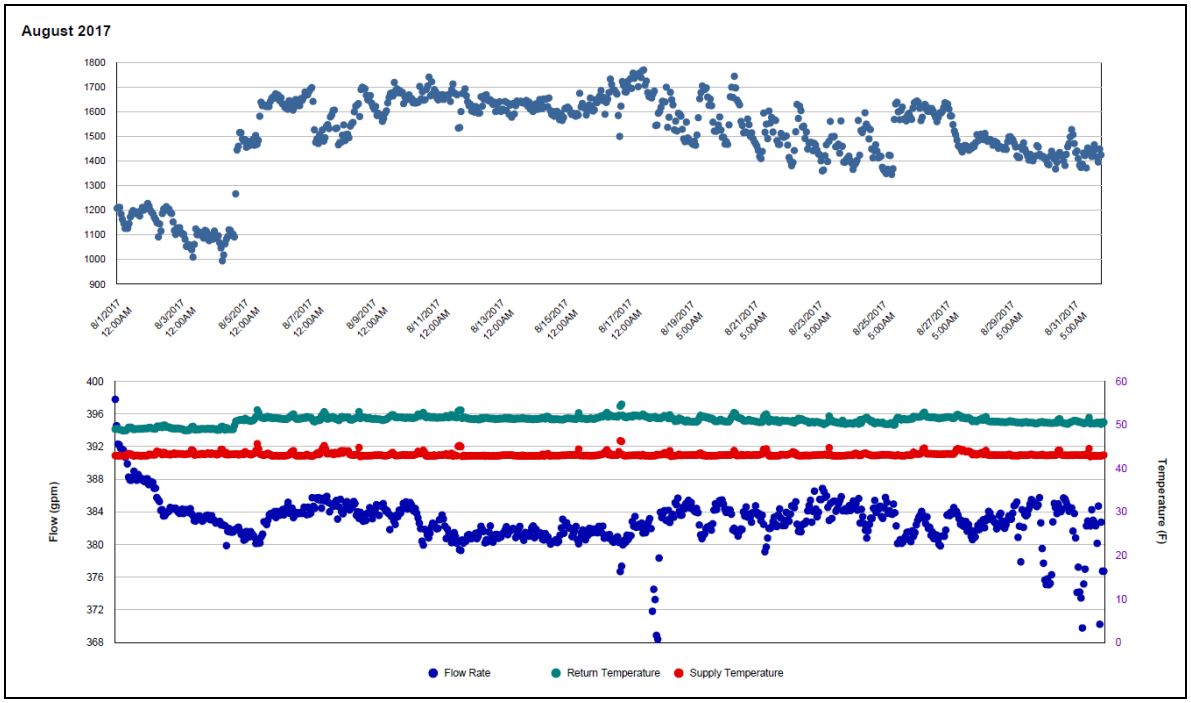
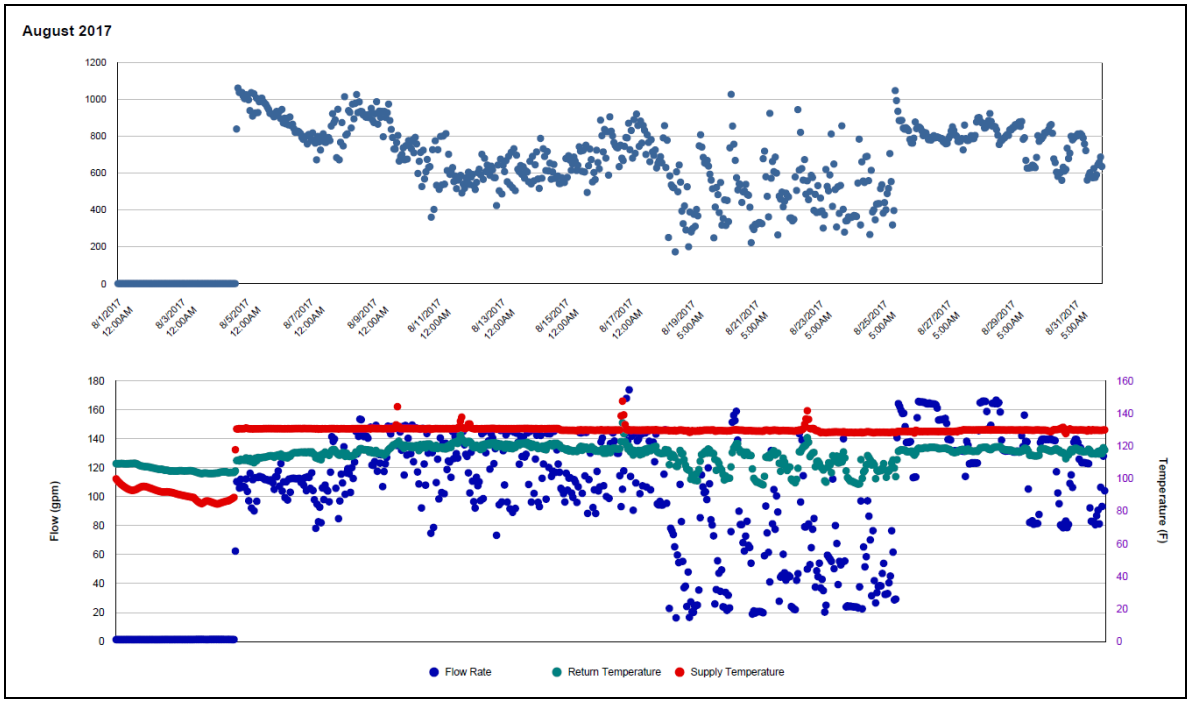
CHW return temperature dropped slightly during 7/31/2017 – 8/4/2017 resulting in a decrease of CHW consumption. HHW flow rate dropped to zero during 7/31/2017 – 8/4/2017. This period is estimated by model.

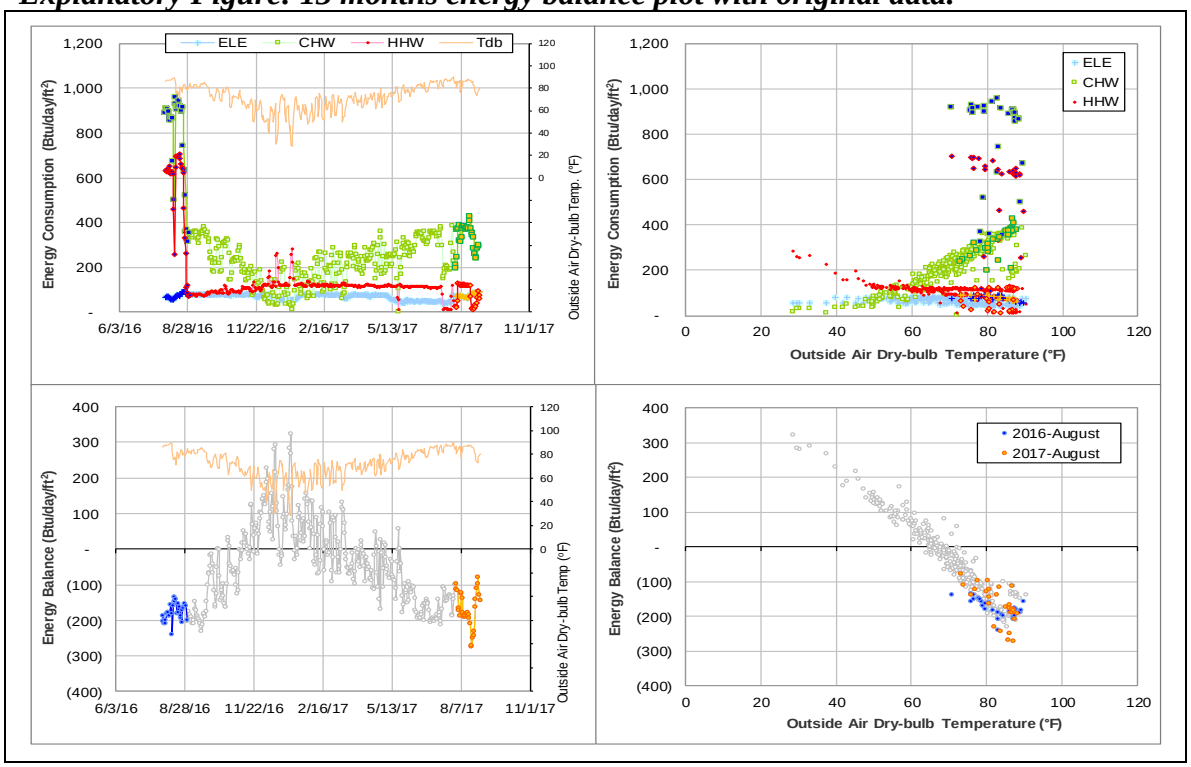
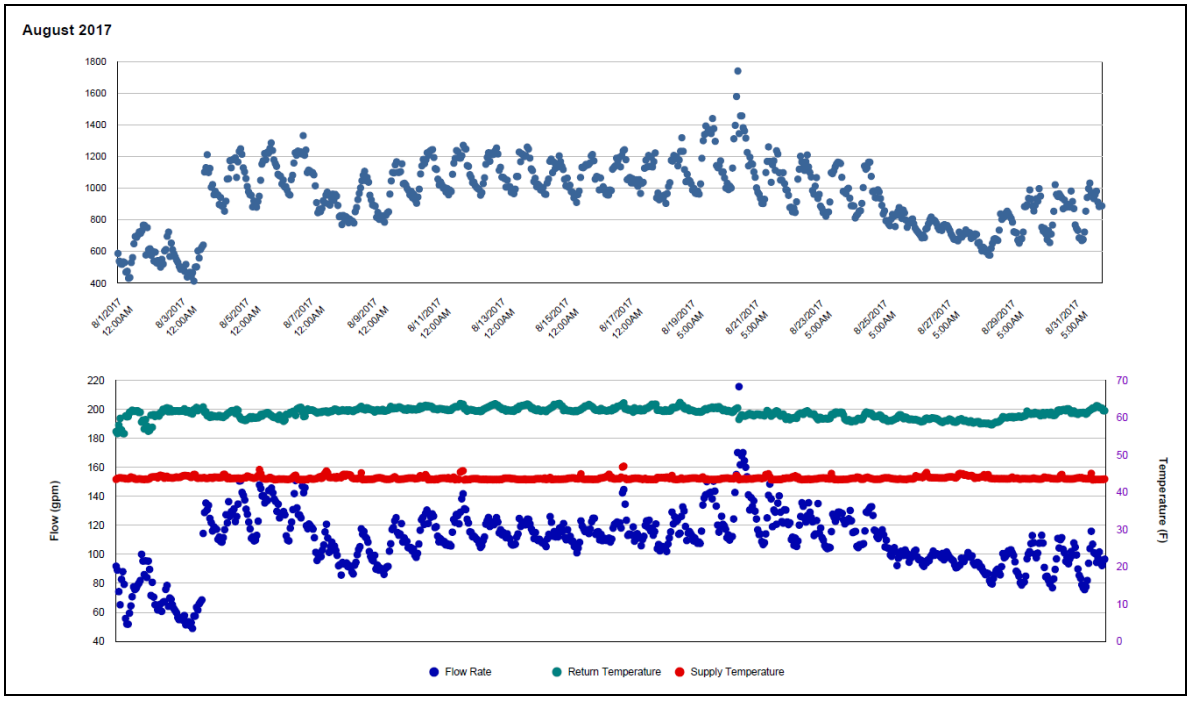
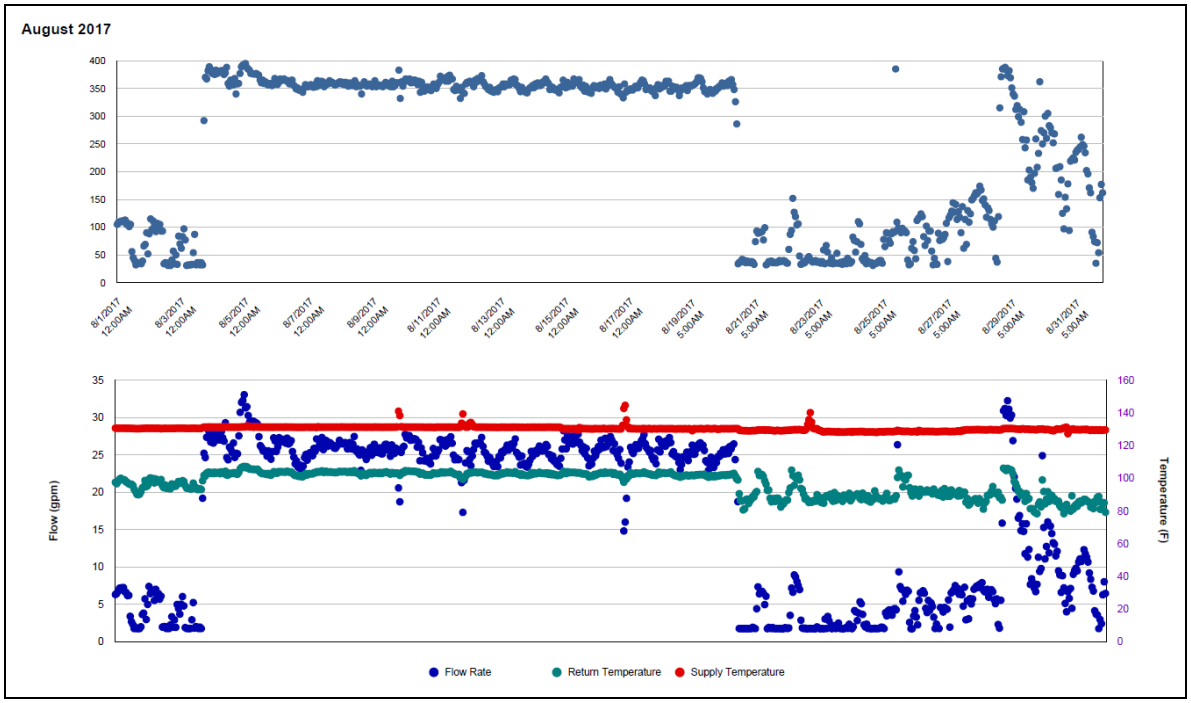
CHW flow rate dropped from its normal rate of 100 – 130 gpm to 50 – 80 gpm during 7/29/2017 – 8/3/2017. HHW flow rate dropped from its normal rate of 22 – 27 gpm to 2 – 8 gpm during 7/29/2017 – 8/3/2017 and since 8/20/2017. These days are estimated by model.
