ESL-TR-17-09-01

TAMU Project

Energy Consumption Data Quality Assurance/Quality Control Assessment Report for the

Month of August 2017

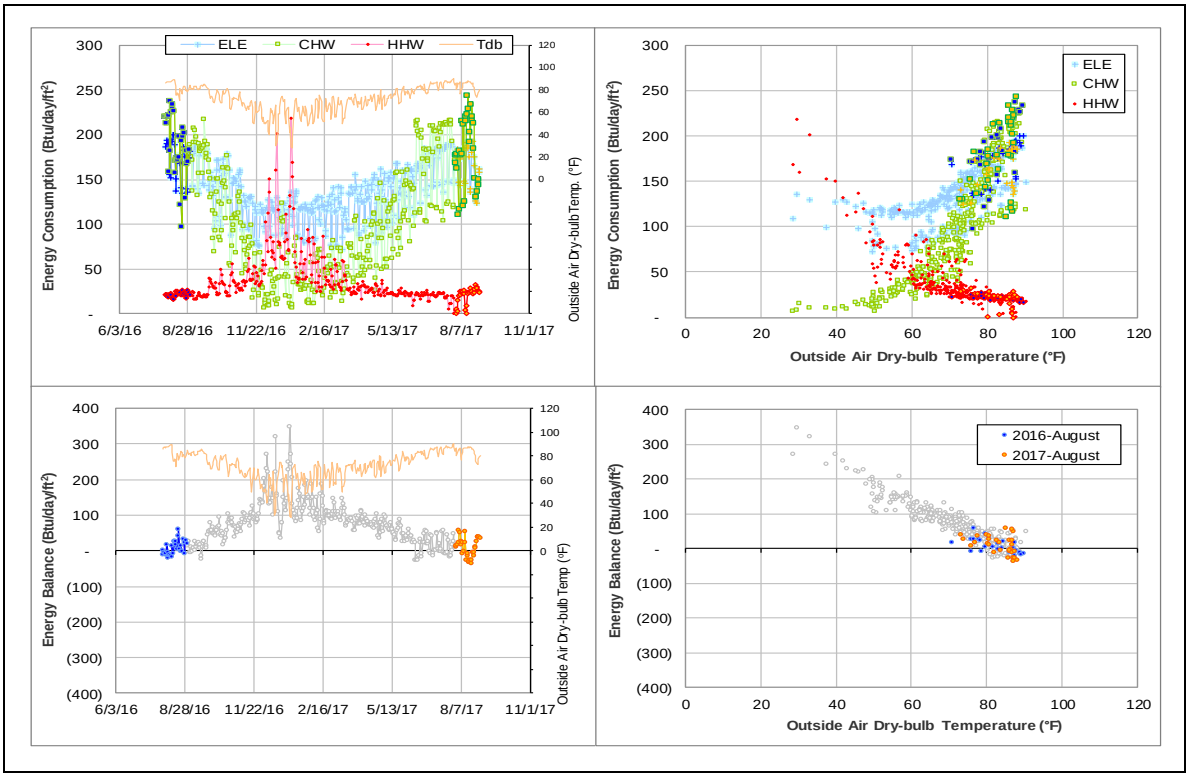
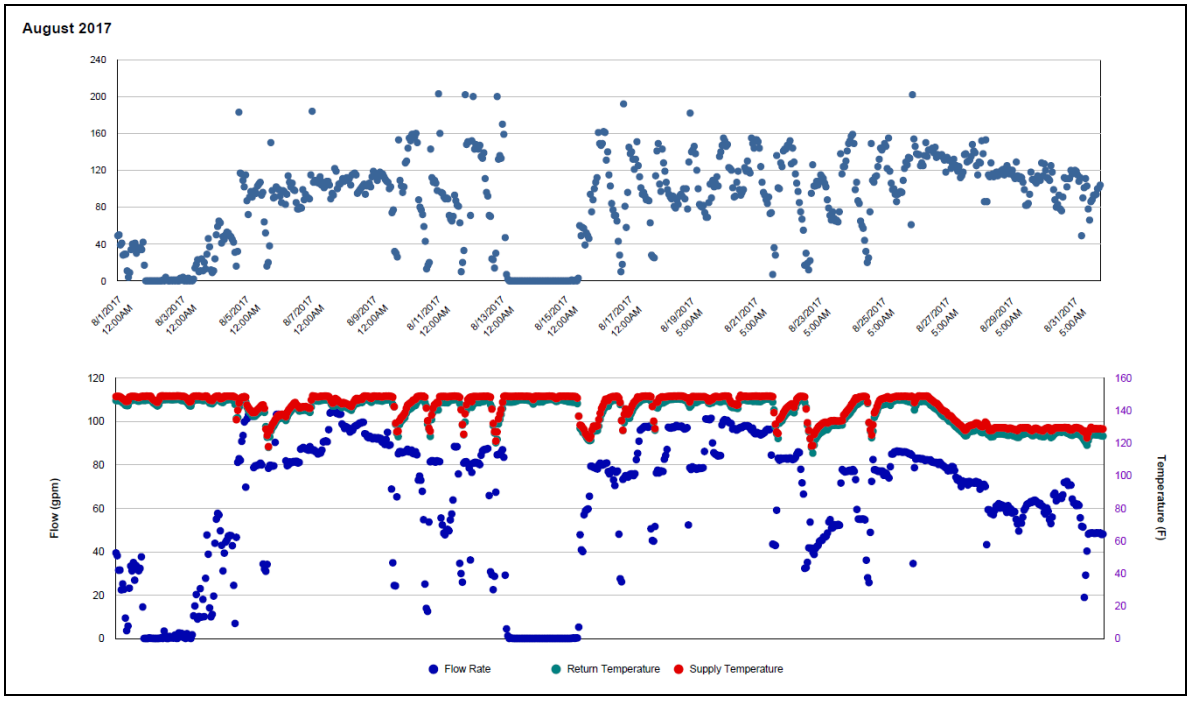
HHW flow rate decreased suddenly to near zero during 7/31/2017 – 8/4/2017 and during 8/13/2017 – 8/15/2017. These periods are estimated by model.

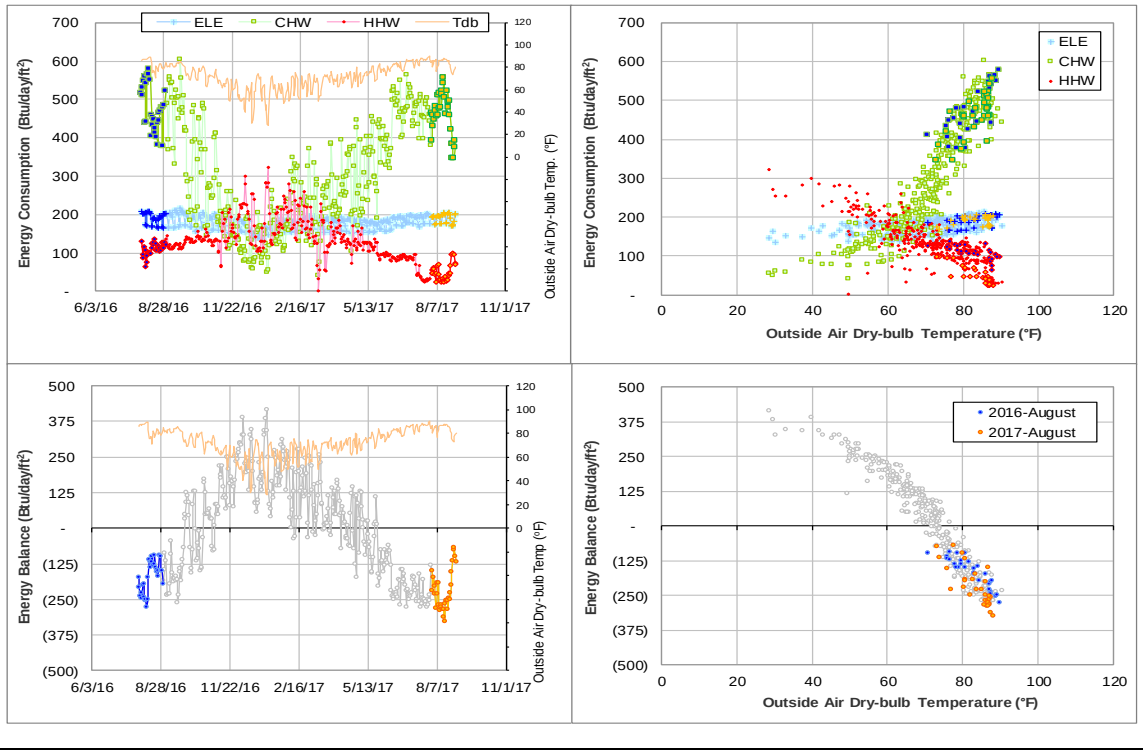
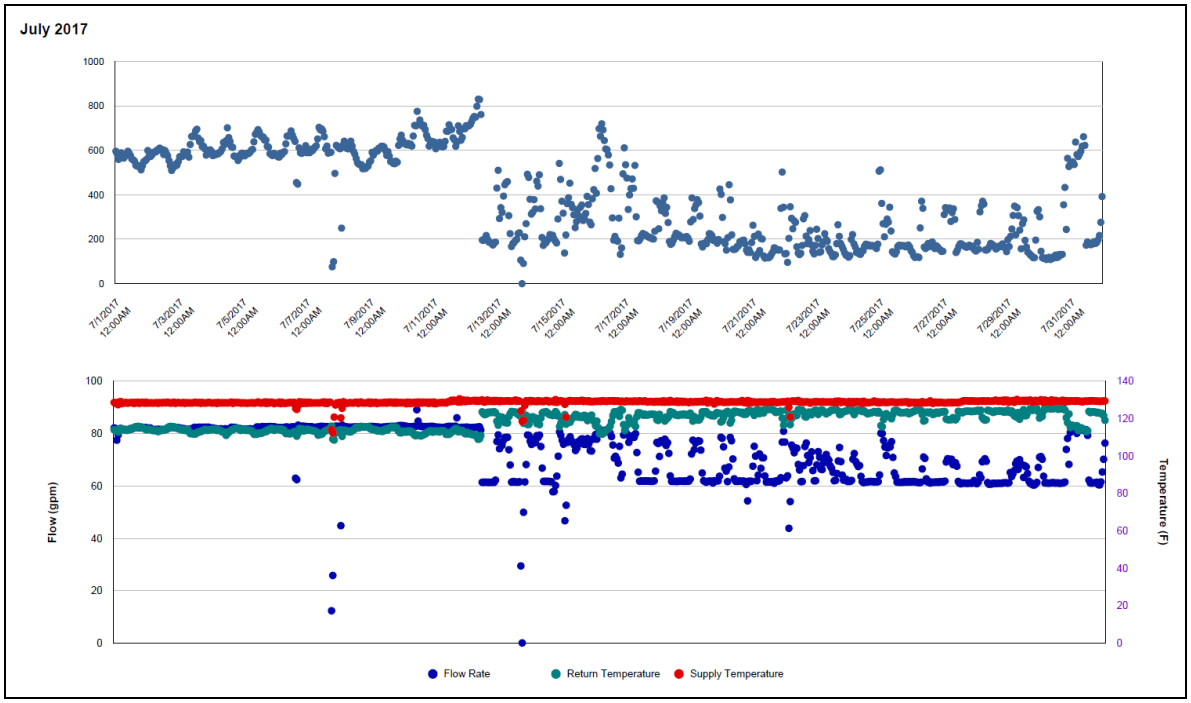
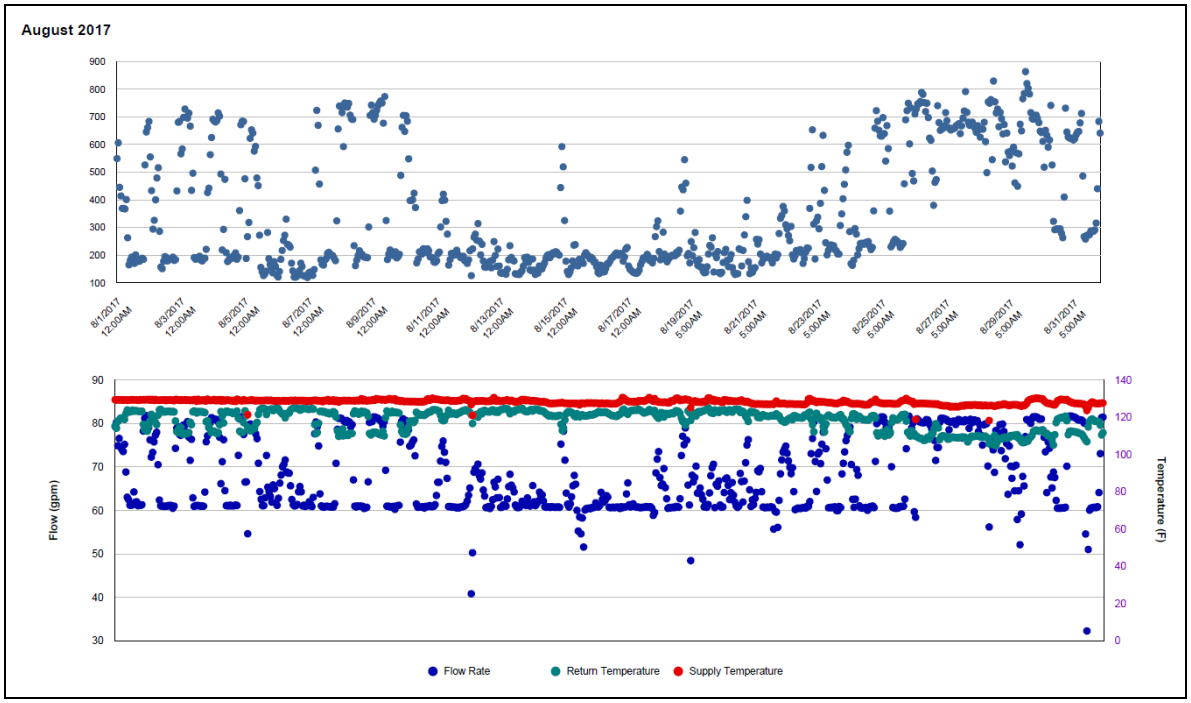
HHW flow rate decreased from about 80 gpm to 60 – 80 gpm since 7/12/2017. This period is estimated by model.

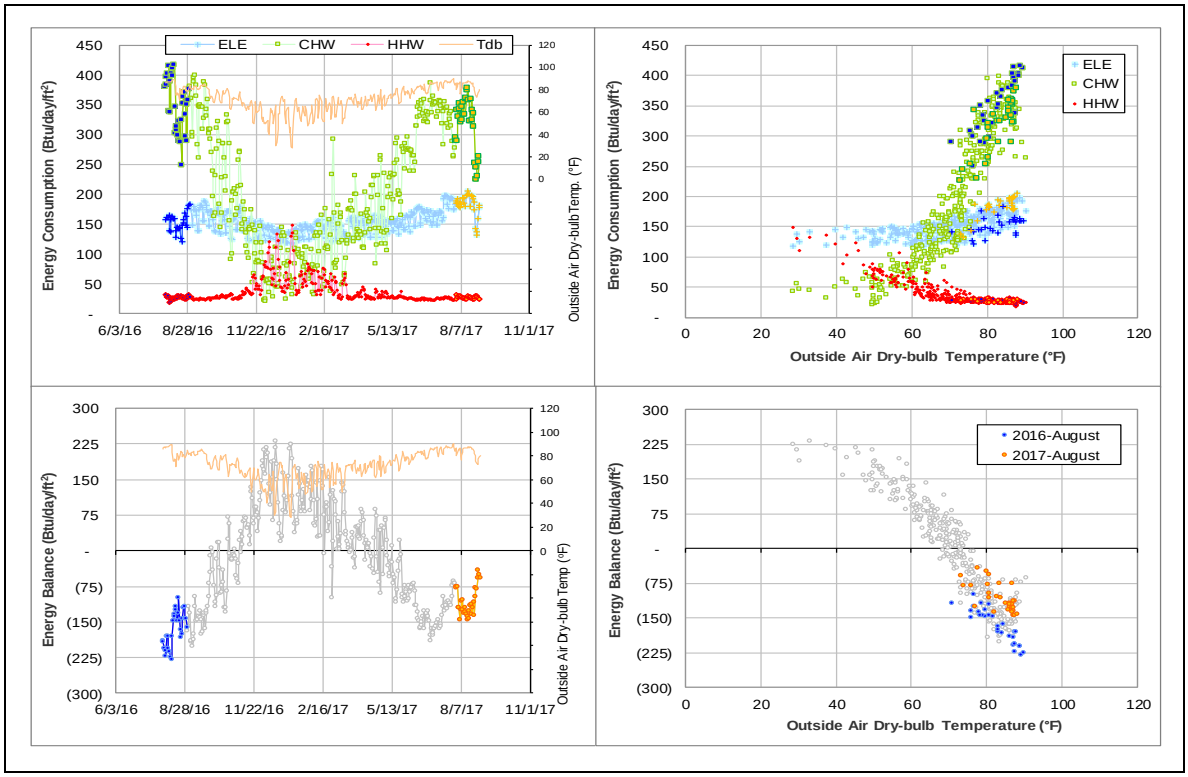
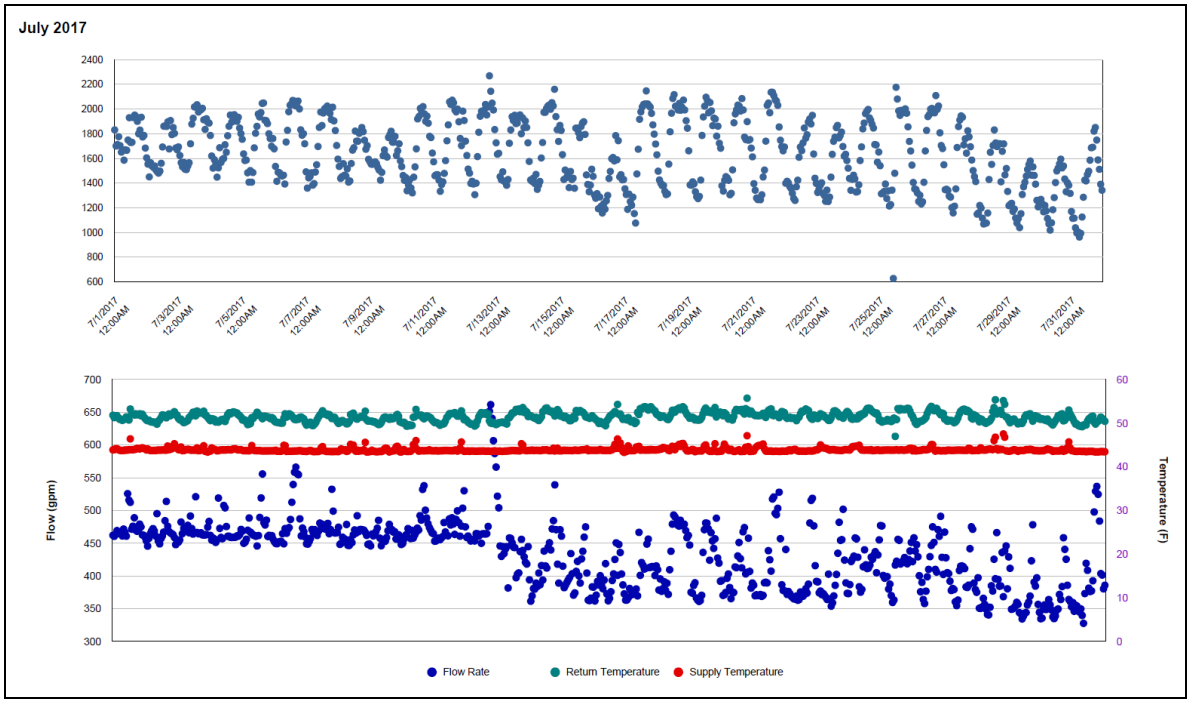
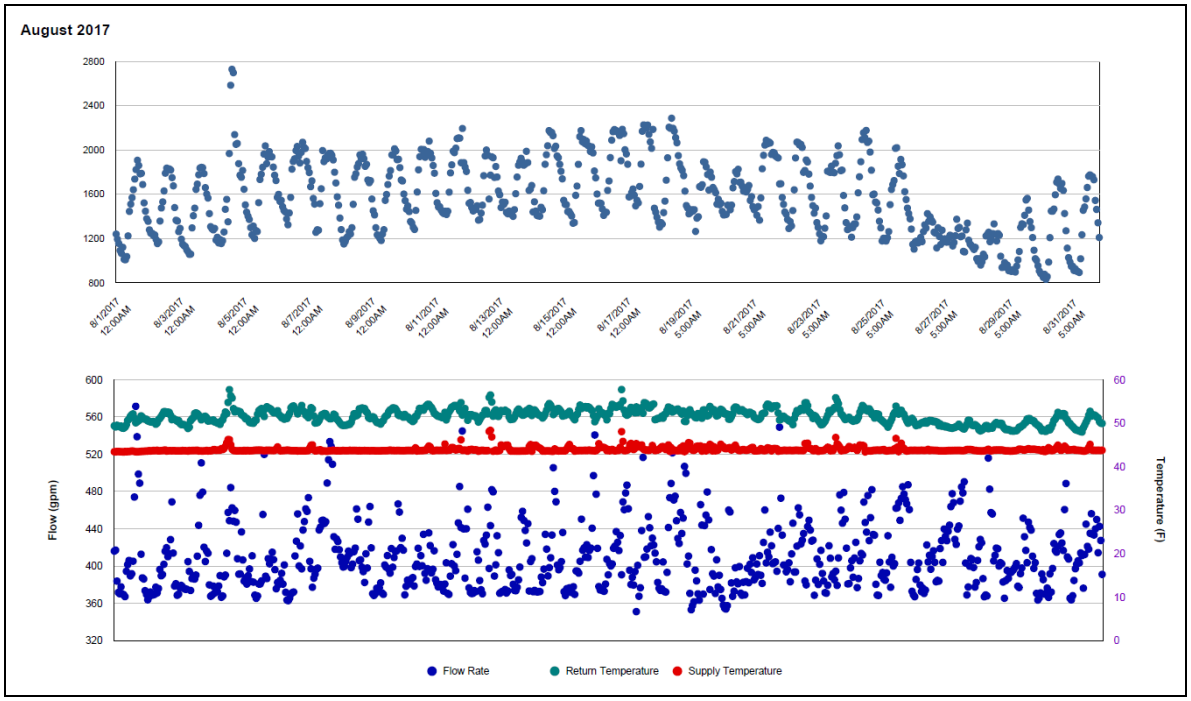
CHW flow rate dropped from 450 – 500 gpm to 350 – 450 gpm since 7/12/2017, resulting in the consumption falling out of the main pattern. This period is estimated by model.

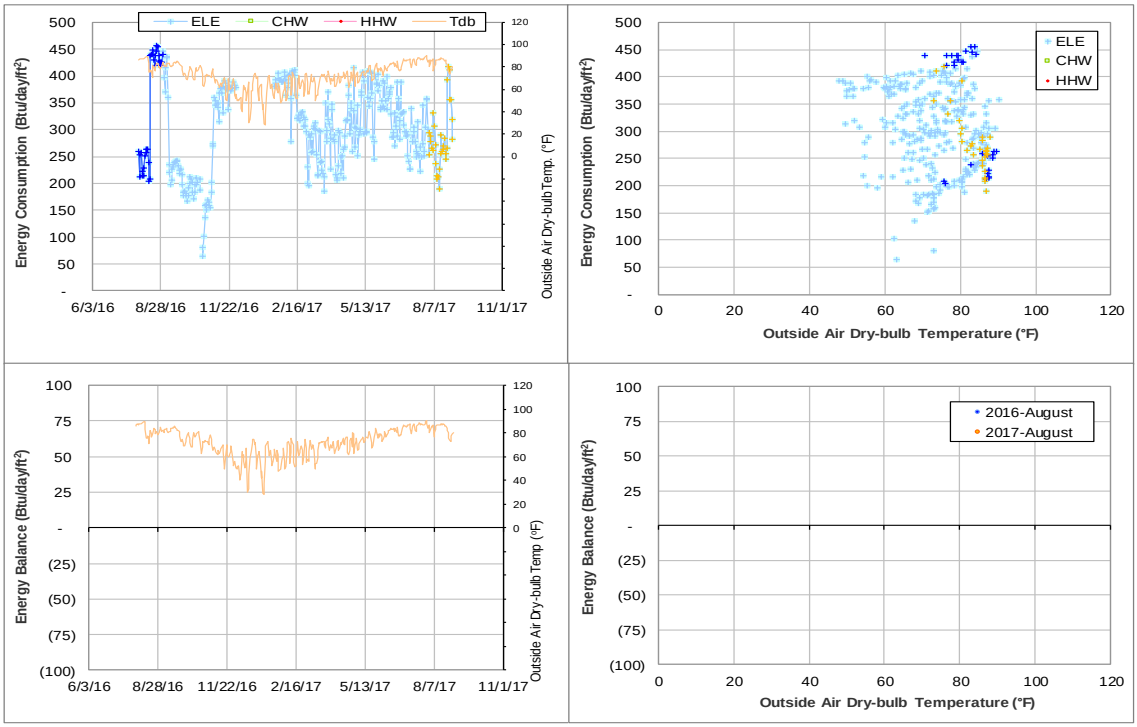
The ELE consumption level has changed frequently since July 2015 as shown in the time series. During the period of 1/22/2017 – 2/15/2017 it increased to the higher consumption pattern but then dropped again. The ELE consumption is estimated using a model based on data during 7/1/2014 – 6/30/2015 when the consumption was stable.

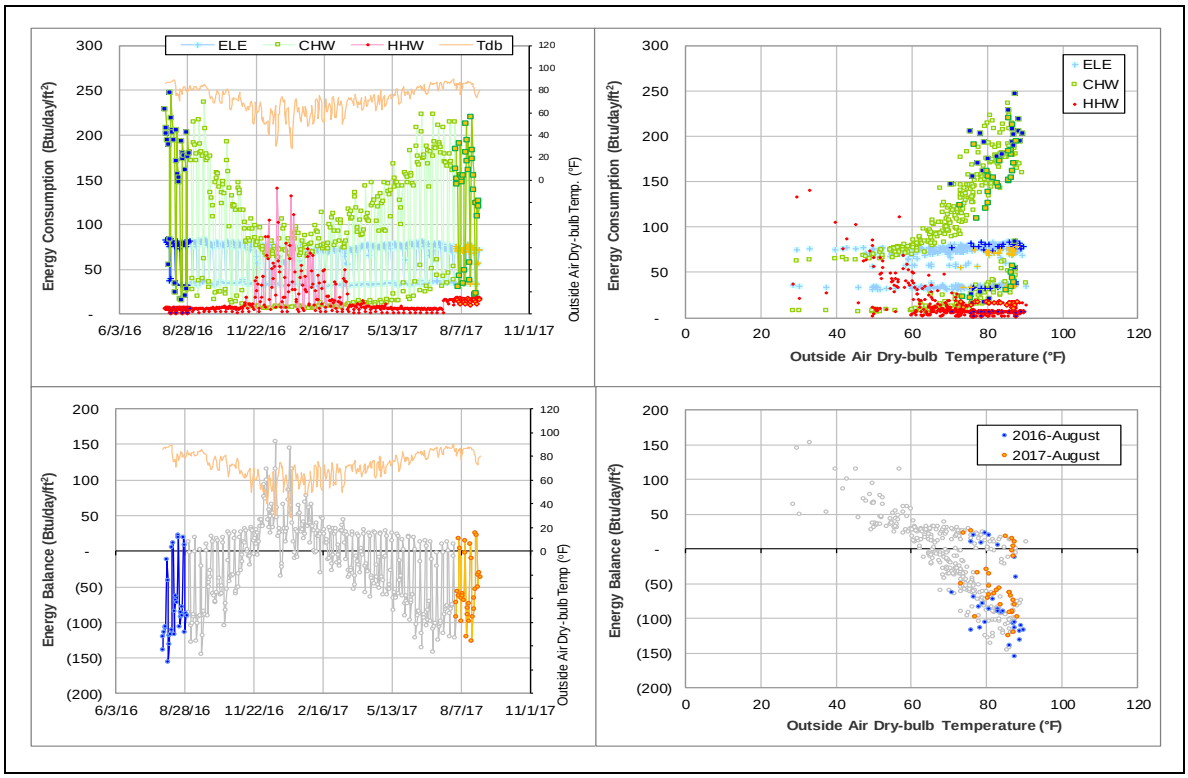
On 7/17/2017, The flow of HHW suddenly increased from a near zero level to slightly higher than 40 gpm. Delta-T significantly decreased at the same time. The combined effect is a sudden increase of HHW consumption. These days are estimated by model.

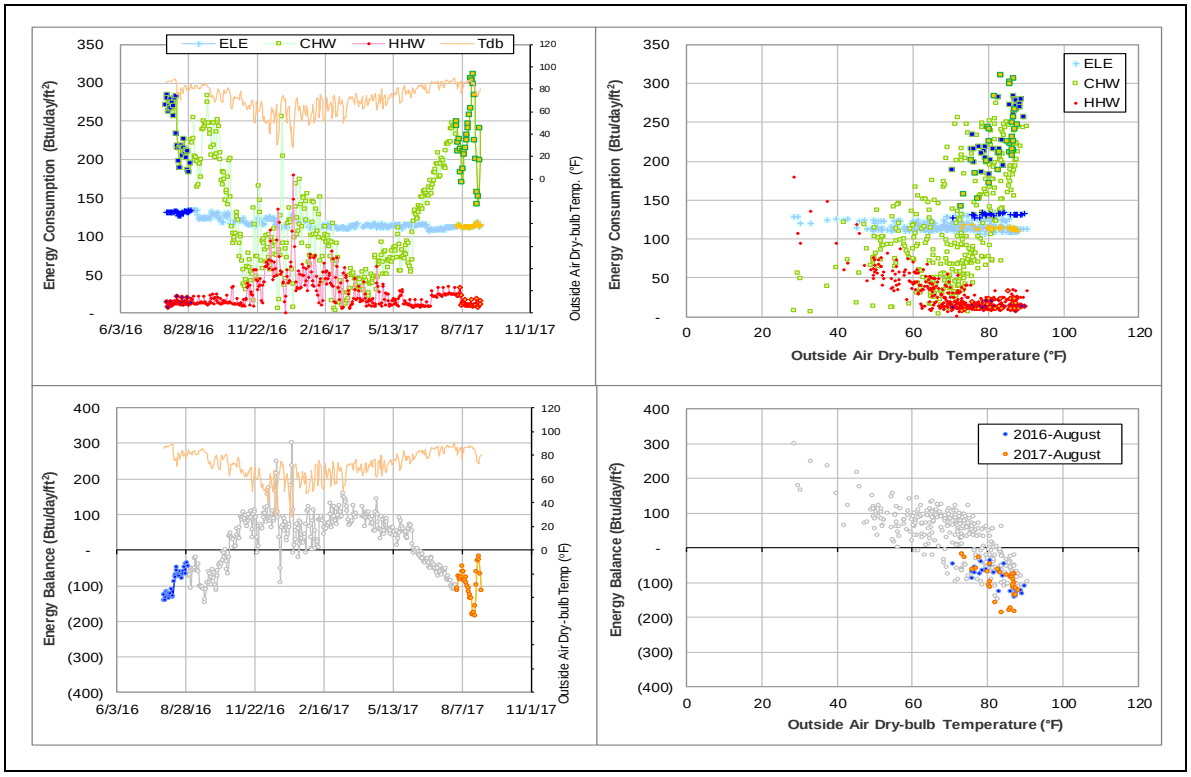
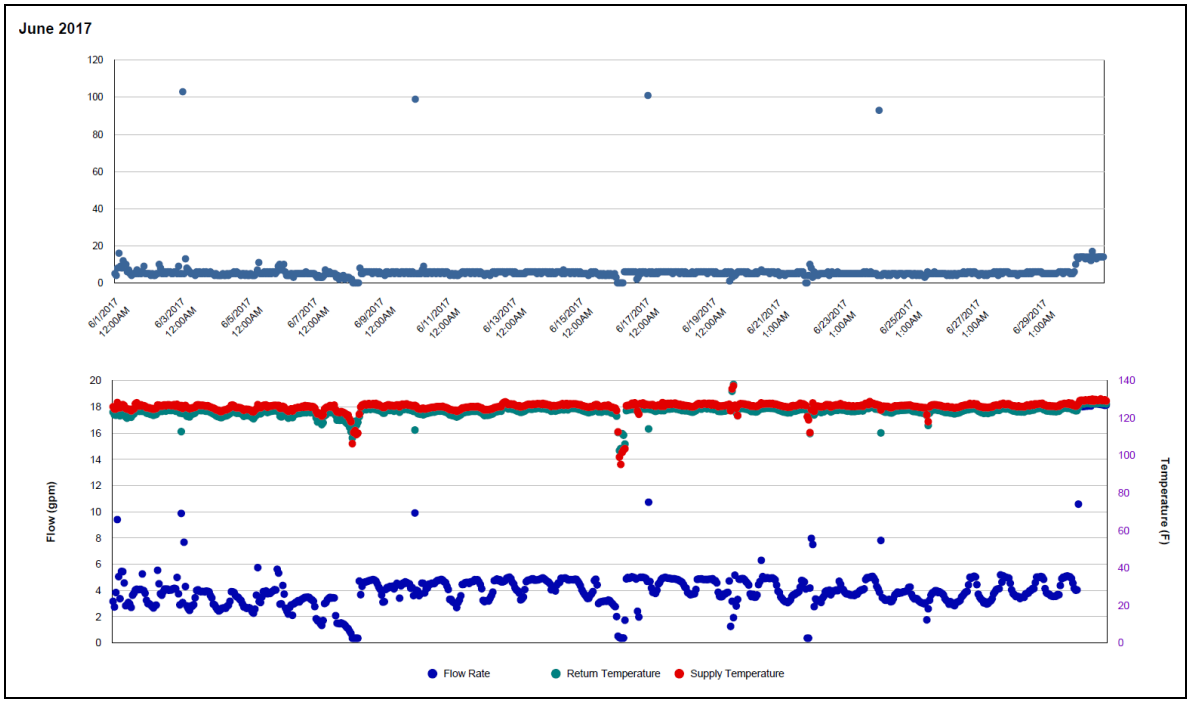
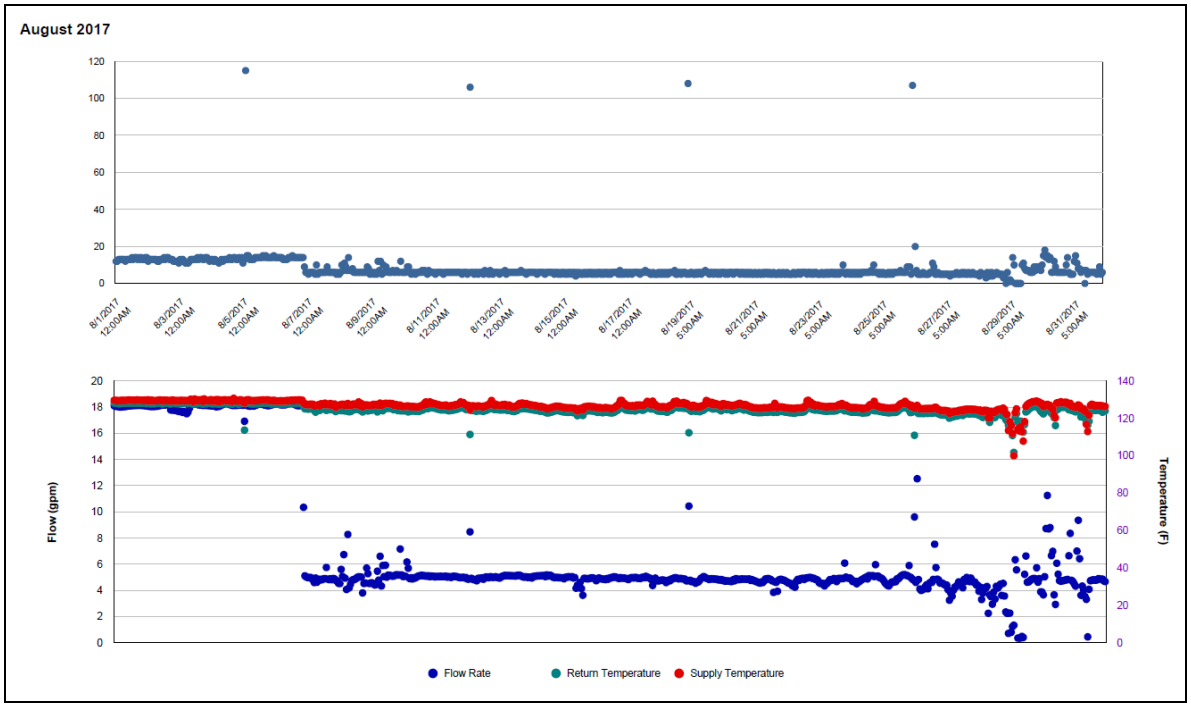
West Campus Parking Garage (TAMU Bldg #1559)

HHW flow rate significantly increased from 2 – 6 gpm to about 18 gpm during 6/30/2017 – 8/6/2017. The consumption of this month is estimated using a model based on the data of 6/1/2015 – 5/31/2016.

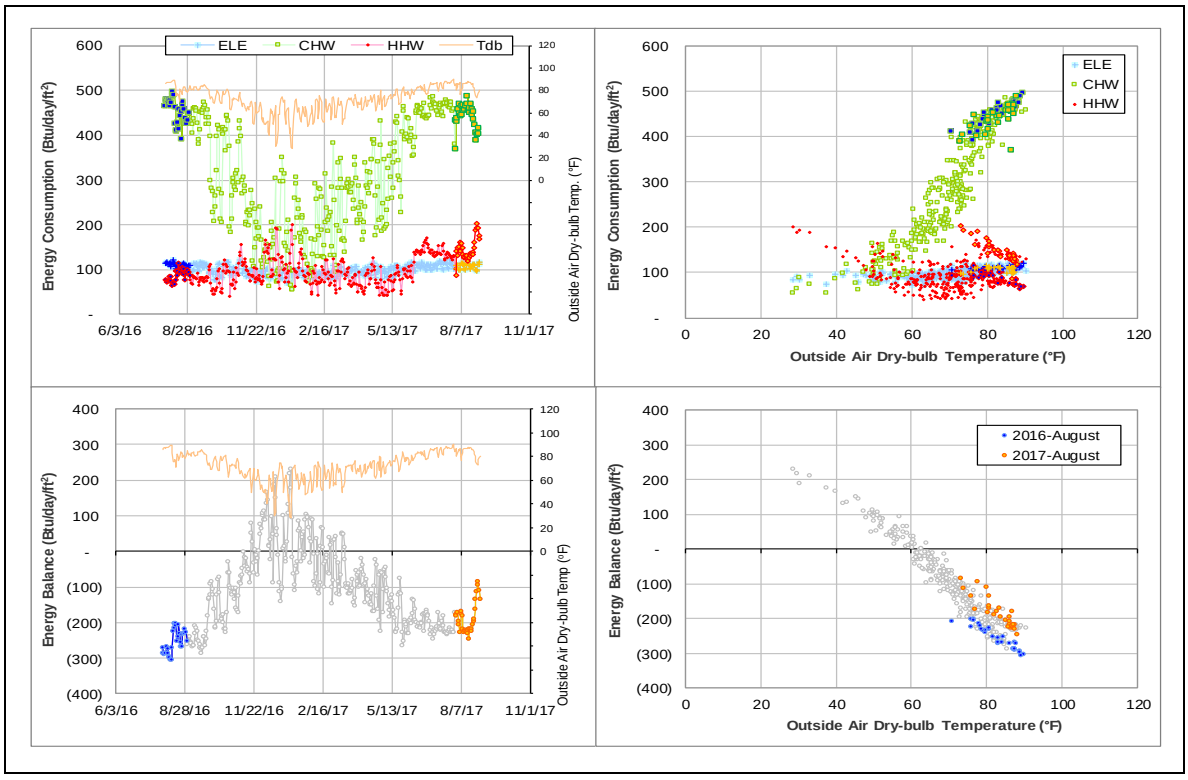
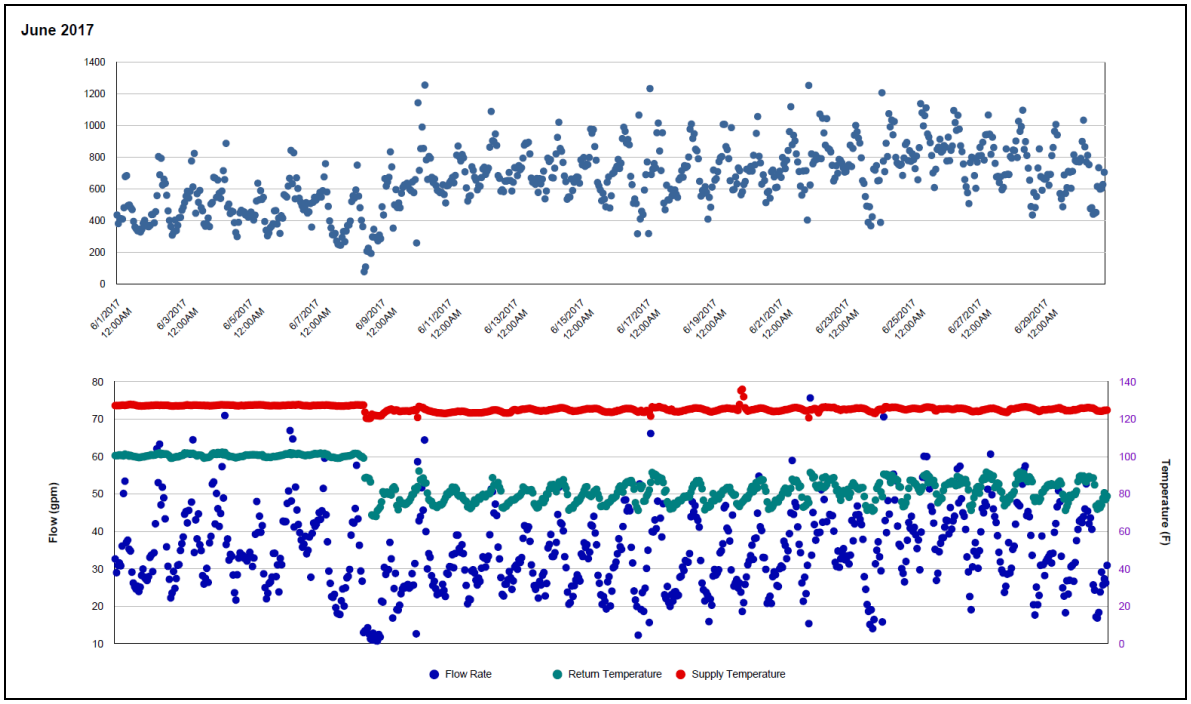
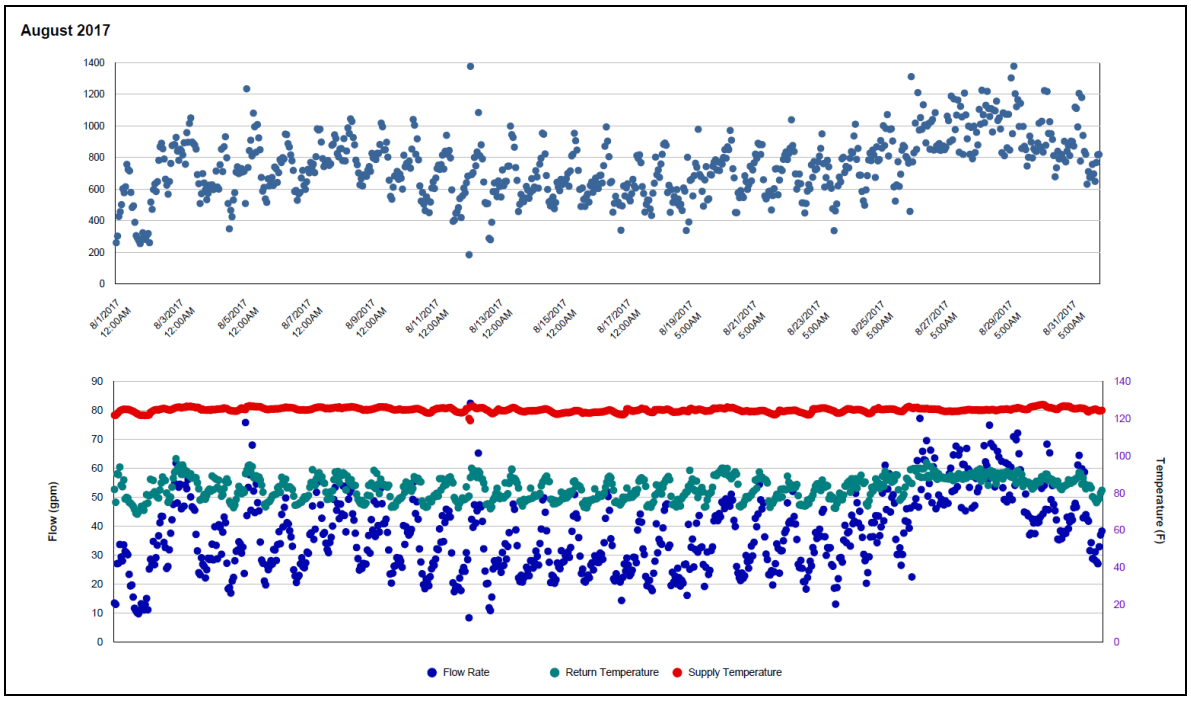
George Bush Presidential Library & Museum (TAMU Bldg #1606)

Return temperature of HHW dropped on 6/8/2017. Delta-T thus increased from about 30°F to 40 – 50°F. As there is no significant change in flow rate, HHW consumption increased significantly. The whole month is estimated by model.

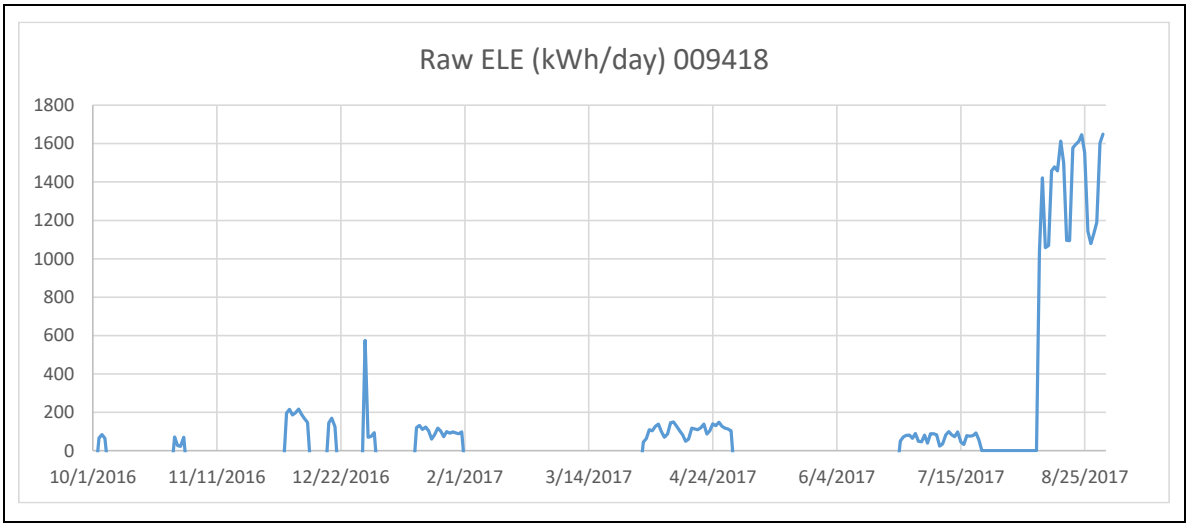
Veterinary Medicine Building 1, 2, and 3 (TAMU Bldg #1812-1813-1814)

The electricity reading of MID 009418 for #1813 has been very low since the data became available in October 2016. The new data are at a much higher level this month after the reported fix to a wire problem. A weekday/weekend variation can be seen during this short period of data. However, as MID 009418 only makes up to 8.2% of the total ELE consumption for building group 1812-1813-1814, the total energy balance for the group does not show a significant difference. The data before 8/10/2017 is estimated.

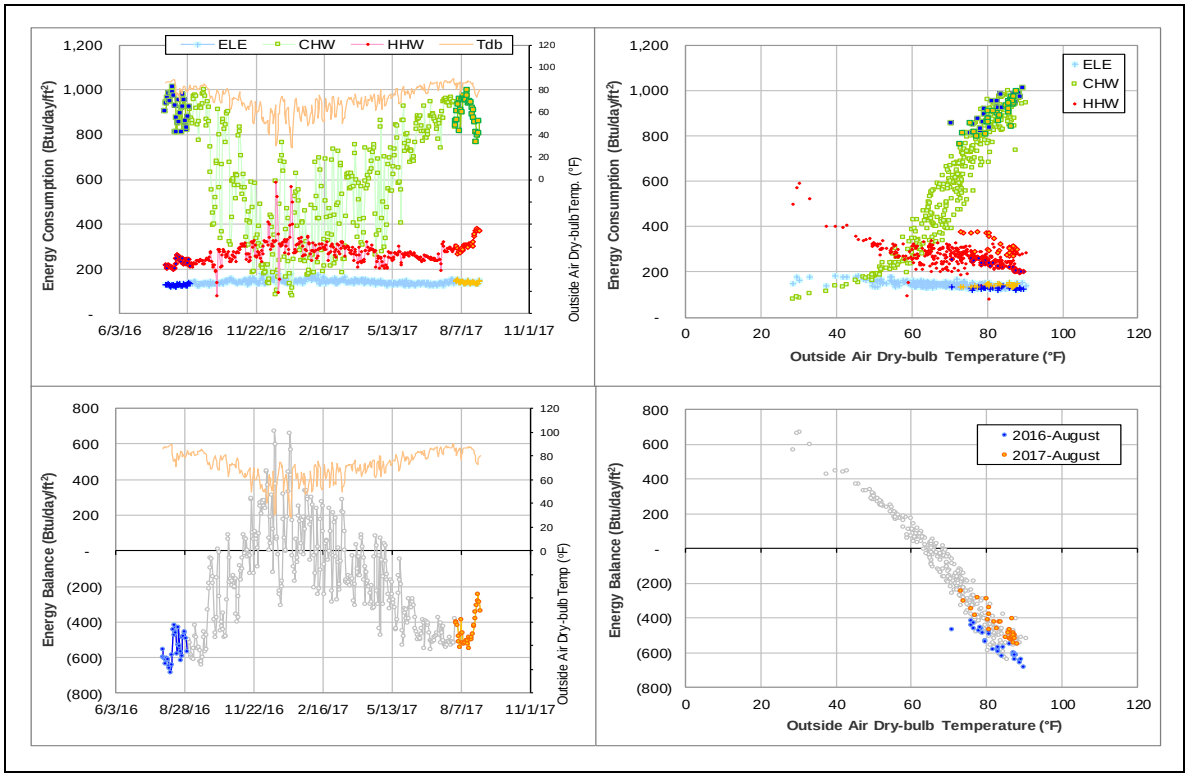
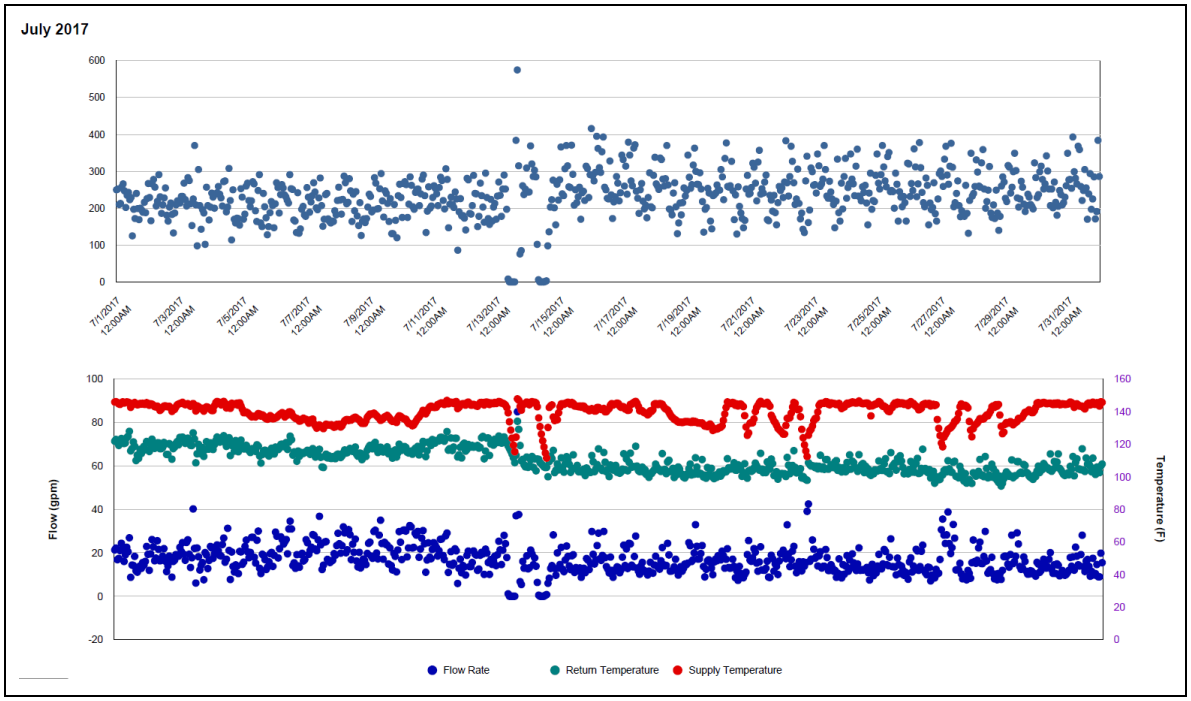
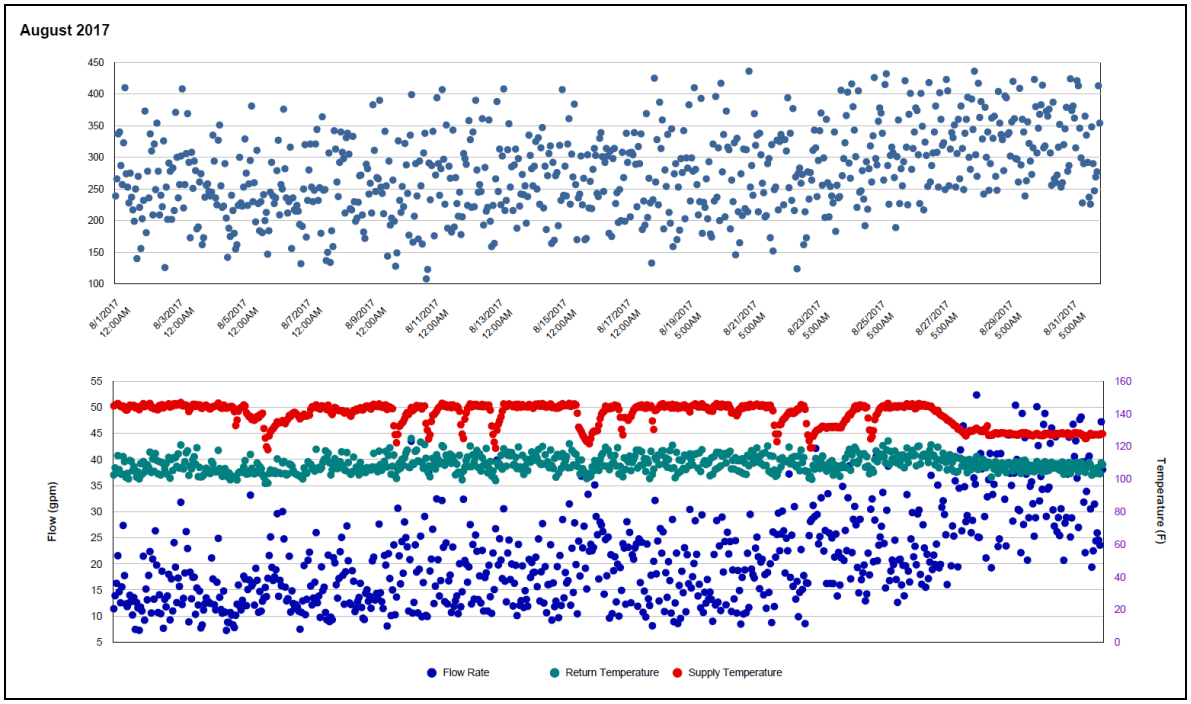
Multi-Species Research Building (TAMU Bldg #1911)

Return temperature of HHW decreased on 7/13/2017, resulting in a larger Delta-T and hence higher HHW consumption. The consumption is going further up in August 2017. This period is estimated by model.

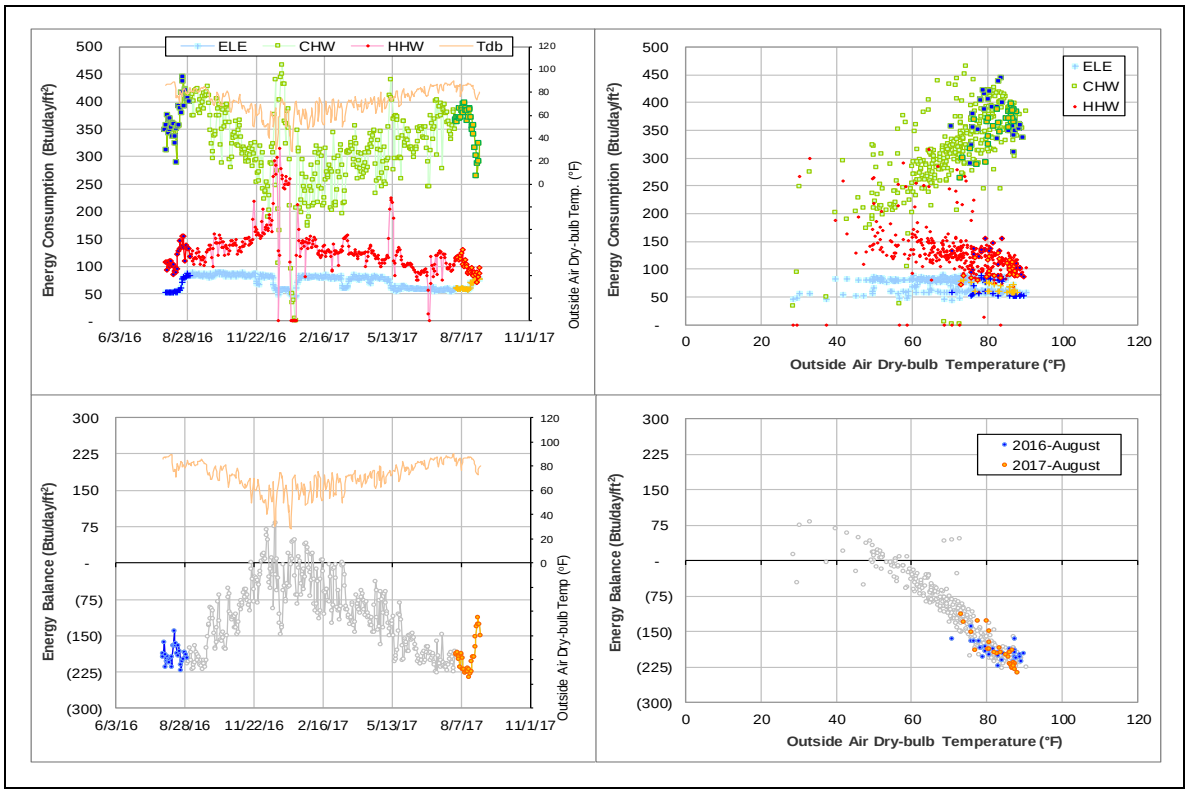
Both the CHW and HHW consumption levels have been unstable and changing frequently. The energy balance load was low with the cross-point temperature around 55°F. The low E_{BL} level suggests an imbalance of metered energy use in the building, but we are not able to determine the cause.

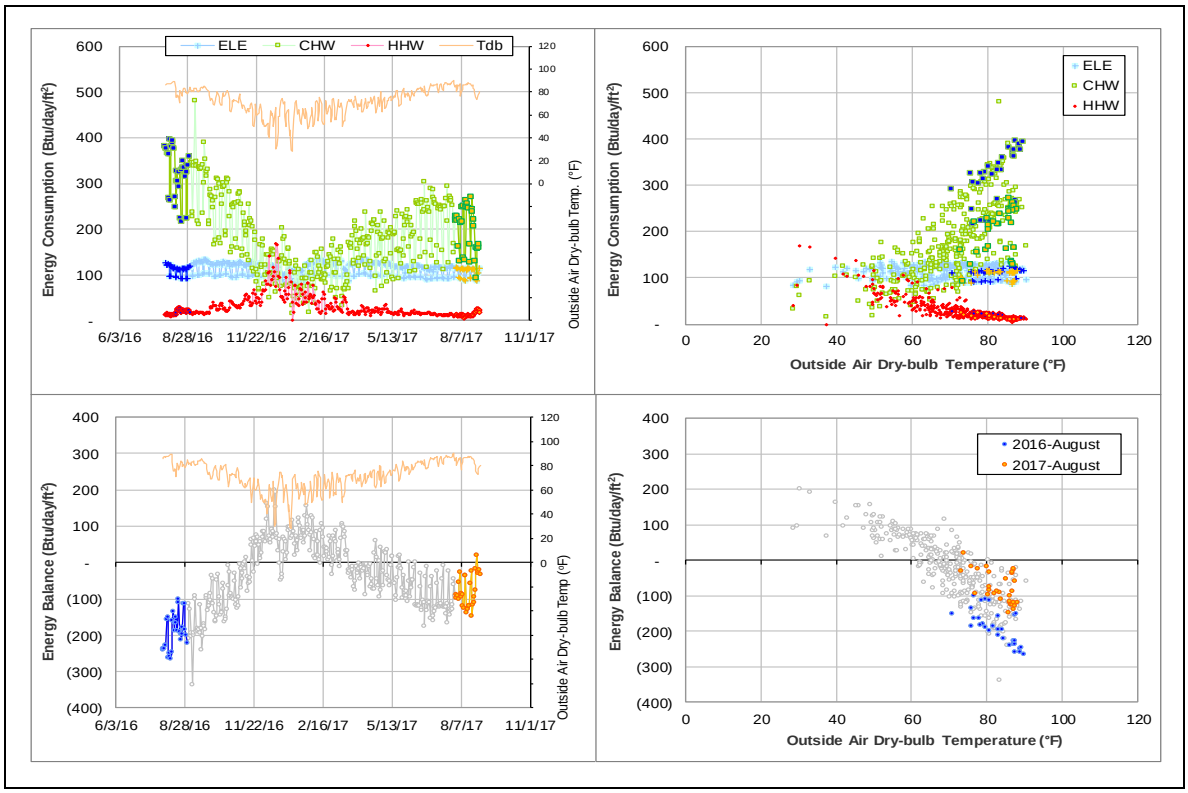
CE TTI Office & Lab Building (TAMU Bldg #325-385)

CHW consumption gradually dropped to a level that is lower than the past year by 50 – 100 Btu/day/ft^2. No obvious sensor reading behavior anomaly is observed. More data is needed to see how the pattern develops.

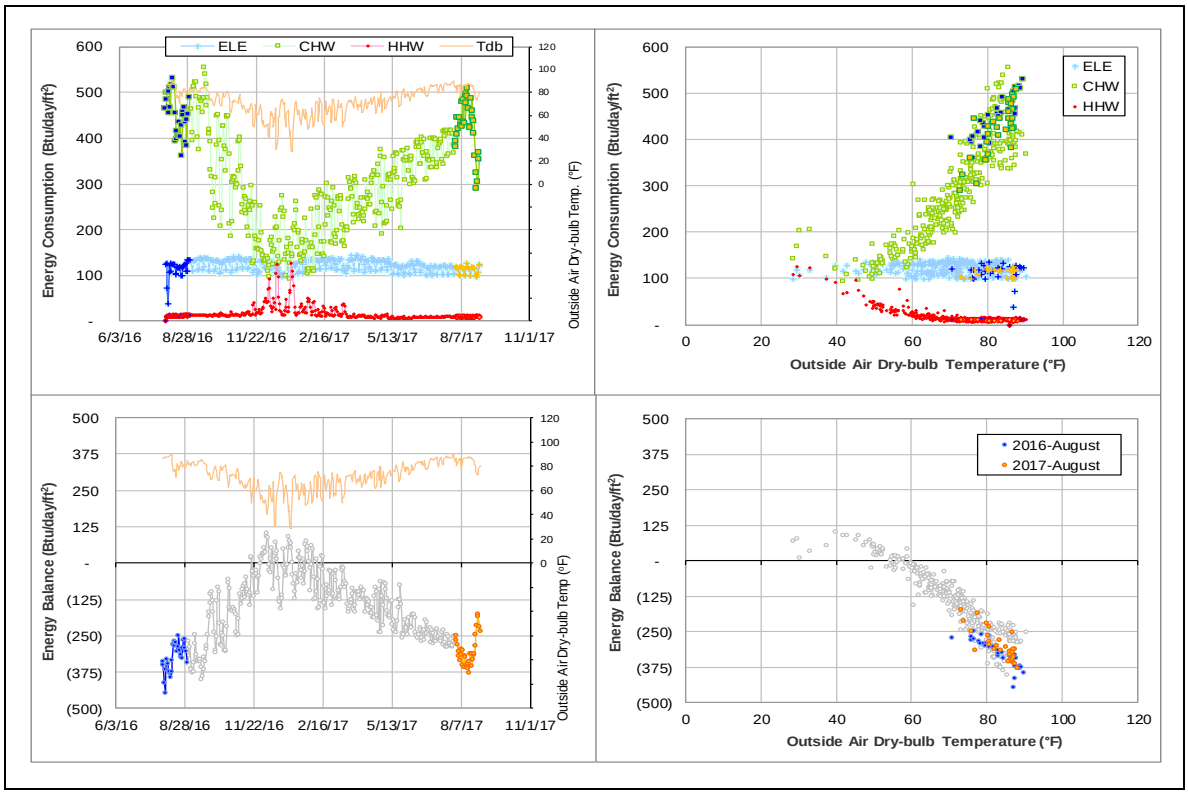
Underwood Residence Hall (TAMU Bldg #394)

The CHW and HHW consumption has decreased since the data return in September 2016. There seem to be two different patterns forming. More data is needed to see how the pattern develops.

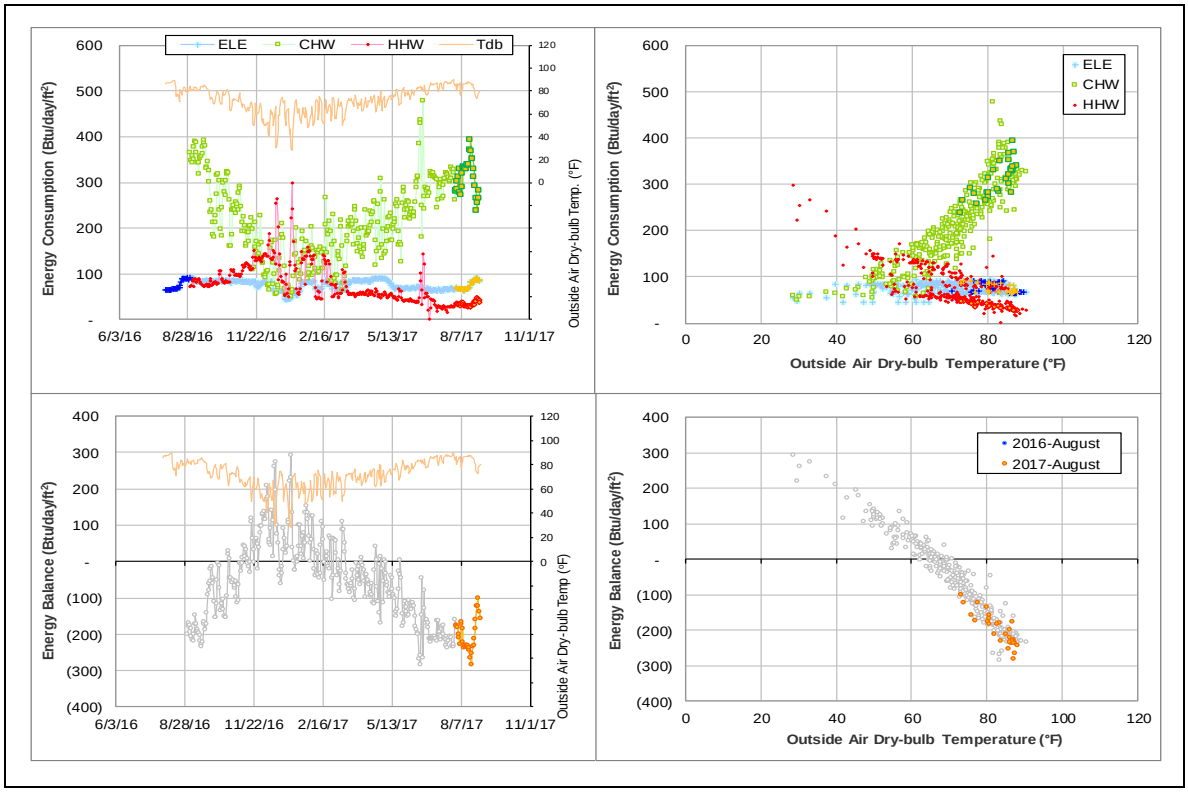
Langford Architecture Center Building A (TAMU BLDG #398)

CHW and HHW consumption has been unstable for several years. HHW flow rate can be seen going up and down between a maximum level and a very low level. The energy balance, however, is not disturbed during these fluctuations.

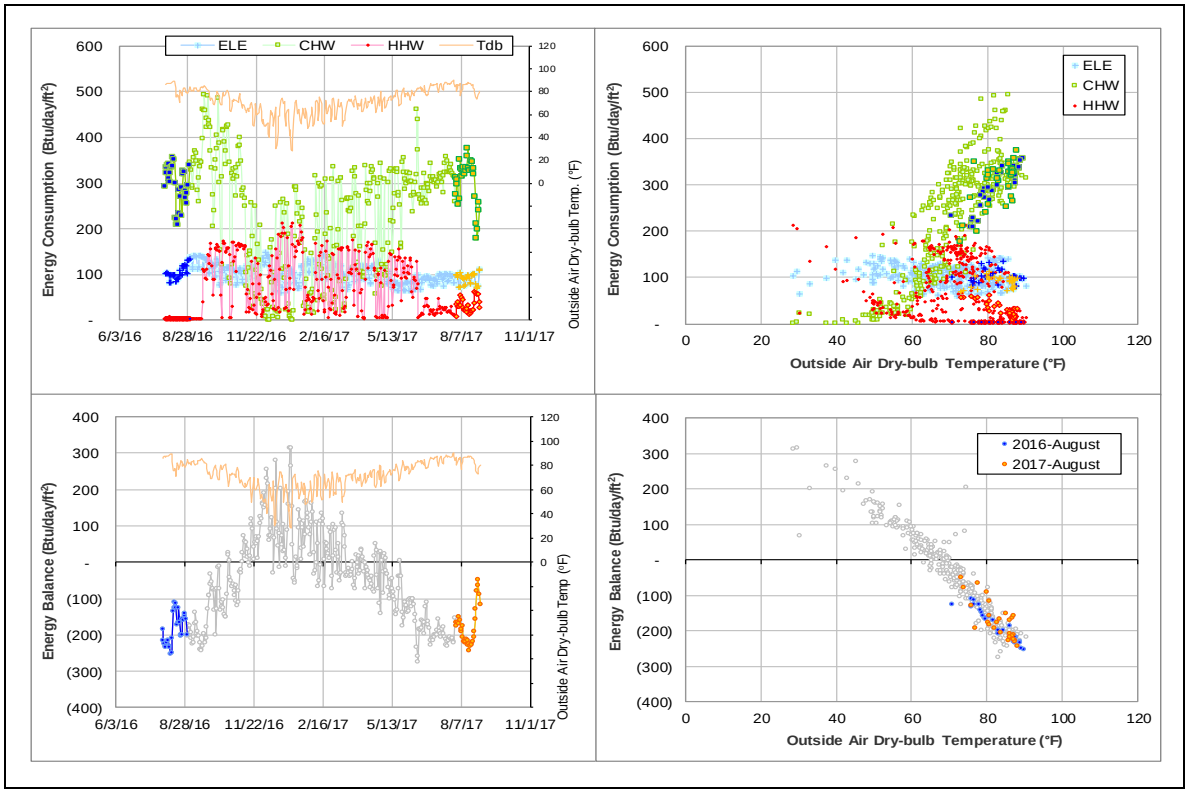
Legett Residence Hall (TAMU BLDG #419)

After the missing period from May to October 2016, ELE and HHW consumption decreased and CHW consumption increased. EB cross-point moved from 68°F to 55°F since then.
