ESL-TR-17-09-01

TAMU Project

Energy Consumption Data Quality Assurance/Quality Control Assessment Report for the

Month of August 2017

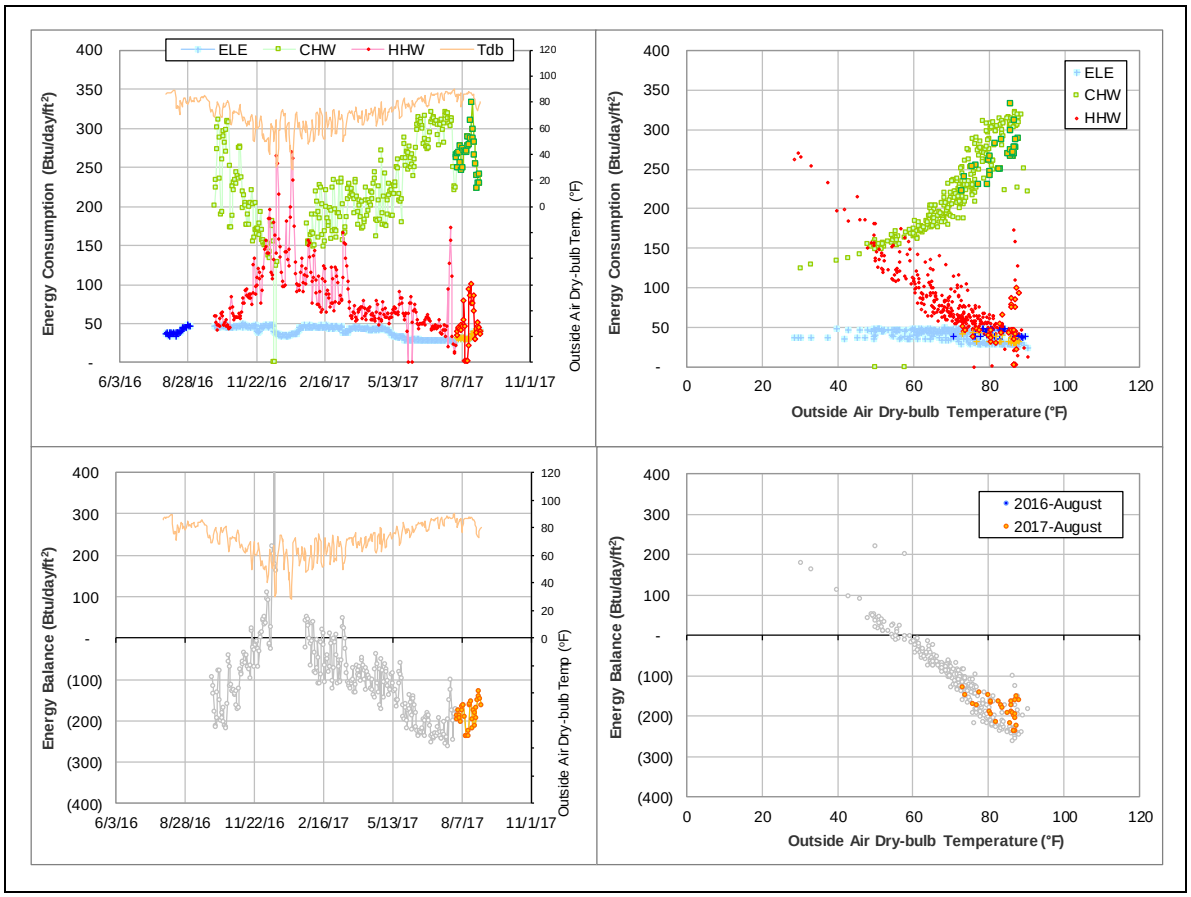
Teague Research Center (TAMU Bldg #445)

The HHW consumption pattern appears to have changed starting 8/12/2017. The pattern has started to show a weekday/weekend setback. In the higher outside temperatures, the new weekday consumption is twice as much as that of the same month last year (approximately a 20 Btu/day/ft^2 increase) and the weekend consumption level is similar to that of the same month last year.

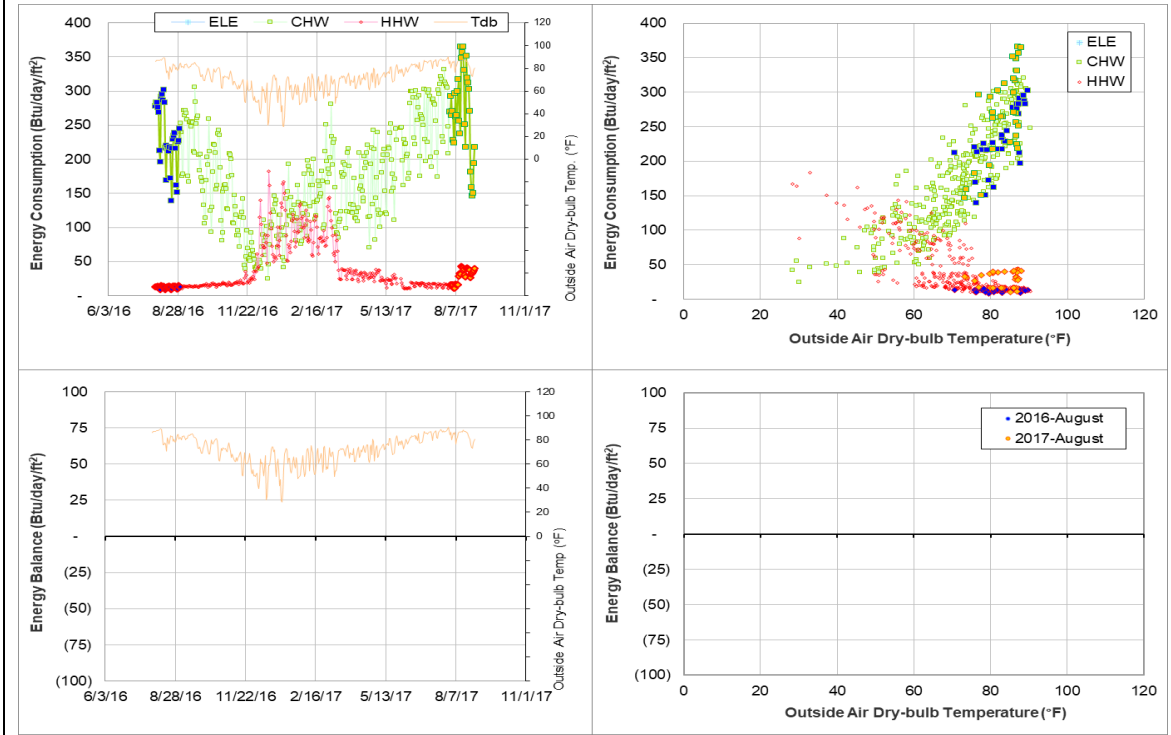
Psychology Building (TAMU Bldg #463)

The CHW consumption pattern versus ambient temperature started to scatter after ESCO implementation in 2011. The scatter started to decrease and a weekday/weekend pattern appeared in 2016. The cross-point temperature for this building over the past three years has been low with a range from 50 – 60 °F. More information is needed to determine the cause of the low temperature range.

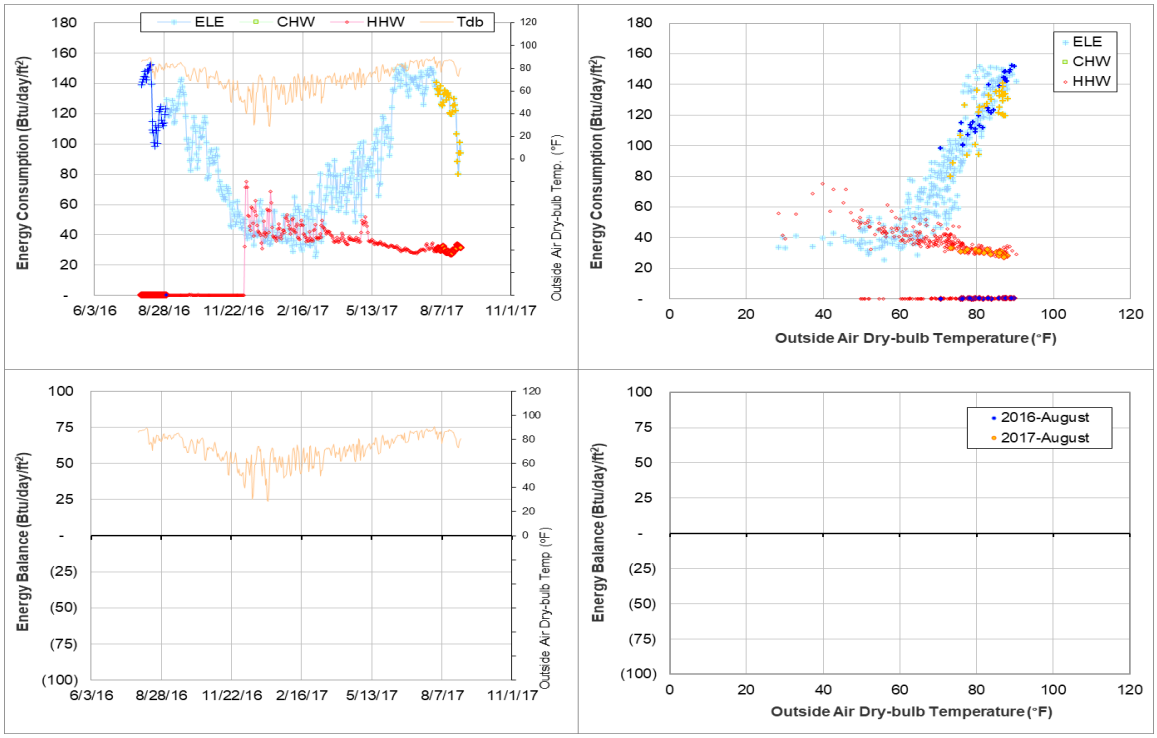
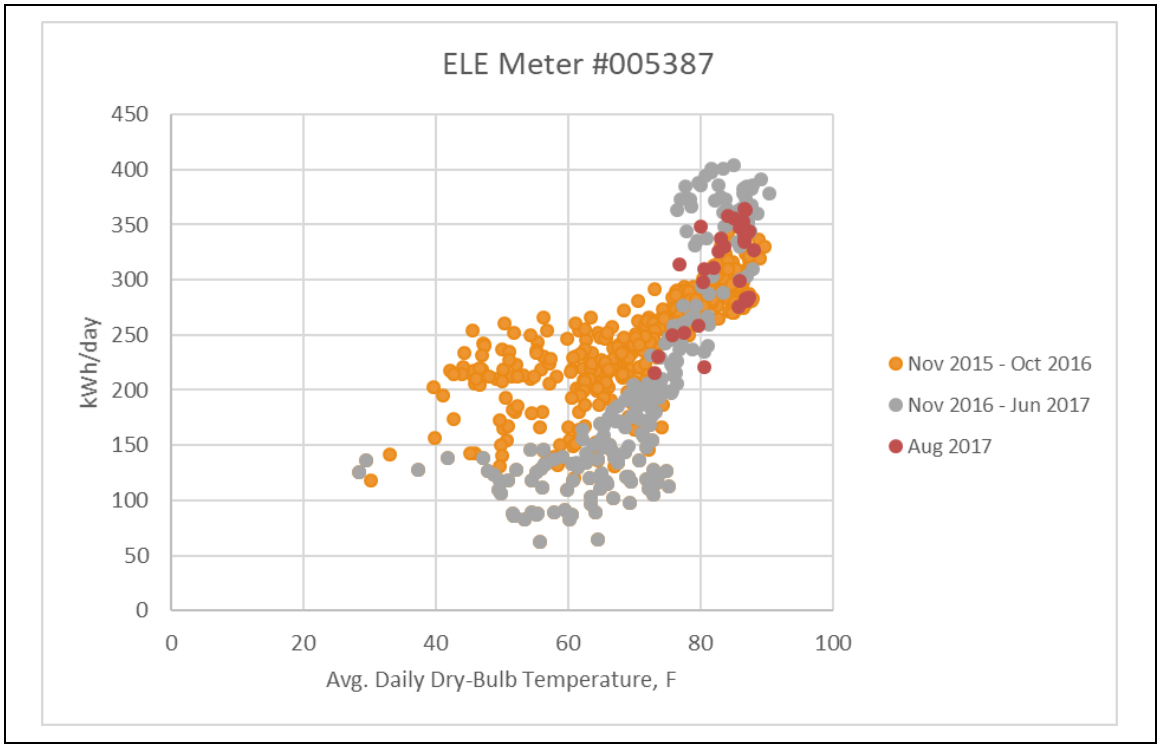
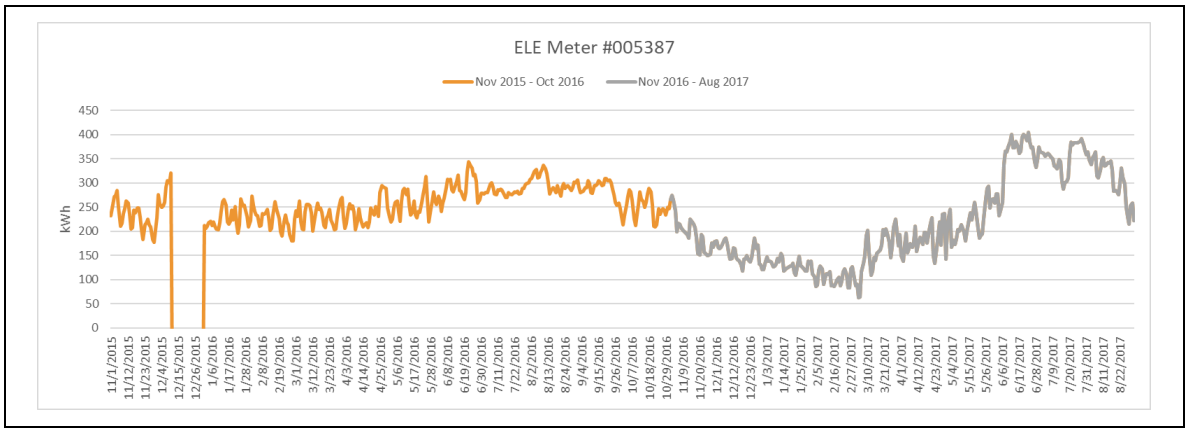
State Chemist Building (TAMU Bldg #464)

There are two ELE meters (#005837 and #005839) for this building. Starting in November 2016, the level for meter #005837 has decreased and the data appears scattered. Compared to April 2016, the average daily kWh for April 2017 has decreased by ~60 kWh. The decrease in this meter can be masked in the 13-month plot that shows the total of the two ELE meters combined. Recently, starting 6/7/2017, the average daily kWh increased by ~100 kWh compared to the consumption pattern before November 2016. Explanatory figures showing the change before and after November 2016 are provided below. Since the combined electric consumption is within the 13-month pattern this month, no estimation was made.

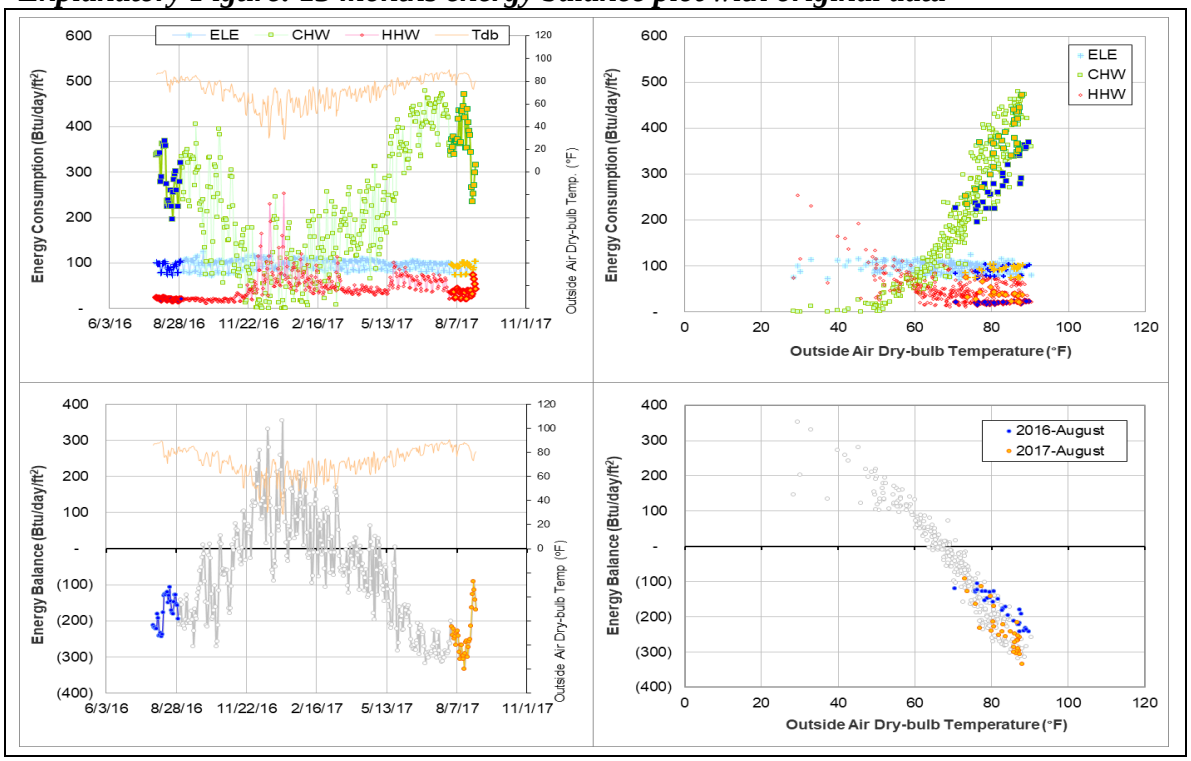
Scoates Hall (TAMU Bldg #478)

Starting in May 2017, the CHW and HHW consumption pattern has started to increase in higher outside temperatures. A more distinct HHW weekday/weekend setback has also appeared. The energy balance has also decreased by about 100 Btu/day/ft^2.

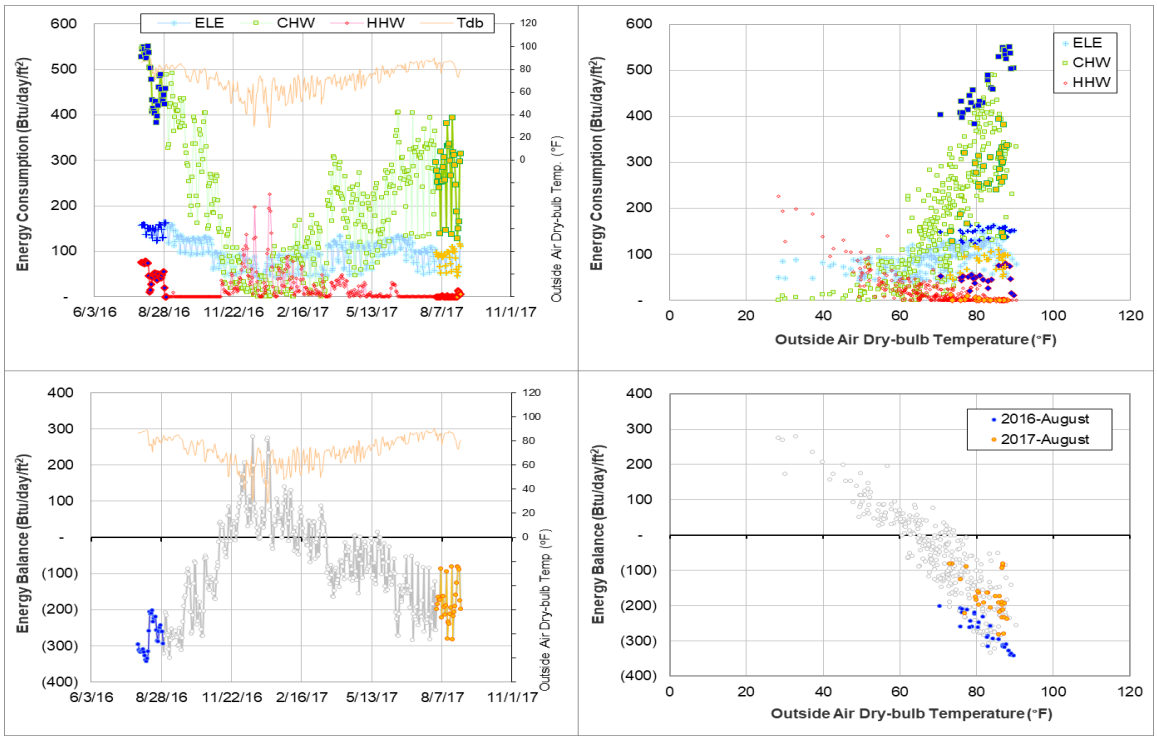
Fermier Hall (TAMU Bldg #482)

CHW and HHW of this building decreased significantly in steps since 6/24/2016. Since the energy balance plot has retained its pattern up to 12/23/2016, the drop may be due to a decrease in usage. The CHW consumption during winter break (12/23/2016 – 12/31/2016) is lower than the recent pattern but does not appear to be a meter issue. This building is in the ESCO list. The decrease in consumption level could be related to it.

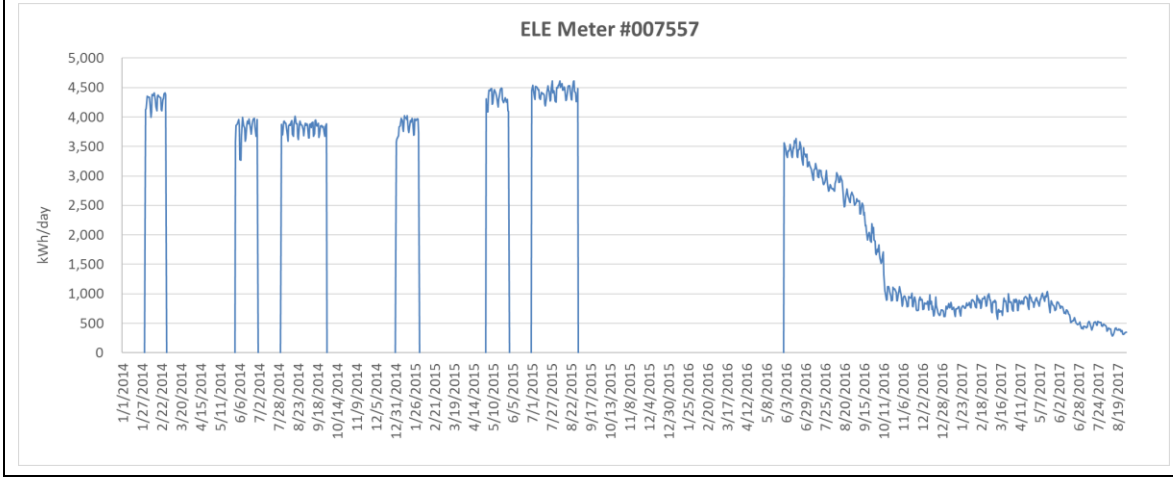
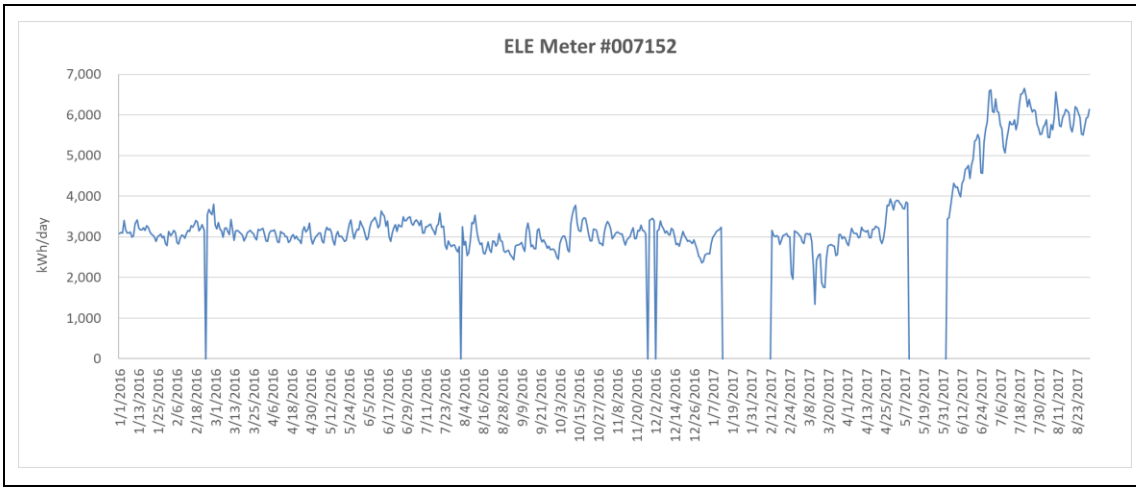
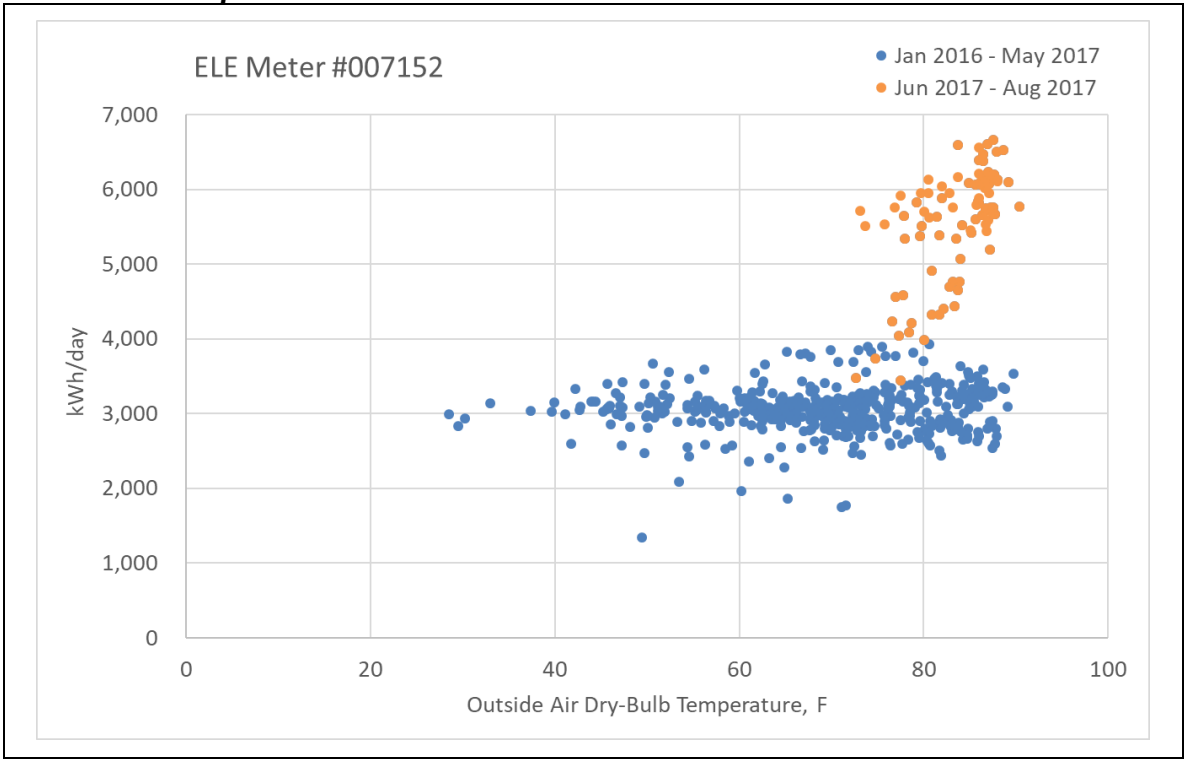
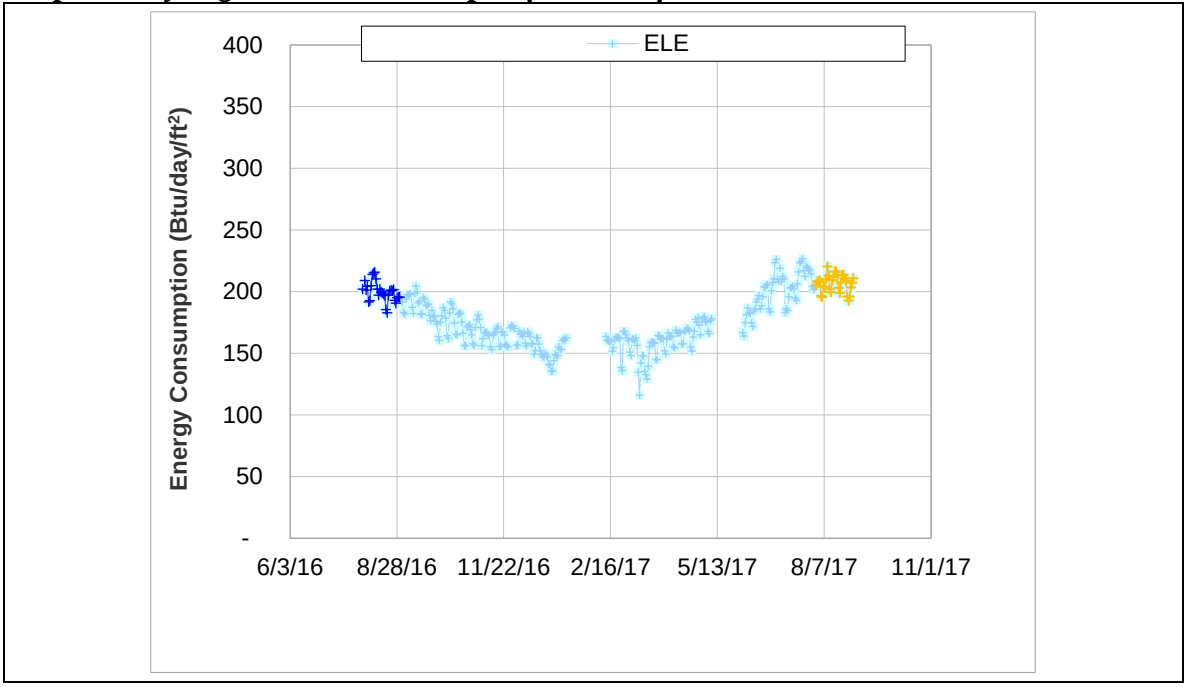
Chemistry Building (TAMU Bldg #484)

Two of the four ELE meters for this building experienced a change in energy consumption level. ELE meter #007557 consumption decreased gradually during 6/1/2016 – 8/31/2016 by over 2000 kWh/day and then decreased further on 6/17/2017 by another 500 kWh/day. ELE meter #007152 consumption gradually increased after a missing period (5/10/2017 – 6/2/2017) by about 3000 kWh/day. The total of ELE use for this building increased back to the level before renovation. We would like to know if this building completed renovation and fully occupied now and if there is any change for the area served by these two meters. More data will be needed to see if the consumption level will stable for these two meters.

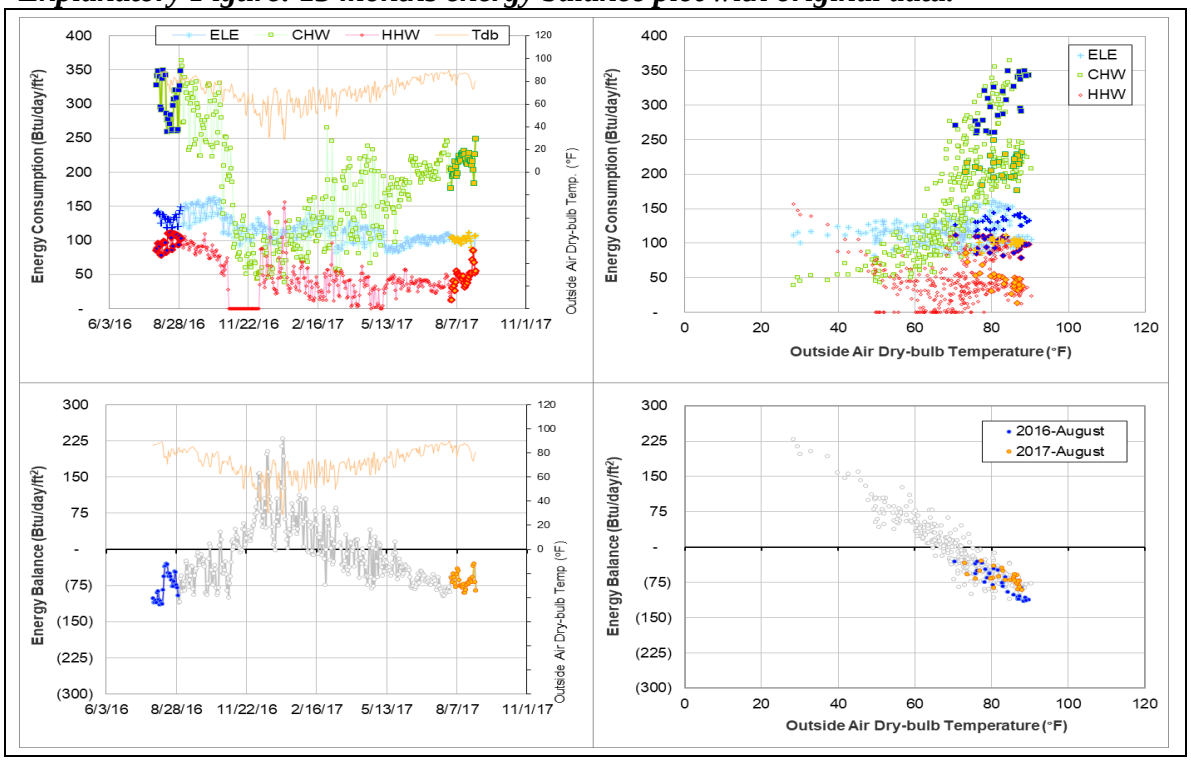
Civil Engineering Building (TAMU Bldg #492)

Starting 10/29/2016, the CHW and HHW consumption levels decreased and continued to remain low. Excluding HHW meter issue from 10/29/2016 – 12/7/2016 (zero flow rate and near zero delta-T), the lower consumption levels may be due to ESCO.

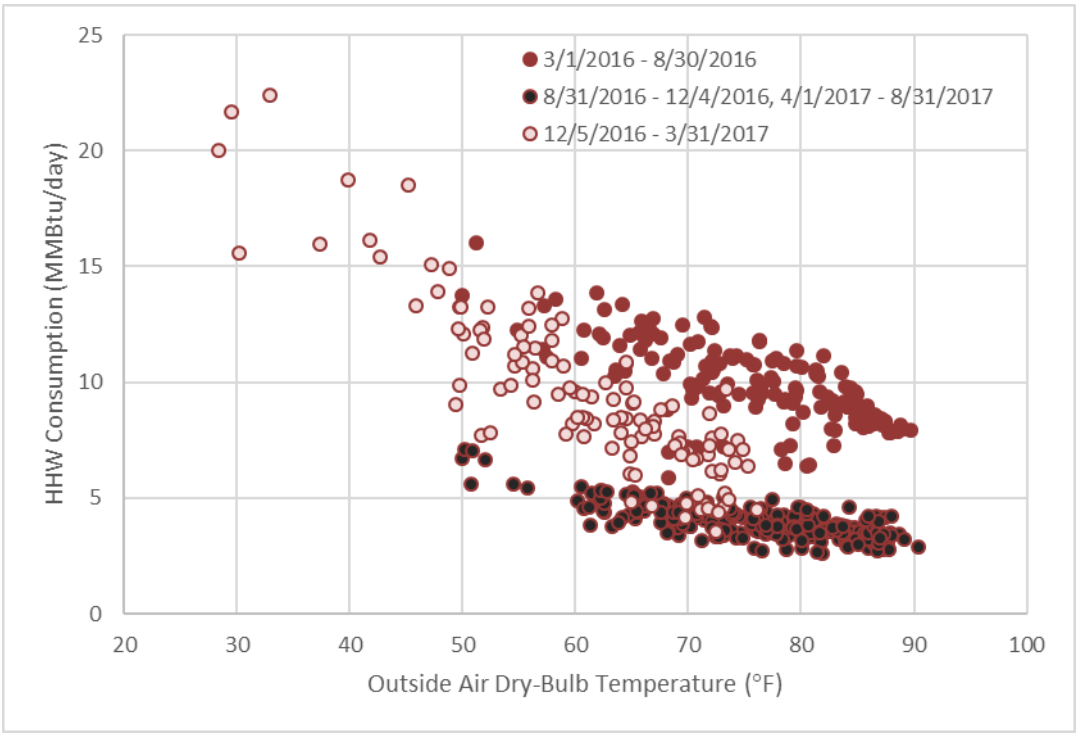
Starting 8/31/2016, the HHW consumption level decreased dropping clearly below the main pattern until 12/4/2016. The data from 12/5/2016 to 3/31/2017 appears between the main pattern and the lower pattern. However, starting April 2017 the data returned to the lower pattern. This does not appear to be a meter issue. More data is needed to see how the pattern continues.

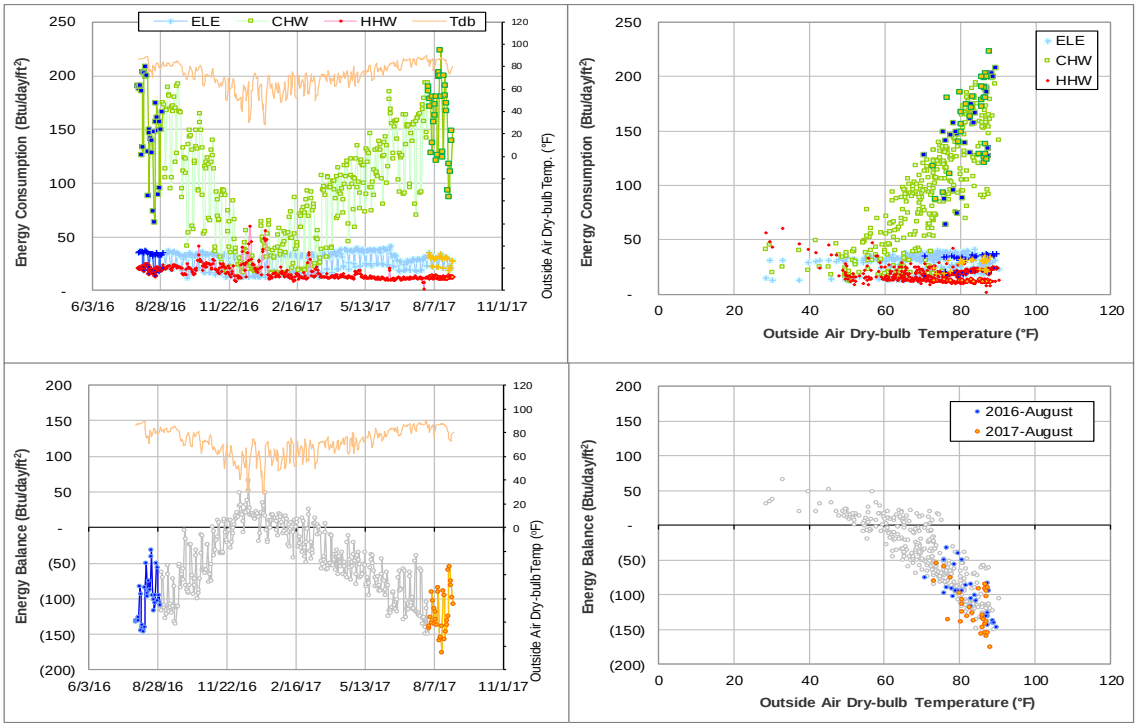
Utilities & Energy Services Central Office (TAMU Bldg #496)

The energy balance scatter is due to the consumption level changes for CHW and HHW. The cross-point temperature of the energy balance is in the range of 50 to 75°F.

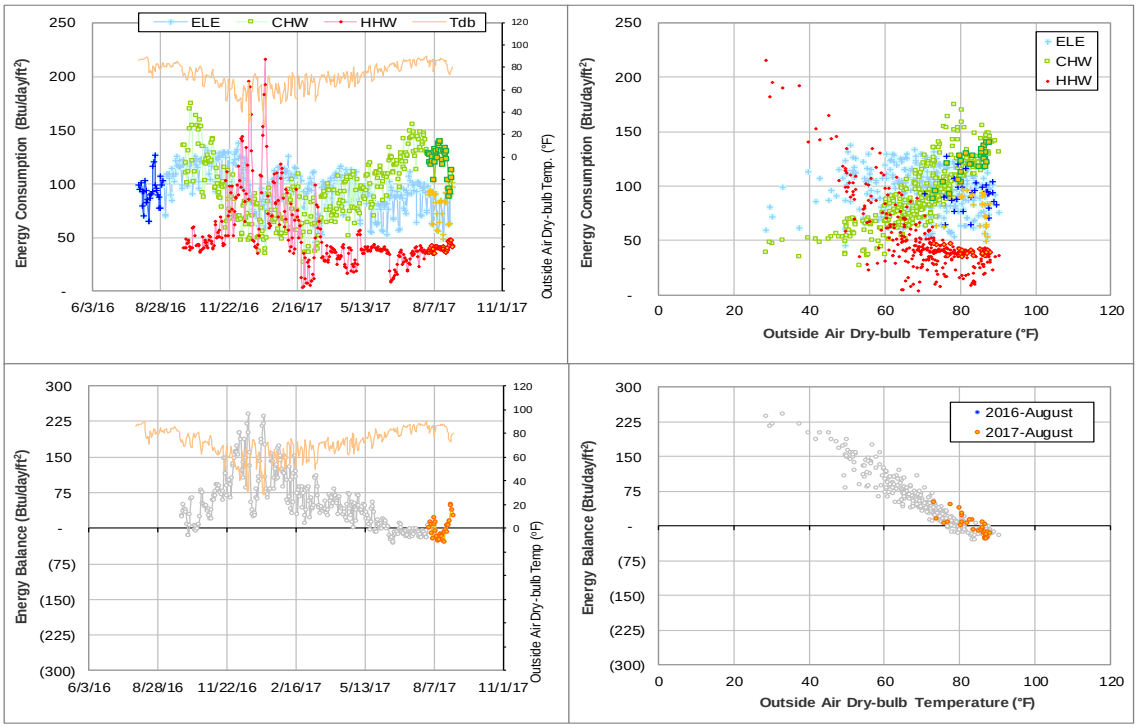
Engineering Innovation Center (TAMU Bldg # 499)

The cross-point temperature of energy balance for this building is high, around 80°F. The CHW consumption is relatively low when compared to the ELE and HHW consumption and could be the reason for the high cross-point temperature.

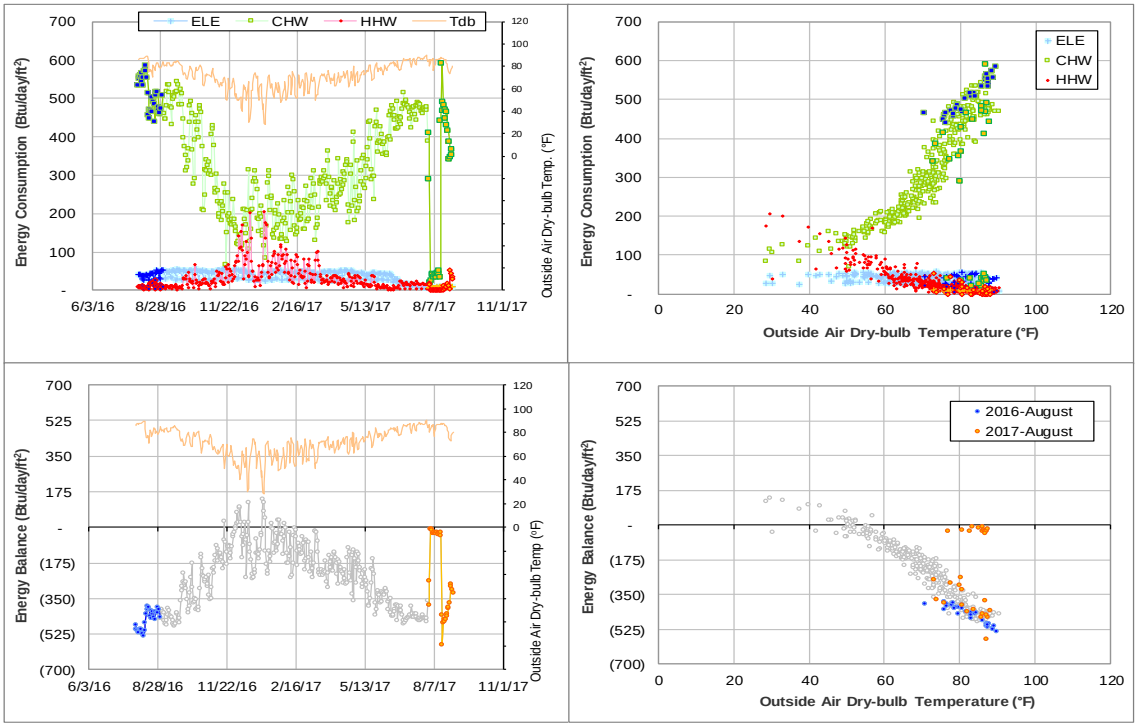
Nagle Hall (TAMU Bldg #506)

The ELE consumption is lower than 50 Btu/day/ft^2, lower than the typical level of 100 Btu/day/ft^2 for office buildings on campus. This meter might not cover the whole building or it is erroneously factored. See also II-2.

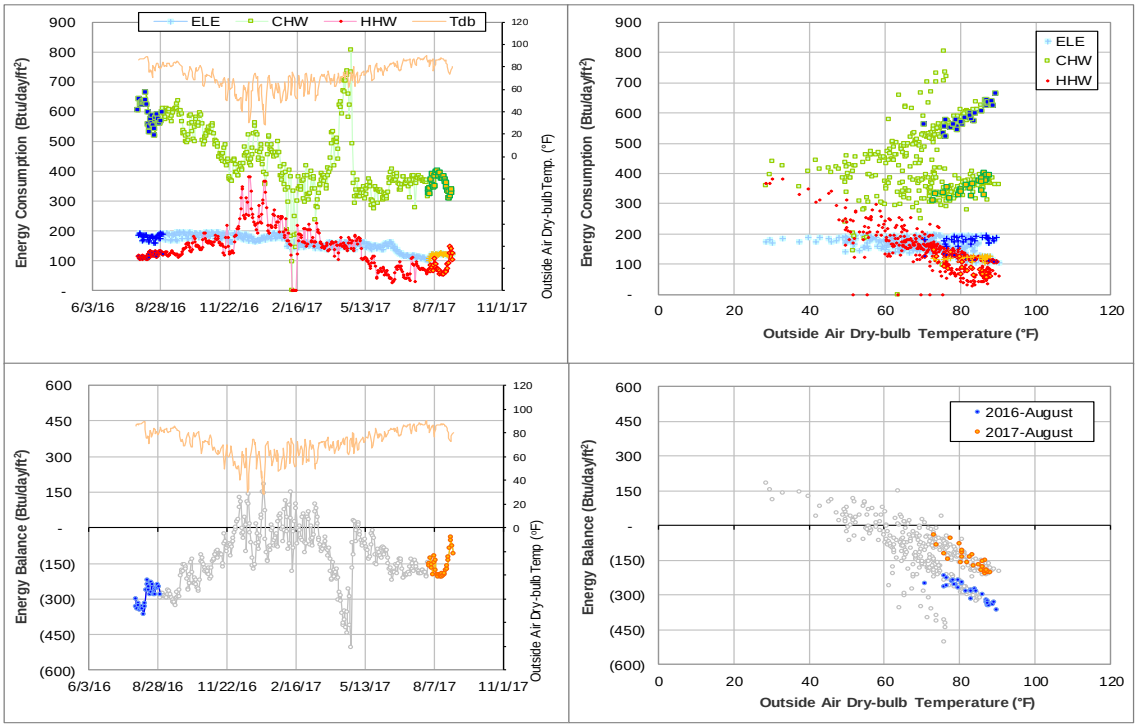
Heep Laboratory Building (TAMU Bldg #511)

The ELE consumption gradually slided down from near 200 Btu/day/ft^2 at the beginning of February 2017 to about 160 Btu/day/ft^2 at the beginning of May 2017. The consumption level further dropped to 110 – 120 Btu/day/ft^2 during summer. There is no identified cause of this change. See also II-2.

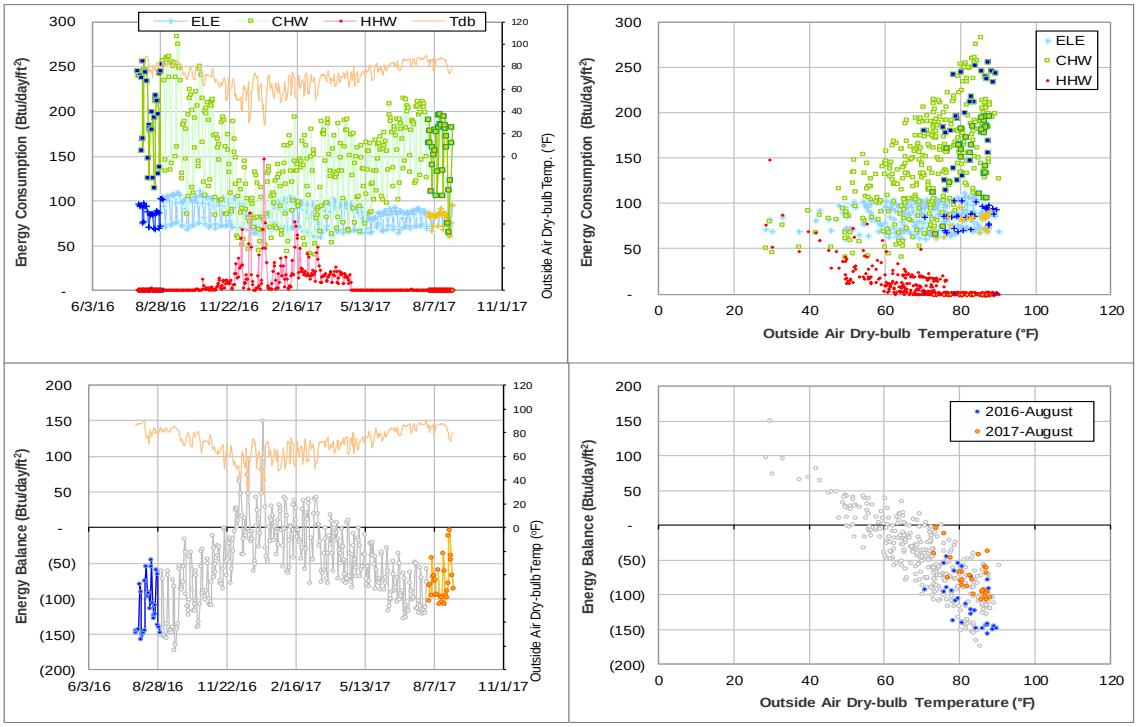
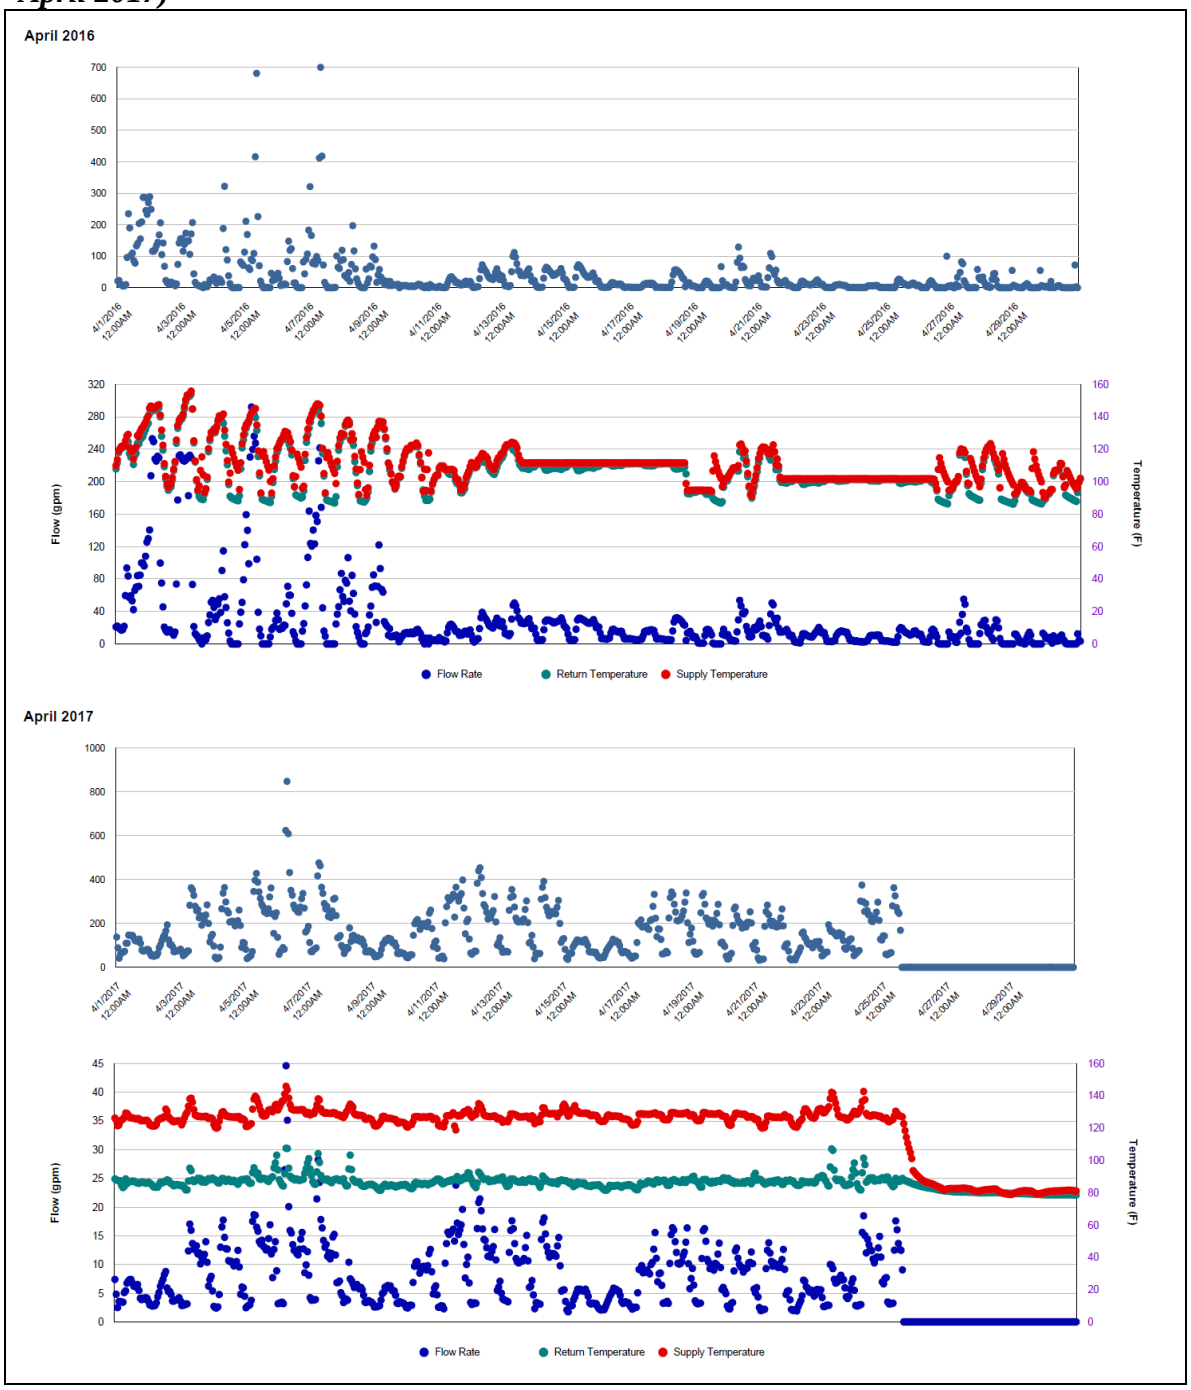
Blocker Building (TAMU Bldg #524)

The delta-T and consumption level for HHW seemed low for the past couple of years and started to change in an unstable fashion in February 2017. The explanatory figures below show the change in Delta-T of April 2016 and April 2017. HHW seemed closed off since the end of April. This increase also contributed to the higher and more reasonable cross-point of energy balance. It continues to seem closed off during the non-heating season.

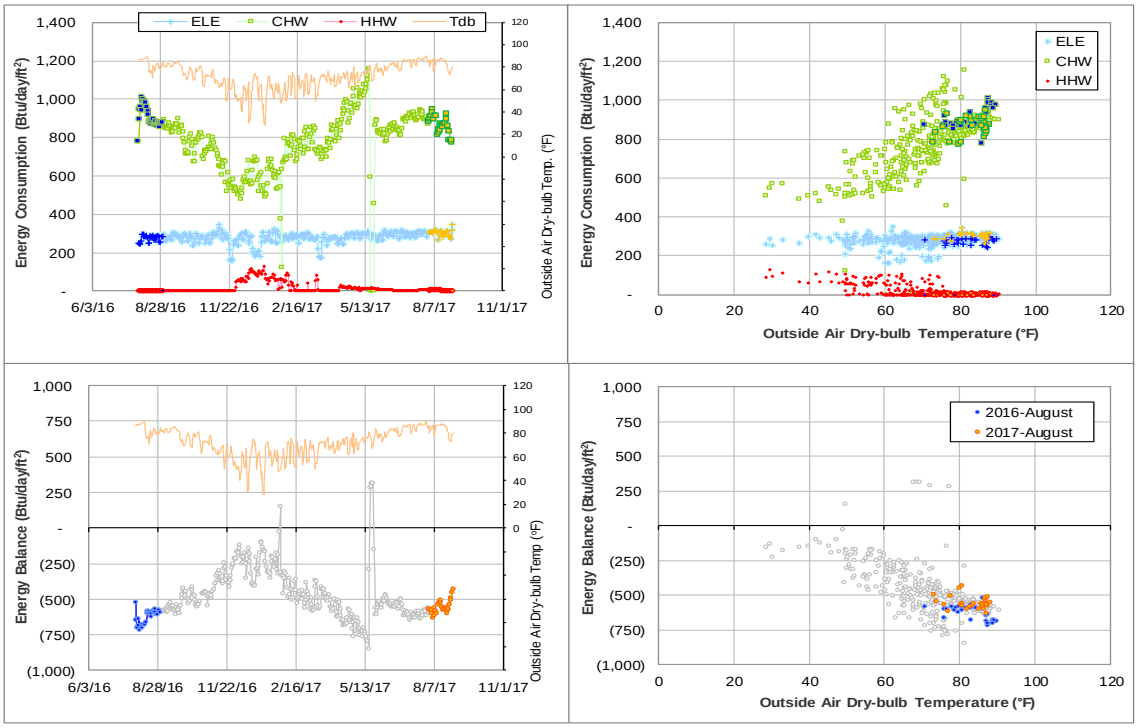
McNew Laboratory (TAMU Bldg #740)

The energy balance level has consistently been low and does not even reach a cross-point temperature. Since 2013, there has been a large decrease in HHW use. After that, HHW consumption decreased gradually year by year. Recently, the CHW has increased starting February 2017, causing the energy balance to reduce even more. More information is needed to help identify the reason causing the low energy balance for this building.

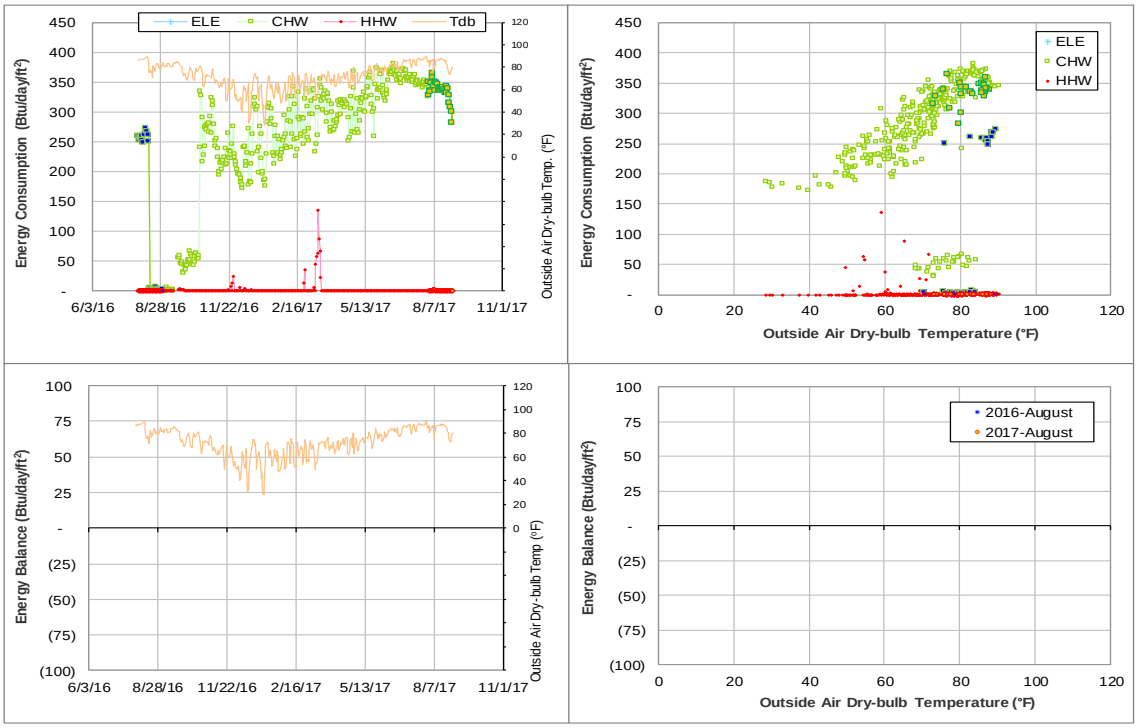
TVMC-Small Animal Building (TAMU Bldg# 880)

The daily HHW consumption pattern is zero or nearly zero for the majority of the days for years. Because the HHW consumption level appears unstable since the data became available, a valid consumption model for this meter has not been created.

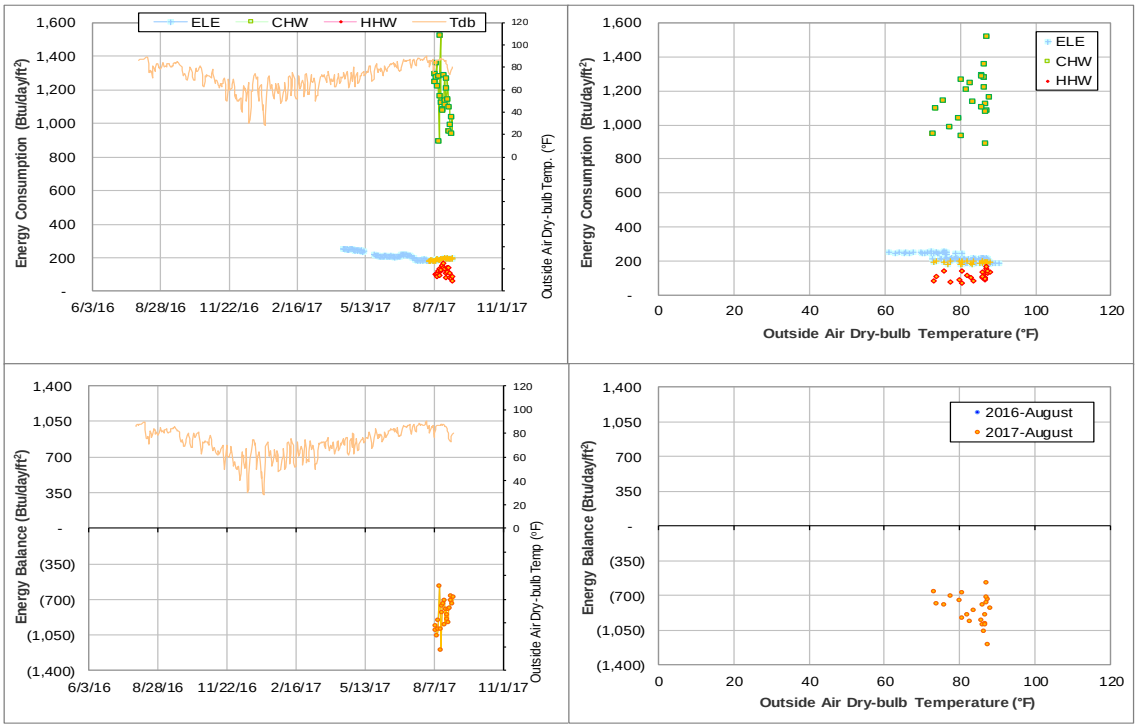
Texas Vet Med Diagnostic Lab (TAMU Bldg# 1041)

This building has six MID's in total (two for each utility type) and they had gone missing since 7/14/2016. The two ELE meters restarted taking data on 3/27/2017.

ELE MID 001466 decreased from a level ranging from 110 to 180 kWh/h to a stable 100 kWh/h level. ELE MID 001539 decreased from a level ranging from 100 to 130 kWh/h to 64 – 72 kWh/h level, and decreased further after a short missing period of 5/12/2017 – 5/24/2017 to 45 kWh/h. This building's total ELE consumption decreased by 33% in daily average value.

The continued missing of CHW and HHW consumption was estimated by first using models based on 8/1/2015 – 7/13/2016 data and then scaling down to 66%. This estimation is observed to match the new data that came available.

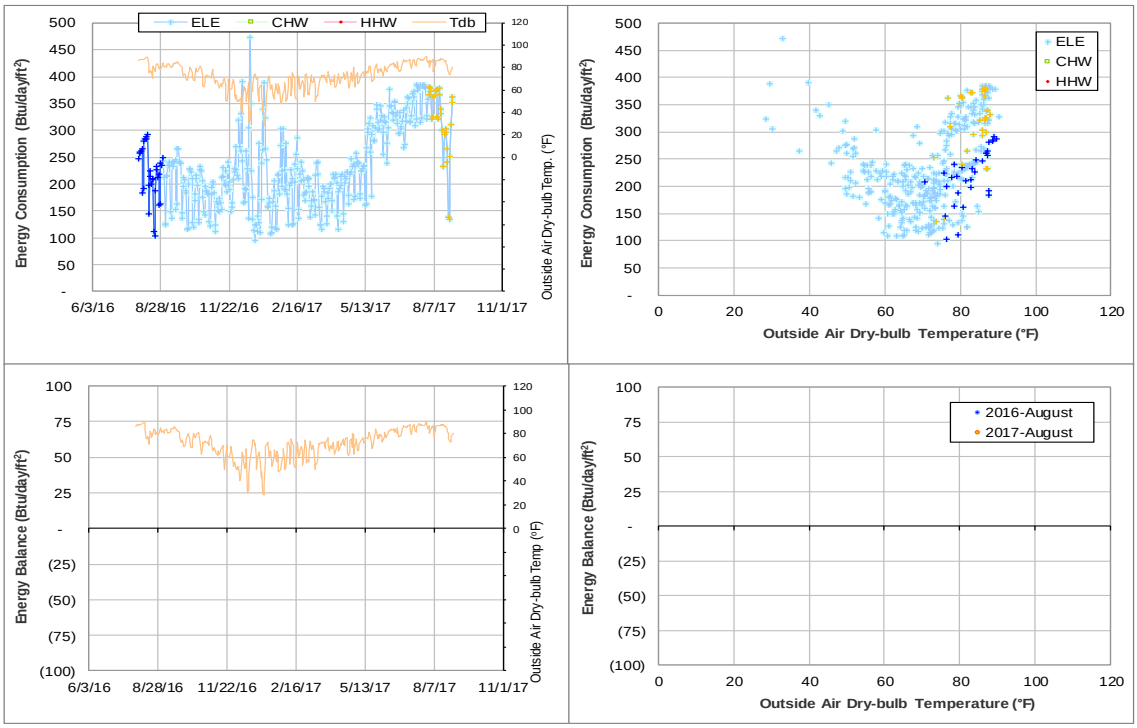
Utilities Energy Office Annex (TAMU Bldg# 1089)

The daily ELE consumption significantly increased since 5/15/2017 by more than 100 Btu/day-ft^2. There is no obvious faulty meter readings.

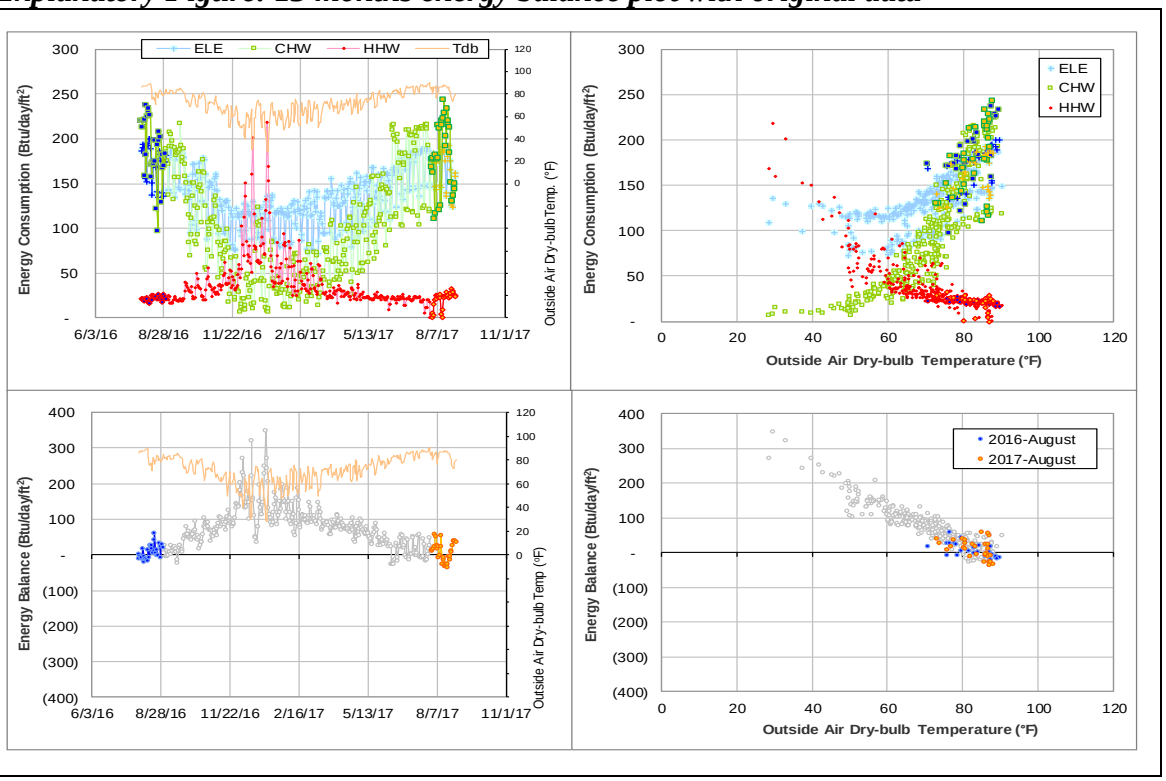
Utilities & Energy Services Business Office (TAMU Bldg #1497)

The CHW weekday/weekend pattern has been changing occasionally since 2015. The most recent change is in July 2017 when the weekend level decreased. There is no obvious faulty meter observed.
