ESL-TR-17-09-01

TAMU Project

Energy Consumption Data Quality Assurance/Quality Control Assessment Report for the

Month of August 2017

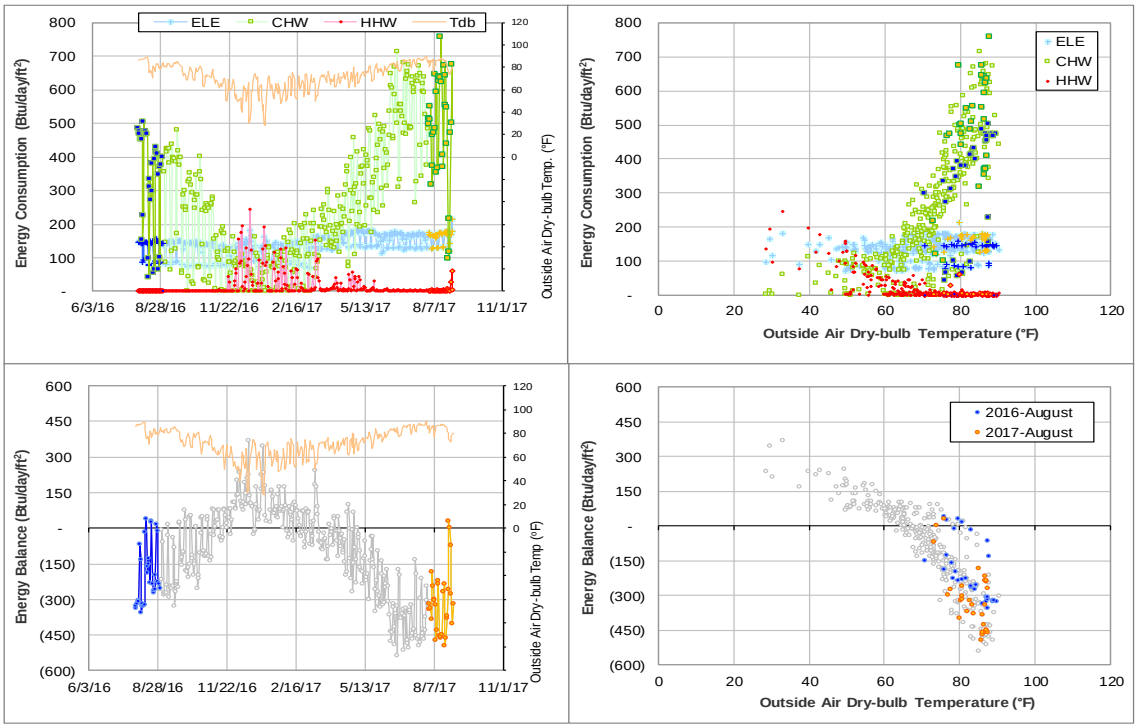
The CHW weekday/weekend pattern has been changing occasionally since 2015. The most recent change is in July 2017 when the weekend level decreased. There is no obvious faulty meter observed.

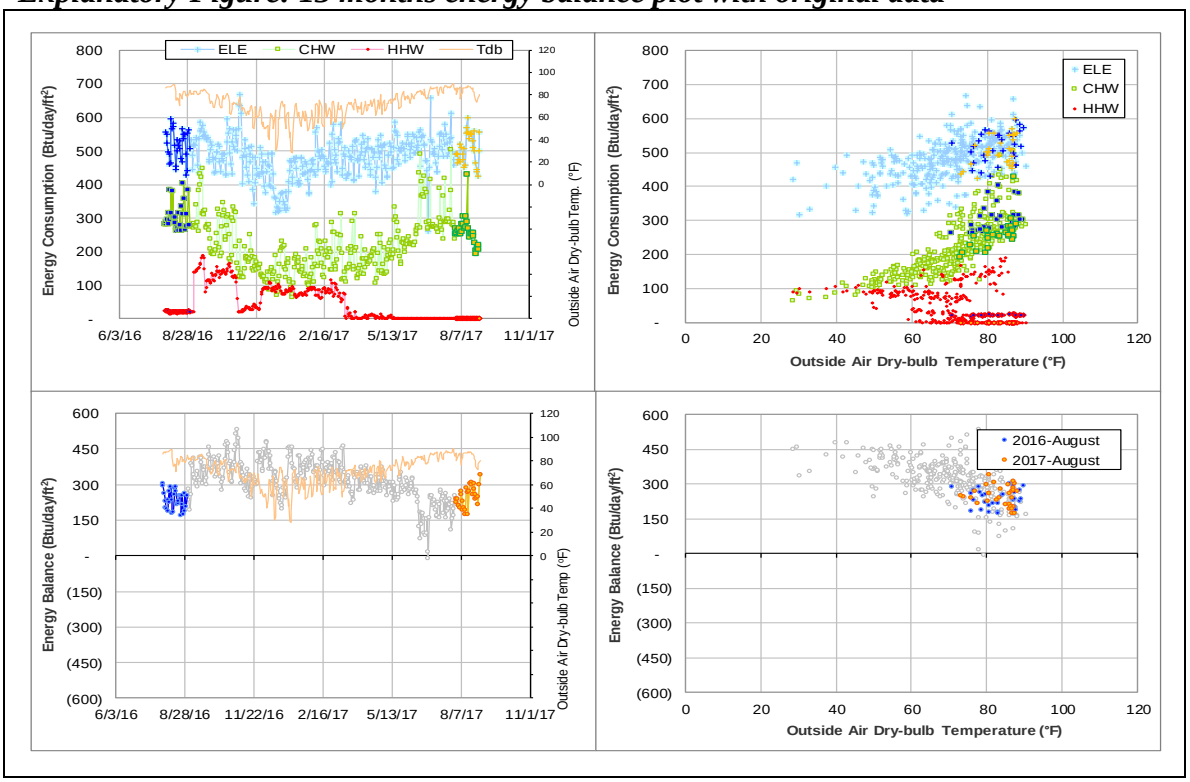
Rosenthal Meat Science & Technology Center (TAMU Bldg #1505)

HHW consumption of this building has been zero or near zero since 3/15/2017. Its hourly flow readings are near zero (less than 0.0060 gpm) and its supply and return temperature readings are close to room temperature. It is suspected to be a close-off but this did not occur in the previous year.

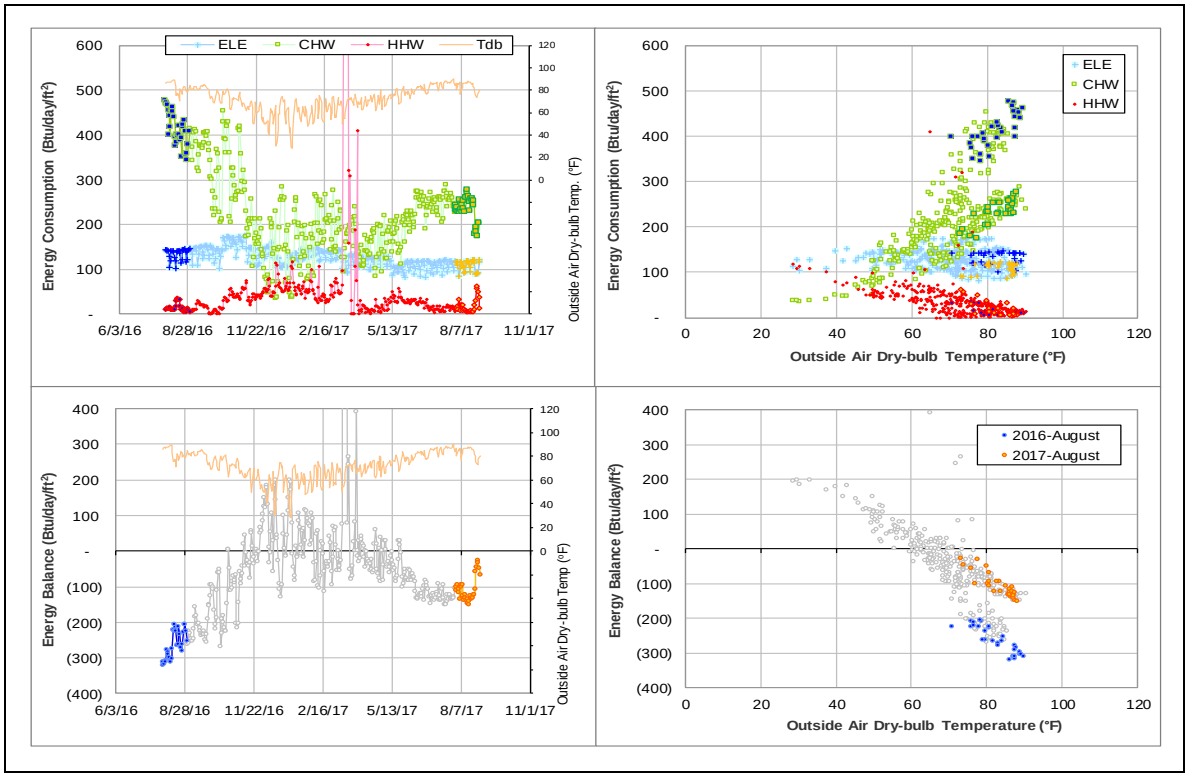
Medical Sciences Library (TAMU Bldg #1509)

On 3/24/2017, CHW flow rate of this building suddenly dropped from about 300 gpm to lower than 100 gpm and the return temperature increased from lower than 50°F to higher than 60°F. Both ELE and CHW consumption level decreased significantly since then.

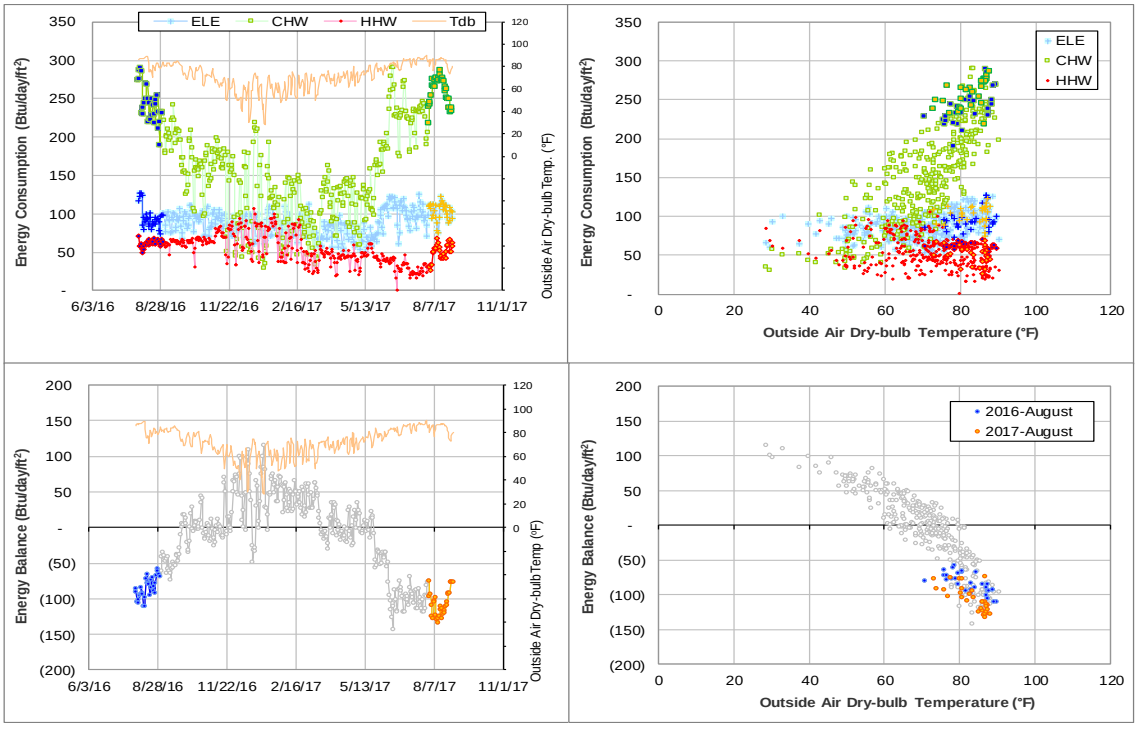
Cox-McFerrin Center for Aggie Basketball (TAMU Bldg# 1558)

The HHW pattern remains scattered and does not appear to be weather dependent.

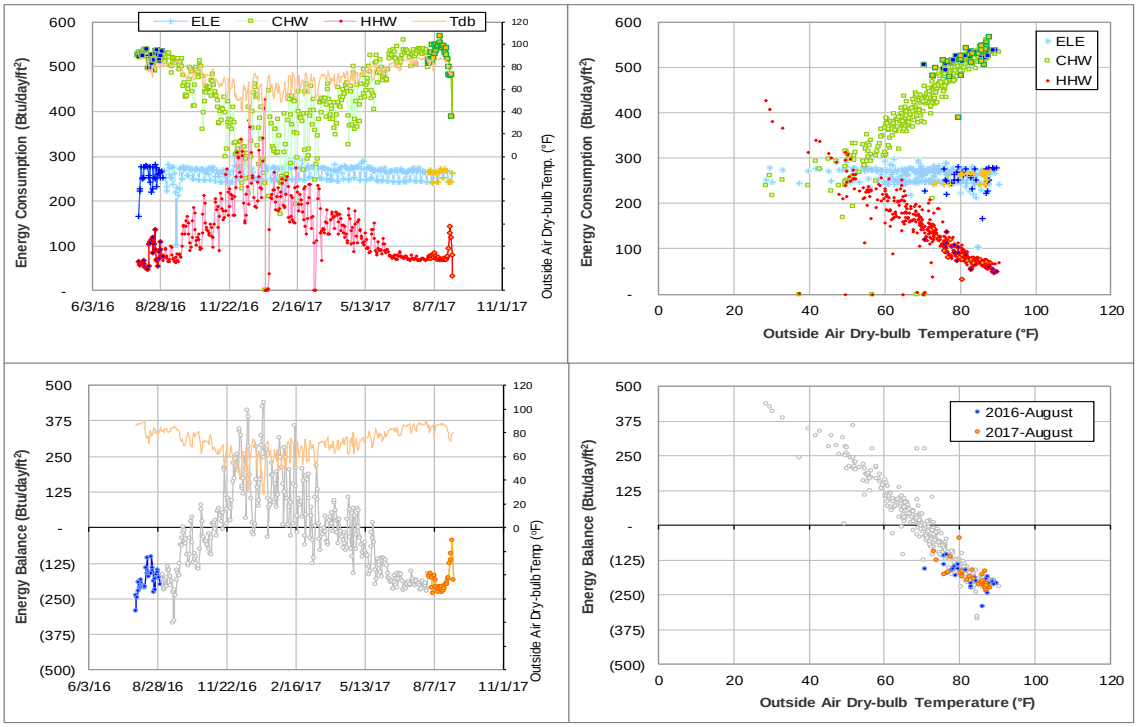
Offshore Technology Research Center (TAMU Bldg# 1604)

The electric consumption for MID 006660 has been zero for most of the time it has been available since 2/1/2015. This meter is suspected to measure consumption for a specific piece of equipment that only runs occasionally.

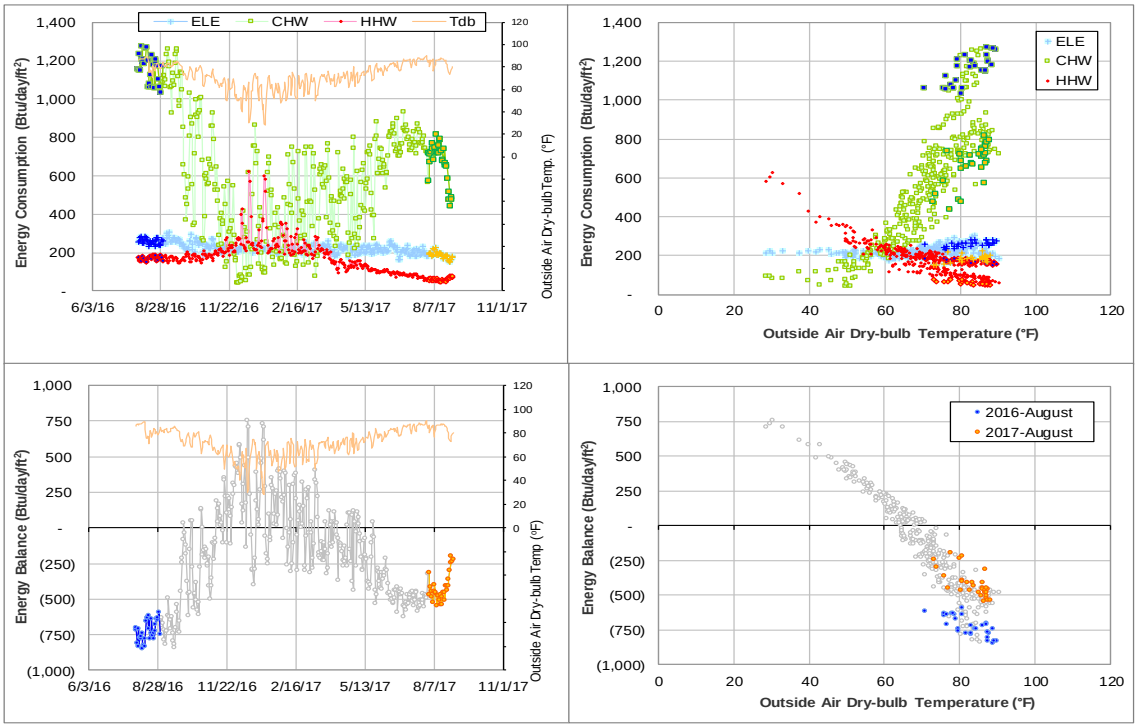
Texas A&M Institute for Preclinical Studies A (TAMU Bldg# 1904)

All ELE, CHW, and HHW consumption of this building has decreased since April 2017. Respectively, the three utilities are now about 100 Btu/day/ft^2 (35%), 400 Btu/day/ft^2 (35%), and 100 Btu/day/ft^2 (60%) lower than the same month in the previous year. However, the energy balance maintained the same pattern. Changes may have been made to this building.
