Fast and Ultimate Vibration Field Solution: From Problem Detection to Field Performance Validation

G. Cicatelli, G. Panceri, A. Scotti
Flowserve Corporation - Italy

26th International Pump Users Symposium
March 15 - 18, 2010
George R. Brown Convention Center
Houston, Texas

Description of the problem

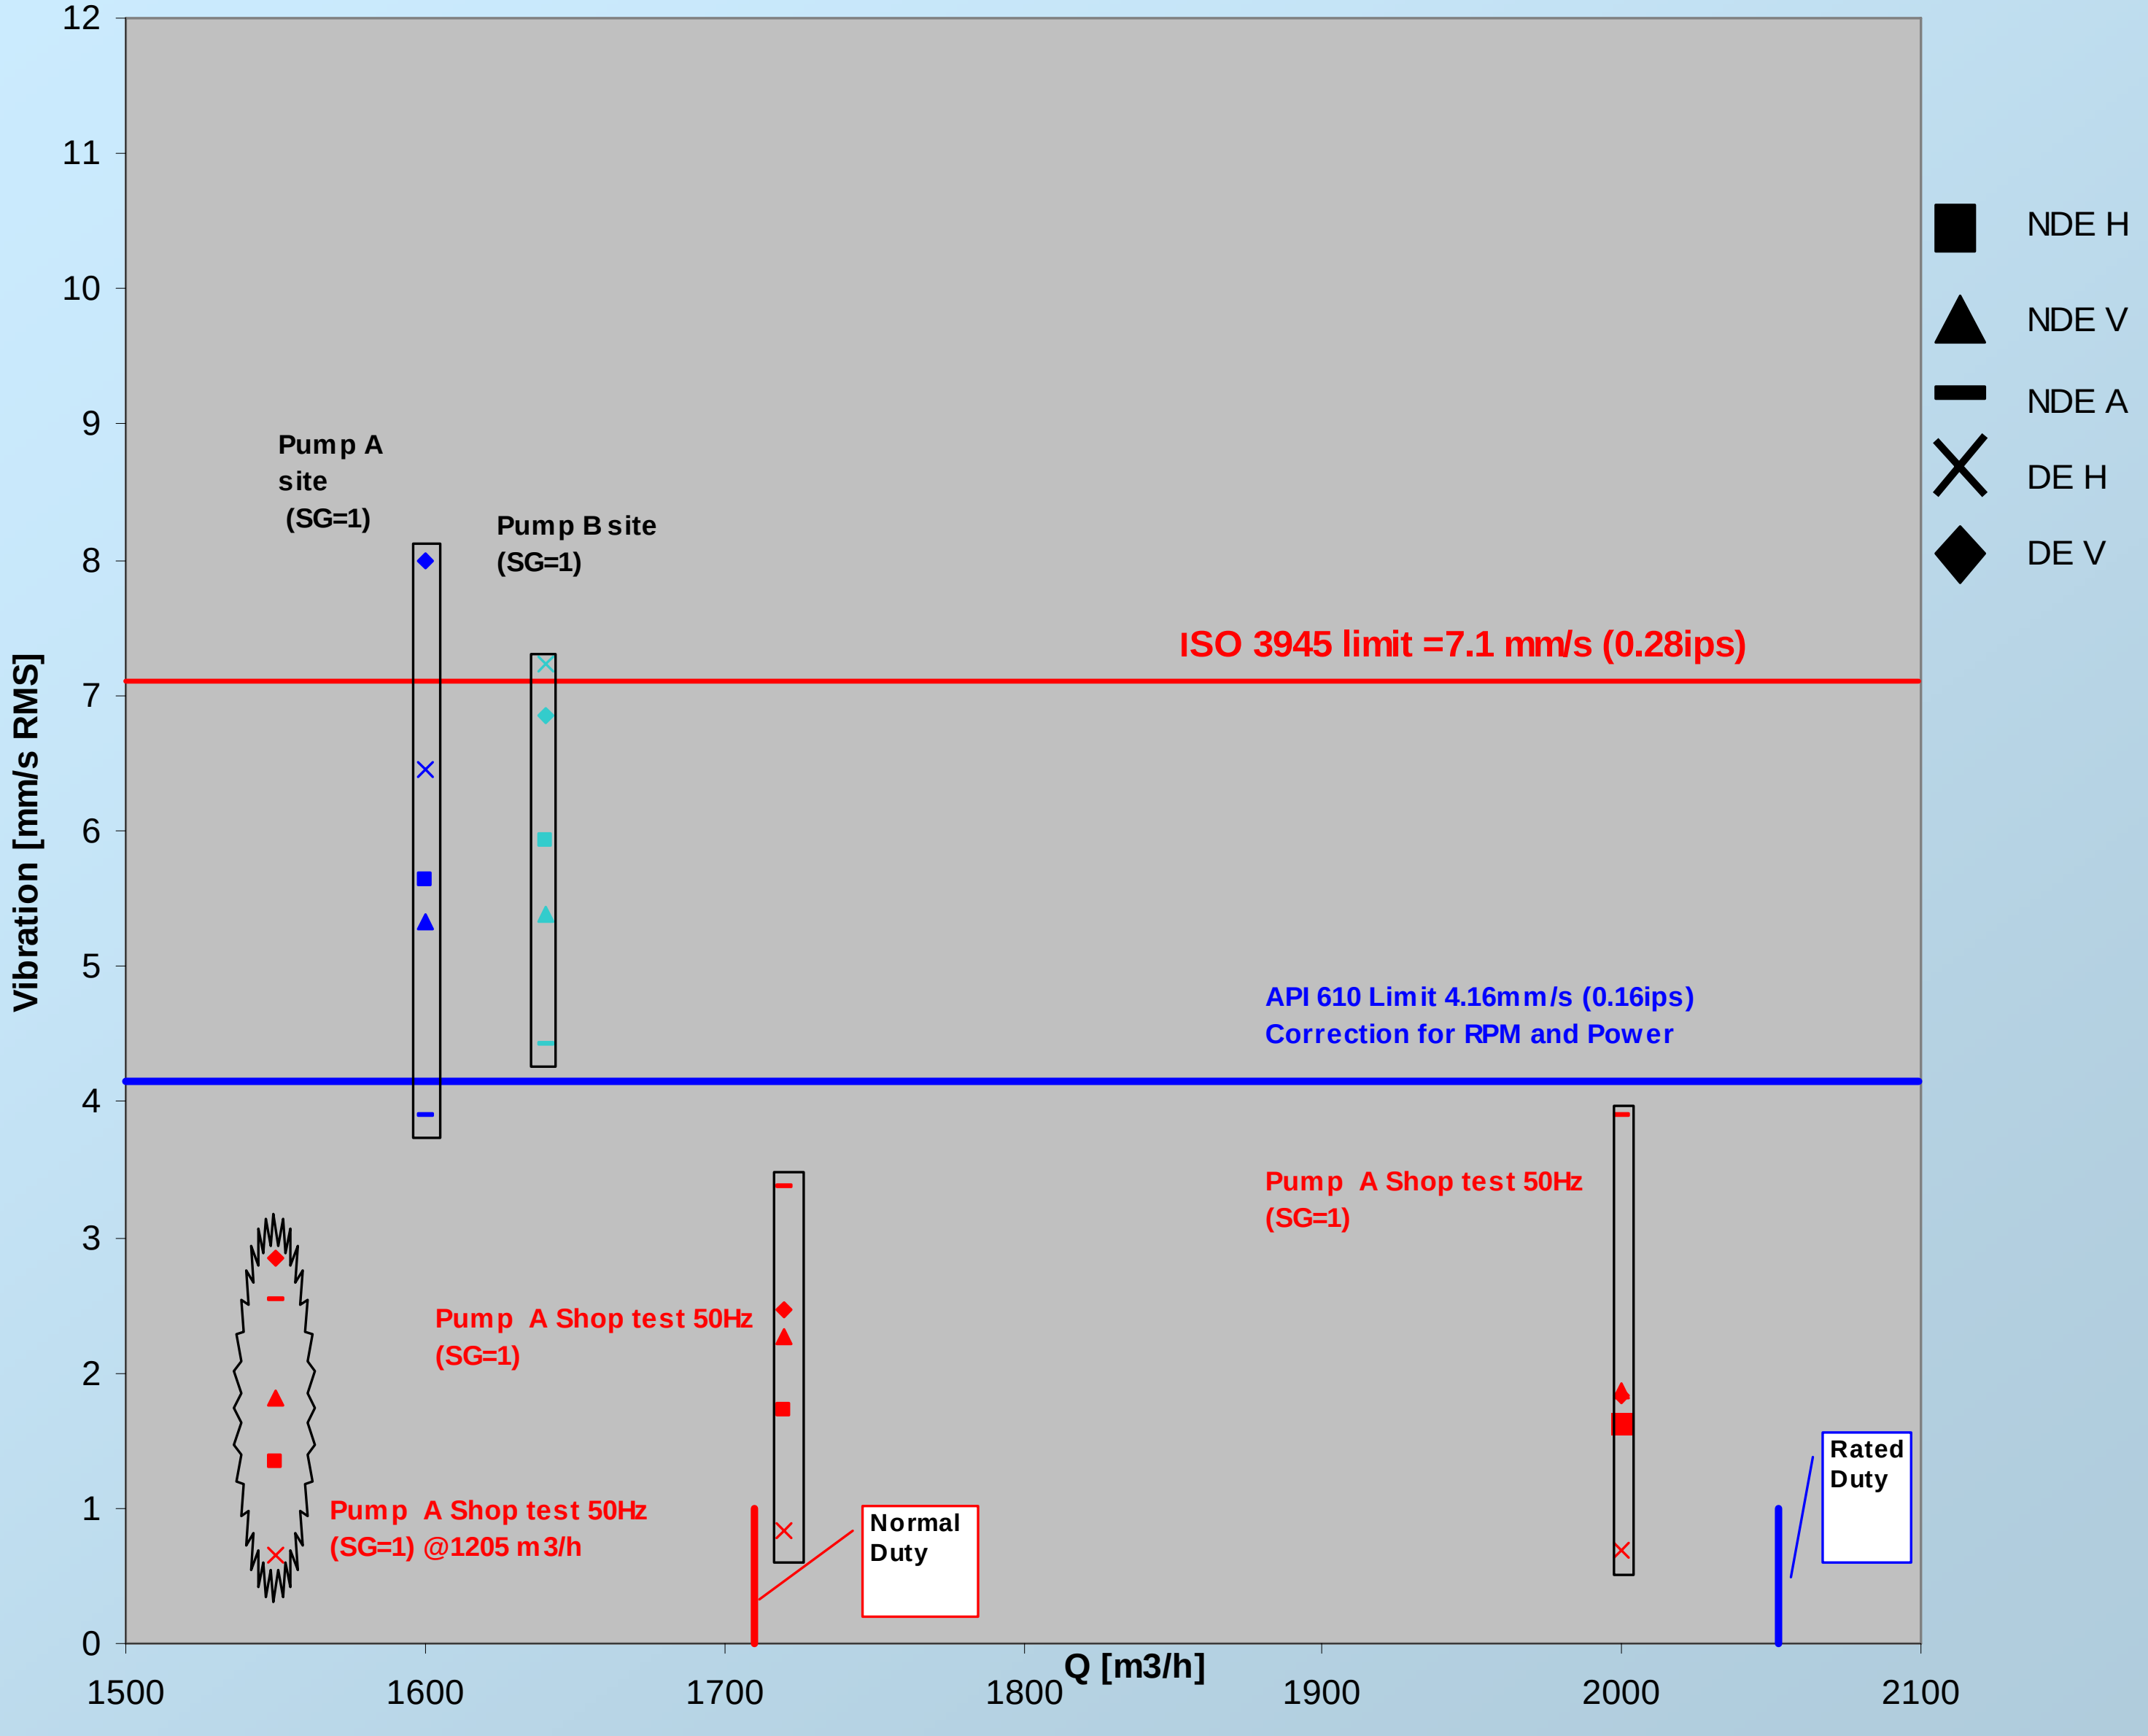
Initial analysis

Spectra analysis and main outcomes

- Confirmation of the measure taken by customer
- Similar behaviour on the two pumps
- Frequency spectra with broadband showing peaks distributed for many frequencies up to 500 -700 Hz (low - medium range)
- Filtered vibrations at key characteristic frequencies (1x, VPF)
  have amplitude around 1.0 – 1.5 mm/s (0.04 – 0.06 ips). But
  overall value is around 5-6 mm/s(0.2-0.24 ips), due to the high number of peaks
- Spectra instability, with high variations in different moments
- Phase not stable
- The higher vibration values were detected on pump casing, and not on the bearing

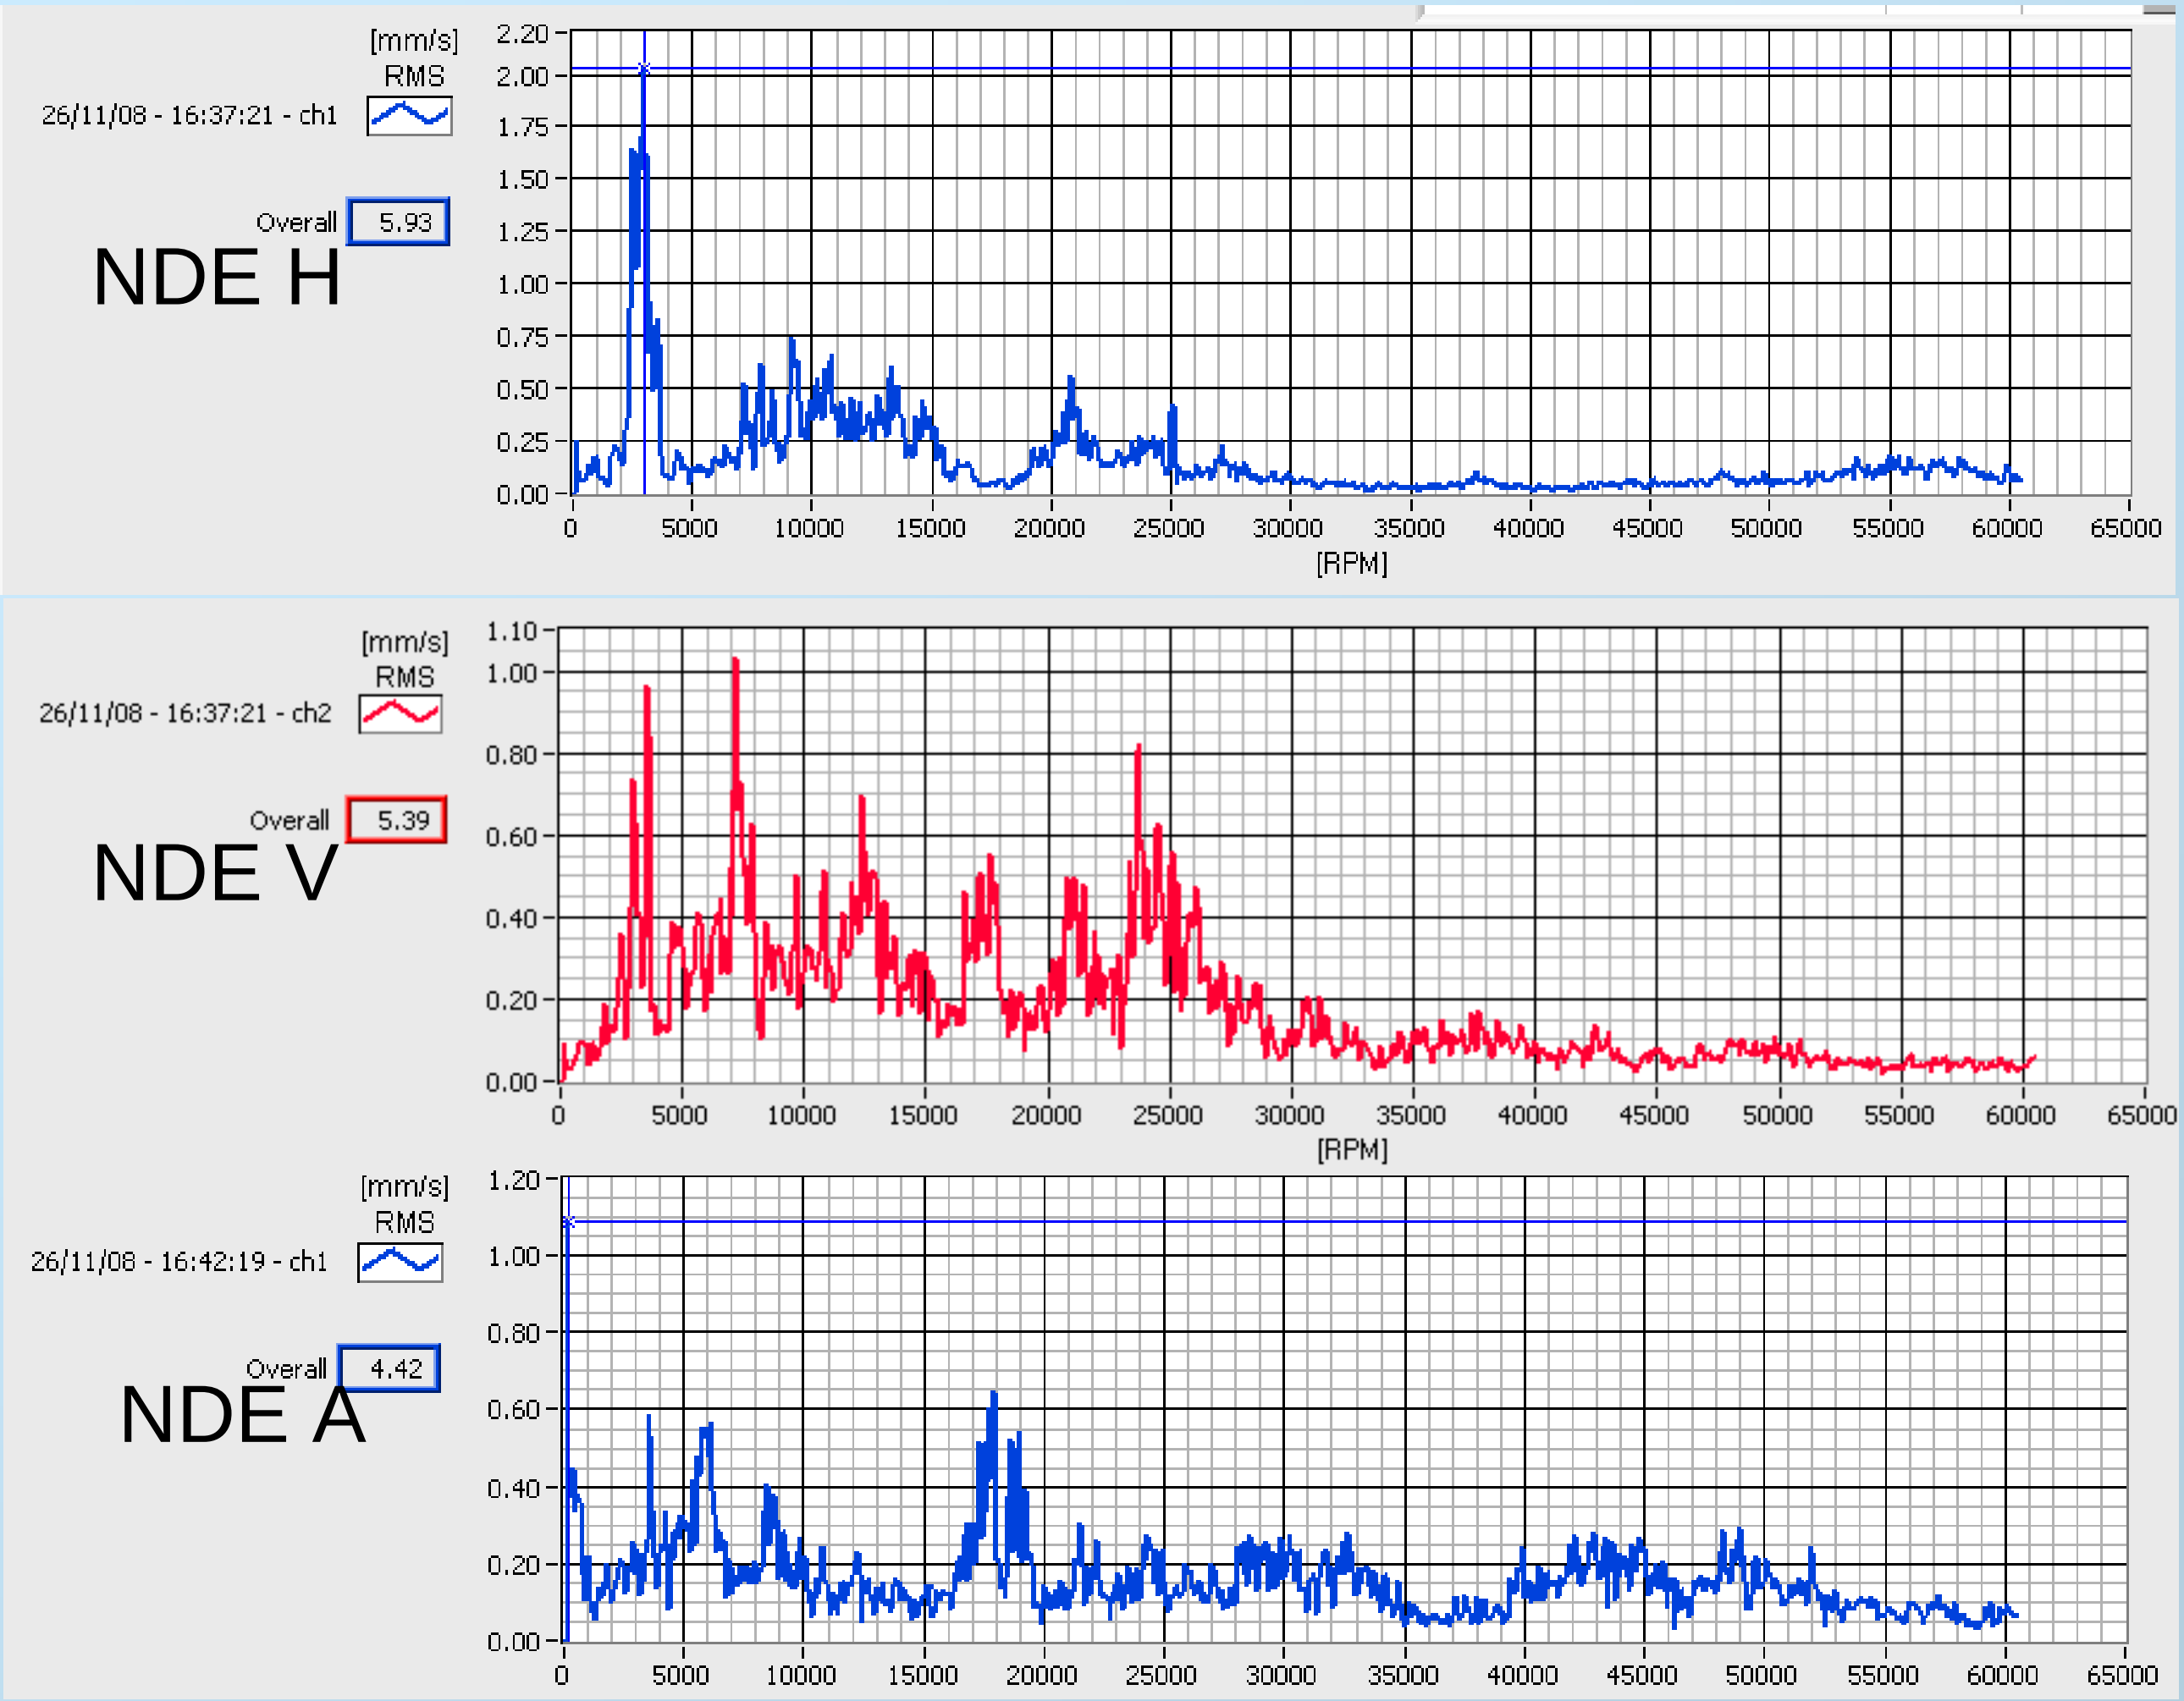
NDE vibration spectra

a) Low amplitude at VPF

(< 1 mm/s = 0.04 ips)

b) High activity mainly across a range up 500 Hz (30000 rpm)

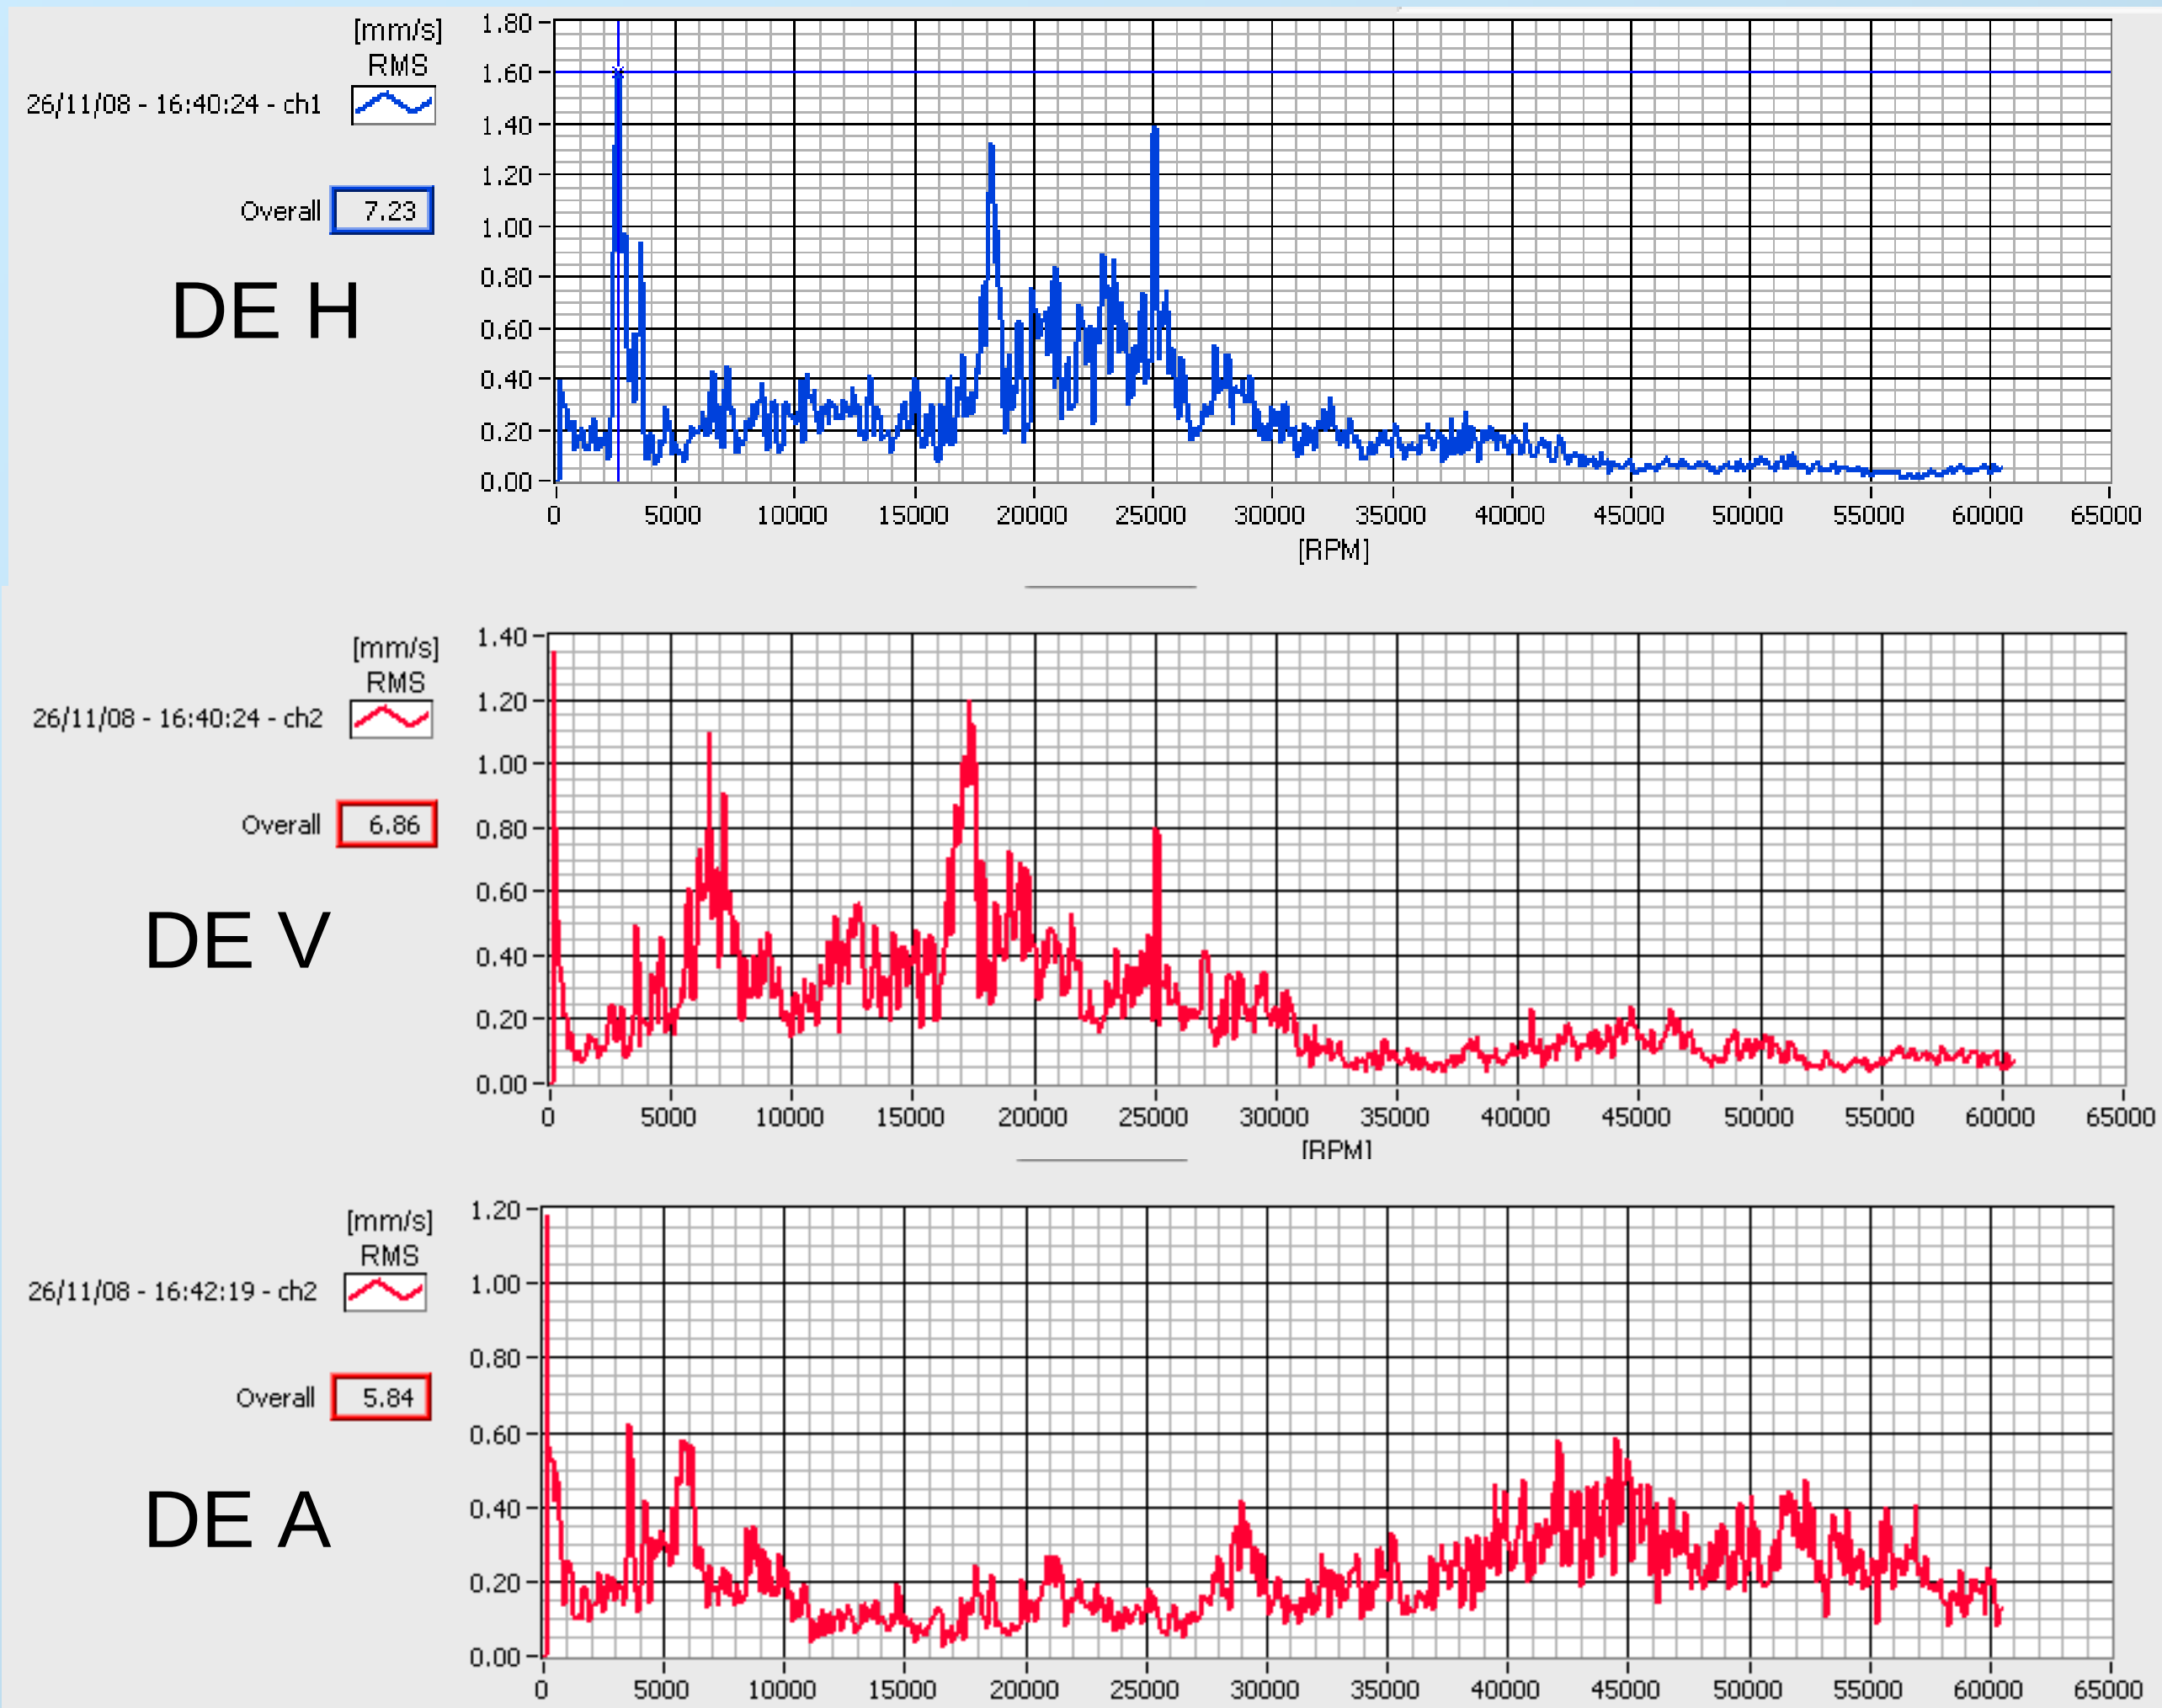
DE vibration spectra

a) Max amplitude at VPF :
1.4 mm/s = 0.06 ips

b) High activity distributed and dominant across a range up 500 Hz (30000 rpm)

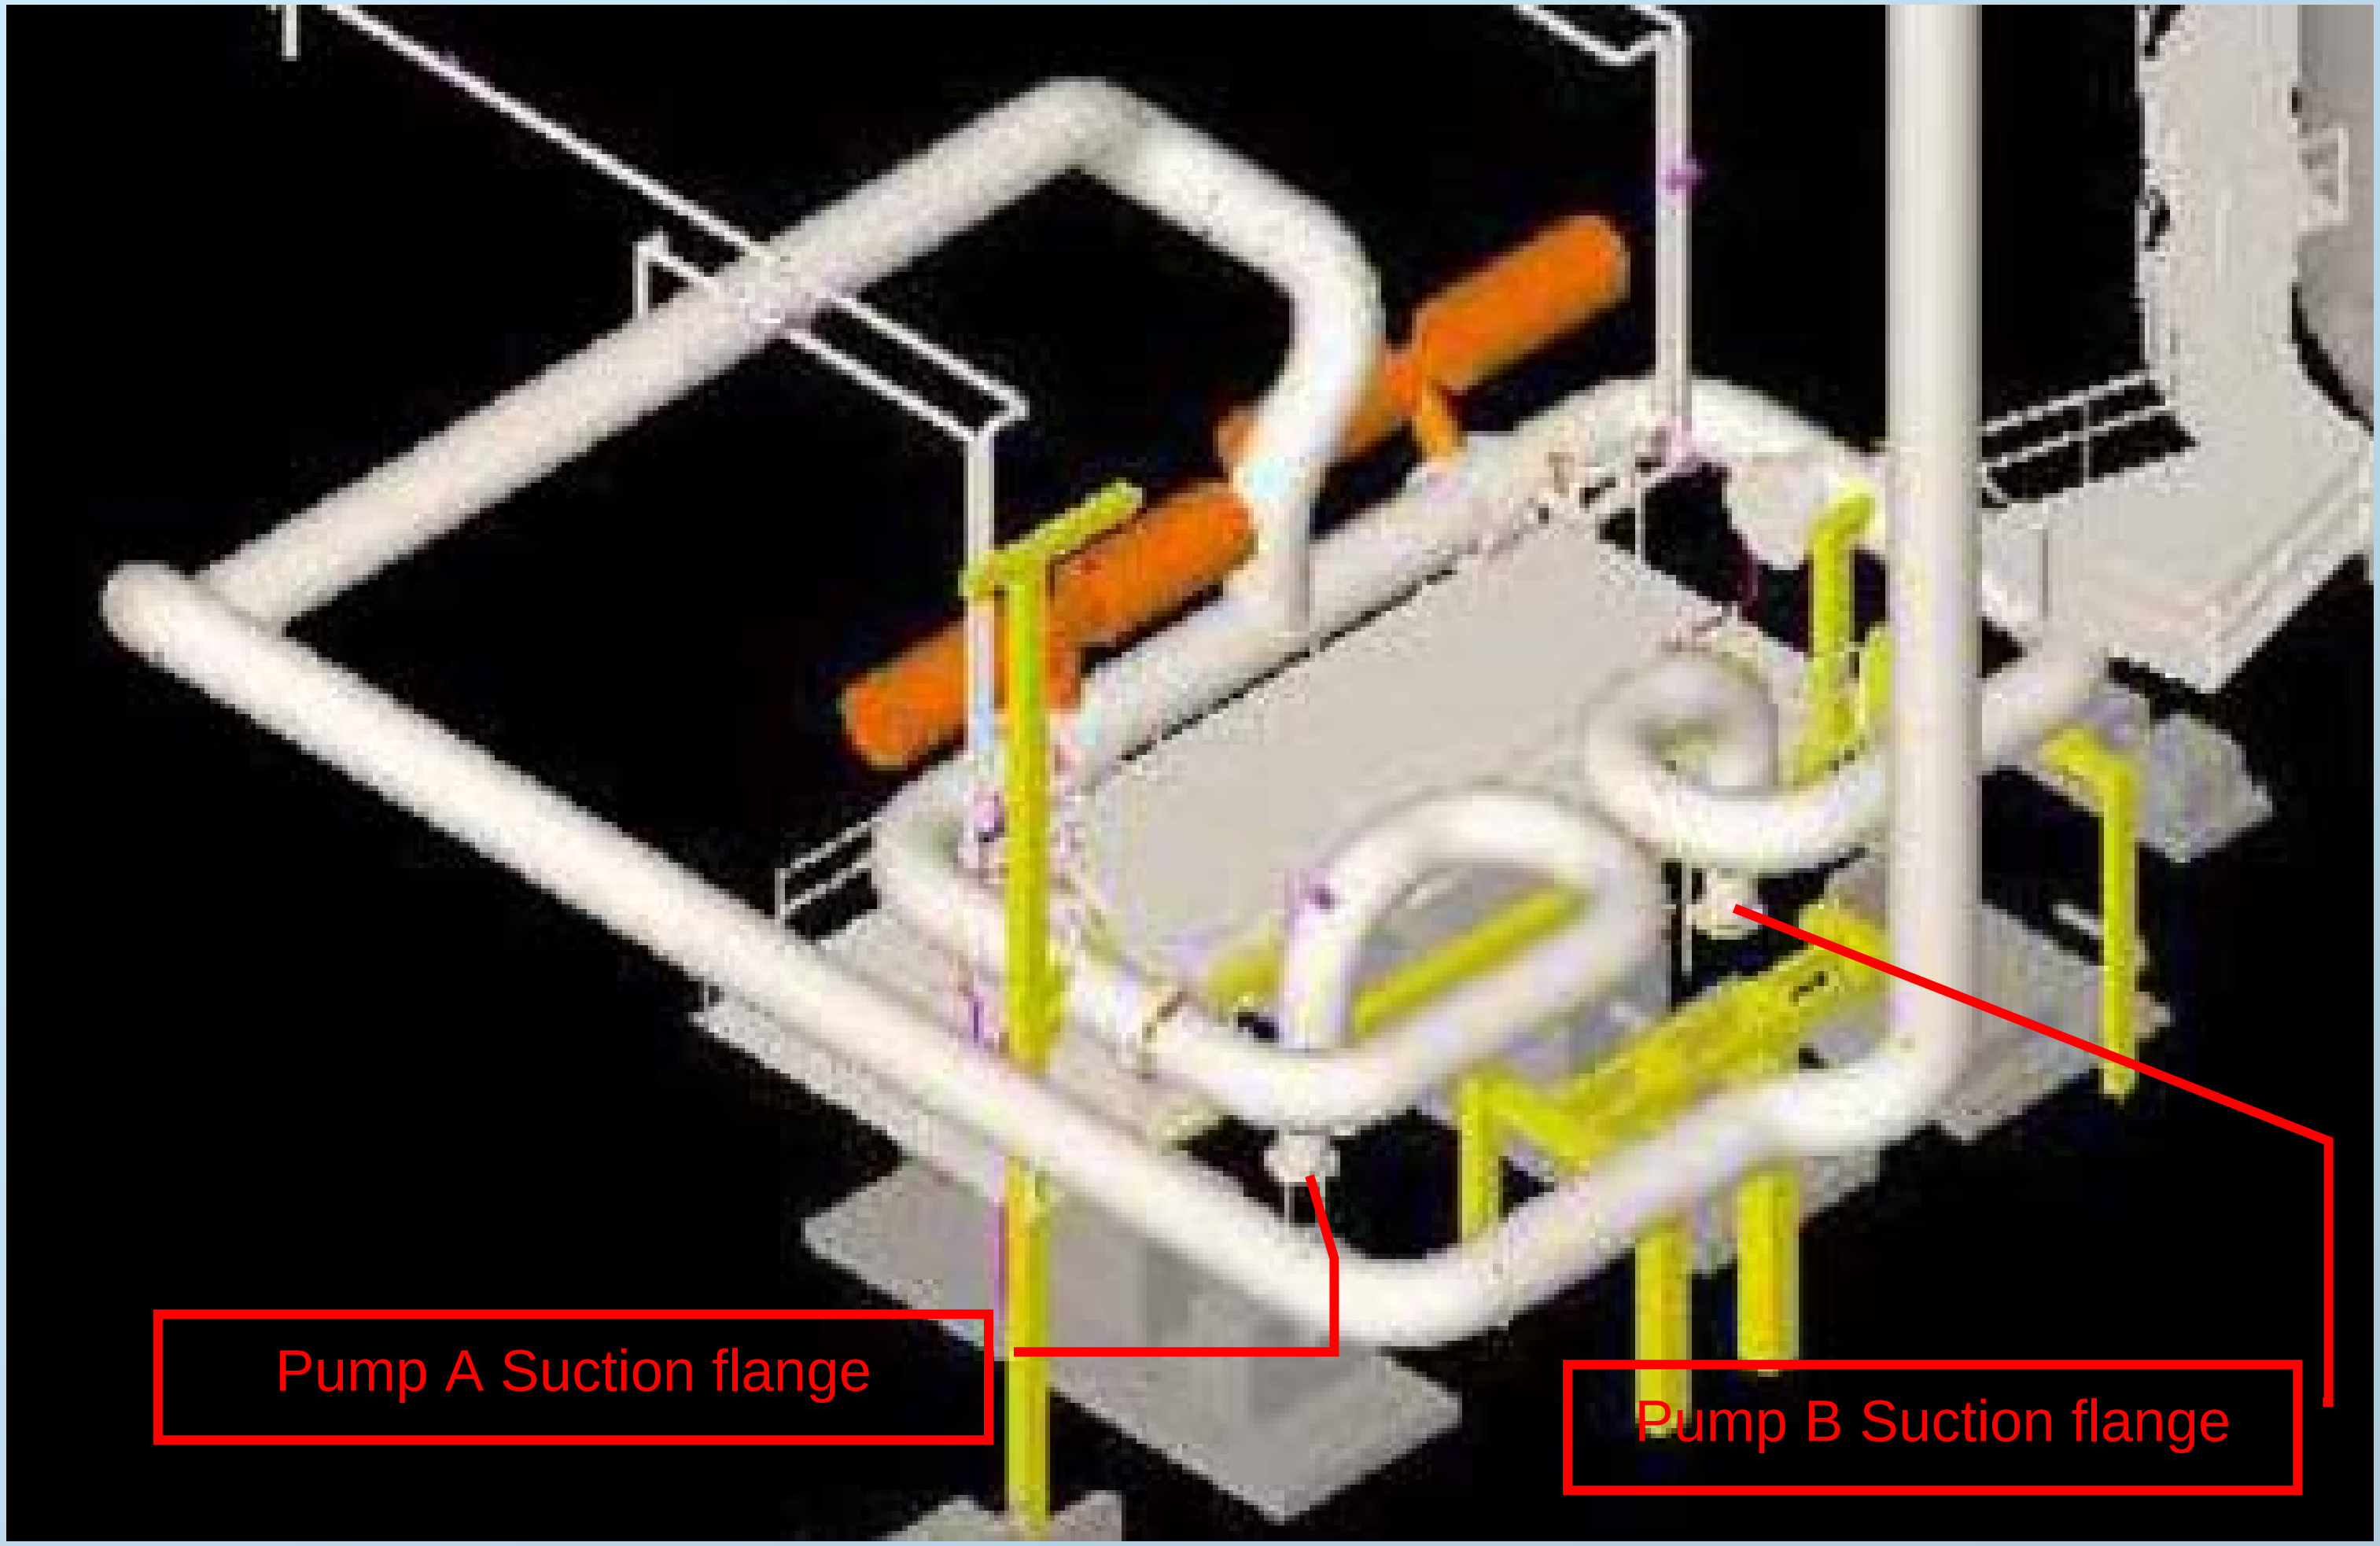
Initial analysis – Suction piping

POSSIBLE CAUSE	Why yes	Why not	Result
Fluid dynamics of the piping	Unsteady and random spectra with a broadband distribution of many peaks of low frequencies are indicative of intense turbulence. Piping was not fully compliant with HI recommendations	Piping designed according to customer best practice	PROBABLE CAUSE
Fluid dynamics of the pump	Unsteady and random spectra with a broadband distribution of many peaks of low frequencies are indicative of intense turbulence. Pump operation at capacity below BEP is potential source of high turbulence	Same type of pump running well in other applications	PROBABLE CAUSE

- The customer modified the piping layout as to have it compliant to Hydraulic Institute recommendation.
- The results of the modification showed remarkable reduction in vibration level, though not within the required acceptance limits.

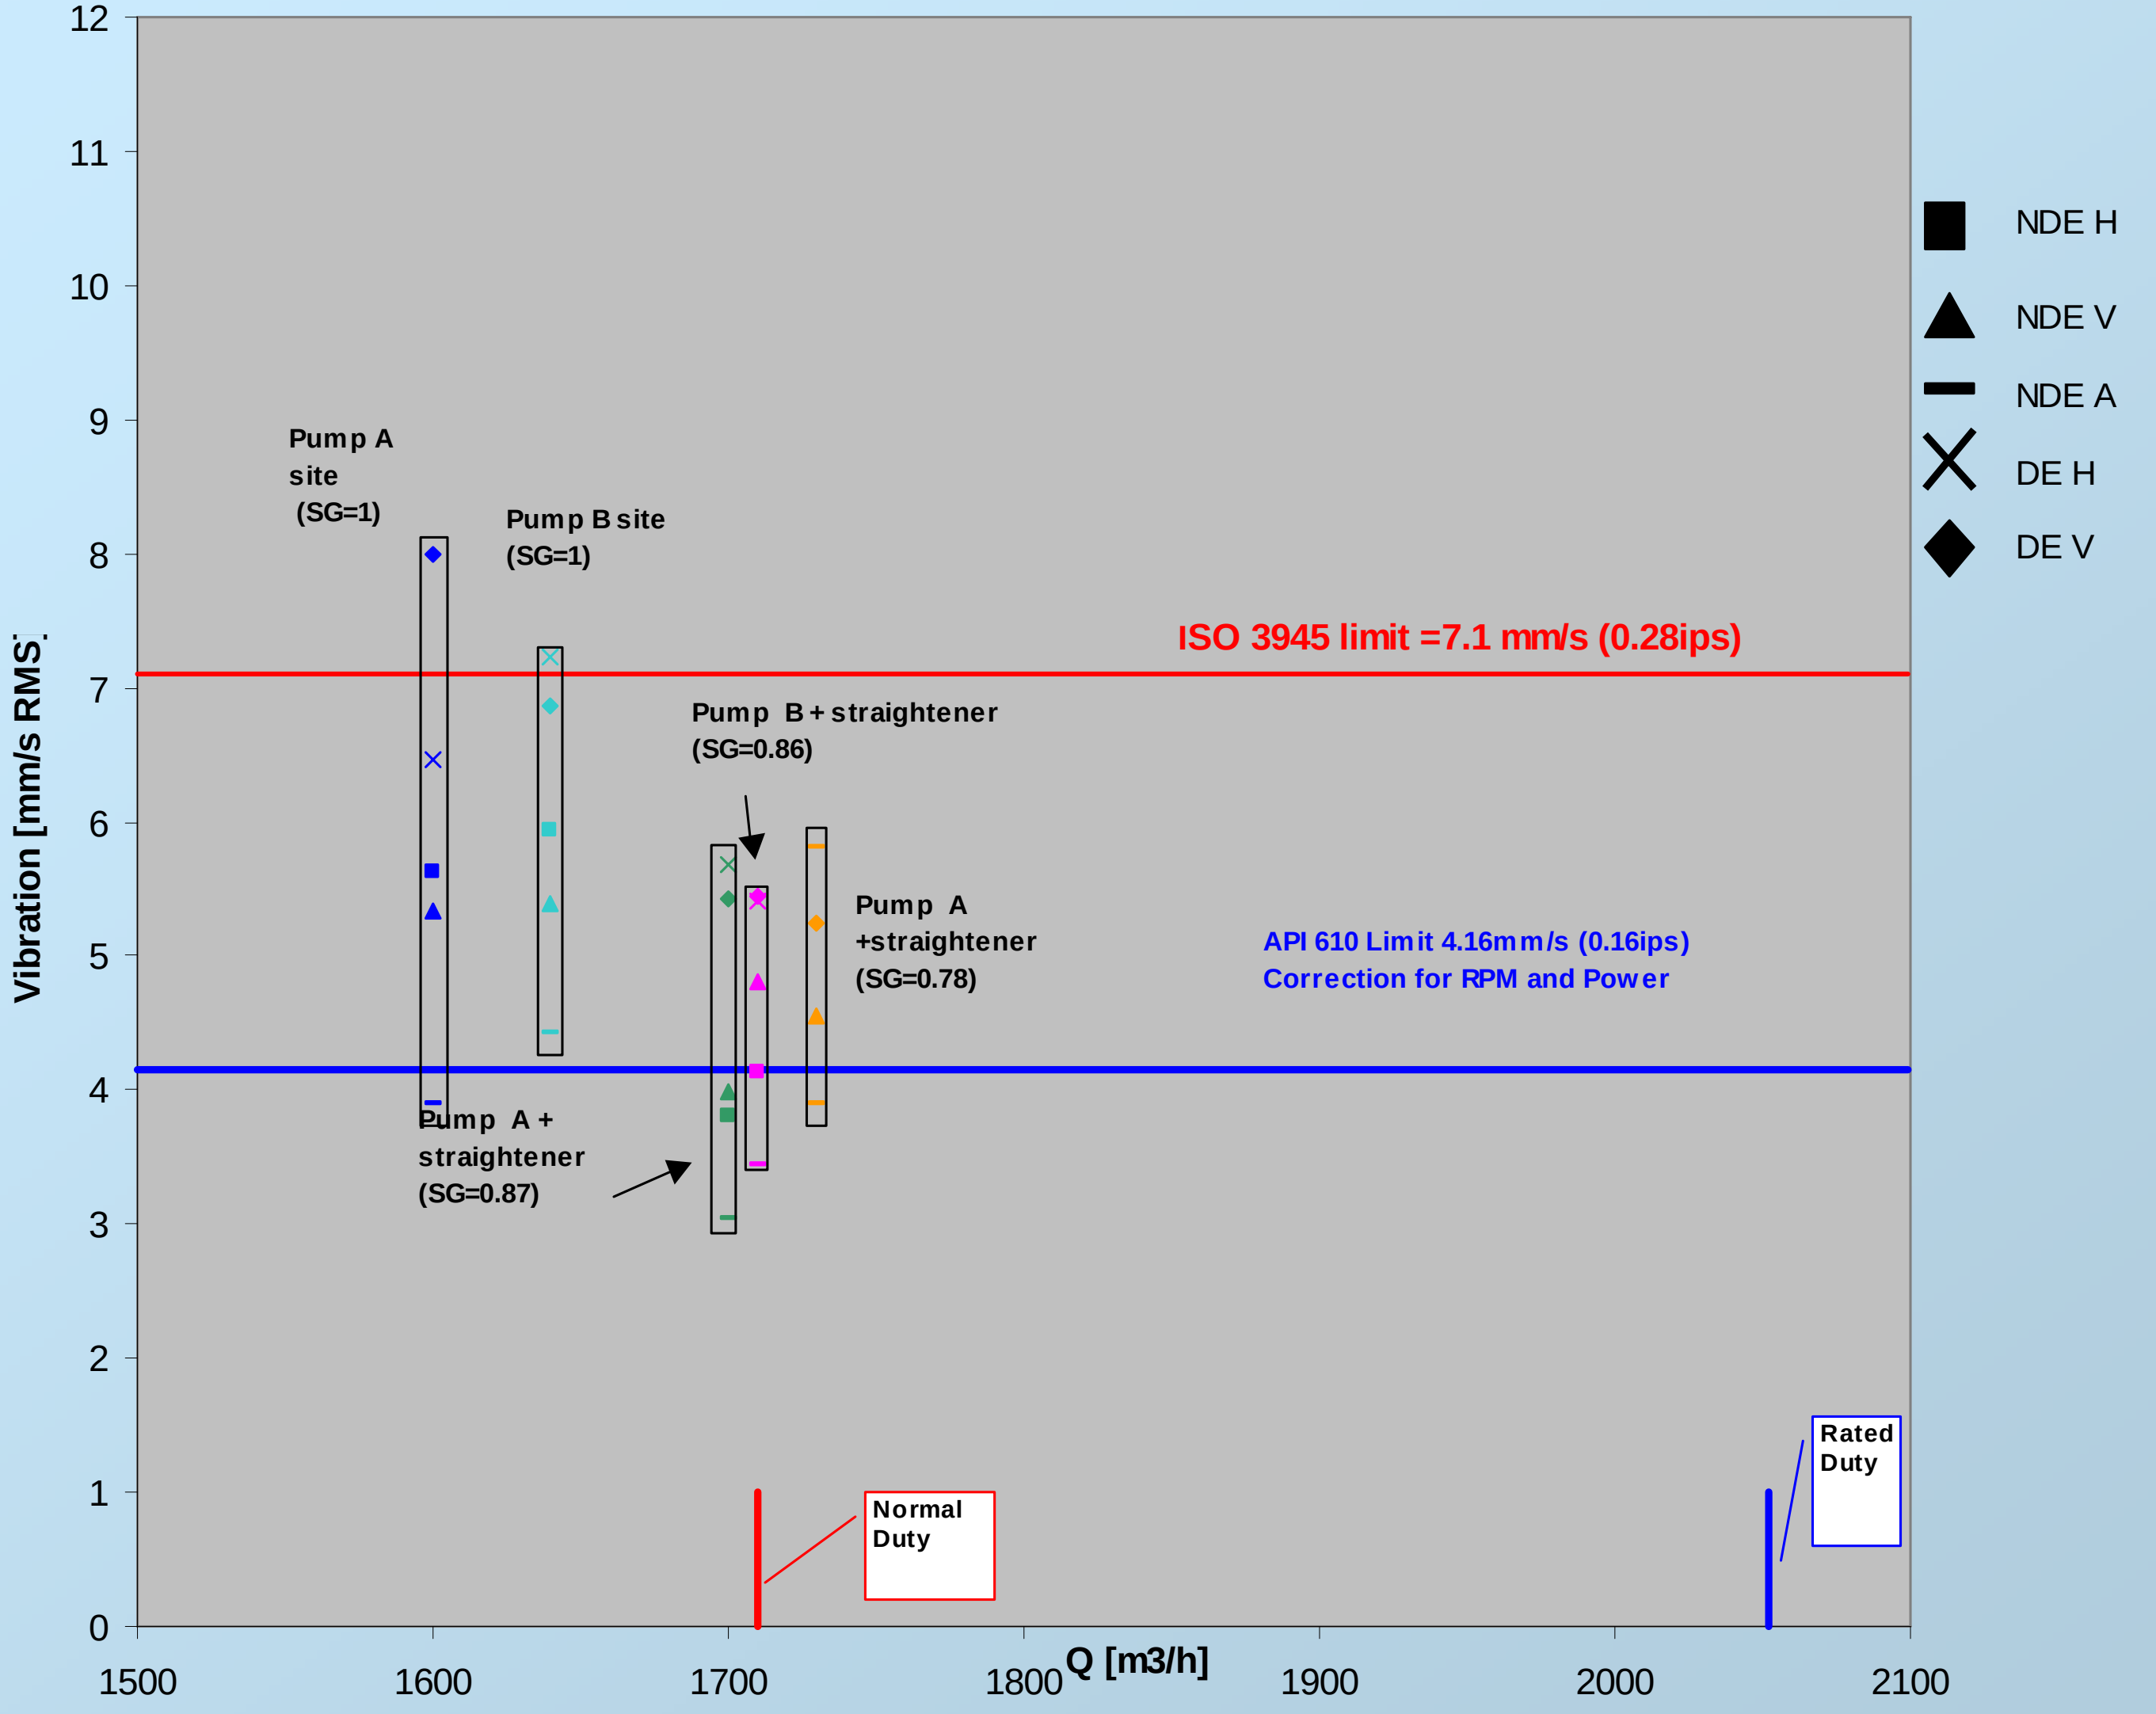
Suction piping with flow straightener (February-March 2009)

The results of the modification showed remarkable reduction in vibration level, though not within the required acceptance limits.
