Fast and Ultimate Vibration Field Solution: From Problem Detection to Field Performance Validation

G. Cicatelli, G. Panceri, A. Scotti
Flowserve Corporation - Italy

26th International Pump Users Symposium
March 15 - 18, 2010
George R. Brown Convention Center
Houston, Texas

Description of the problem

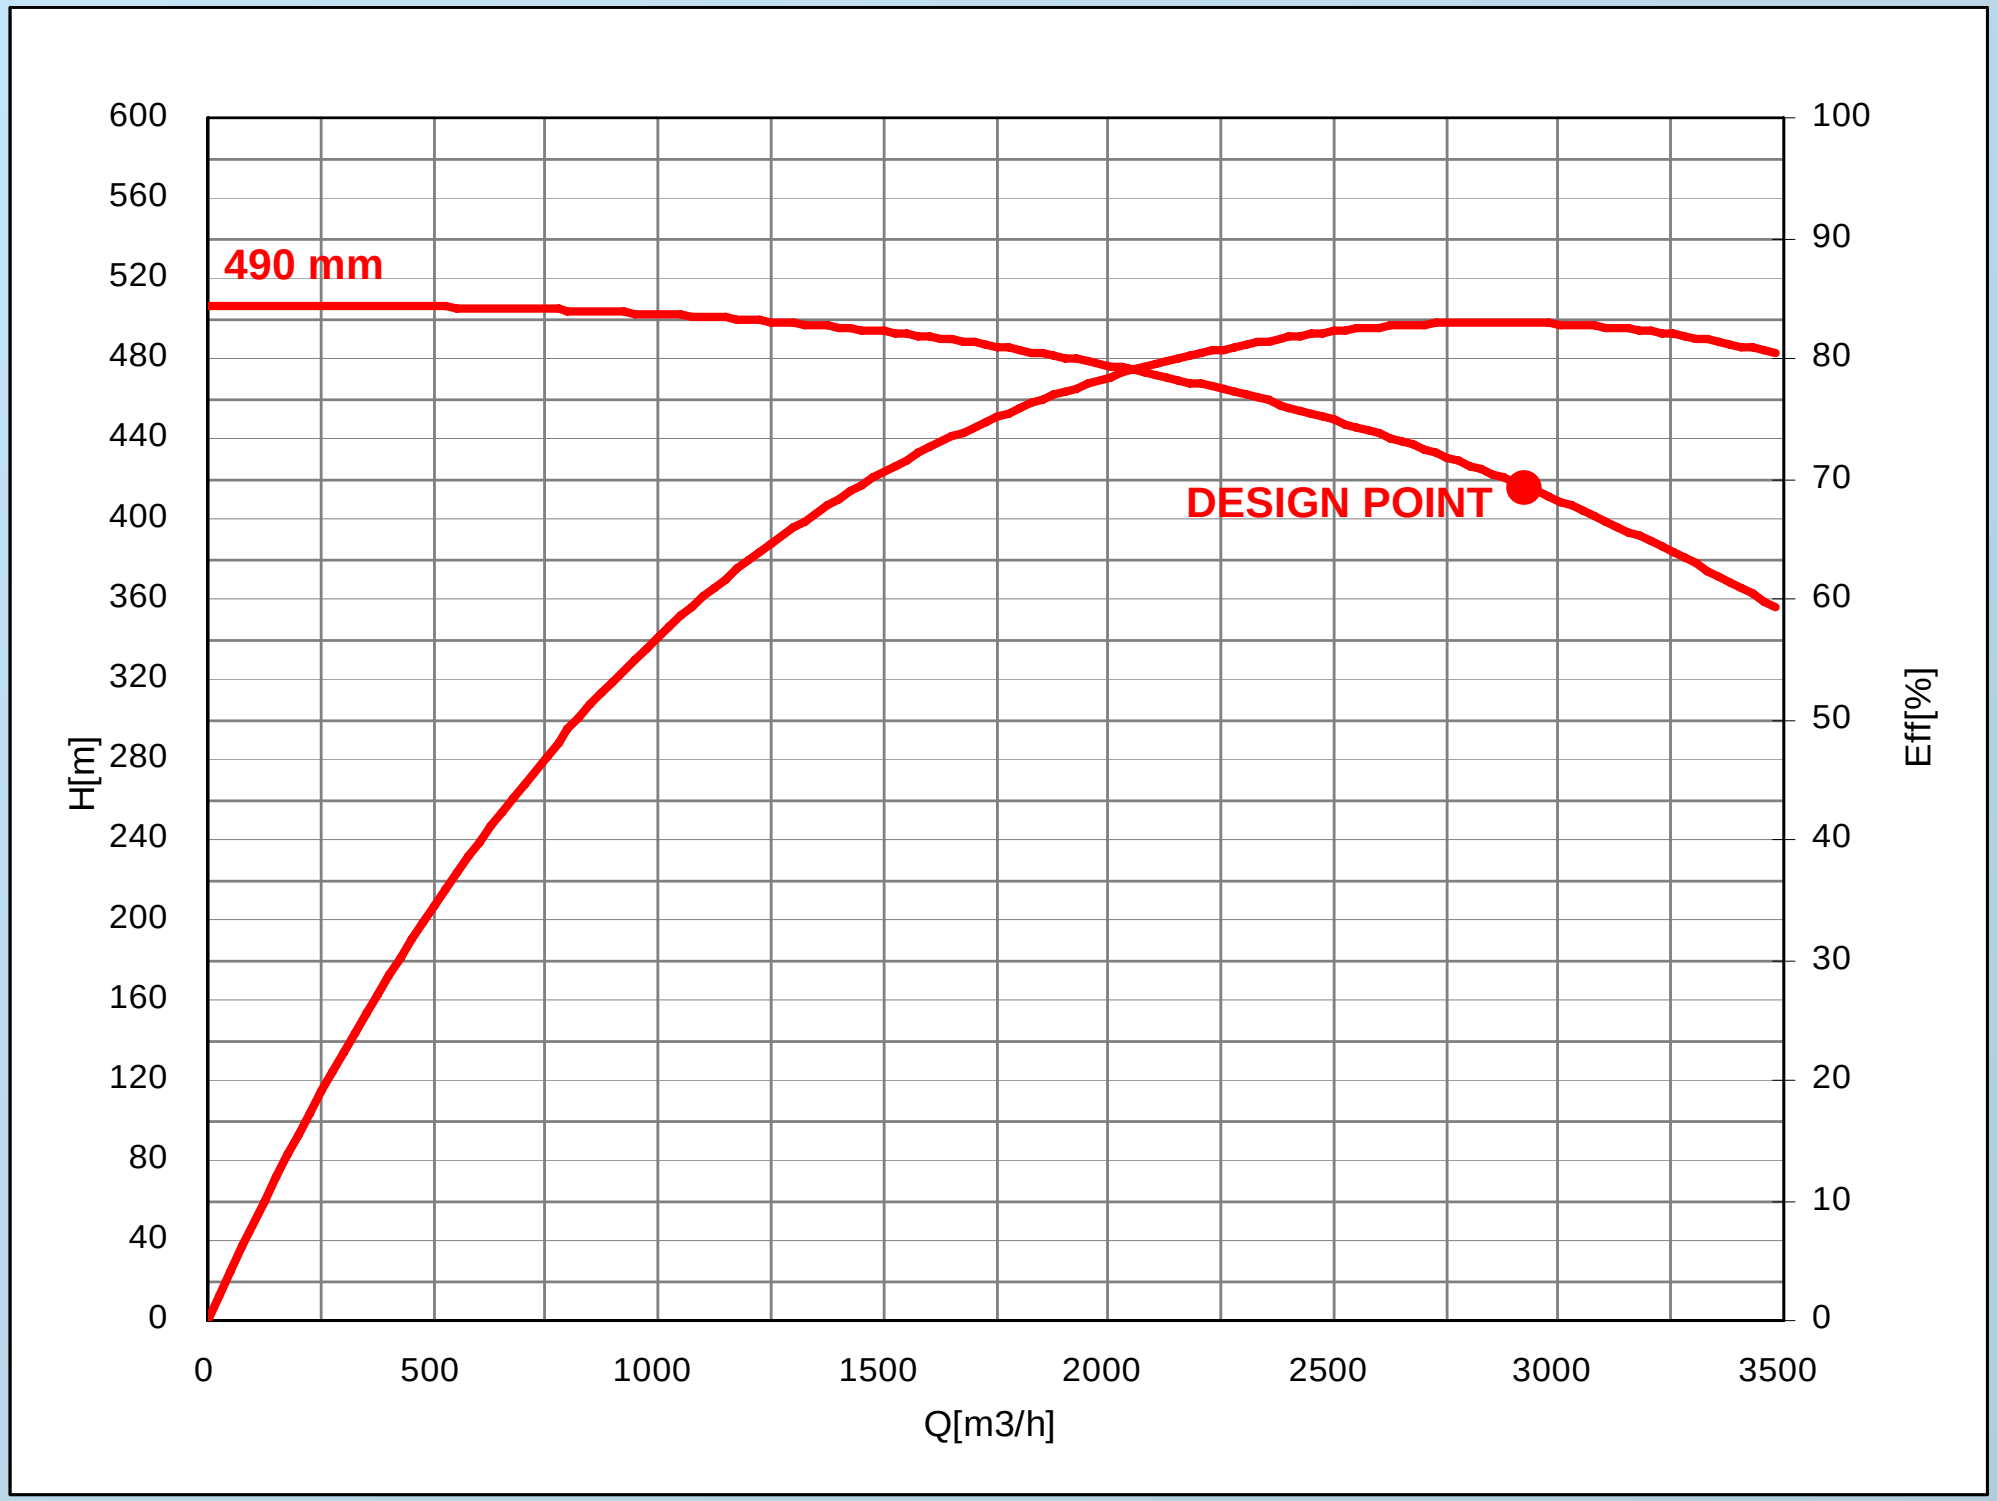
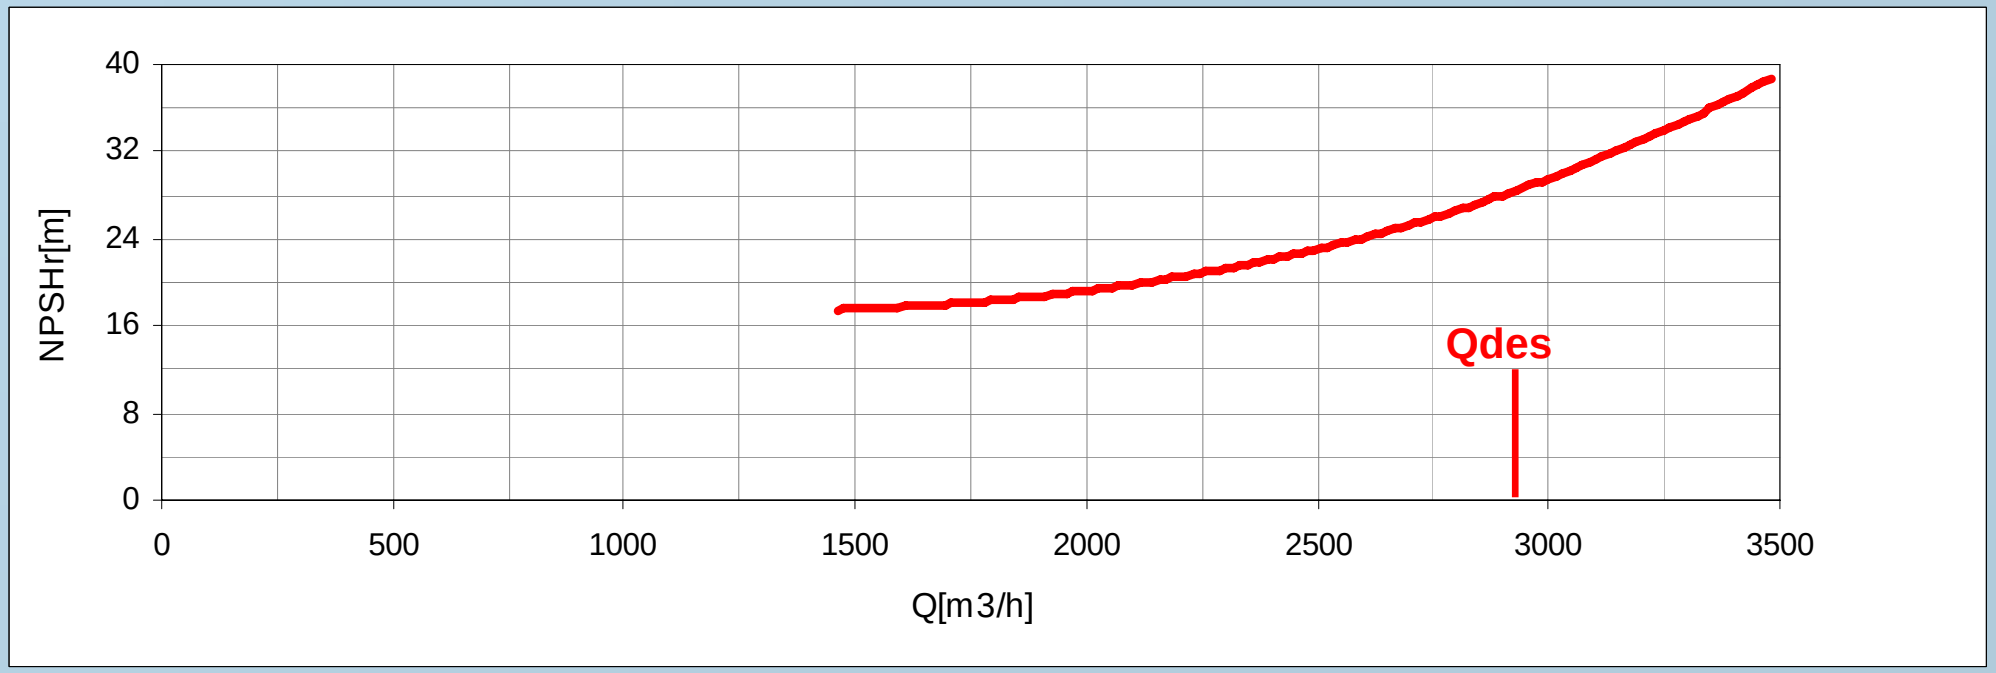
Test Curves

Qrs/Qsl = 0.65

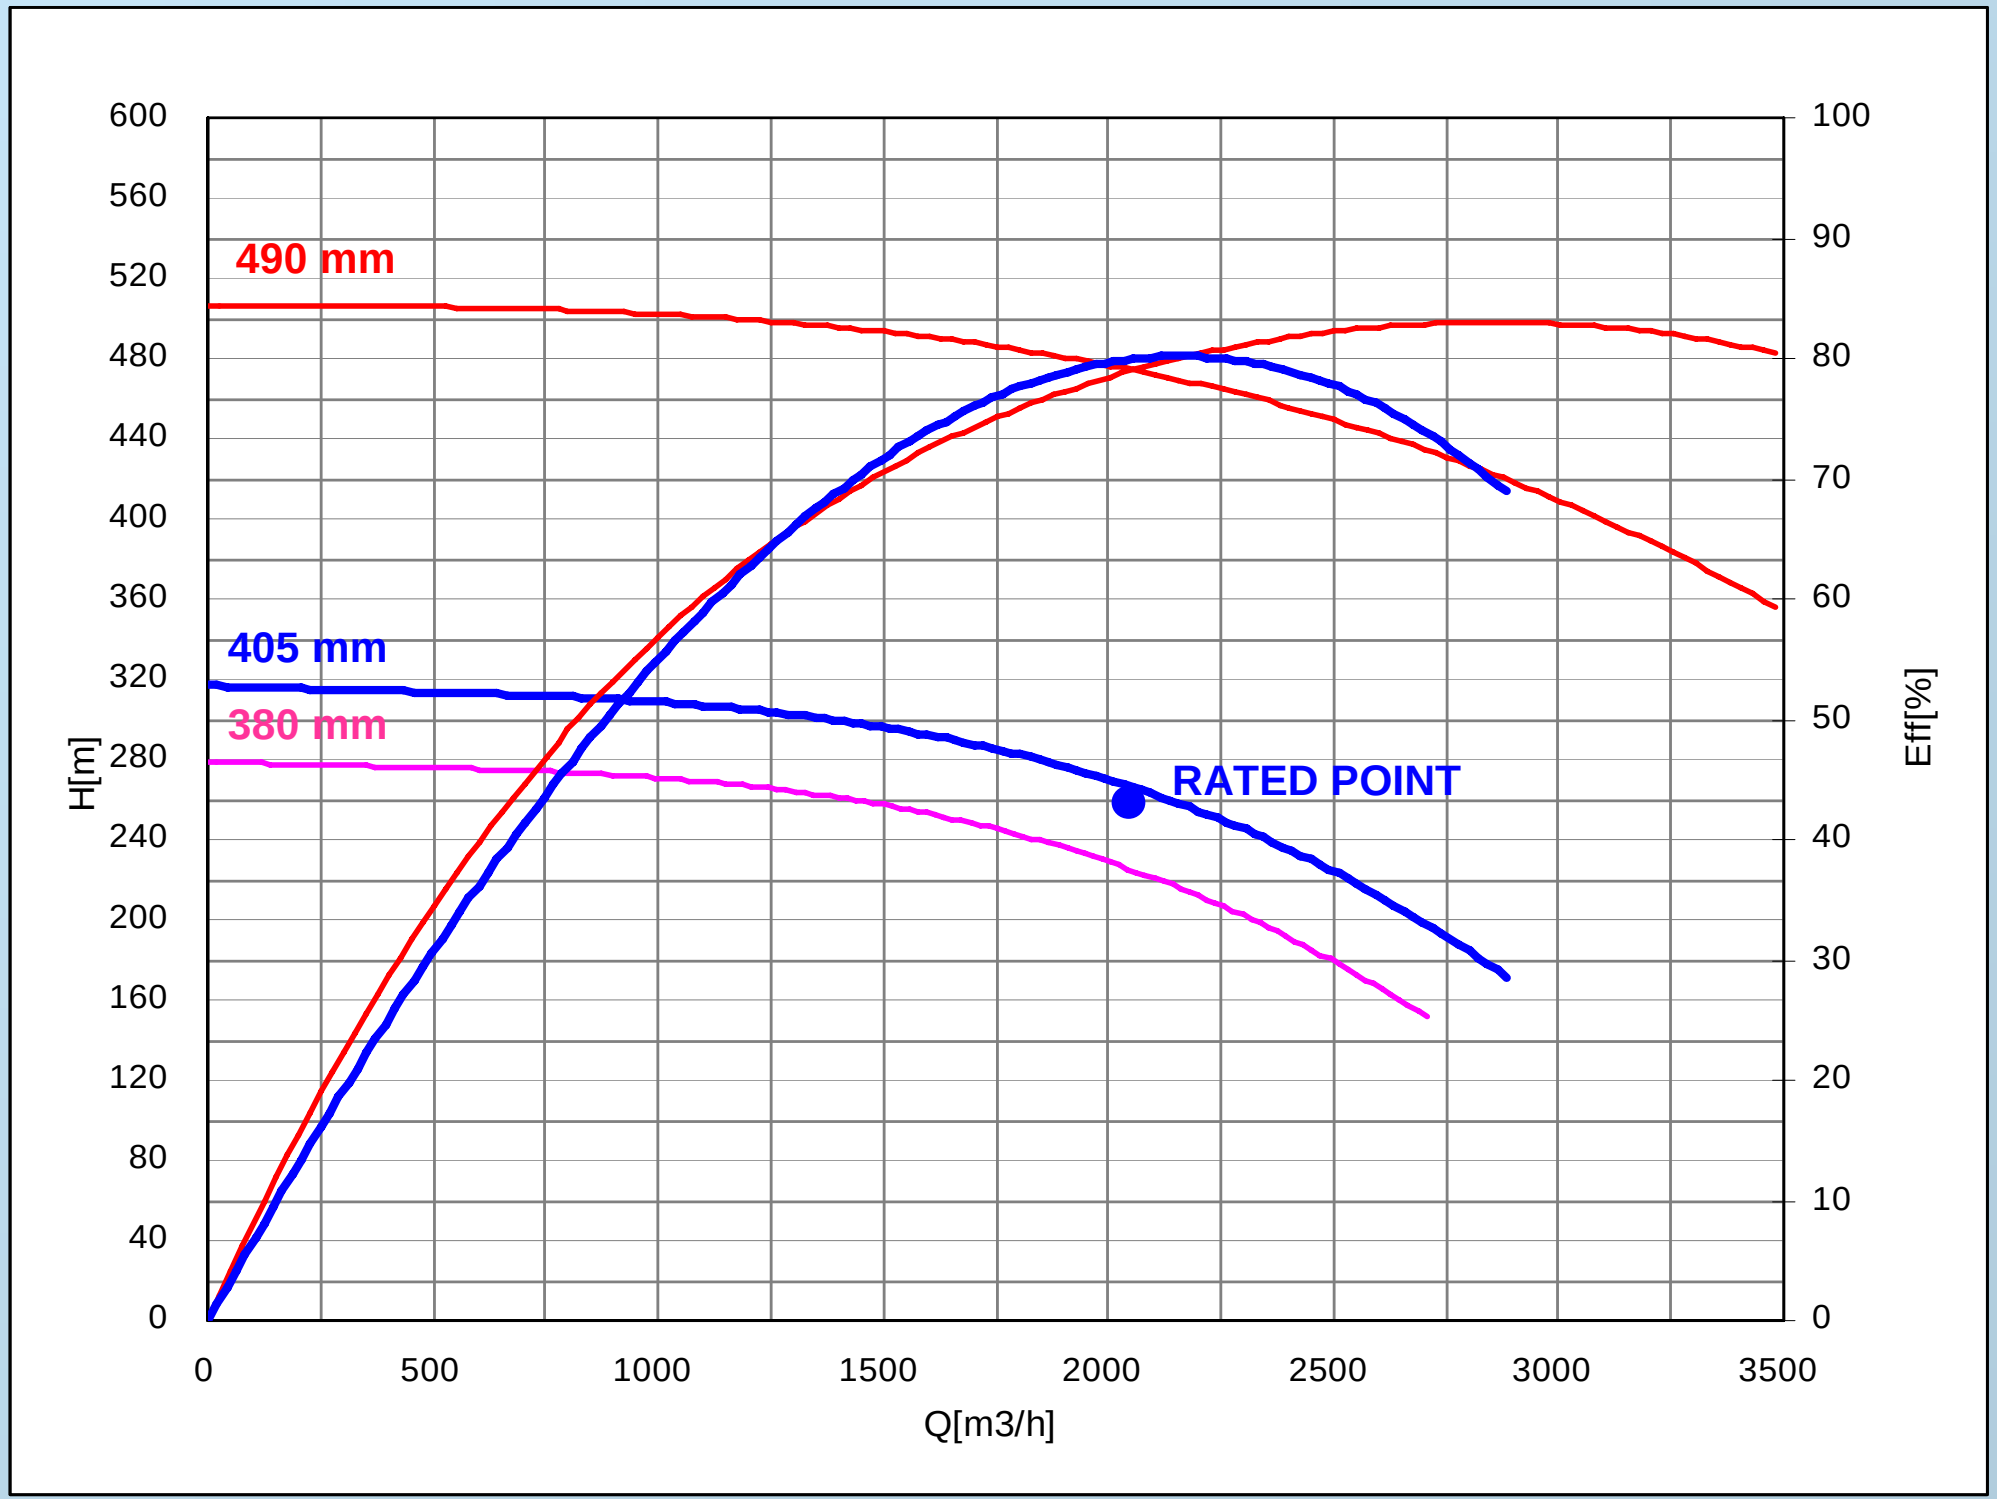
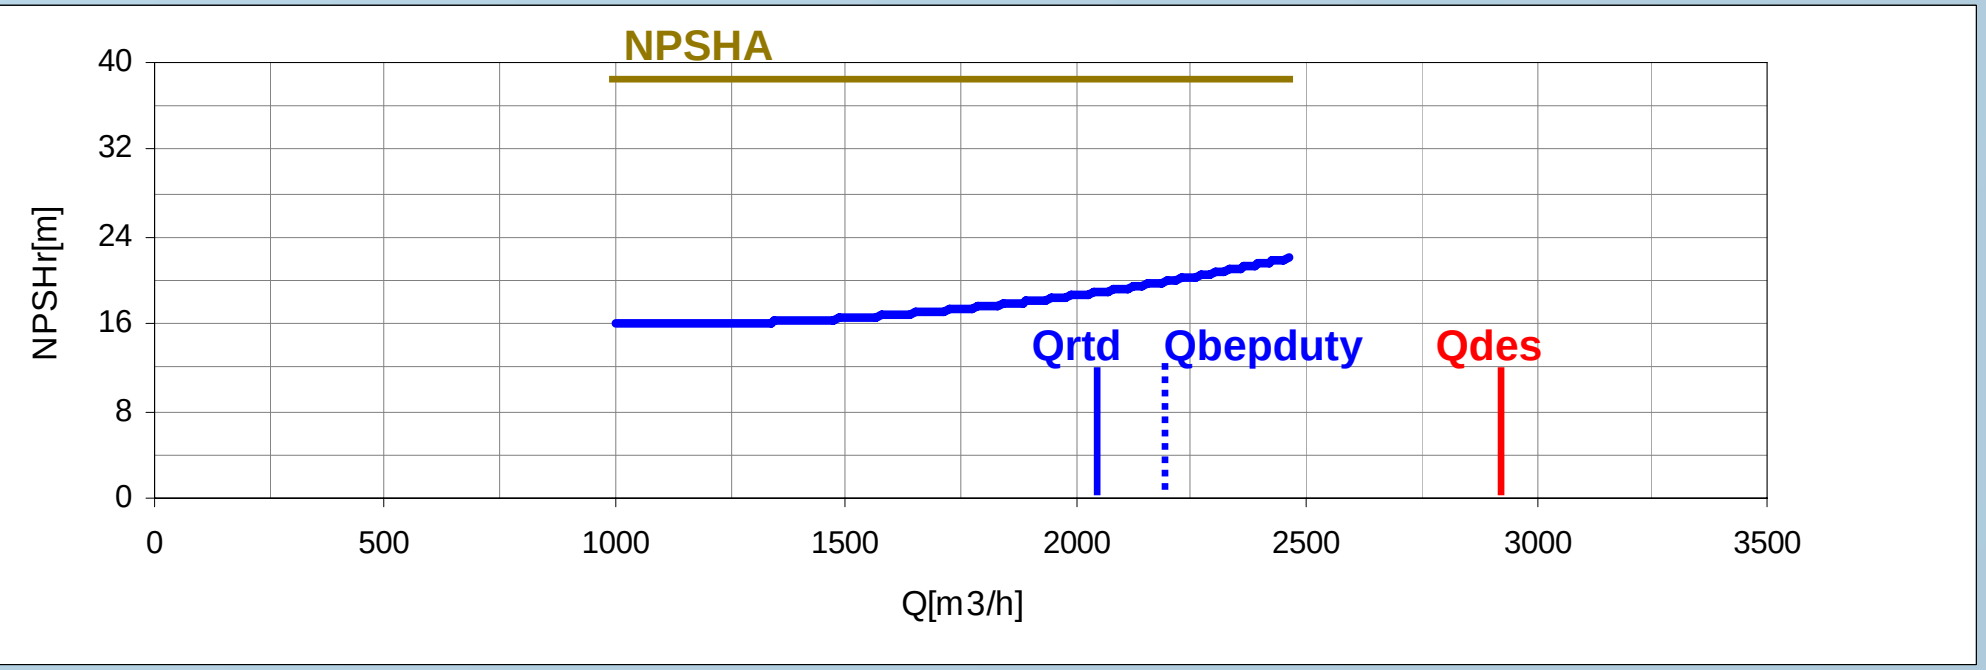
Test Curves

D_{cw}/D_{2duty}= 1.30 (B-Gap : very large i.e . low vibrations at VPF)

Impeller trimming

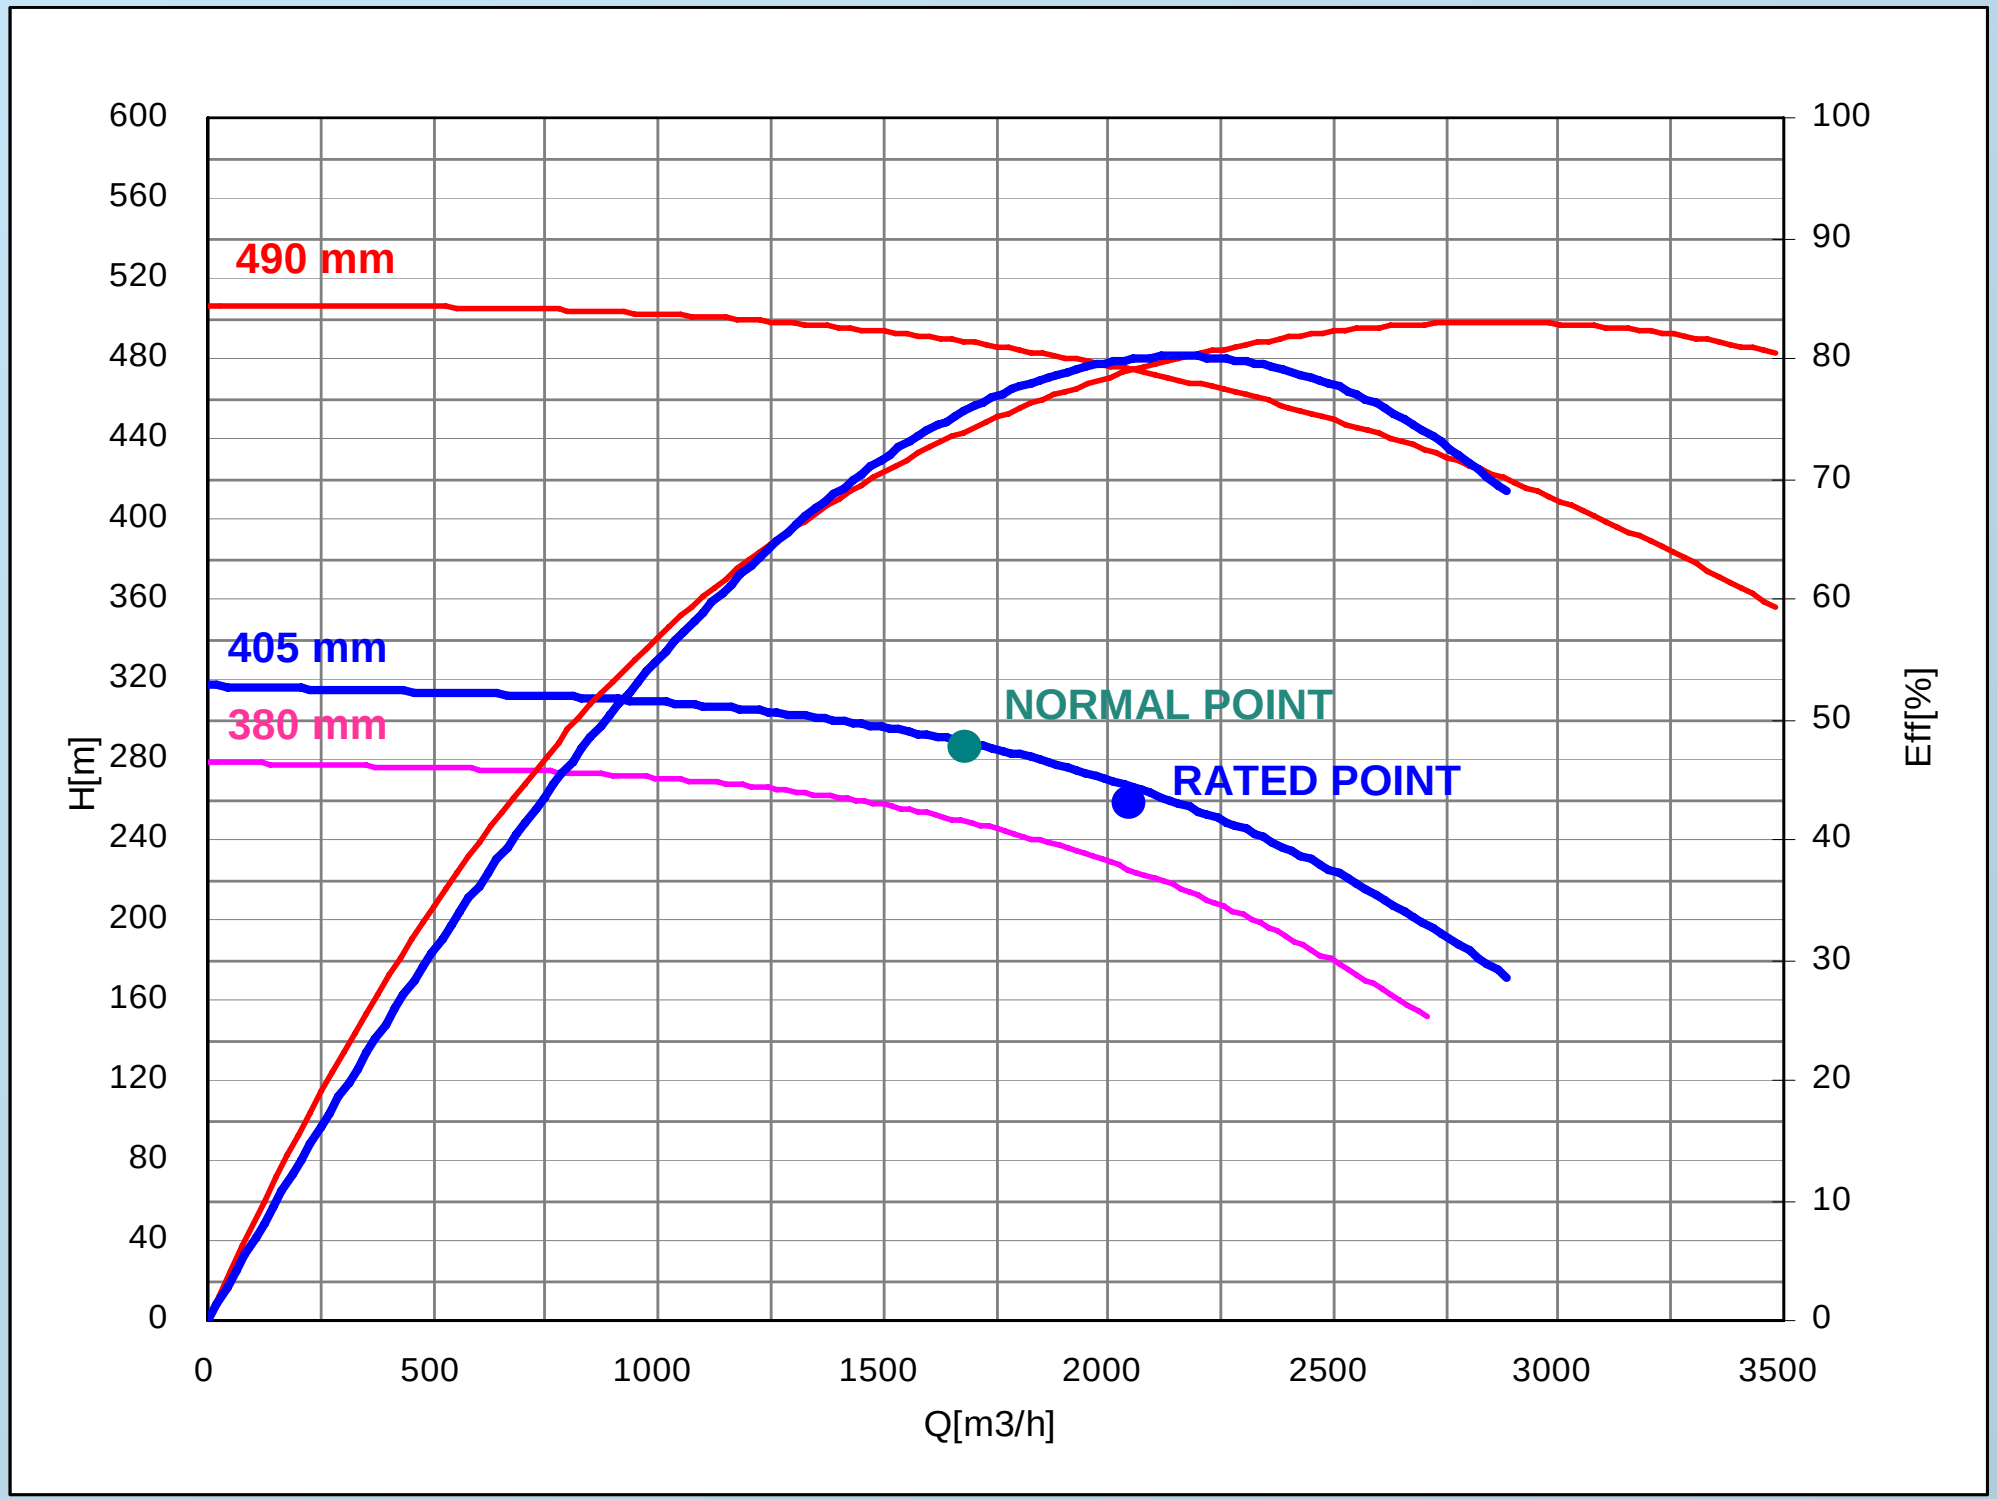
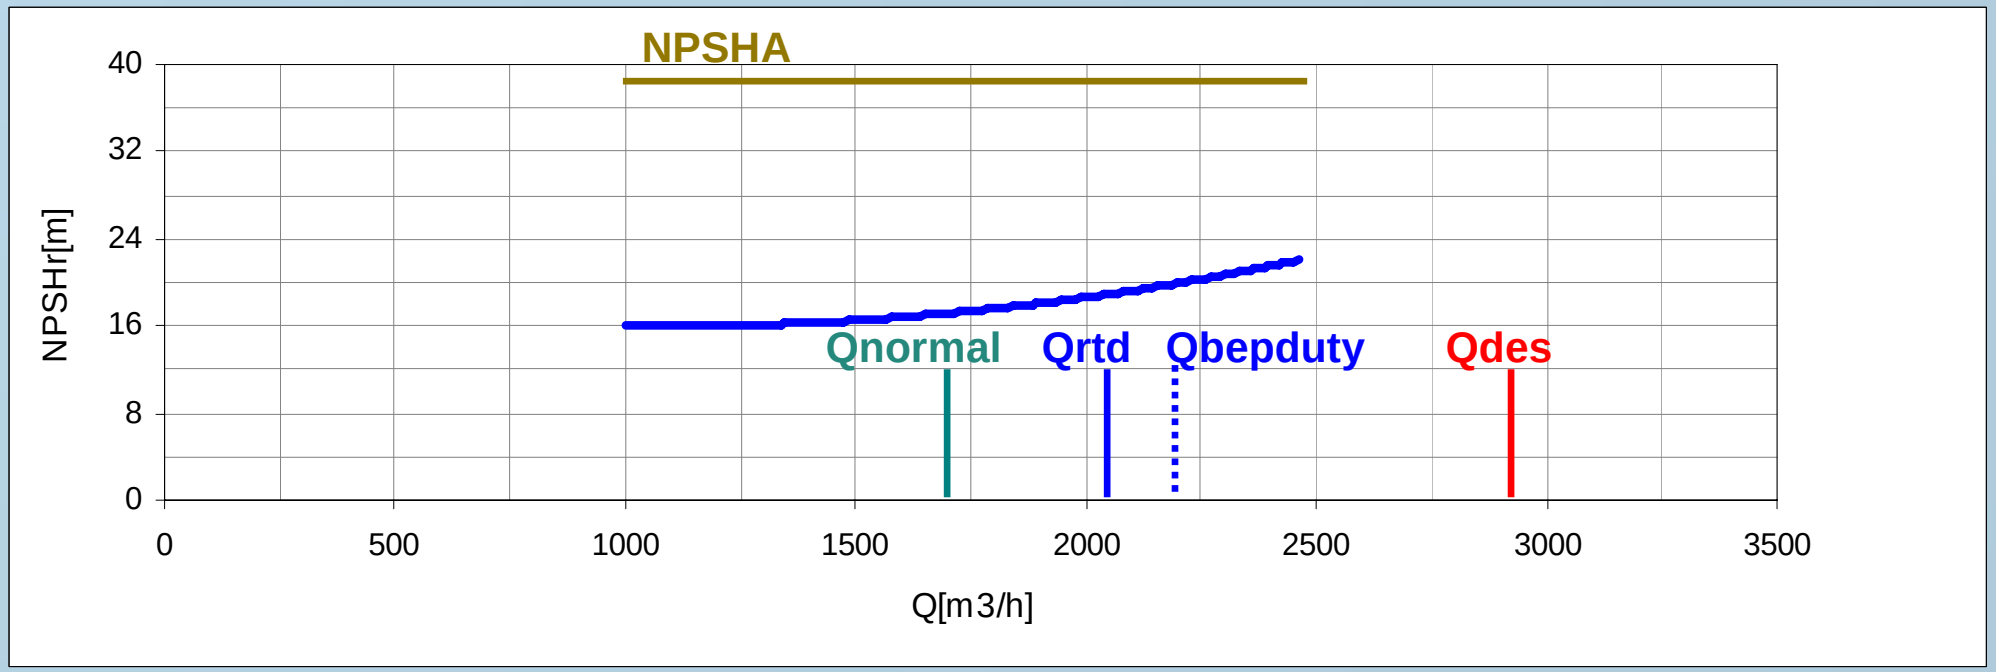
Test Curves

Qn = 59% of Qdes – RED FLAG

Qnormal / Qrs = 0.82

Suction recirculation is root cause of vibrations

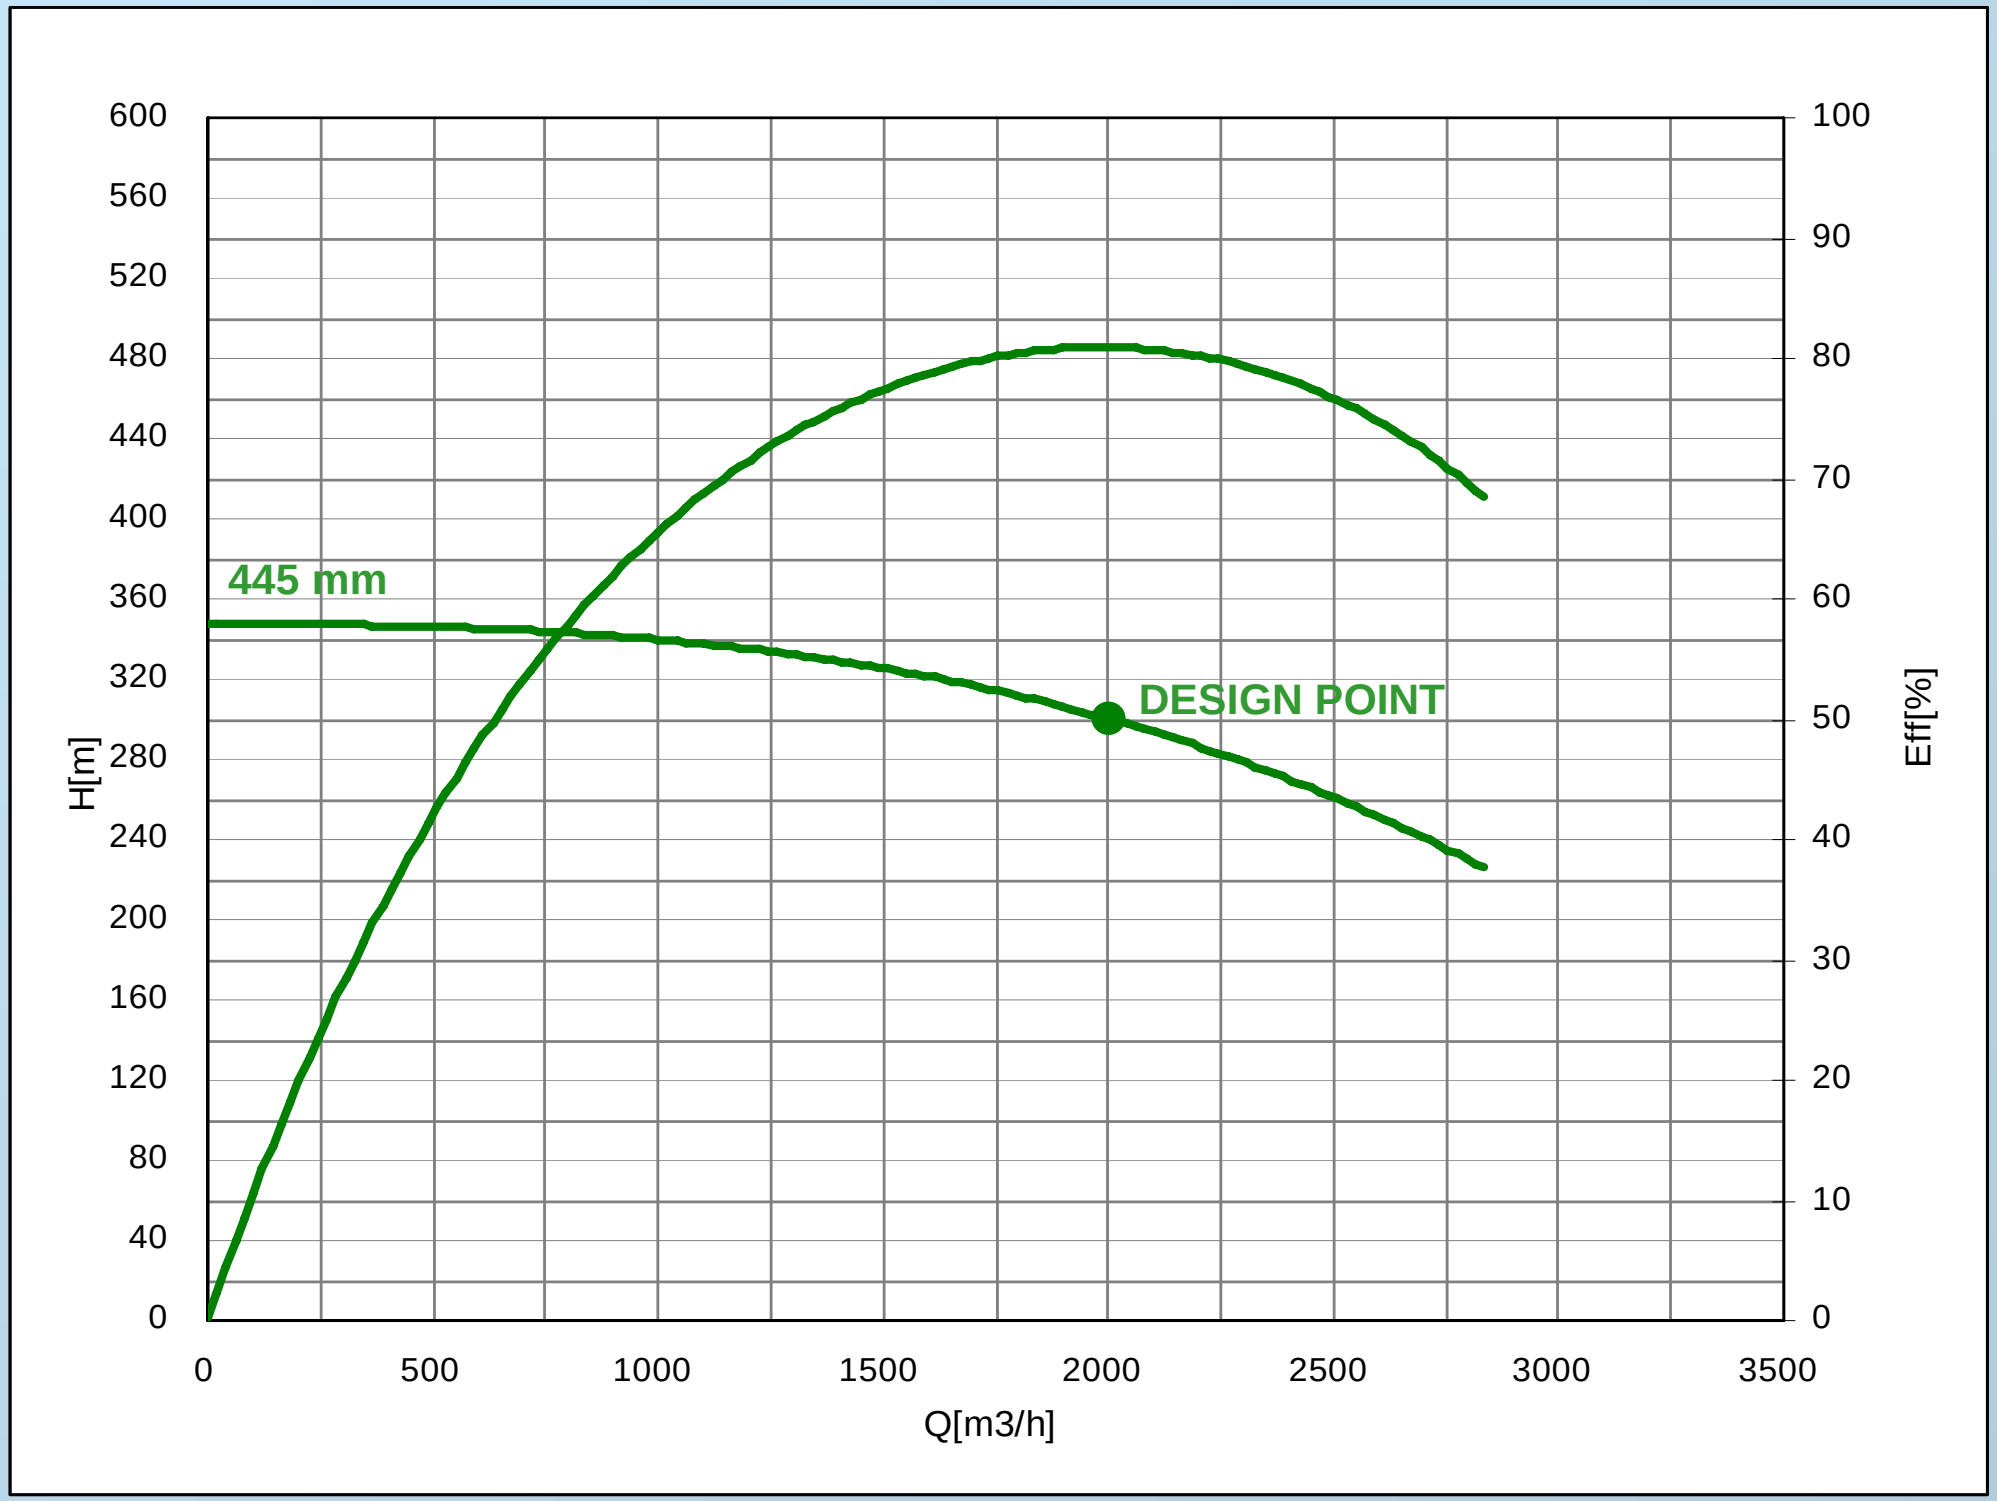
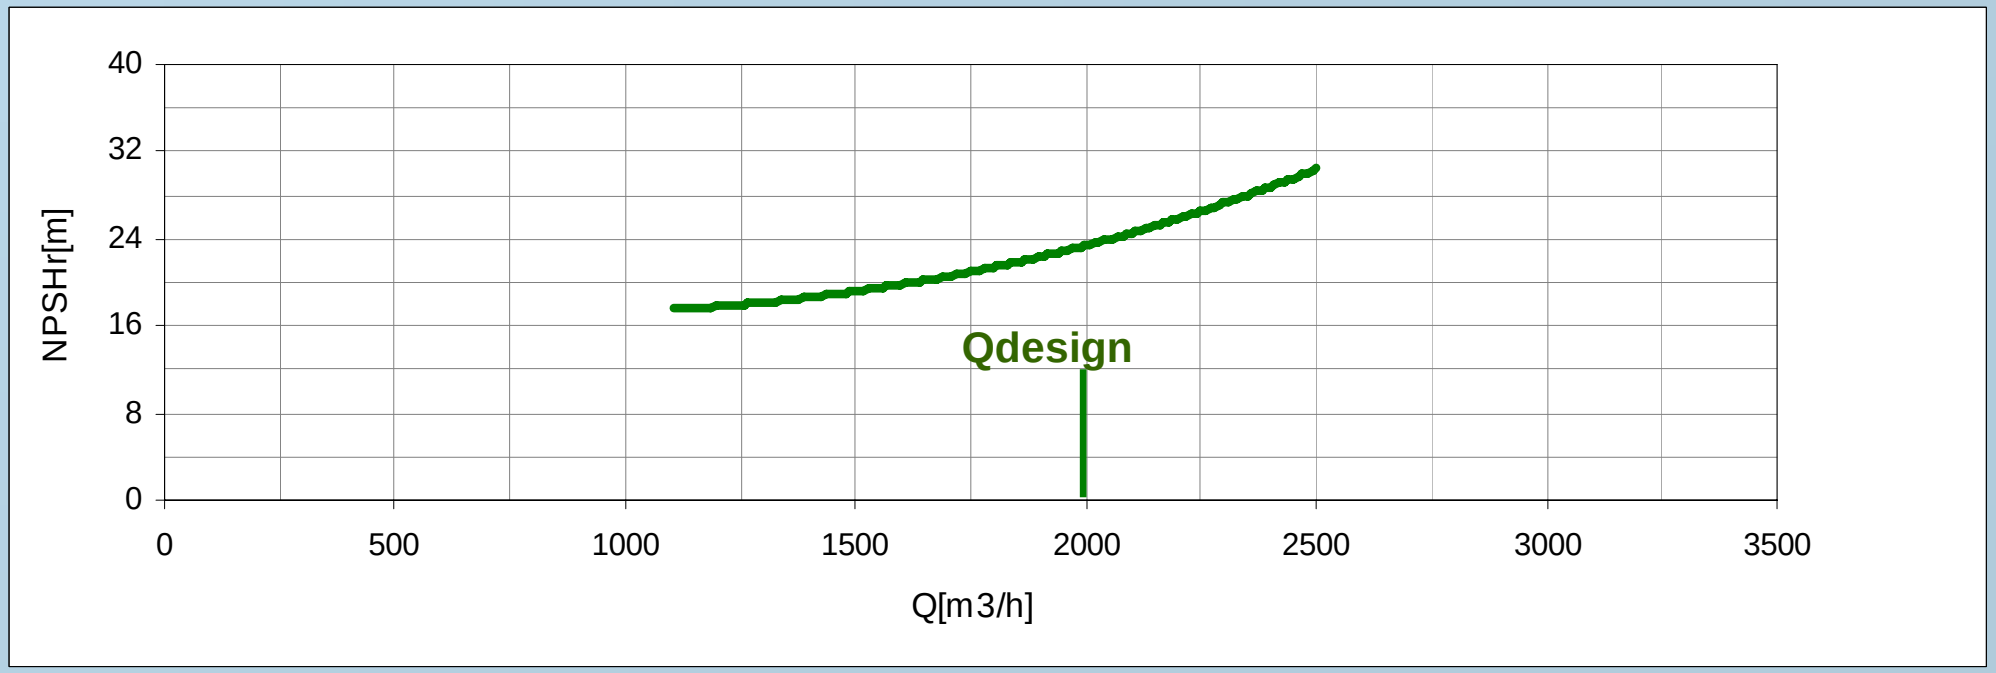
Expected Curves

Qrs/Qsl = 0.66

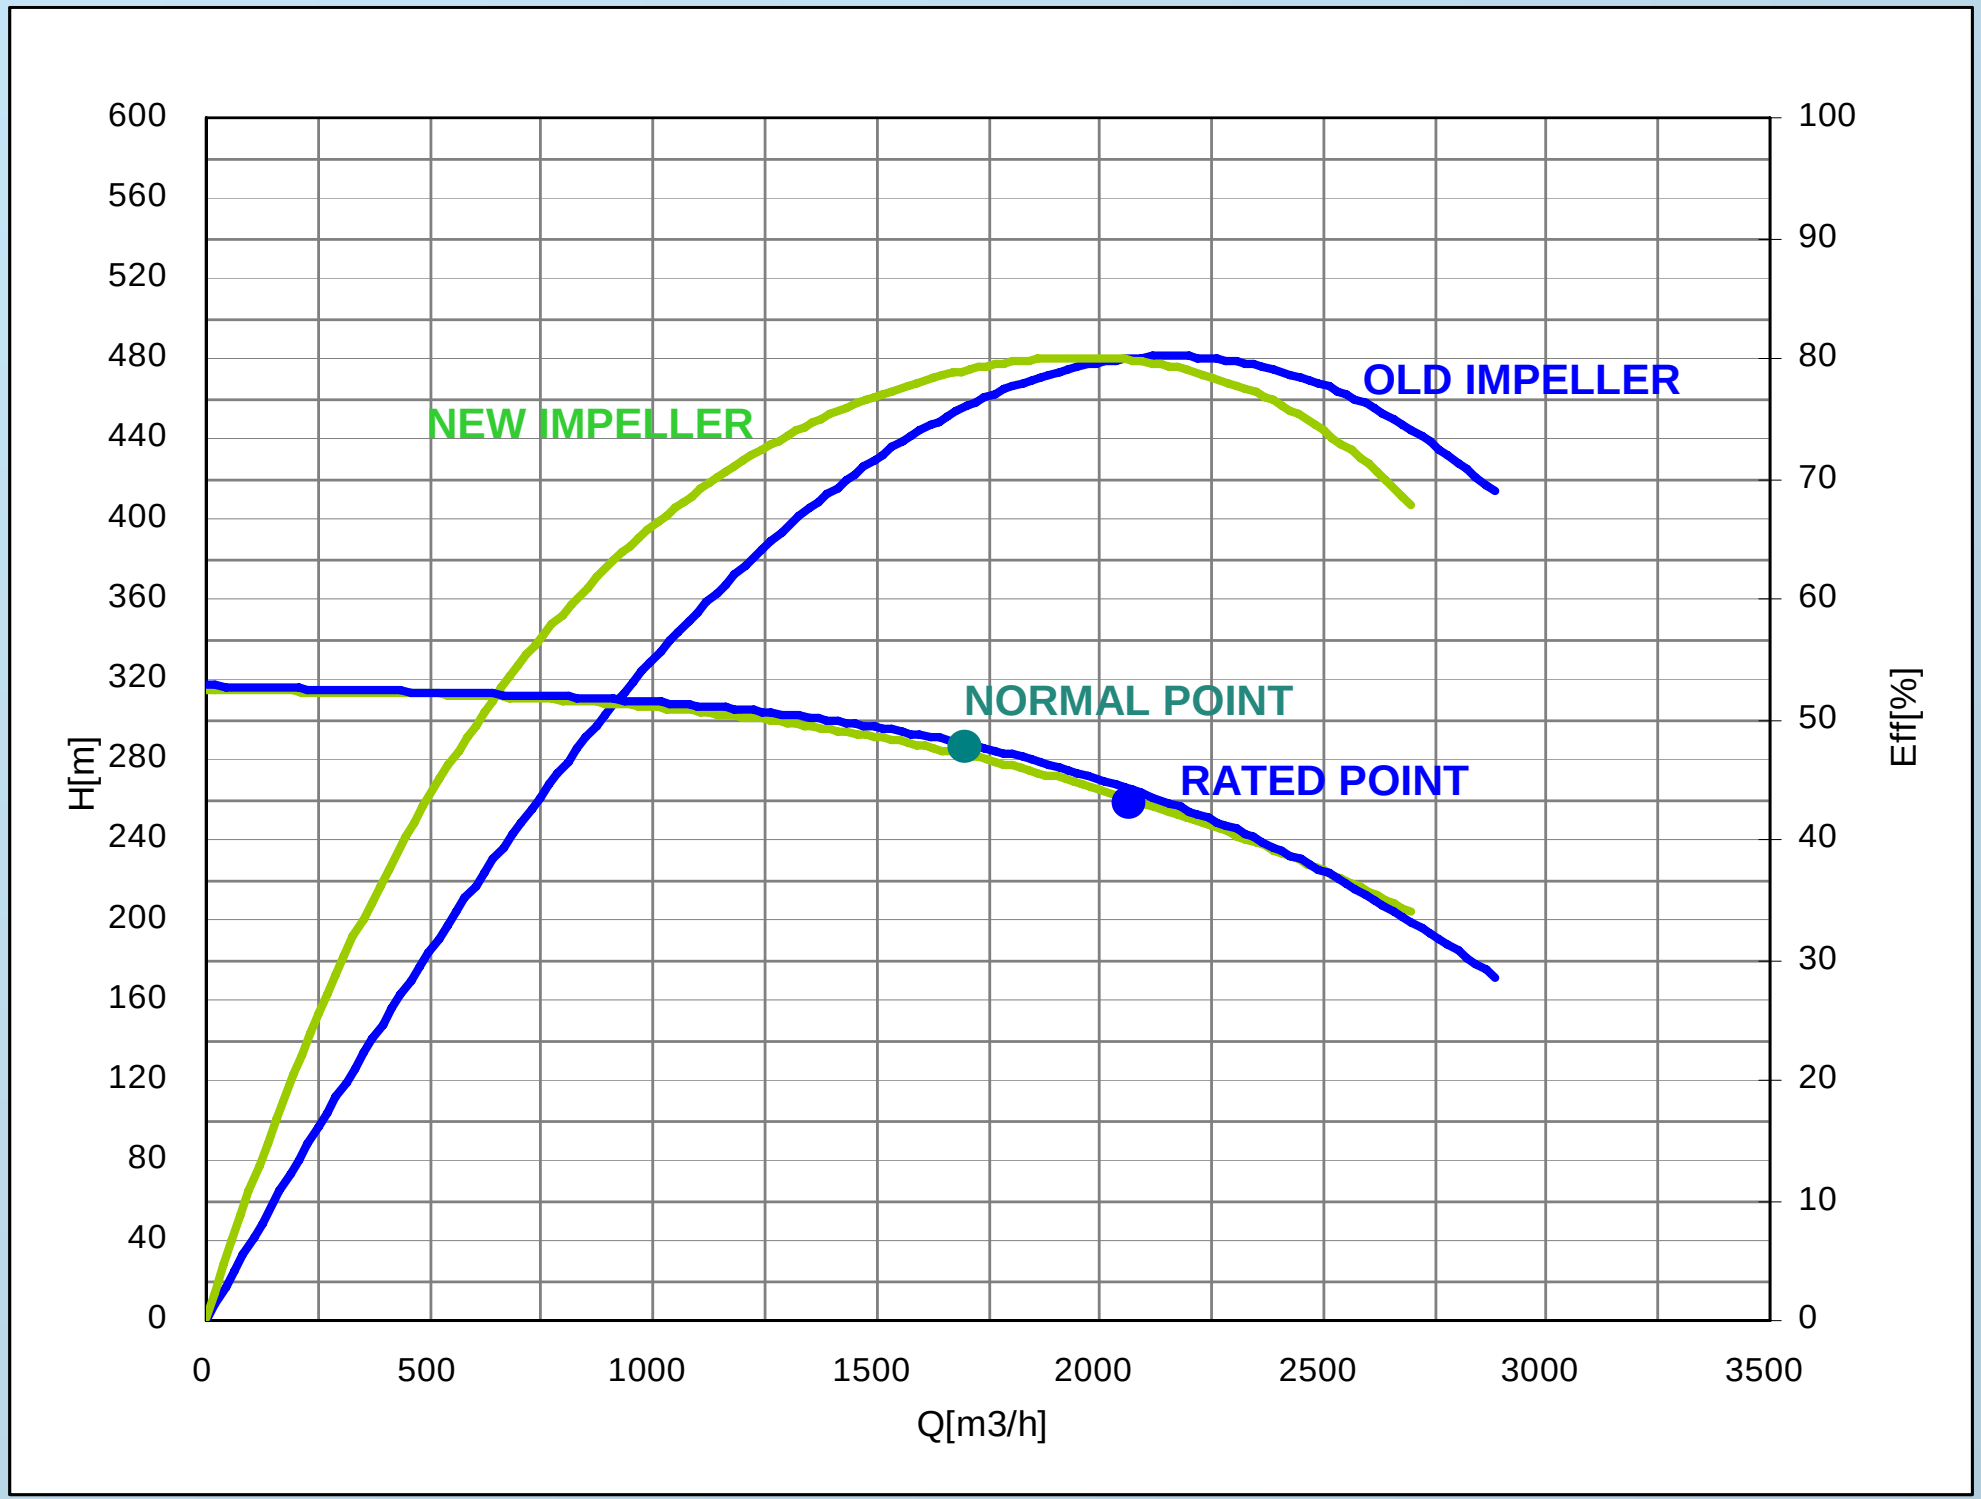
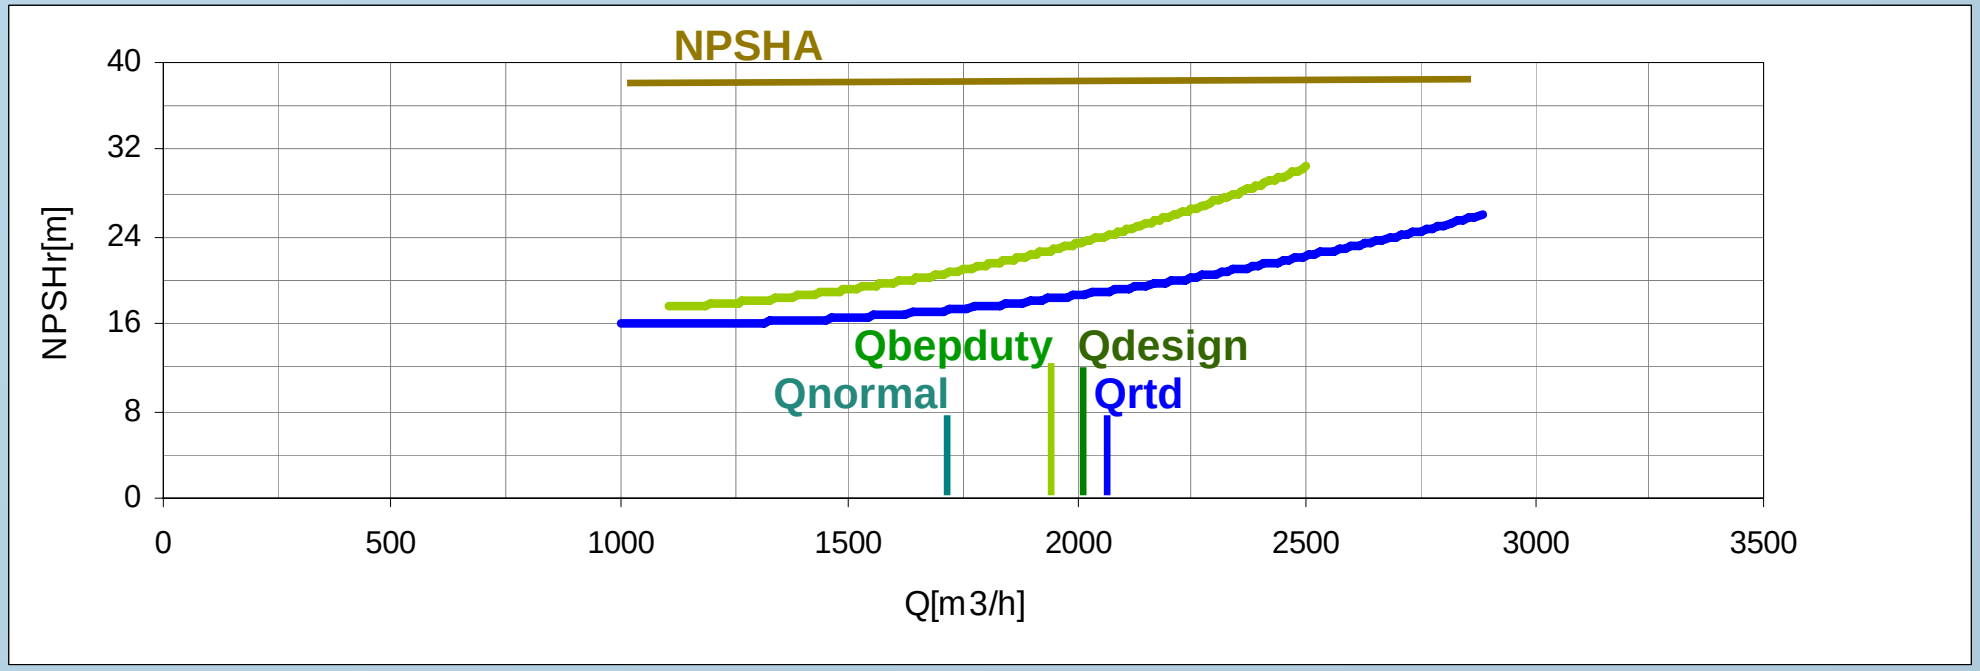
Expected versus Test Curves

The incidence is near to the shockless condition for the rated capacity . Also it is far below the critical value (causing flow separation and suction recirculation) for the normal point

No suction recirculation
