Fast and Ultimate Vibration Field Solution: From Problem Detection to Field Performance Validation

G. Cicatelli, G. Panceri, A. Scotti
Flowserve Corporation - Italy

26th International Pump Users Symposium
March 15 - 18, 2010
George R. Brown Convention Center
Houston, Texas

Description of the problem

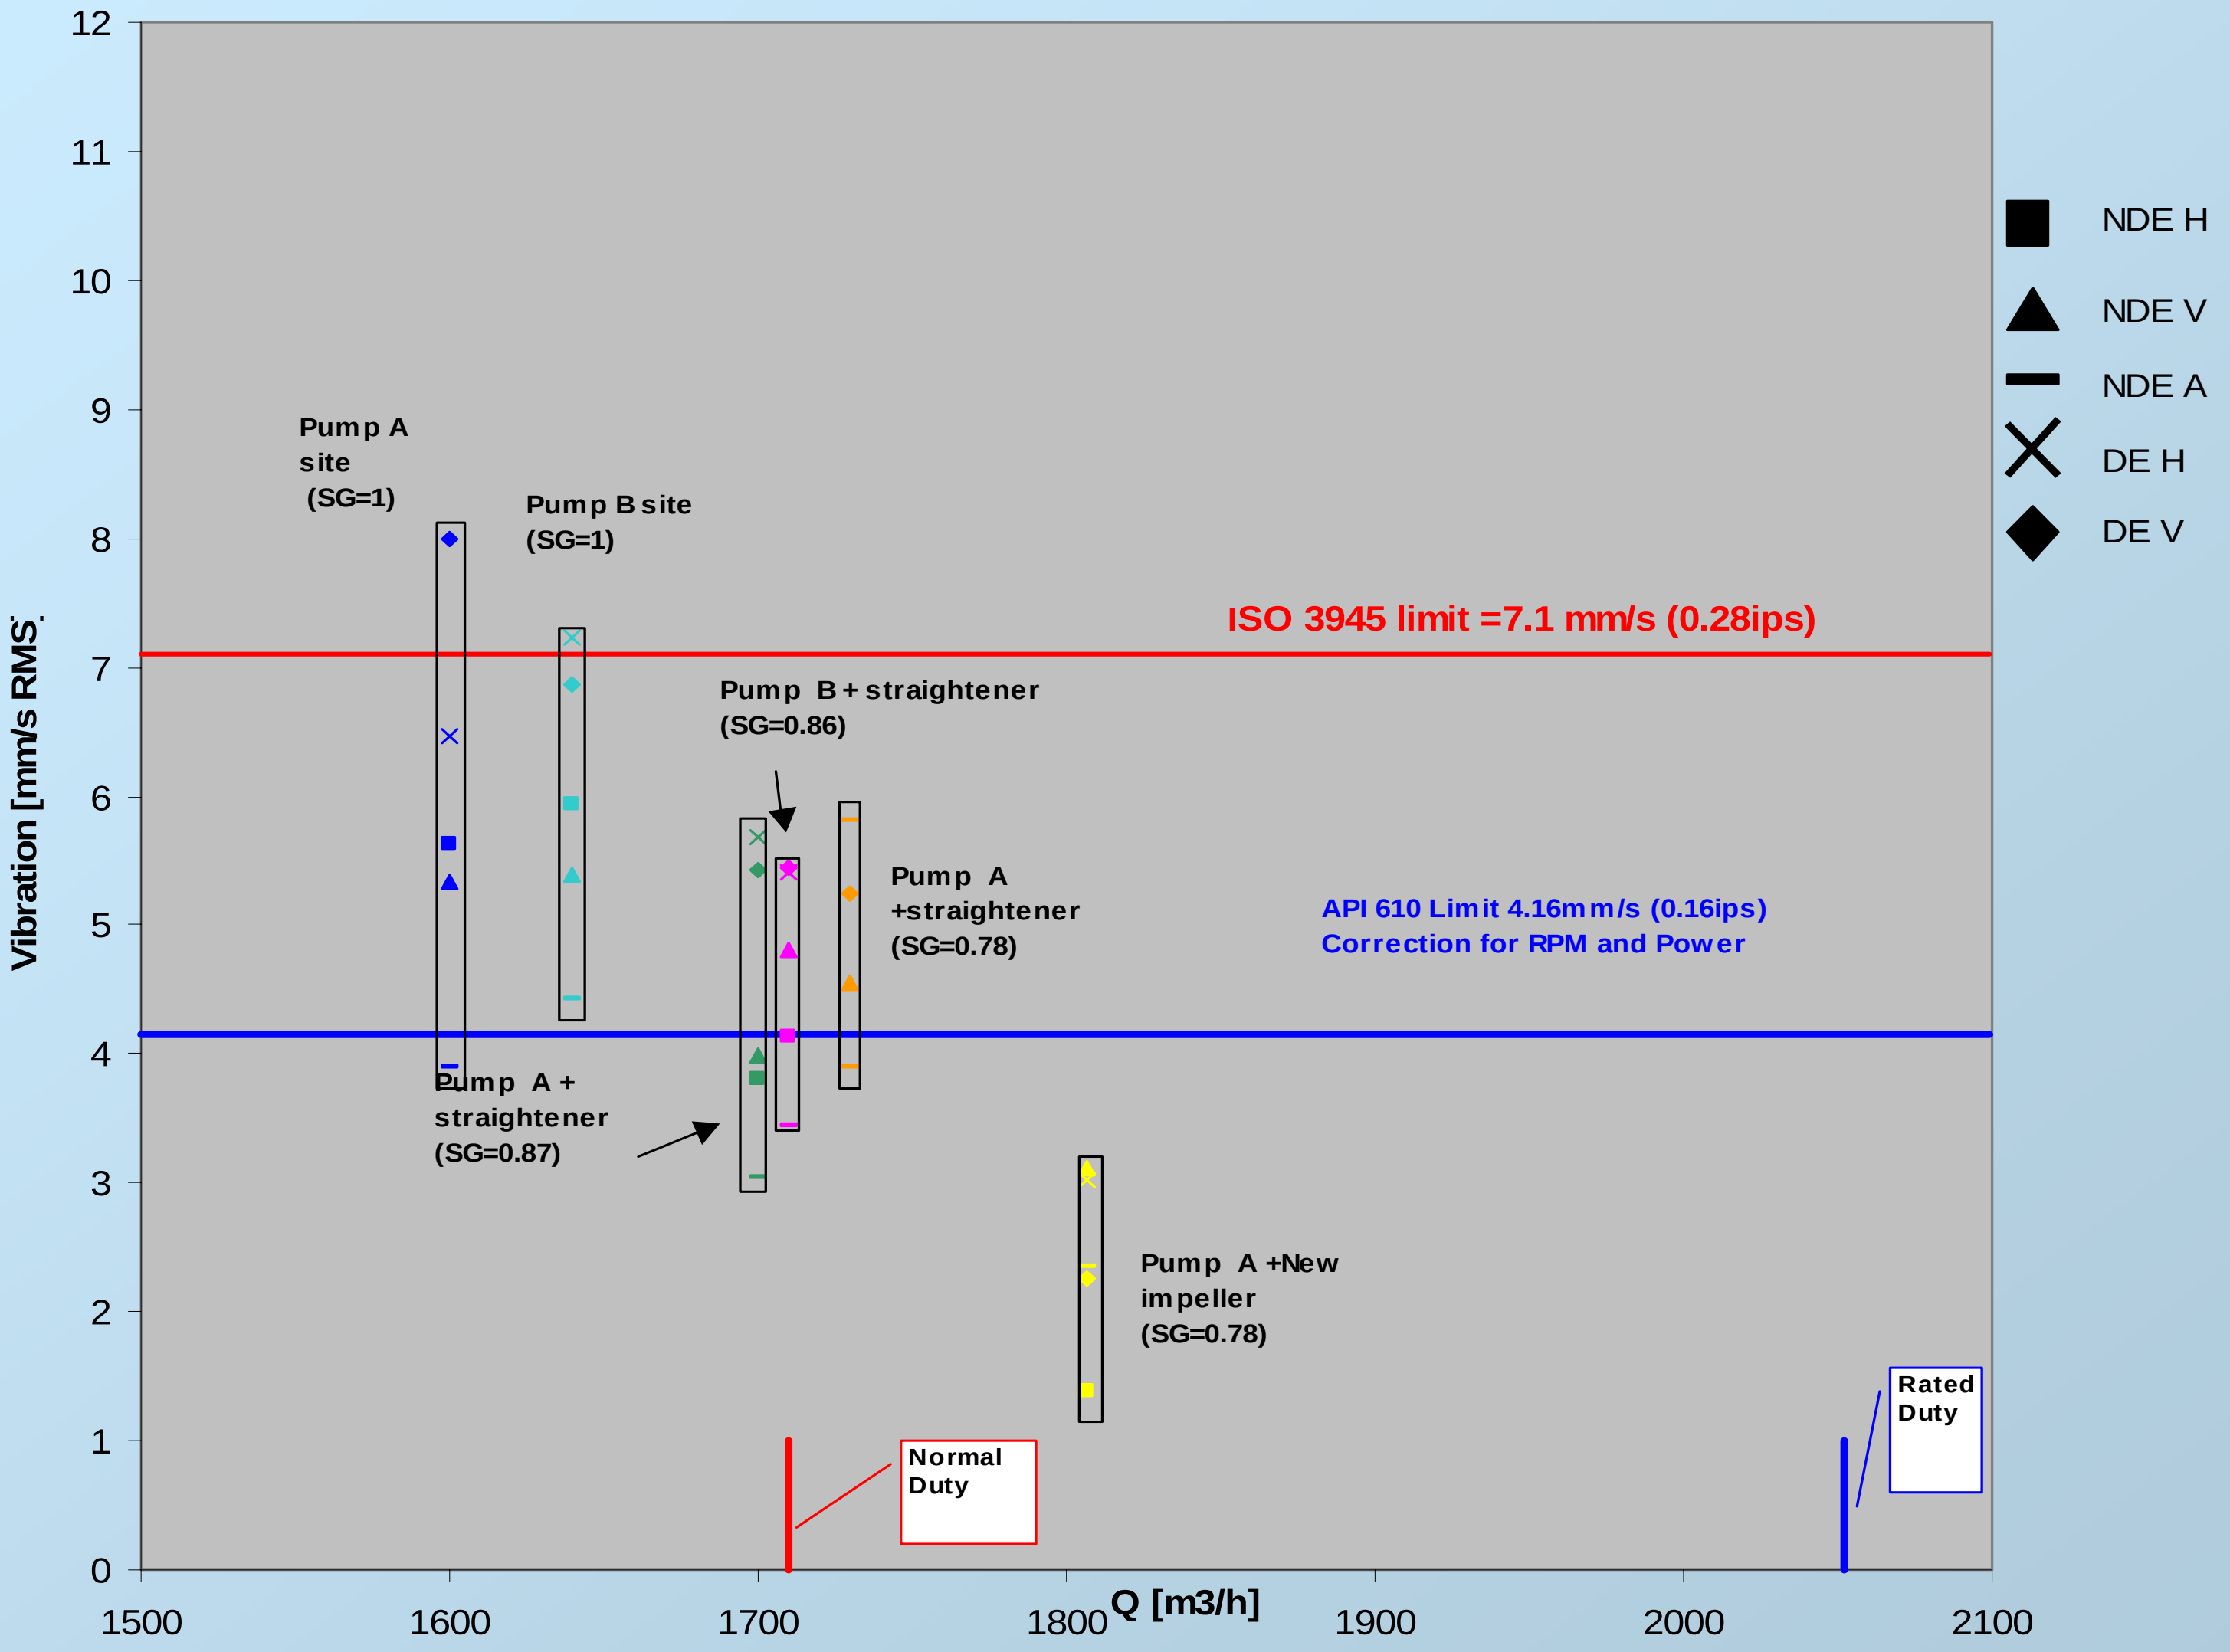
Preliminary field results pump A
(July 2009)

Pump accepted : August 2009 **Plant released to full production : September 2009**

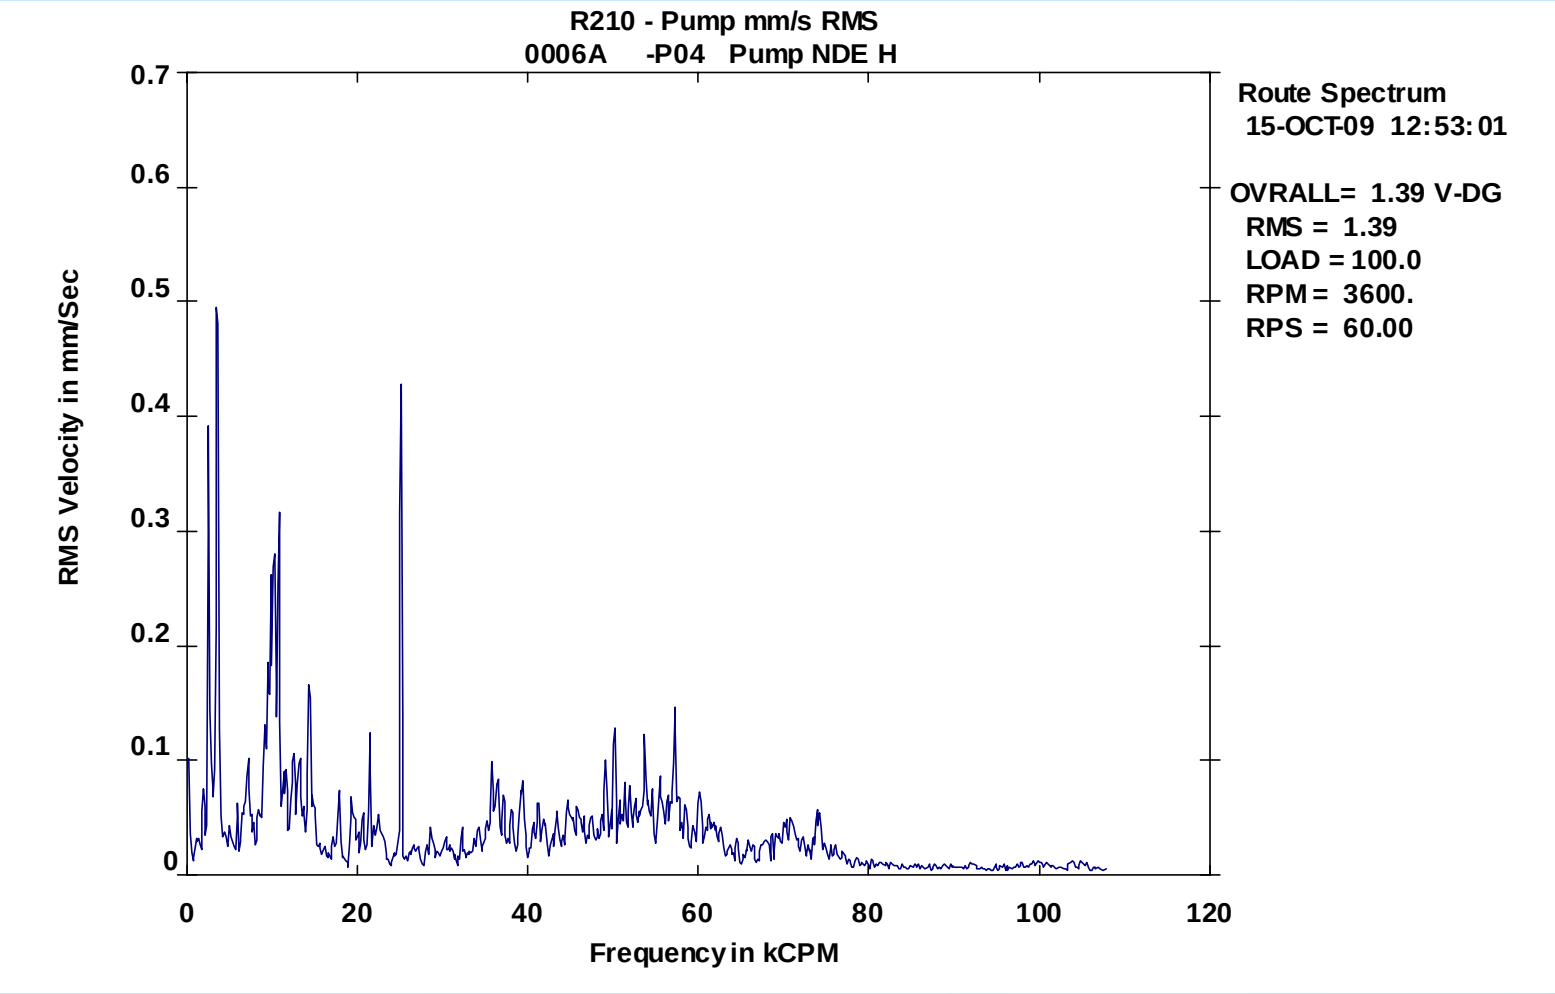
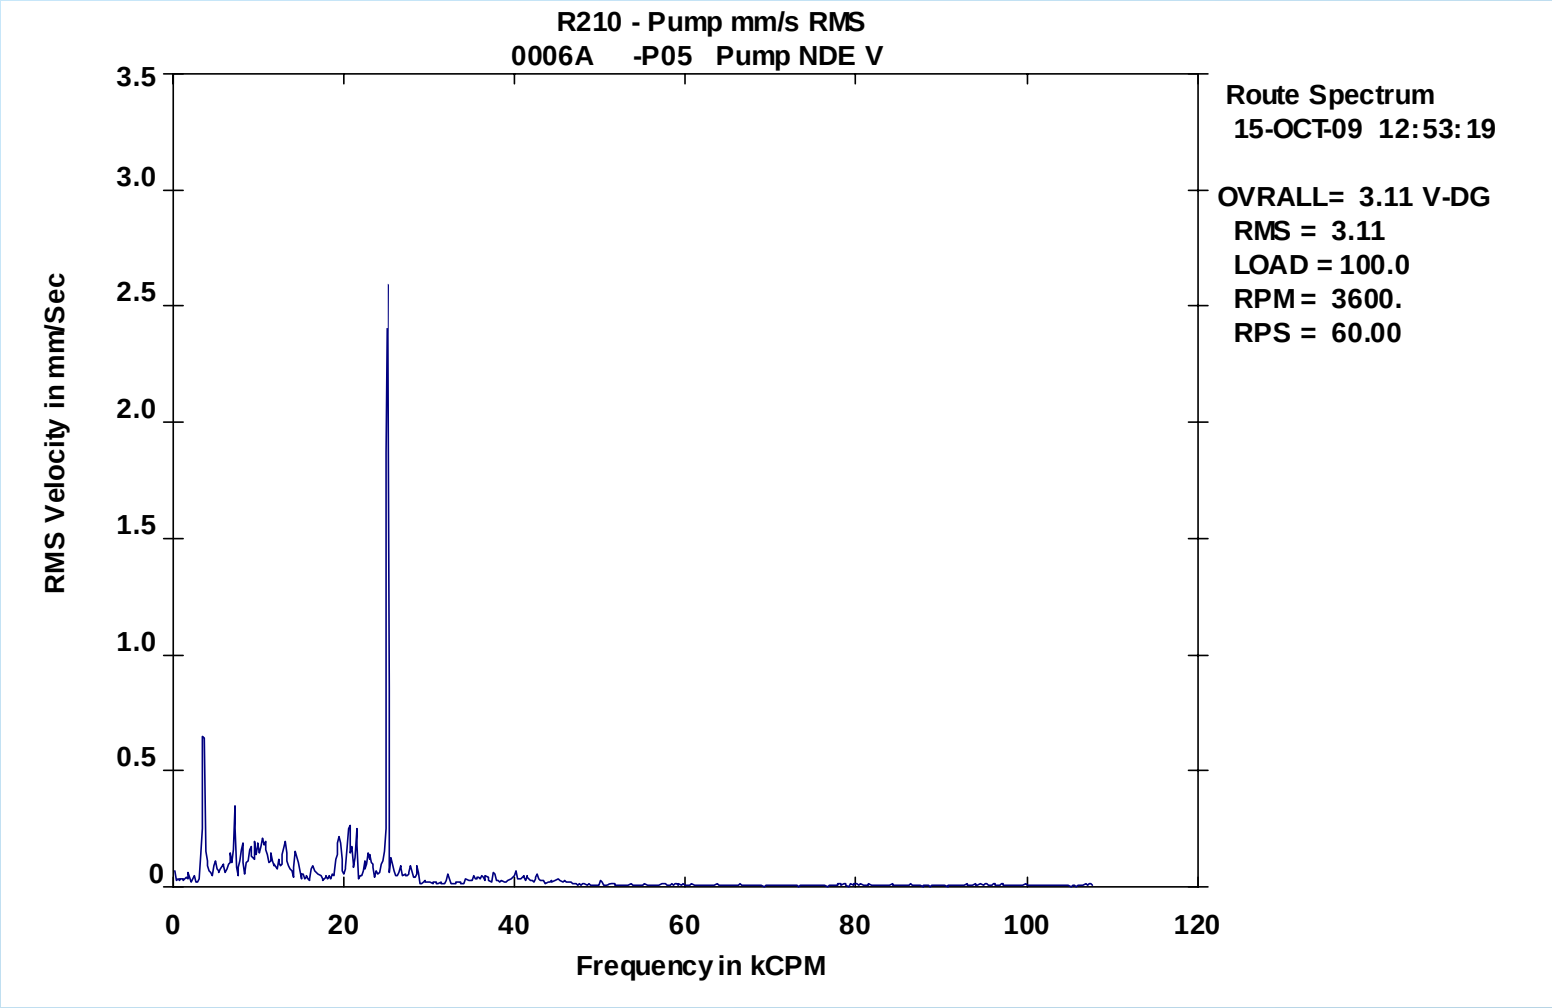
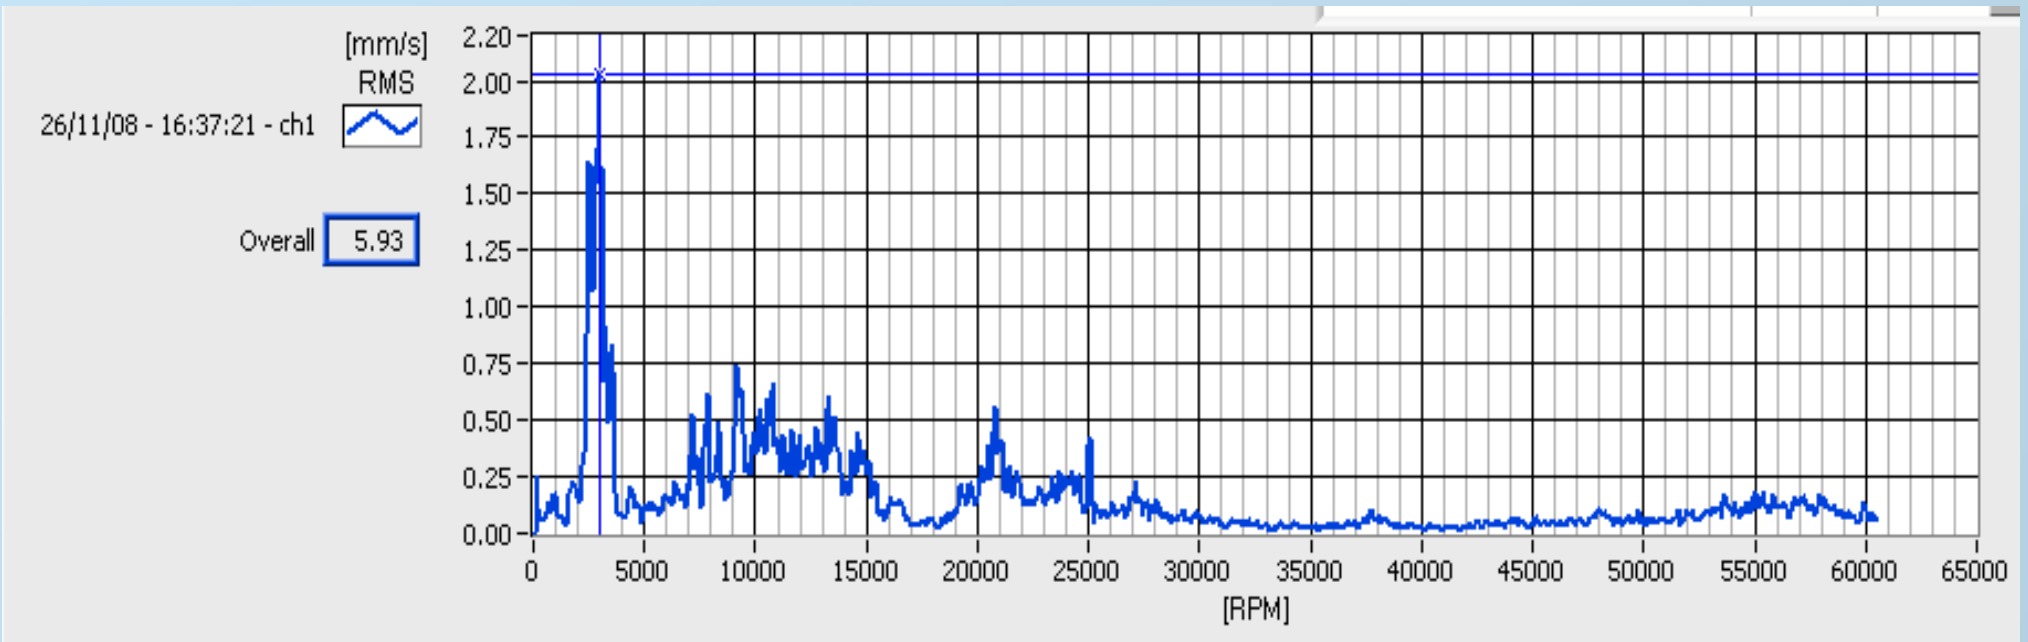
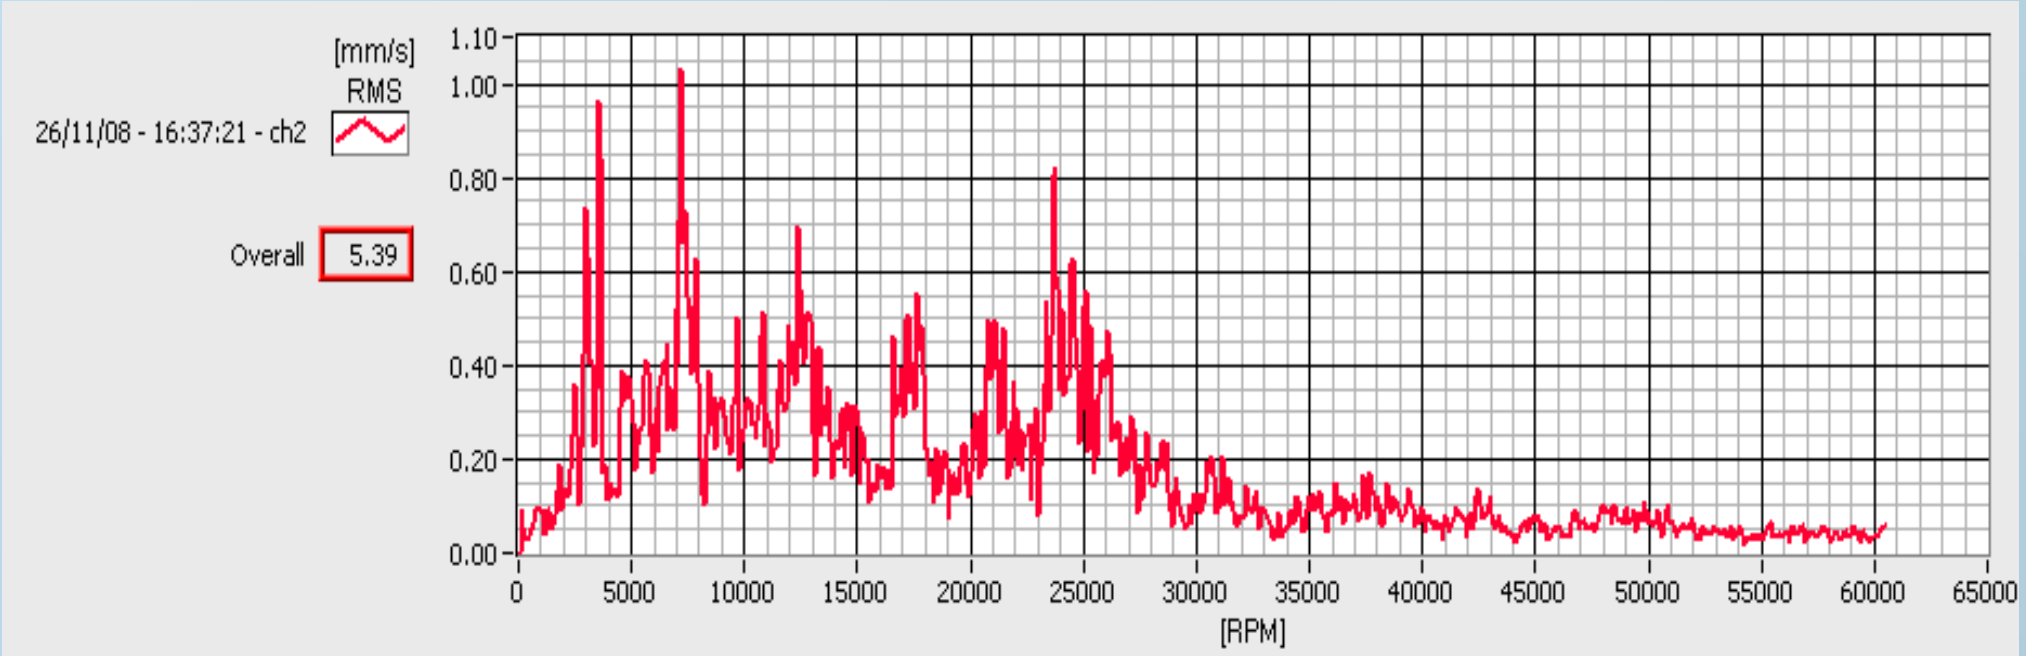
Field data comparison at normal capacity NDE (October 2009)

Old	New
H mm/s(ips)	5.93 (0.23)	1.39 (0.05)
V mm/s(ips)	5.39 (0.21)	3.11 (0.12)

A new impeller was designed with geometry fully optimized for the intended operating range , particularly the inlet geometry (customized design).

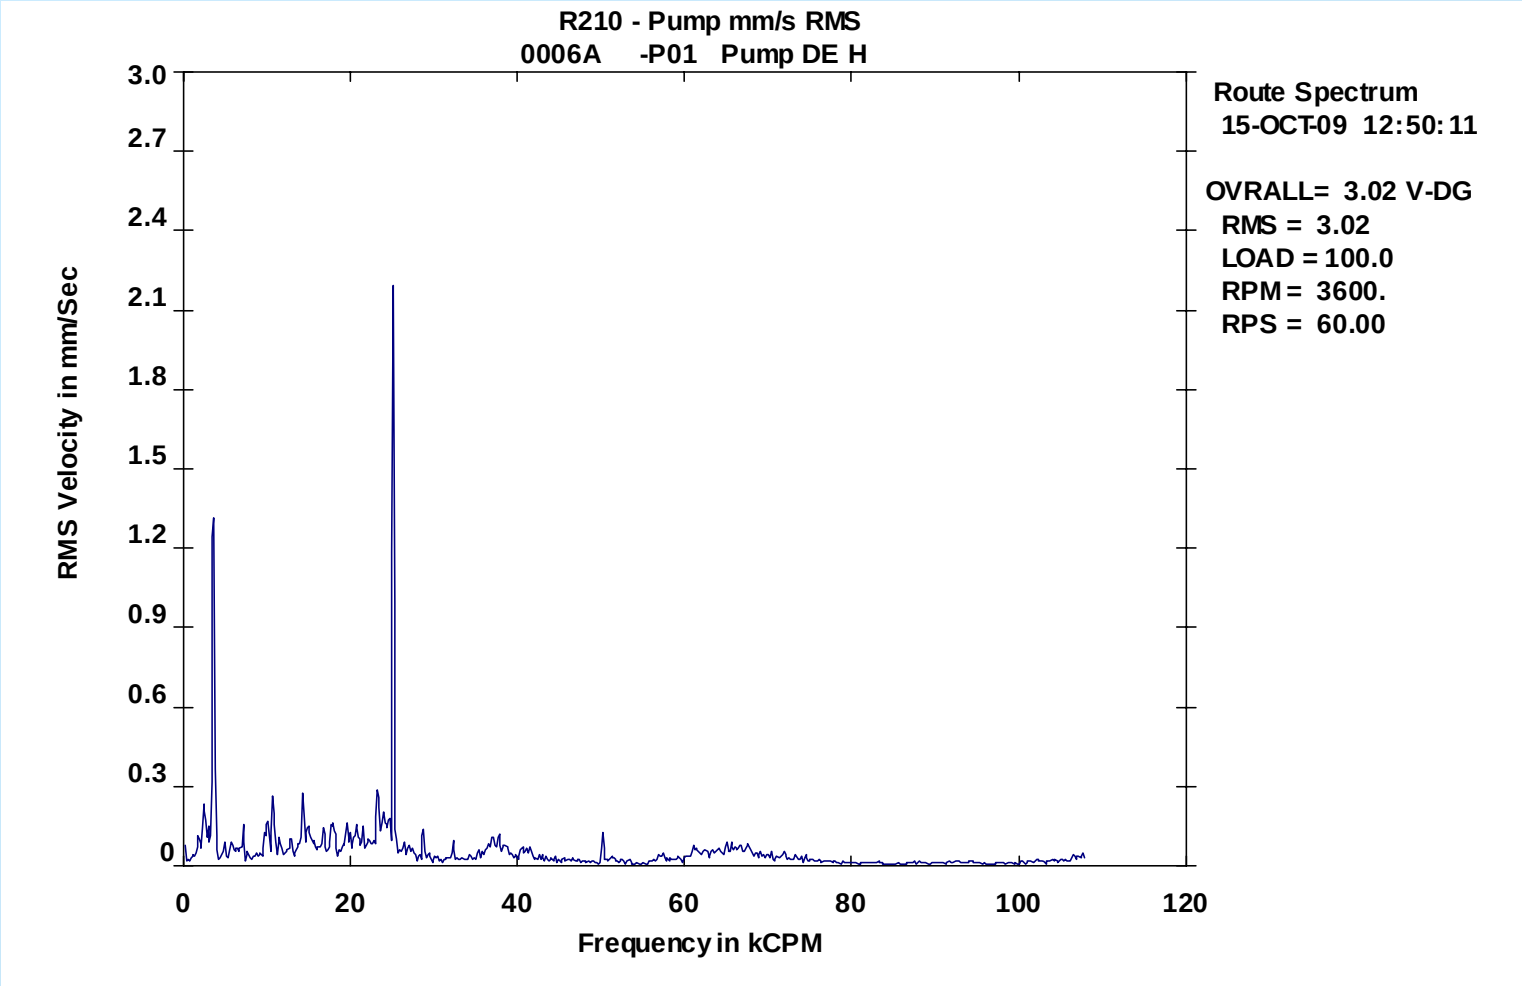
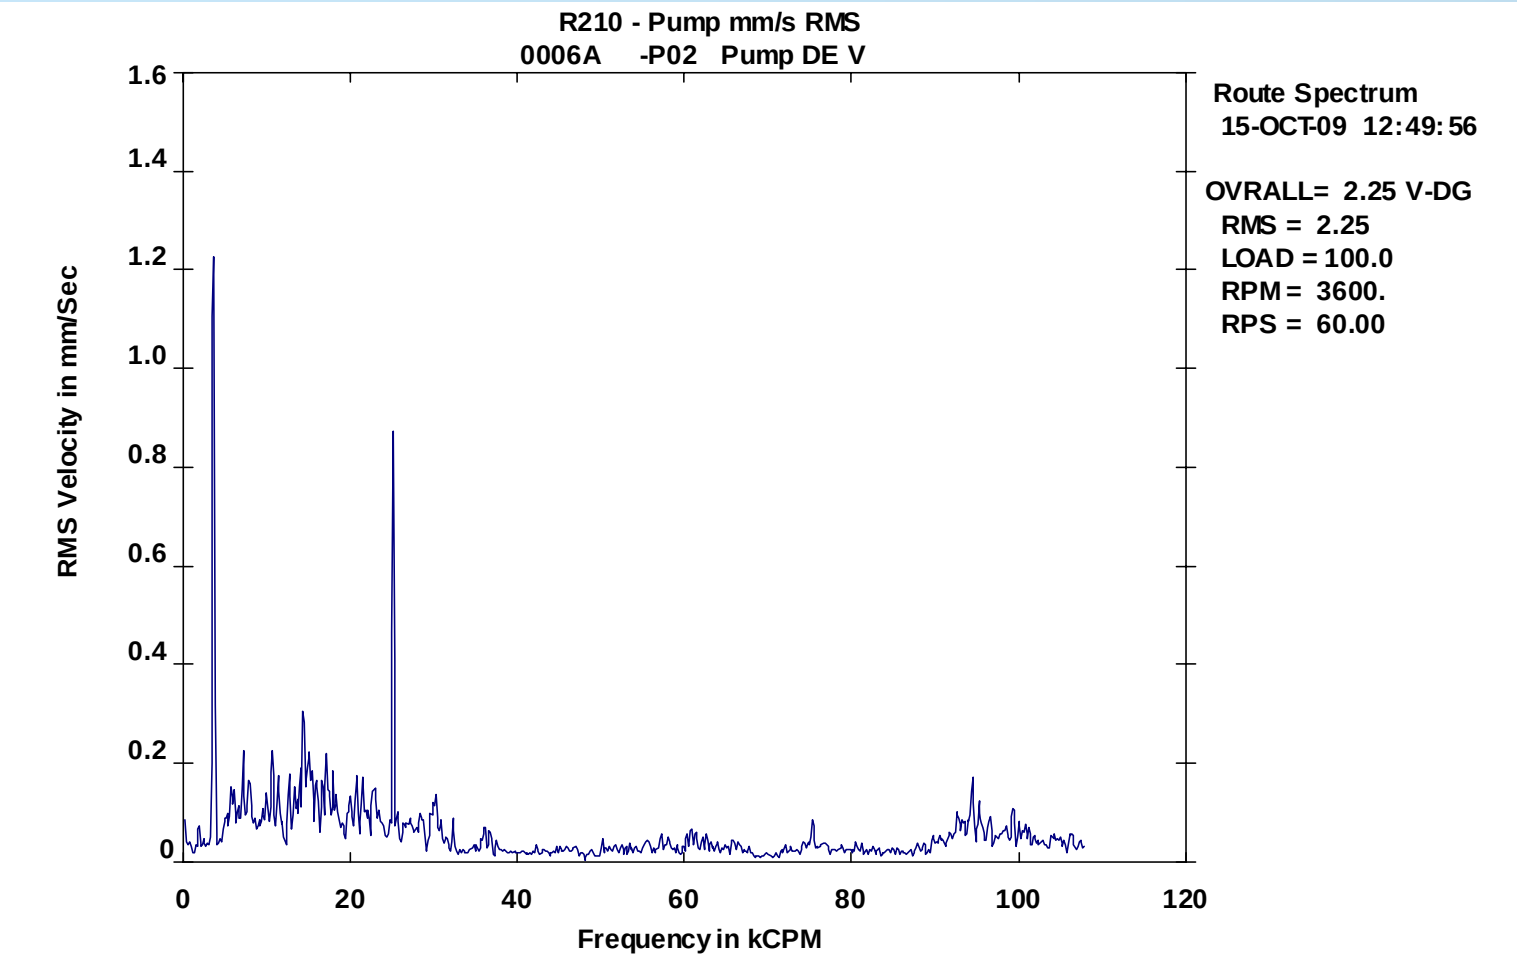
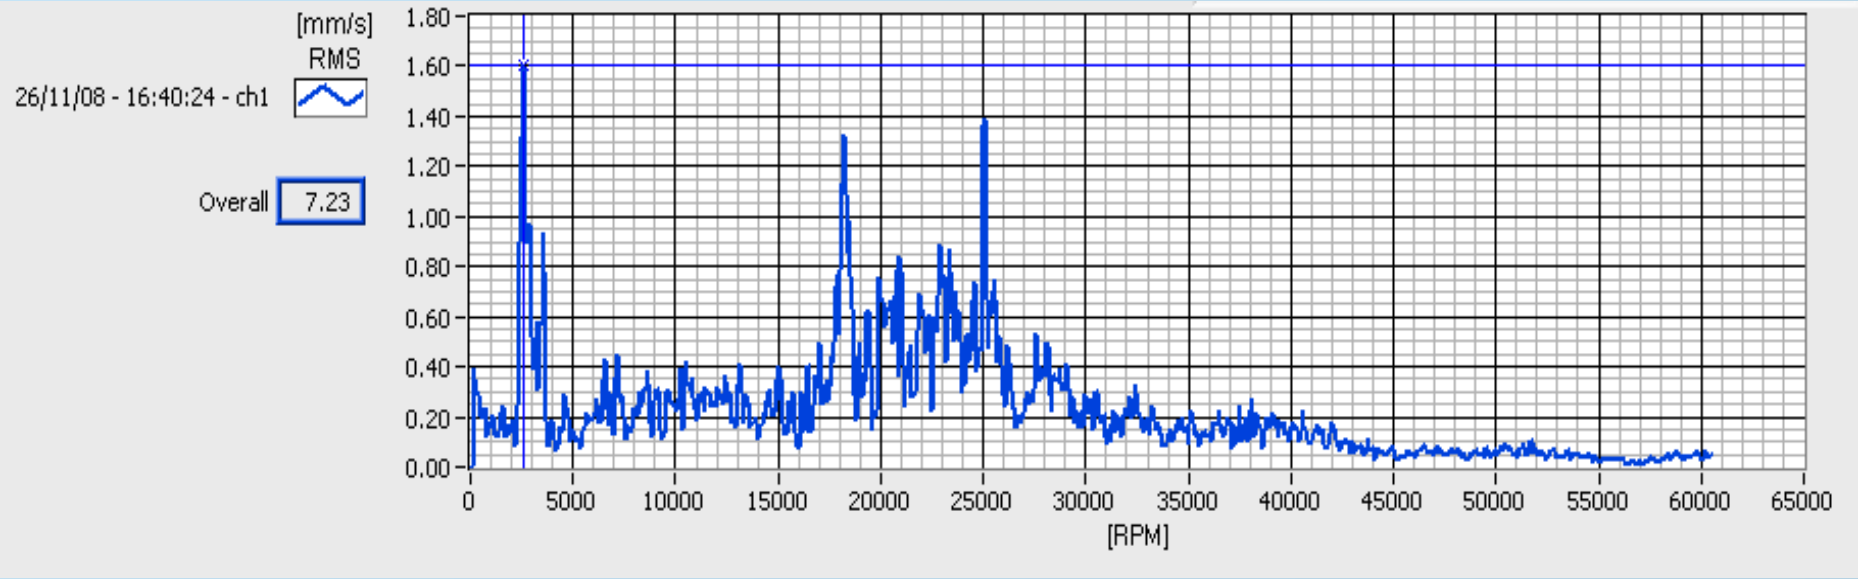
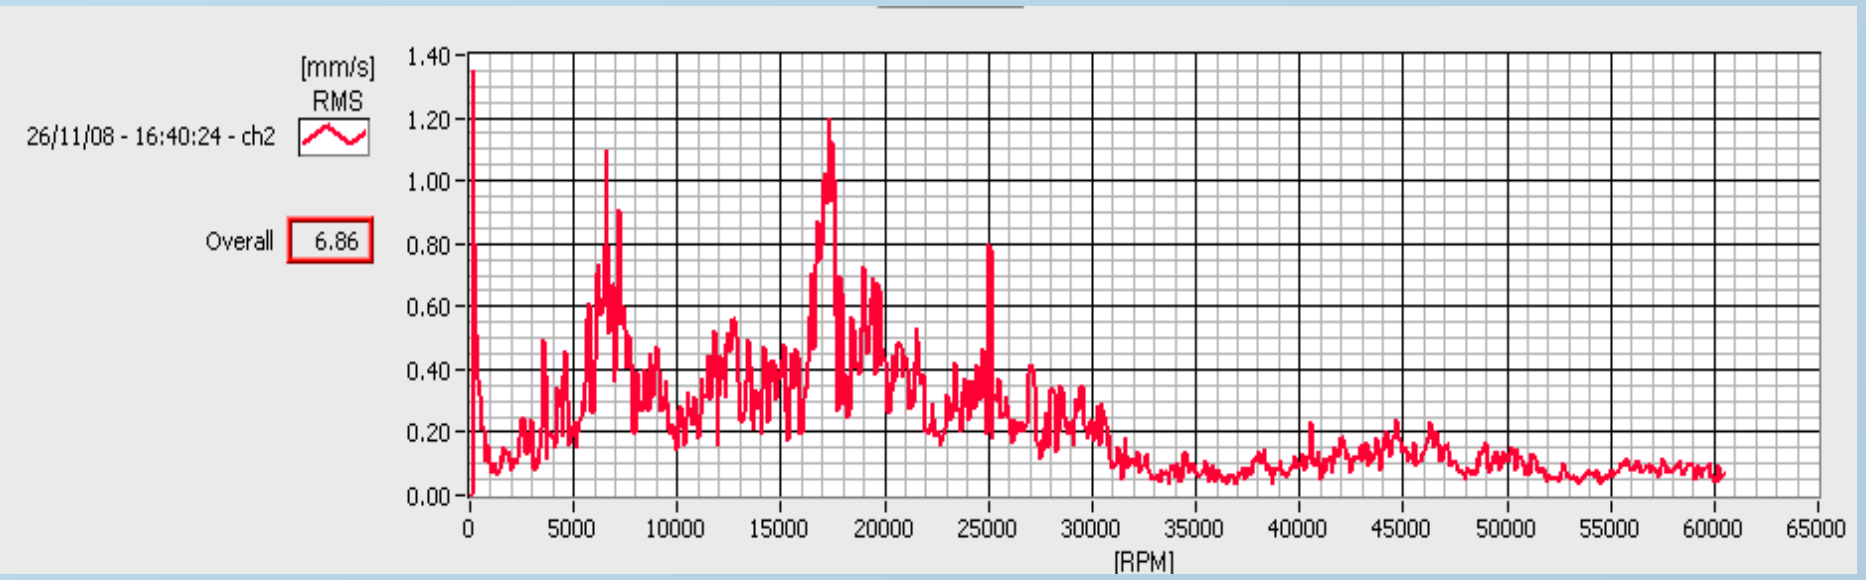
DE (October 2009)

Old	New
H mm/s(ips)	7.23 (0.28)	3.02 (0.12)
V mm/s(ips)	6.86 (0.27)	2.25 (0.09)
