ON-SITE DETERMINATION OF THE CONTROL LINE FOR INTEGRALLY GEARED COMPRESSORS FOR AVOIDANCE OF IMPELLER FATIGUE FAILURES

ABSTRACT

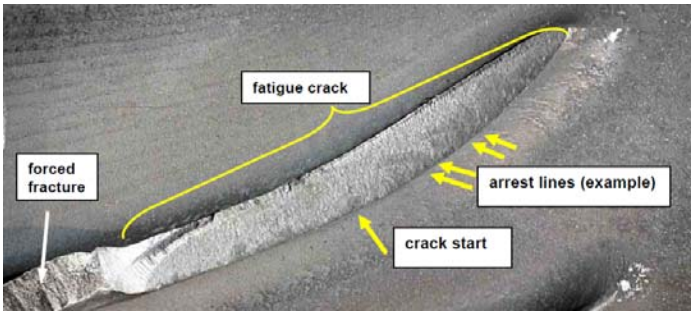
Figure 3: Photography of crack surface

The fracture surface of the failed impeller shows macroscopic characteristics of a fatigue fracture, cf. Figure 3. The crack start is located at the blade surface on the suction side, approx. 8 mm above blade ground and approx. 57 mm apart from the inlet edge. Referring to the direction of rotation, the crack started at the back side of the blade. The whole length of the fatigue crack is 88 mm.
6 arrest lines were counted on the fracture surface. The whole fracture surface is very smooth. The crack starts in the near of a machining mark and follows it at the blade surface till transition to forced fracture.
Material imperfections or corrosion in the near of the crack start were not found.

A machining imperfection, which was found at the blade root, determines only the ***location*** of crack initiation, but is not considered as the root cause of the failure.

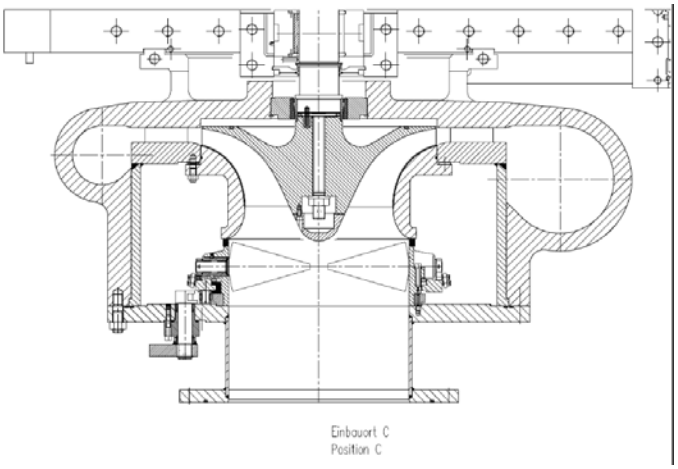
Figure 4: Compressor cross section

A cross sectional view of the compressor is shown in Figure 4 zooming in on the 3rd stage. This view indicates the variable inlet guide vanes (IGV) in front of the impeller as well as the vaned diffuser, which is of the low solidity type (LSD). A contour ring secures a low tip clearance of the semi-open impeller.

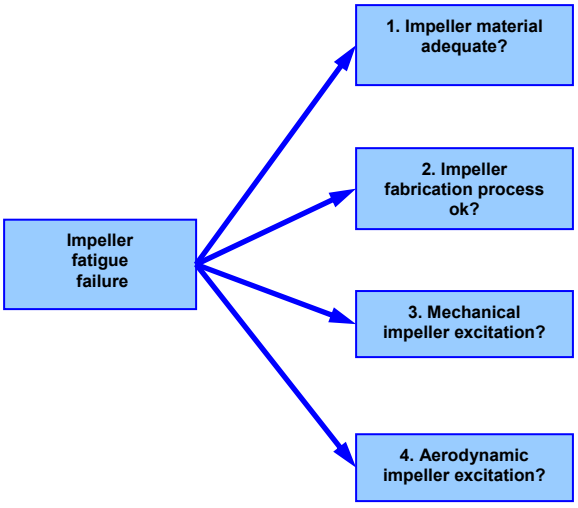
Figure 5: Failure tree for impeller fatigue failure

Different methodologies may be applied for a systematic and comprehensive root cause analysis. The authors have good experience with the failure tree, which is basically the same as the fishbone method or the cause and effect diagram.
The failure tree as shown in Figure 5 covers the main topics for an impeller fatigue failure.

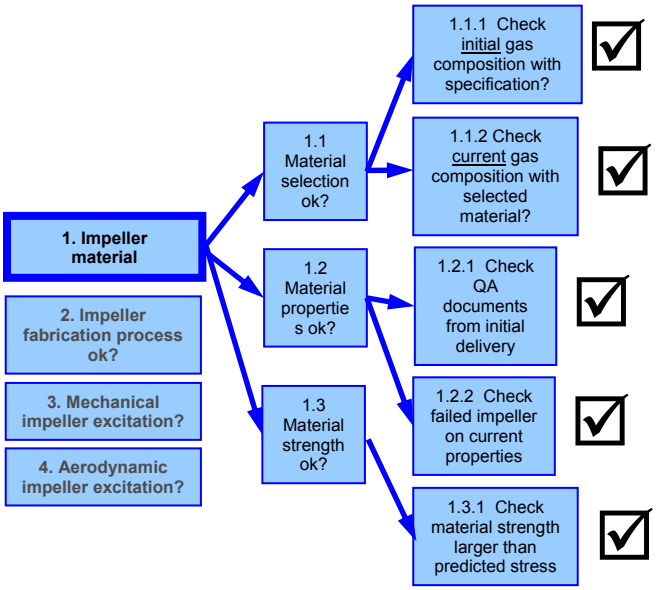
Figure 6: Impeller material topics

The first topic 'Impeller material adequate?' shall verify, whether the impeller material was suitable for this application. The potential causes for inadequate material are depicted in Figure 6. All sub-topics were checked and no indication was found, that the root cause of the failure was due to inadequate impeller material.

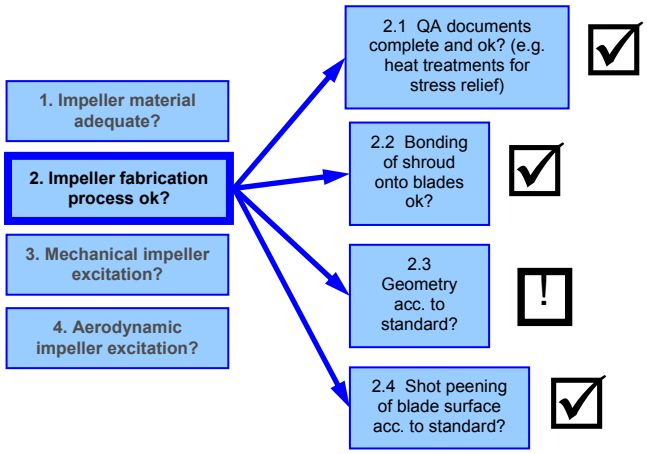
Figure 7: Impeller fabrication topics

The second topic 'Impeller fabrication process ok?' shall verify, whether the impeller manufacturing process could have initiated the failure, cf. Figure 7. In fact, a machining mark was found at the blade root, but this determines only the *location of crack initiation* and is not considered as the root cause of the failure. Such a machining mark occurs unavoidably at the transition from flank milling of the blade to the radius at the blade root and is present on all milled impellers without causing trouble. On the basis of a huge available reference base it can be concluded, that another mechanism than stress concentration by the machining mark must have led to the failure. Naturally, any crack will have its origin in either a material inhomogeneity or in a geometry imperfection, both being unavoidable in a real world and harmless, if of minor extension.

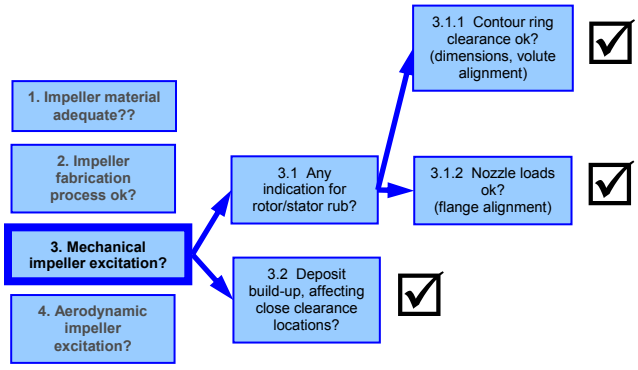
Figure 8: Mechanical impeller excitation topics

The third topic 'Mechanical impeller excitation?' shall verify, whether there is any evidence that a mechanical impeller excitation could have been the excitation source leading to the fatigue, cf. Figure 8. In particular a possible rotor/stator rub must be considered, if the clearance of the contour ring was not properly set or if unexpected high pipe deformations generate large nozzle loads, which in turn can deform the volute and bridge the gap between blade and stator. Such a rub can cause a broad-band excitation and the location of excitation at the blade tip is ideal to excite the first blade bending mode shape. However, in this case no indication was found at all pointing to a rub as root cause. The damage found at the contour ring was evaluated as consequential damage of the blade failure.

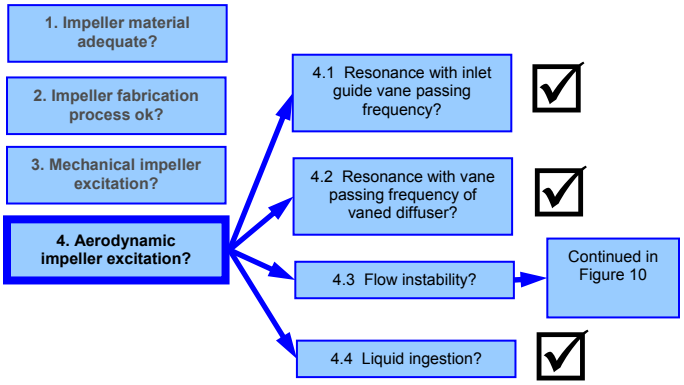
Figure 9: Aerodynamic impeller excitation topics

The fourth topic 'Aerodynamic impeller excitation?' (Figure 9, Figure 10) requires input from dedicated analysis.

Before we turn our attention to sub-topic 4.3 of Figure 9, we can quickly resolve sub-topic 4.4 ‘Liquid ingestion?’. If liquid is swallowed by an impeller, e.g. due to condensate being accumulated during stand-still in a piping sag, strong blade excitations will occur. In the current investigation no evidence of liquid ingestion was found, so that this topic can be ruled out as well.

The sub-topic 4.3 of Figure 9 ‘Flow instability’ is the most complex one of all the listed sub-topics. For a better understanding of the criticality of different operating conditions an excursion is made at this place to results from R&D testing. With the awareness of these R&D results we afterwards will step back into the RCA.

With these insights from analysis of trend data and from review of the commissioning data we can eventually step back into the RCA, where we stopped at sub-topic 4.3 of Figure 9.
We know that the surge line was determined on-site according to common practices. In the post-failure analysis indications of flow instabilities could be detected already before the whole unit went into deep surge. By an excursion to R&D results it was shown that in particular in this region flow excitations may exist with the potential to generate high, destructive blade vibrations.
Evidence was found that the unit was indeed operated repeatedly in this zone. Since the comprehensive root cause analysis did not reveal any other deficiency, it can be deduced that this phenomenon is a possible explanation for the impeller damage.

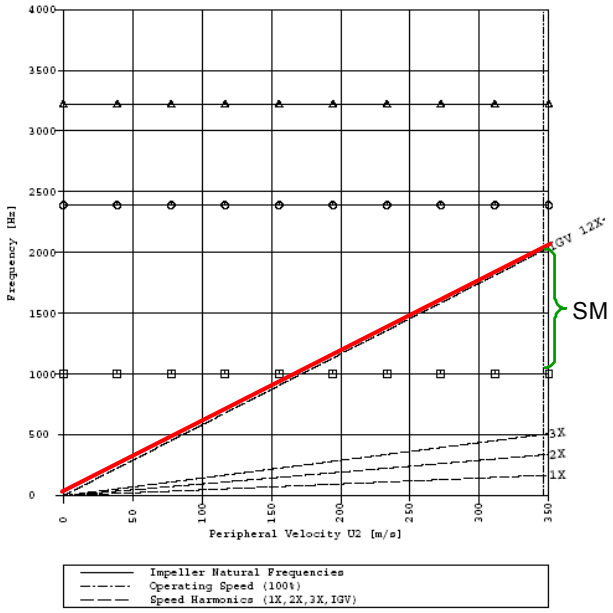
Figure 11: Campbell-diagram of the failed stage

The sub-topic 4.1 checks whether or not a resonance of an impeller blade bending mode with the IGV passing frequency prevails. The Campbell-diagram as shown in Figure 11 confirms that the 12X excitation line of the IGV does not excite the first blade bending. Thus the design criterion for the IGV/impeller interaction is fulfilled.

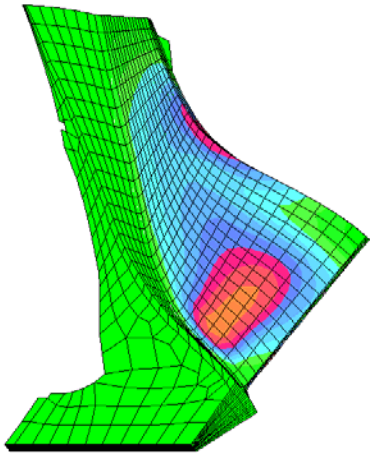
Figure 12: Dynamic stress distribution from impeller finite element analysis

The input for this Campbell-diagram is provided from a finite-element analysis of the impeller. Figure 12 displays the stress distribution for a vibration in the first blade bending mode. Similar plots can be generated for the higher blade modes but are not shown here, since they have never been involved in failures of this impeller type.

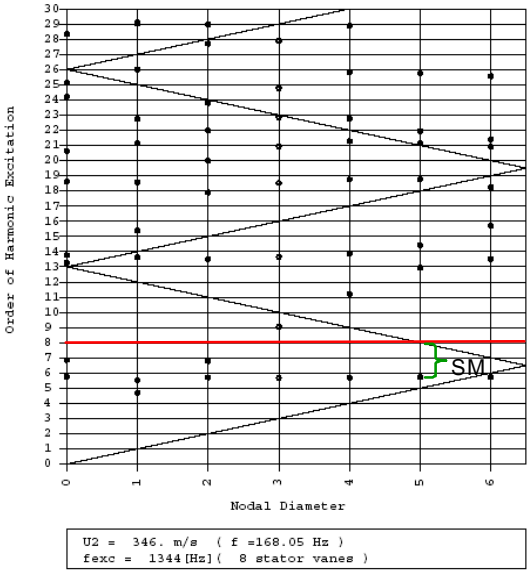
Figure 13: Interference diagram of failed impeller (Case: Design-Normal 47.5Hz)

In the current case the only relevant harmonic order of the stator components is determined by the LSD vane count of z=8; a horizontal line is drawn at the respective harmonic excitation order. It can be deduced from Figure 13 that a comfortable safety margin (SM) of more than 24% exists. This safety margin easily covers line frequency variations.

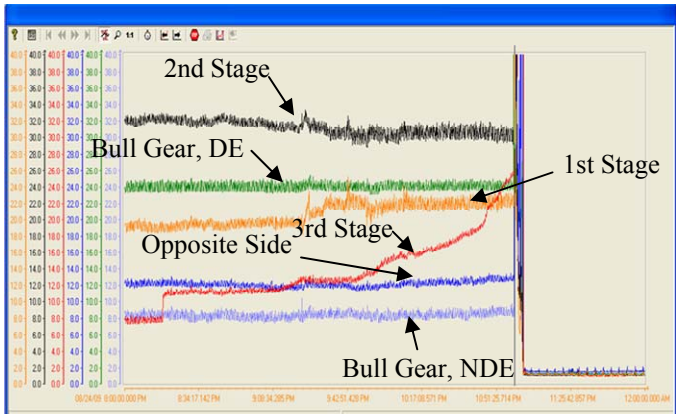
Figure 20: Trend data from site indicating the instant of impeller failure, shaft vibration amplitude

In the current case the usual shaft vibration level belonging to the corresponding radial bearing was about 7-8 µm. It was overshot at about 8:15 PM, more than two hours before the breakdown of the 3rd stage's impeller.
It can be seen in Figure 20 that the vibration amplitude rose progressively before it jumped above the shutdown limit at 10:59 PM.

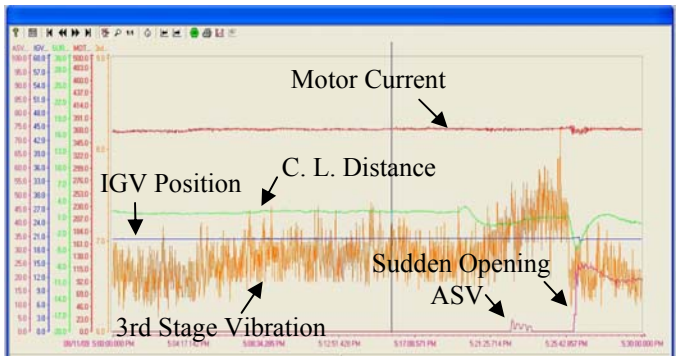
Figure 21: Trend data from site indicating operation near control line

Though deep surge has not been observed, Figure 21 shows another remarkable fact. The compressor is operating in turndown condition, on the verge of the control line or even on this limit. Such operation cases are quite common and not suspected to be harmful. However, it is an area of the operation envelope where potential local flow instabilities (e.g. stall phenomena) may appear without the entire machine falling into deep surge. Evaluation of the whole amount of available DCS charts supports the finding that the machine did run quite often in this operational area.

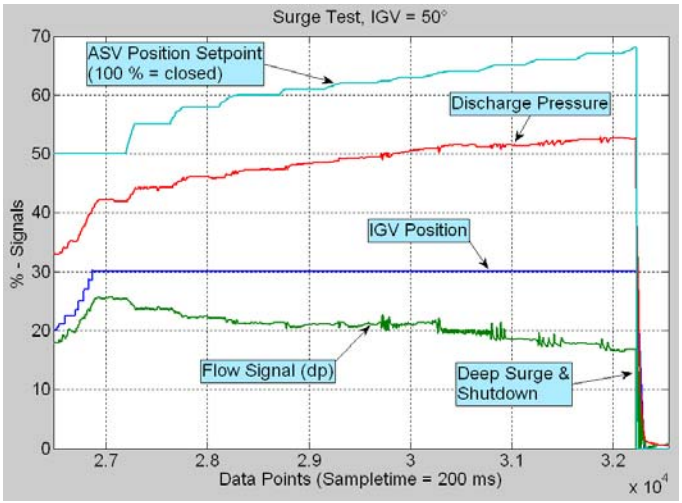
Figure 22: Commissioning data from site, surge tests at 50° IGV angle

During commissioning, decisive signals had been recorded with high sampling rate (a feature of the deployed controller) and on this basis the further analysis will be conducted.
Figure 22 displays the course of the most interesting raw signals during surge test at one fixed IGV position. This diagram is in the time domain, so we can see that the test has been conducted very carefully and ends with a deep surge cycle event. During the test, the ASV is closed stepwise (increasing signal). The response of the valve actuator causes slight signal fluctuations in the discharge pressure and flow signal, noticeable by the ripples on these curves which follow each increase of the ASV setpoint. In a careful post-failure analysis of these curves the increasing ripple of these curves could also be interpreted as indication of beginning flow instability, although deep surge with flow reversal did not yet take place.

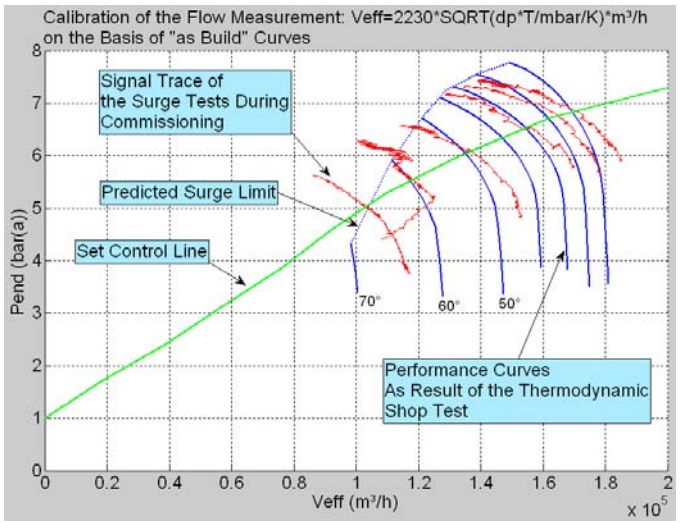
Figure 23: Comparison of test run results with commissioning data

As explained above, the volumetric flow can be represented by a formula that contains differential pressure, absolute pressure and temperature. In this case we have atmospheric suction conditions, so the influence of the ambient pressure is insignificant. By the choice of a suitable proportionality constant it was possible to approximate both performance maps: the theoretically combined shop test data and the experimentally gained curves from the on-site surge tests.
The result is reproduced in Figure 23.
Note that during the surge tests the IGV positions were not exact the same as in the calculated performance map. The main finding when interpreting this composed chart is that some of the evaluated surge points are located left of the predicted surge line. This particularly applies to the lines with positive pre-swirl, IGV close to minimum opening.
This finding does not oppose the stability limit found during single – stage testing. Obviously the stages can transgress their individual operation margin without giving cause for deep surge of the complete machine.

Figure 23 also shows the set control line of the anti surge controller. At the lower edge this line cuts the stability limit according to shop test results and so the controller definitely does not enforce enough safety margin to protect the machine against local flow instabilities. As a result of operational data analysis we have already stated that turndown operation was

quite common in the time before the failure happened. That means the machine had been run in exactly the area in which protection against local flow instabilities was not ensured.
