EXPANDER FIELD REMANENT LIFE ANALYSIS AND ASSESSMENT

by
David H. Linden
Executive Vice President
CONMEC, Inc.
Bethlehem, Pennsylvania

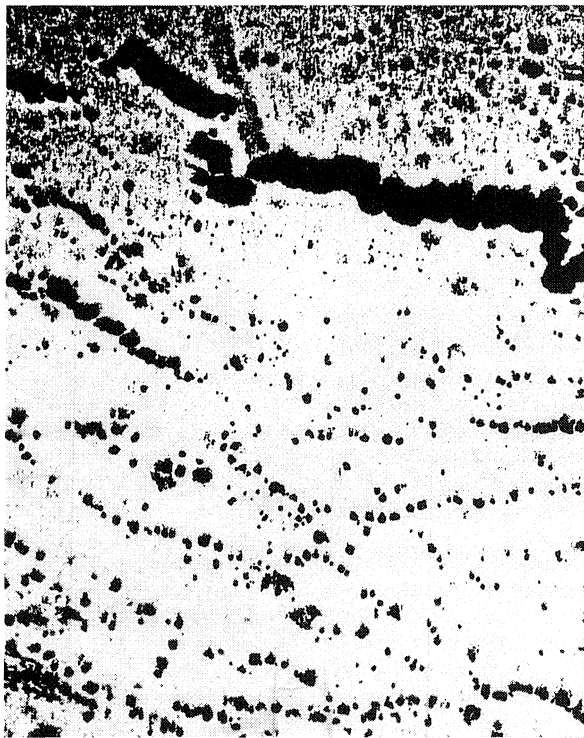
High temperature creep. Creep is characterized by material deformation, under stress and at elevated temperature, that can cause unacceptable dimensional changes, local creep crack growth, and in its most severe manifestation, creep rupture (separation) of the component. Within the life time of the part, creep is addressed in the component design phase by maintaining design stresses at a level where, given the component operating temperature, distortions will be acceptable and rupture will not occur. Creep is manifested by the formation of microscopic creep voids in the grain boundary area. As growth and accumulation of creep voids continue, voids join together until a critical flaw size is reached, forming a crack or cracks which lead to eventual failure. These voids are observable through optical microscopy. The formation of creep voids are shown in Figure 1 within an FCC casing subject to high operating temperatures and stresses. The density of creep voids, along with changes in microstructure, can be used to predict remanent creep life.

Figure 1. Example of High Temperature/Stress Creep Voids in Stainless Steel Casing.

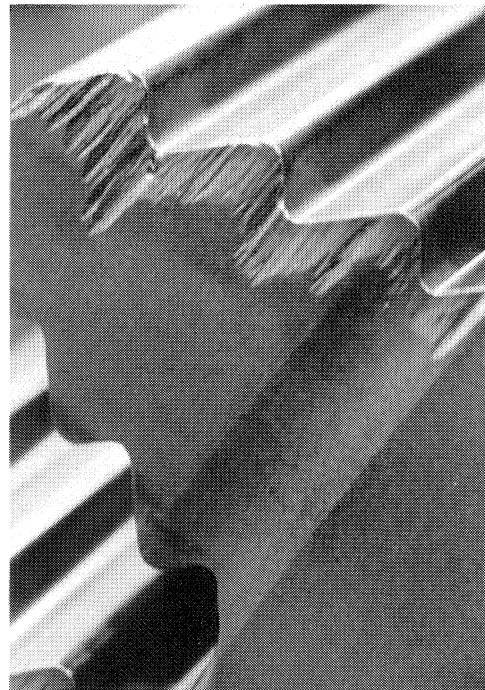
Erosion can effect the life of casing components, including stator vanes and rotor components. An example of the severe stress concentration that can be created as the result of catalyst erosion can be seen in Figure 2.

Figure 2. Rotor Disc Erosion Causing Severe Stress Concentration.

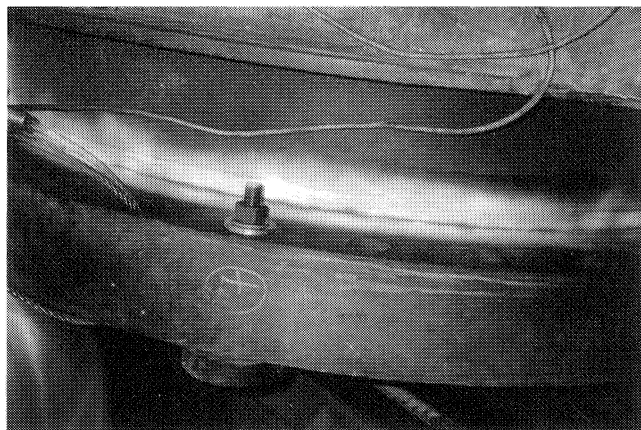
Shutdown corrosion. Shutdown corrosion has been significant in a number of FCC expander installations. The formation of polytheonic or other sulfur bearing acids can lead to stress corrosion cracking of the austenitic 300 series stainless steel components. This phenomena is typically related to a shutdown condition where condensation combines with the sulfur in the flue gas. Sulfur acid attack often leads to stress corrosion cracking. An expander inlet flange is shown cracked in Figure 3 as the result of stress corrosion cracking and polytheonic acid attack.

Figure 3. Stress Corrosion Cracking Resulting From Polytheonic Acid Attack.

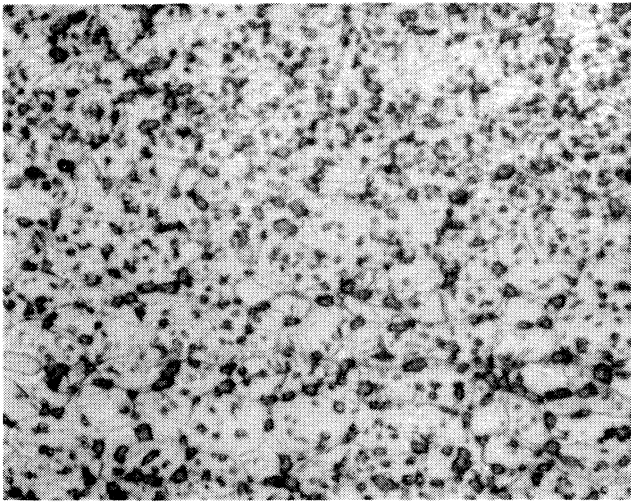
Sigma phase embrittlement. When the austenitic and nickel base alloys used in expanders are exposed for long periods of time at temperatures between 1050°F (565°C) and 1550°F (843°C), a brittle intermetallic sigma phase precipitates into the grain boundaries and within any ferrite phase. Sigma phase contains approximately equal parts of chromium and iron. Sigma is a brittle phase that tends to form as platelets. This brittle phase can affect superalloys and austenitic stainless steels used in the gas expanders. (Note that sigma phase embrittlement is a different phenomena than sensitization, or intergranular corrosion, which occurs in a similar temperature range.) The most significant effect of sigma phase is in the loss of material ductility, fracture toughness, impact strength, and in some alloys, reduction in stress rupture and LCF strength. Normal operating loads can cause major component cracking that often "runs" during typical startup or shutdown cycles. Sigma phase embrittlement has been found in most grades of stainless steel expander casings. It has been directly attributed to nosecone weld failures and flange and casing cracking. The time of operation, along with the temperature of the components determines the rate and degree of sigma phase formation. The lack of weldability from sigma phase embrittlement has also been a major problem during repair of FCC expander casings after service. For example, the room temperature toughness may be so low that cracks will "run" or "craze cracking" will occur during repair welding due to the thermal gradients generated at the crack tip regions. Unfortunately for today's FCC expanders, sigma phase precipitation occurs most rapidly in the 1300°F (704°C) temperature range. In general, several years of operation in the sigma phase temperature range are required to precipitate five to 10 percent sigma phase in 300 series stainless steel. An expander casing with sigma phase embrittlement after only 40,000 hr of operation is shown in Figure 4.

Figure 4. Sigma Phase After 40,000 hr. 347 stainless steel casing.

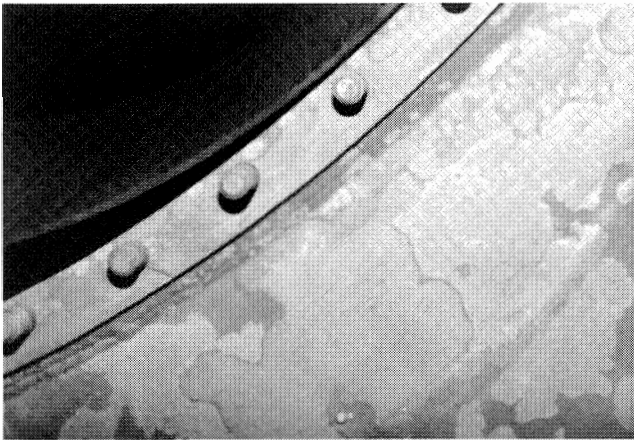
Alloy steel. Alloy steel casings have been found to suffer more from oxidation problems than the stainless steel casing. A typical general oxidation type corrosion of an expander exhaust casing is shown in Figure 7. The oxide scale can be fairly heavy but rarely limits operating life.

Figure 7. *Typical Alloy Steel Exhaust Casing Oxidation.*

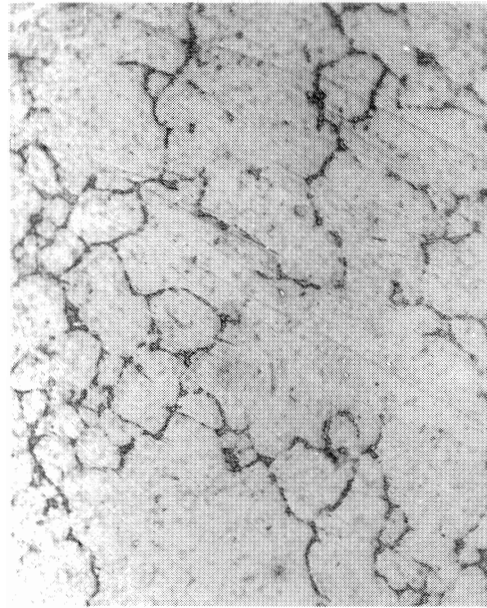
Stainless steel. Austenitic stainless steel casings suffer uniquely from sigma phase embrittlement. An illustrative example of this damage, and the effect of elevated metal temperature, can be seen in Figures 8, 9, and 10. The microstructure of the material was specifically examined for evidence of sigma phase which is a strong indicator of inservice aging. The photomicrographs shown in Figure 8 are taken from the gas path side of the inlet casing, which is exposed to full inlet temperature. Note the extensive sigma phase present at the grain boundaries, comprising 10 percent to 15 percent of the area. With this level of sigma and other aging effects, this casing would be susceptible to inservice cracking and a repair welding effort would be most difficult. Impact testing of materials removed from FCC service has shown that the impact energy can degrade from an original value in excess of 200 ft-lb to less than 20 ft-lb.

Figure 8. *Inlet Casing Microstructure After 60,000 hr. Note: Severe sigma phase-400X.*

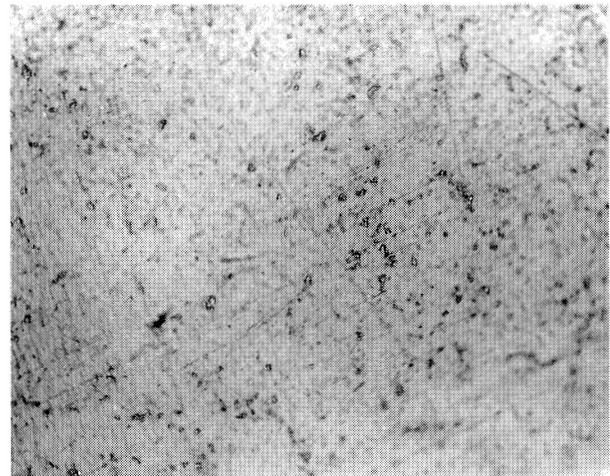
In contrast to the extensive sigma phase found in the inlet casing, the same expander exhibited virtually no aging affects on the cooler discharge casings. Figure 9 is taken from the discharge region where metal temperatures are approximately 1000°F (540°C).

Figure 9. *Exhaust Casing Microstructure After 60,000 hr. Note: Lack of sigma phase-400X.*

There is little evidence of sigma phase formation. The dark regions in Figure 9 reflect a soft ferrite phase. The degree of sigma formation is very temperature dependent as is evident in this example. The temperature difference between the inlet and exhaust casings shown is approximately 300°F (170°C). The hotter inlet casing shows significant aging while the cooler exhaust casing does not.

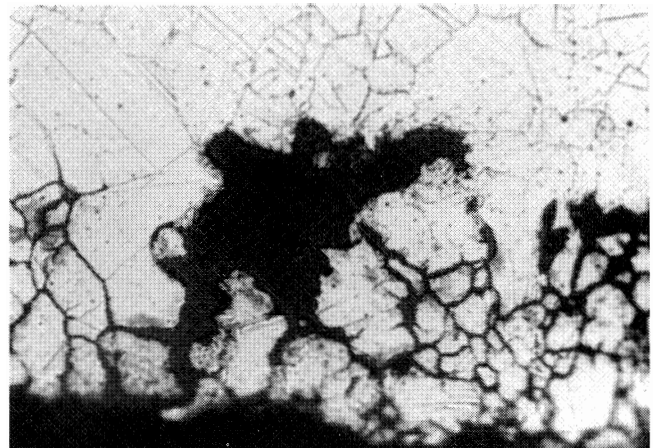
Figure 10. *Nosecone Microstructure After 60,000 hr. Note: Surface oxidation.*

Nosecone. Expander nosecones are subject to the full inlet conditions of the flue gas. This component often shows the greatest amount of creep damage, inservice aging, erosion, and corrosion when compared to all other stationary components. A nosecone after 60,000 hr of operation is shown in Figure 10. It has experienced a significant amount of corrosion (oxidation) along with sigma phase embrittlement. The nosecone was found to have a significant high temperature oxide/sulfide scale over the entire surface. The corrosive scales were found to be approximately 0.015 in (0.40 mm) to 0.020 in (0.50 mm) thick. These scales would be considered heavy for the time of service and may be indicative of higher than normal operating temperatures and high flue gas sulfur levels. The amount of sigma phase present would make this nosecone very susceptible to cracking and may not allow for future repair. The sigma phase was nearly continuous throughout the grain boundaries and can be seen in Figure 10.

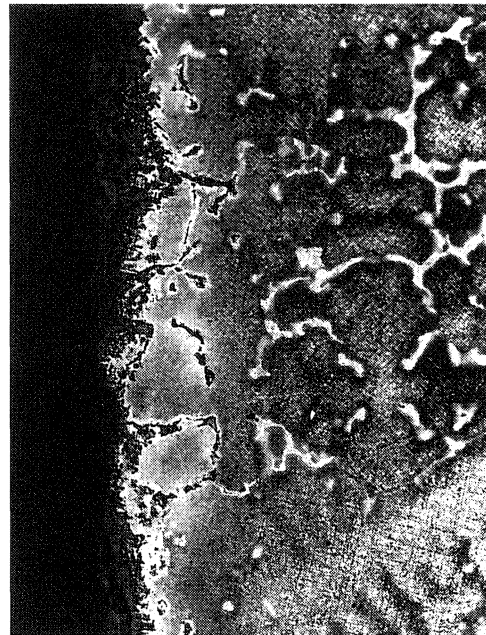
Figure 11. Stellite Stator After 45,000 hr. Note: Grain boundary precipitates.

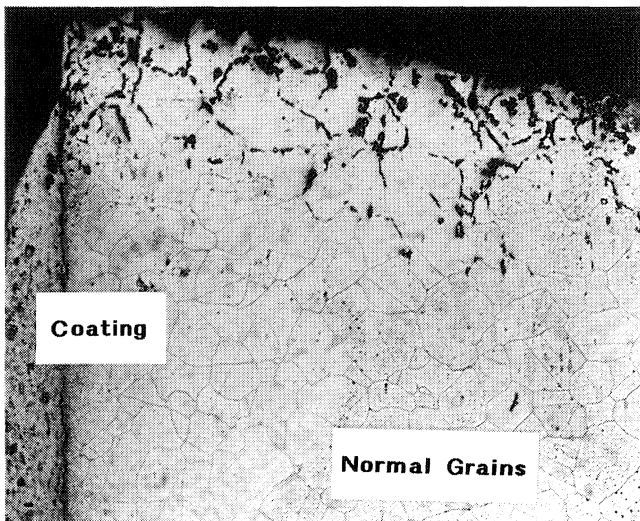
Examination of rotor blades after 50,000 hr of operation can show signs of inservice aging. If higher than normal operating temperatures have been experienced, significant grain growth and creep damage may be noted. Extensive grain growth in a Waspaloy blade is shown in Figure 12 after severe temperature excursion and the replacement of the blades was warranted.

Figure 12. Waspaloy Rotor Blade Grain Growth. Note: Normal microstructure at bottom and blade coating (50X).
