ASIA TURBOMACHINERY & PUMP SYMPOSIUM

LASER WELDING FOR TURBOMACHINERY ROTOR RESTORATION

Dr. Michael W. Kuper
Materials Engineer
Elliott Group
Jeannette, PA, USA

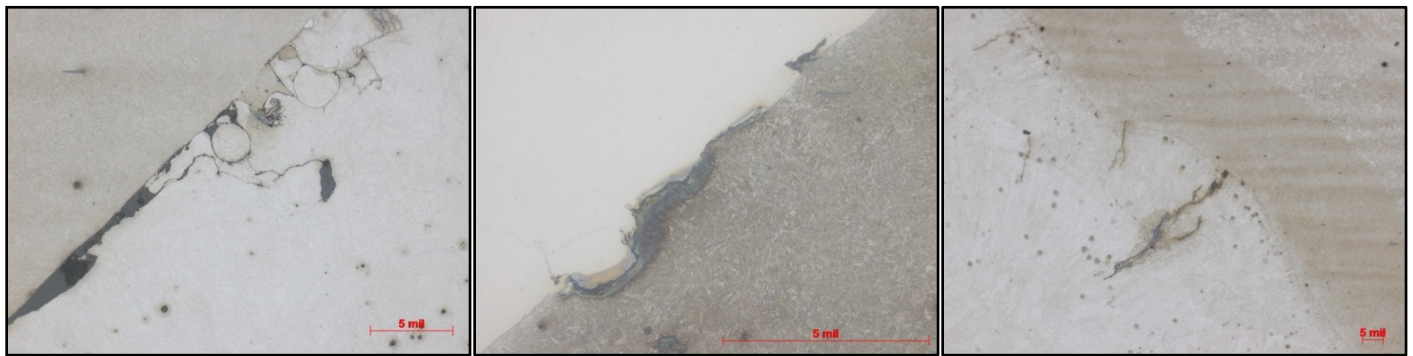
Porosity is characterized by voids that occur within the weld deposit, created by escaping gases that become trapped during solidification, which has been witnessed in-situ [12]. For LBW, there are several methods by which gasses can be introduced into the weld pool, but the main theories include trapping shielding gas or metal vapors, cavitation caused by unstable keyhole welding, and gasses that were entrapped in the powder particles during the atomization process and released during welding [13]. In addition, porosity can occur from poor shielding gas coverage during welding, which is usually caused by an improperly aligned gas lens or turbulence near the weld pool. This may occur because of the turbulence created by rapid oxidation of the solidifying weld pool or possibly from gasses created from burning the oxygen found in air. Lastly, lack of base metal and filler material cleanliness can also contribute to porosity. Welding over organic matter (oil, grease, dirt, oxides, etc.) causes outgassing during welding that becomes trapped in the weld pool as it solidifies.

Lack of fusion is characterized by locations where the filler metal did not fuse with the base metal. This occurs when the heat source generates insufficient heat to coalesce the filler and base metals. The typical causes for this include poor welding angle, excessive filler material feed rate, and/or inadequate laser power. Similar to lack of fusion, unfused particles are characterized by remnants of unmelted powder being present in the weld. This type of defect is exclusive to LBW-P because it involves powder while LBW-W does not. The cause unfused particles is similar to lack of fusion, where there is insufficient heat to fully melt and fuse the filler material with the base material. This generally occurs because the laser did not have the time, power, and/or correct positioning to melt all of the filler metal in the weld area.

Cracking is characterized by weld metal fracture because of stress. Cracking can be caused by a multitude of factors, though common examples include highly restrained joint design, rapid cooling rates, filler metal susceptibility, contamination, weld bead profile, and/or incorrect welding parameters.

Figure 4: Common defects found in laser welding including unfused particles (left), lack of fusion (middle), and cracking (right). These defects were found in a weld made using powder based filler metal delivery. Porosity can be seen speckling each image.

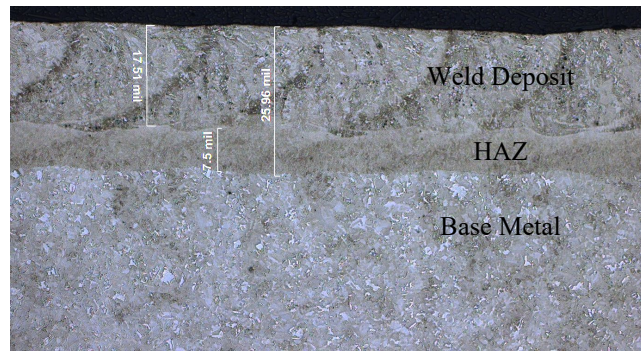
All welds passed liquid penetrant testing and side bend testing. The macro test also passed inspection, meaning it contained no visible cracks at 5X magnification. Figure 6 shows a cross section of a LBW overlay, which highlights the small size of the HAZ in the LBW overlay, averaging 0.00975" thick in this study. Additionally, the LBW weld deposit was clean with no detectable porosity. The dark speckles on the image are from slight surface rust.

Figure 6: Cross section of a LBW overlay showing thickness measurements of the fusion zone, HAZ, and overall region affected by welding.

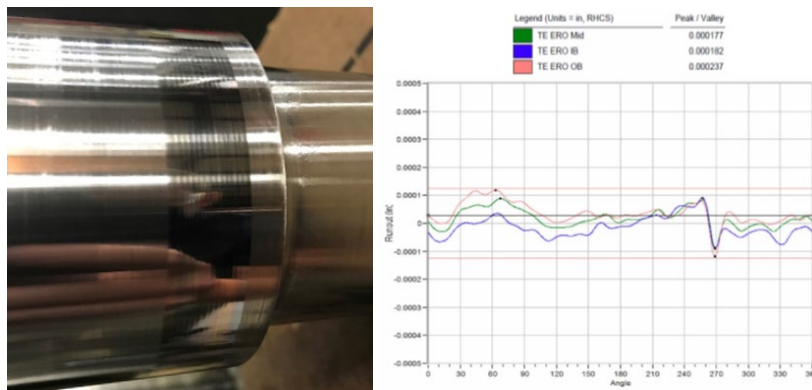
Example Repairs
In addition to the mechanical testing performed for the procedure qualification, repair welds were performed on two damaged shafts. The first shaft was damaged by extensive pitting corrosion in the seal, probe, and journal areas, shown in Figure 7. The figure also shows the repaired shaft after welding and after final machining. The probe area was also ground and burnished, which can be seen in Figure 8 along with the electrical runout measurements. The difference in color between the repaired area and the rest of the shaft resulted from the difference in hardness of the substrates during burnishing, however, the mechanical and electrical runout readings were within the required tolerances.

Figure 8: Example of a burnished probe area after repair (left). The repaired region appears dark because of a difference in hardness between the base and weld metal, however, the repair met the geometric tolerances, surface finish, and electrical runout (right) required for a probe area.
