**Evaluation of Canal Lining Projects  
in the Lower Rio Grande Valley of Texas  
2011 Ratings and Analysis**

**By  
Gabriele Bonaiti, Askar Karimov, Guy Fipps, P.E.  
Texas AgriLife Extension Service  
College Station, Texas**

**Texas Water Resources Institute Technical Report No. 412  
Texas A&M University System  
College Station, Texas 77843-2118**

## **2011 Ratings and Analysis**

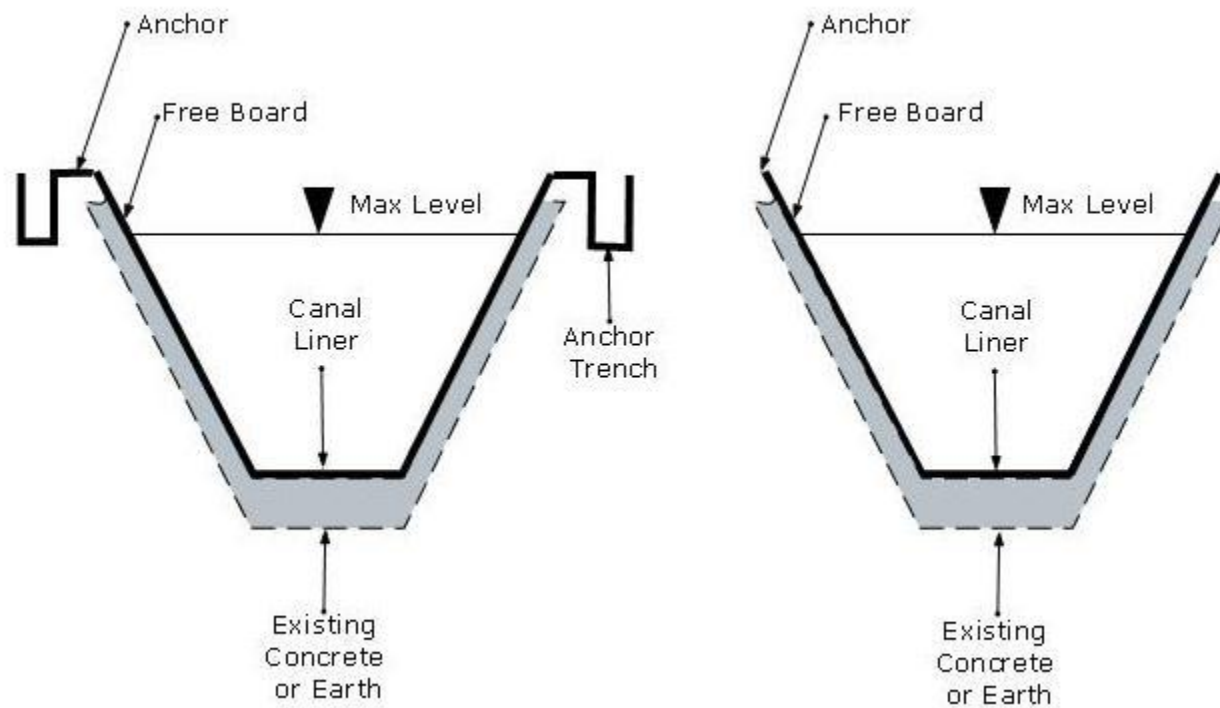
Figure 3. Ratings were completed separately for the anchor (i), free board (ii), and wetted area (iii).  
 A: Liner with anchor trench. B: Liner without anchor trench

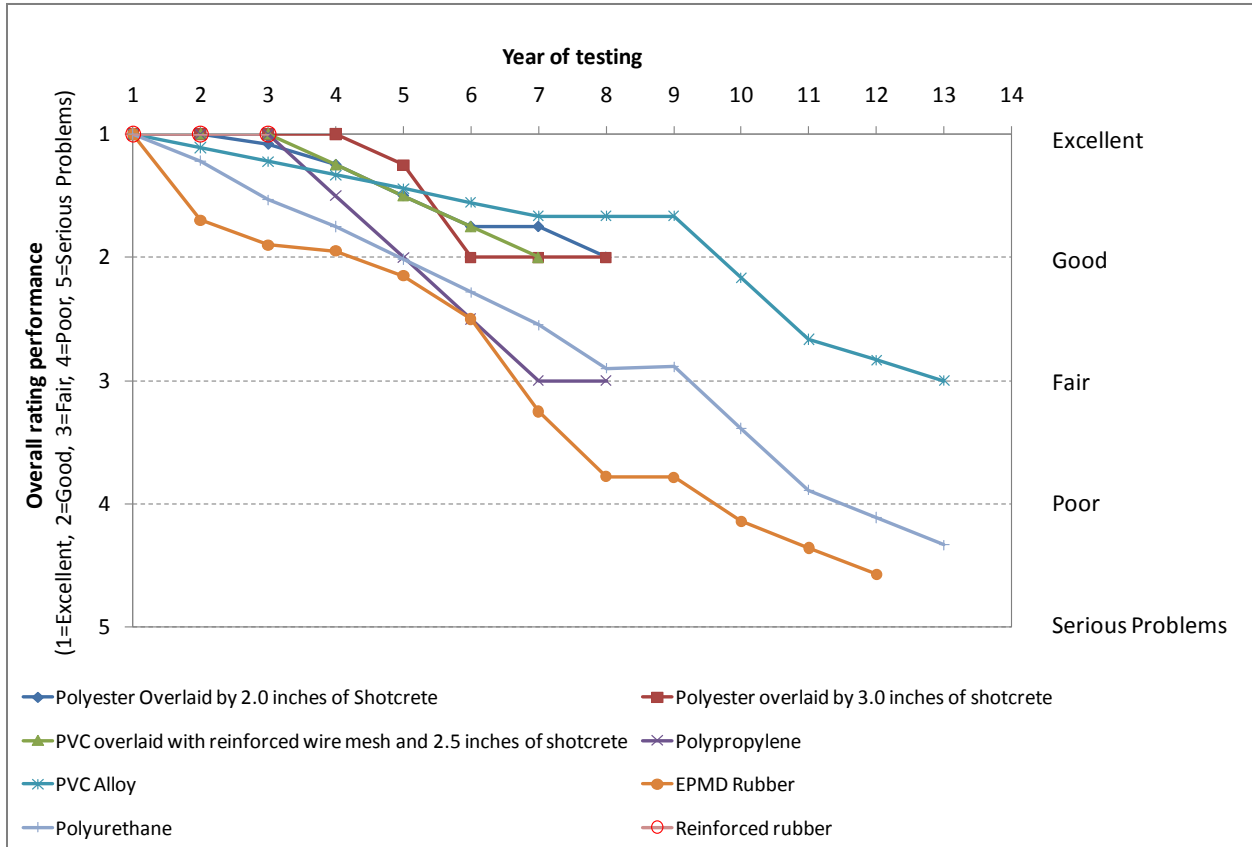
Table 3 lists the average ratings for each type of liner. The changes in ratings over the past five years are shown in Figure 4. We grouped all the projects into two categories: liners with a protective barrier, and liners without a protective barrier. Liners with a protective barrier performed very well and have required no maintenance, while the performance of the liners without a protective barrier has varied dramatically.

Figure 4. Average performance rating results by lining material for the year 2011.
