THE FIRST AFRICAN BAPTIST CHURCH
A STUDY OF THE ARCHITECTURAL DESIGN AND CONSTRUCTION OF A
19TH CENTURY CHURCH HOUSE

A Thesis

CHRISTOPHER SCOTT HUNTER

The intent of this study is to examine, document, and develop a record of the existing building of the FABC. This examination will also include a study of the building systems and the materials and methods used for construction.

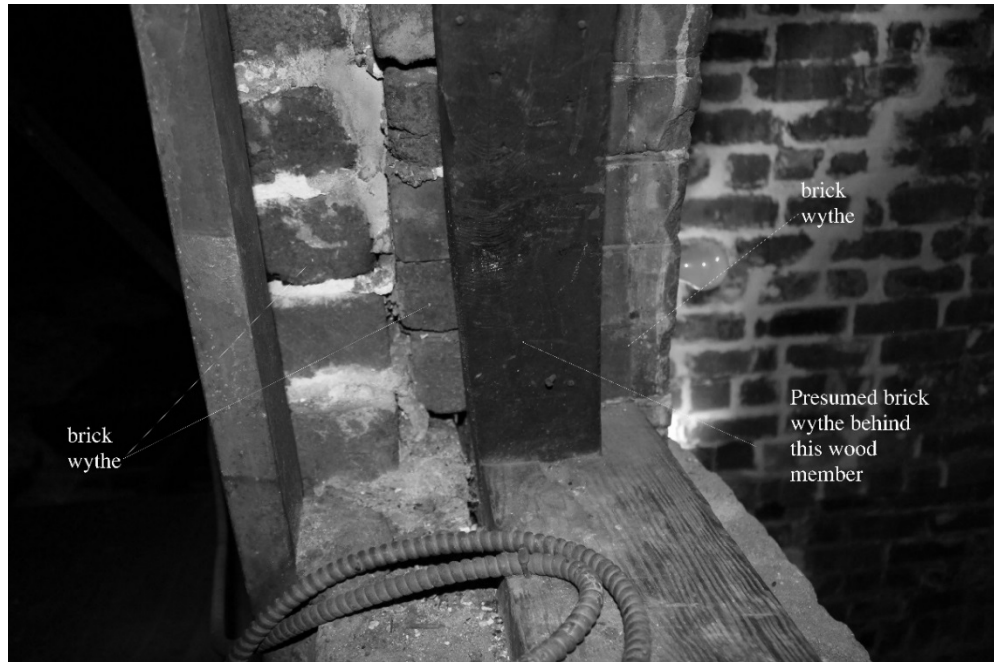
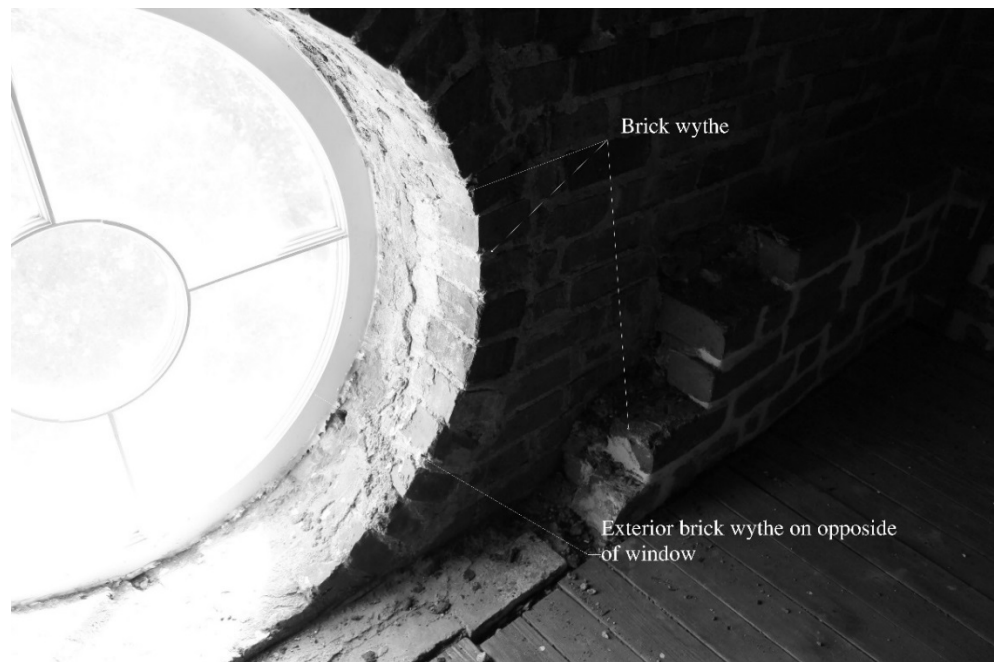
FIGURE 34. Image of a multi brick wythe wall in the bell tower of the First African Baptist Church (Photograph by the author)

FIGURE 35. Image of a multi brick wythe wall in the bell tower of the First African Baptist Church (Photograph by the author)

Figure 33 shows a graphic example of a wythe wall, while Figure 34 and Figure 35 are photos of the wall section details in the bell tower of the FABC.

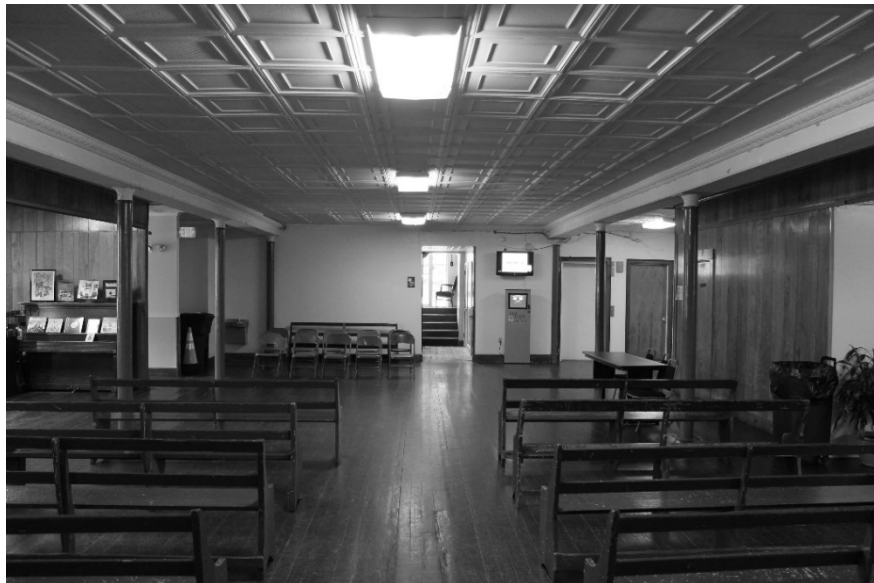
The structural system of the church consist of wood joists which frames the flooring for the fellowship hall, the main sanctuary, and the upper balcony. A wood tongue and groove floor is applied throughout the building. The main sanctuary has a series of 4” pipe columns, which support the floor framing system for the upper balcony, while the fellowship hall has a series of 6” pipe columns, as shown in Figure 36. Figure 37 shows a columns penetrating the wooden flooring in the fellowship hall. The pipe columns support the main sanctuary floor framing system.

FIGURE 36. Image of the pipe columns in the Fellowship Hall of the First African Baptist Church. (Photograph by the author).

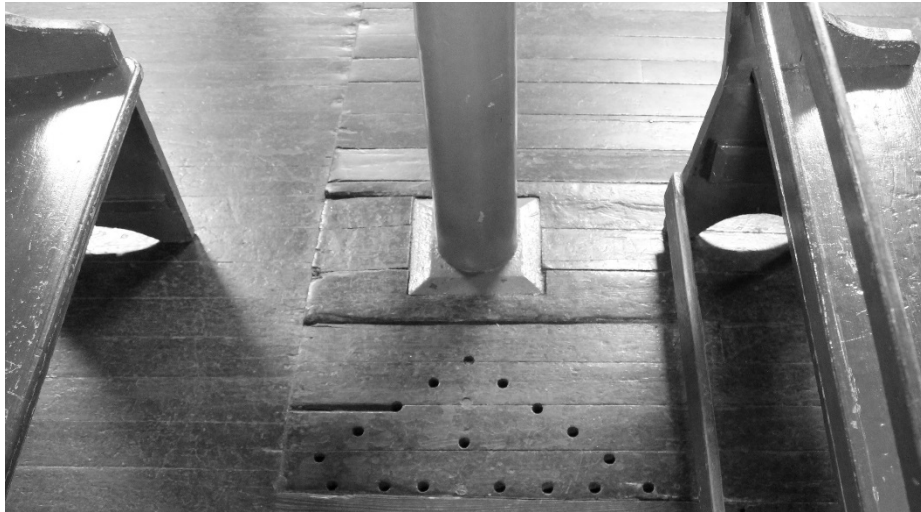
FIGURE 37. Image of the pipe column at wood flooring in the Fellowship Hall of the First African Baptist Church. (Photograph by the author)

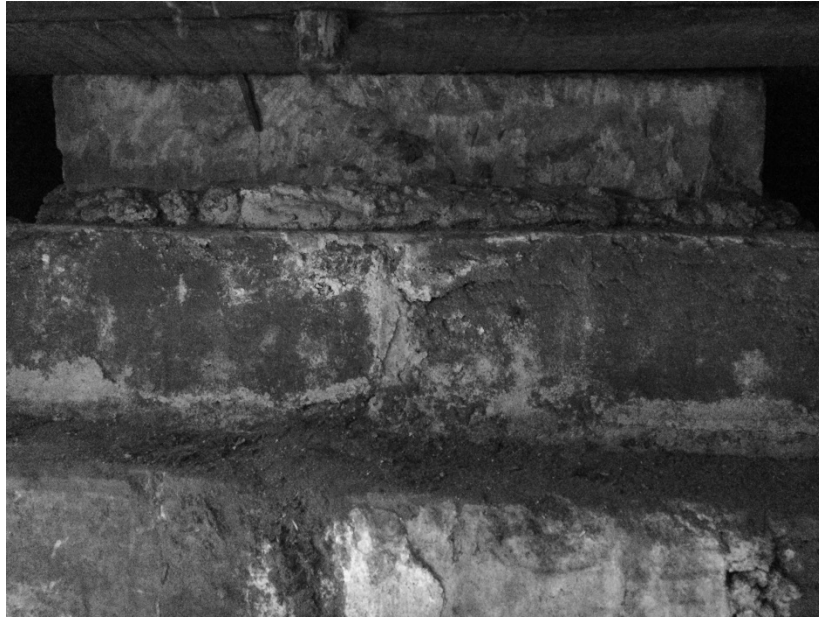
The fellowship hall has a series of pipe columns which are supported by masonry step footers, shown in Figure 38, with a solid cut stone located at the top of each masonry footer. Figure 39 shows the stepping pattern at the base of the foundation walls, where the footer base is spread wide to allow the structural load from the columns to be more evenly distributed to the ground. A series of primary wood beams and joists have been used to frame and support the balconies.

FIGURE 38. Stone atop masonry step footing supporting pipe column above, at the First African Baptist Church
(Photograph by the author)

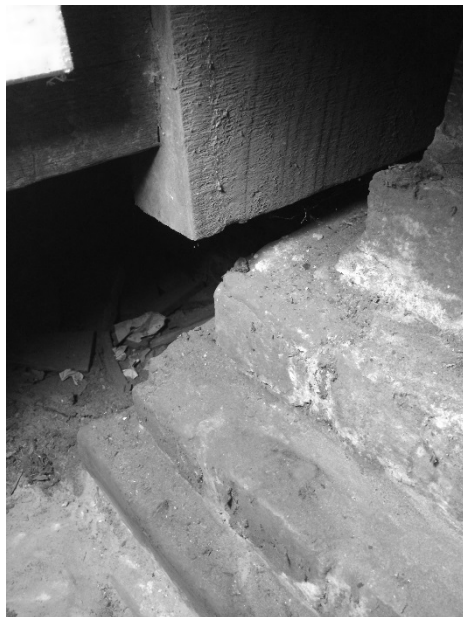
FIGURE 39. Profile of masonry step footing and wood beams in crawl space at the First African Baptist Church
(Photograph by the author)

4. The building frame of metal columns, wood floor joists, and heavy timber construction, from what can be observed, also appear to be in good condition. As observed and photographically documented, the floor joists in the crawl space appear solid, but this conclusion may change if a more extensive and complete review of all the floor joists in the crawl space were to occur. The heavy timber members used to frame and support the roof of the building also appear in good condition. This study has documented that structural work was conducted on the church steeple, with the intent of stabilized the steeple. Also noted in this study is the current condition of the flooring in the steeple. There are small holes as well as exposed metal reinforcing in the floor where a topping of concrete has worn away. This is cause for concern for the floor condition of the steeple, as it would need to be further investigated by a hired design professional and / or general contractor for proper technical analysis.

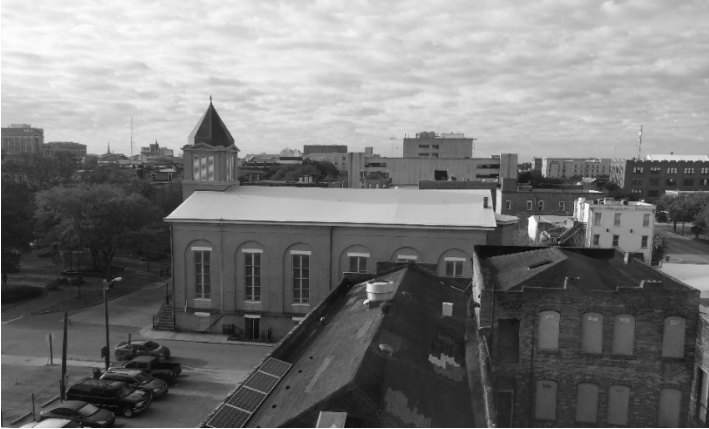
The roof of the church is a gable in configuration, and it is covered with a white membrane for water drainage, as shown in Figure 40. There is a lightning protection system installed on the roof. Figure 41 shows the lightning protection cabling located at the ridge of the roof.

FIGURE 40. Image of the finished roof system. (Photograph by the author)

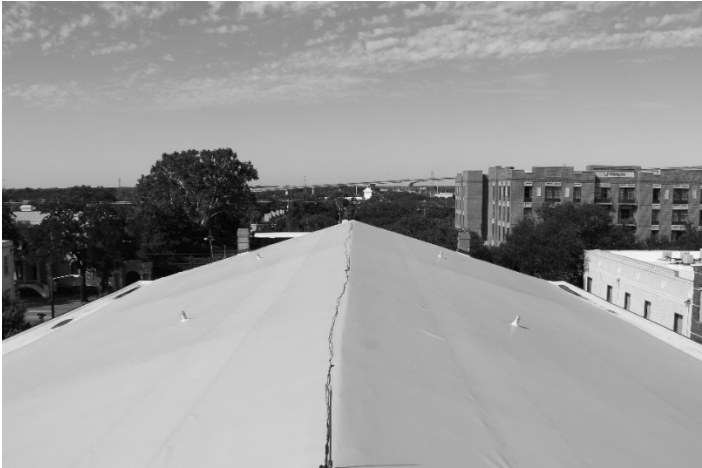
FIGURE 41. Image of the finished roof system (Photograph by the author)

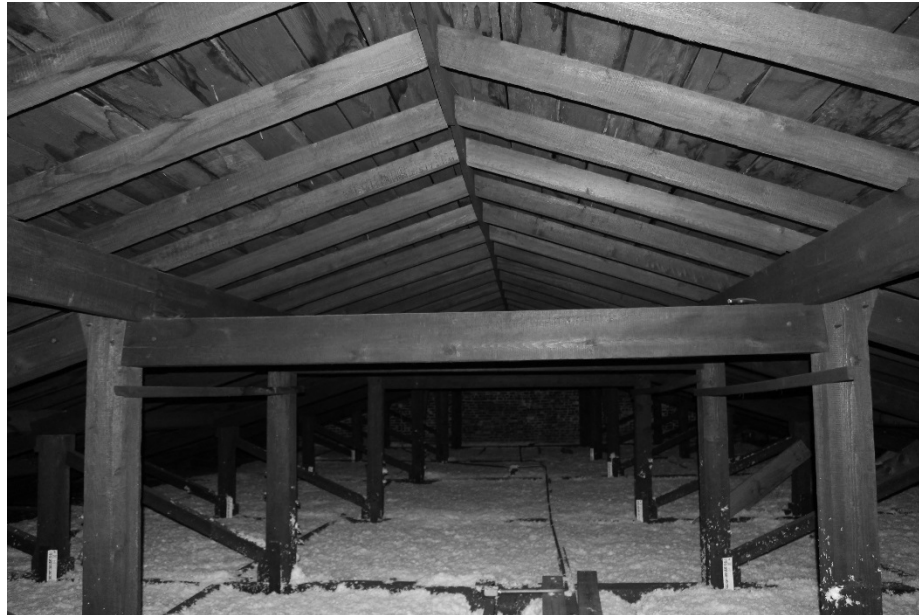
FIGURE 46. Image of heavy timber structural members framing the roof of the church building.
(Photograph by the author)

Figure 46 shows the roof framing with heavy timbers, located directly above the main sanctuary. Insulation has been blown into place to create a thermal envelope. Figure 47 is an example of a birdnotch joint used in the roof framing of the church building, while Figure 48 illustrates an example of a pinned connection as well as a notching joint from one beam to its supporting member.

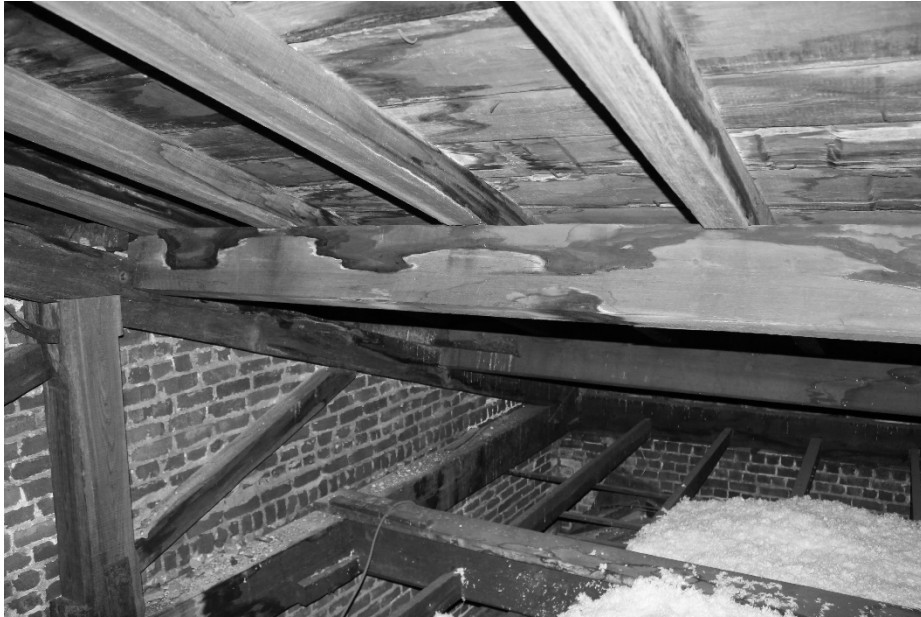
FIGURE 47. Image of wood purlins, using a birdnotch joint, supported by heavy timber structural members. (Photograph by the author)

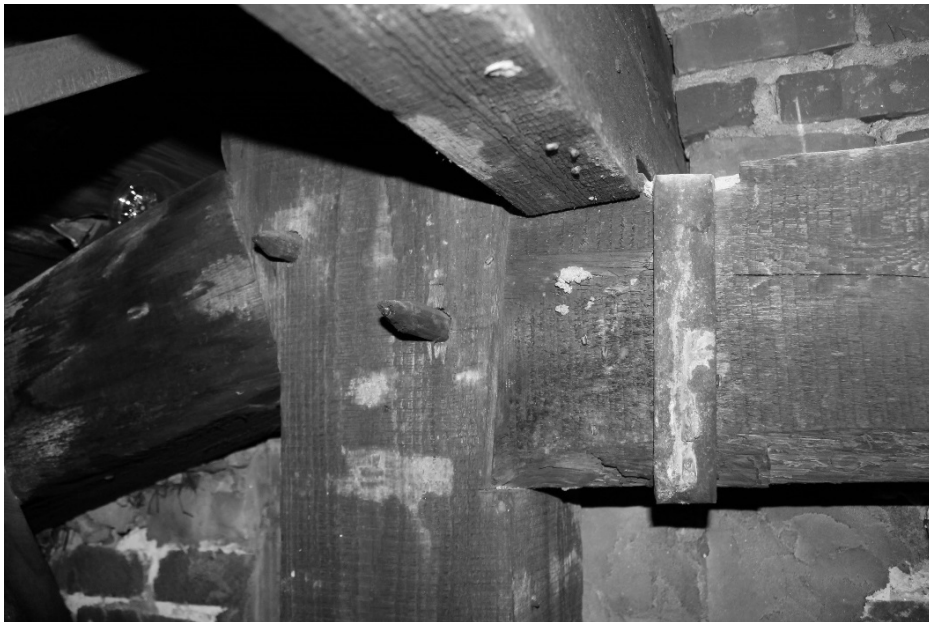
FIGURE 48. Image of tapered wooden pins (nails). (Photograph by the author)

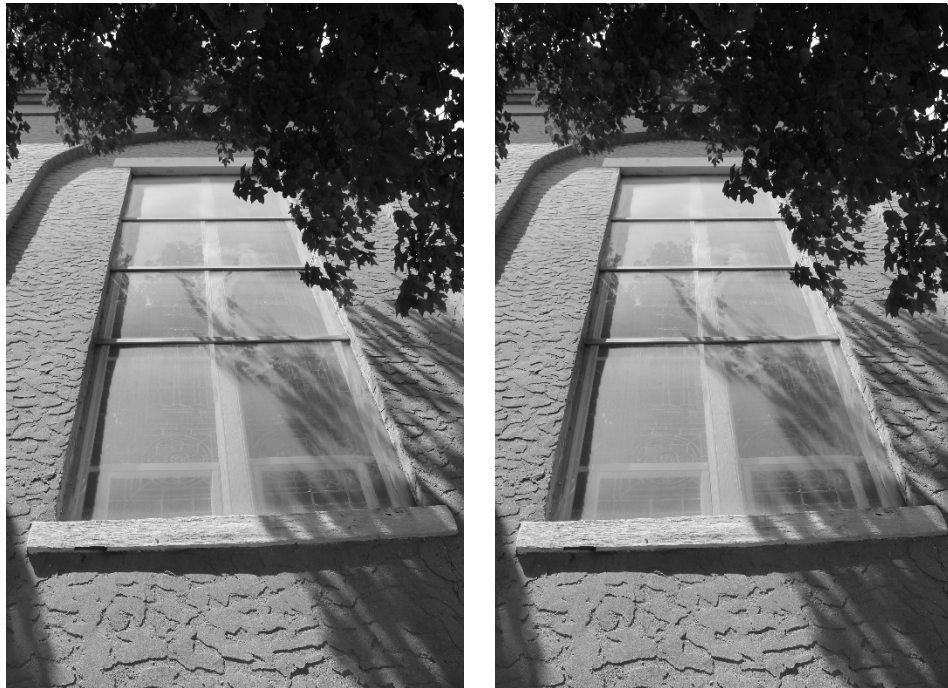
Today, all the stained glass windows are protected from damage by the placement of plexiglas panels covering each exterior window as shown in Figure 61.

FIGURE 61. Image of protective plexiglas panels on the exterior of the building.
(Photograph by the author)

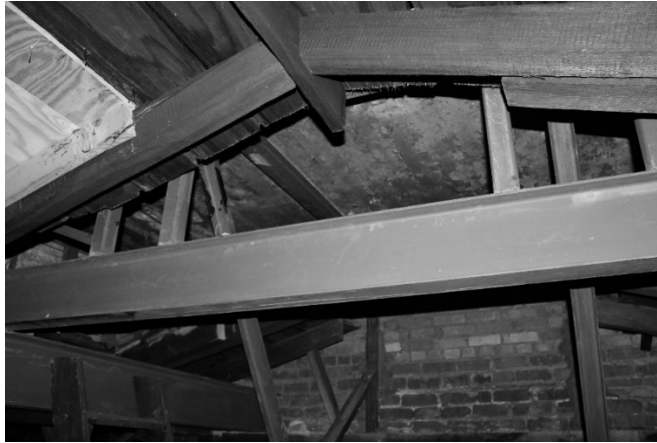
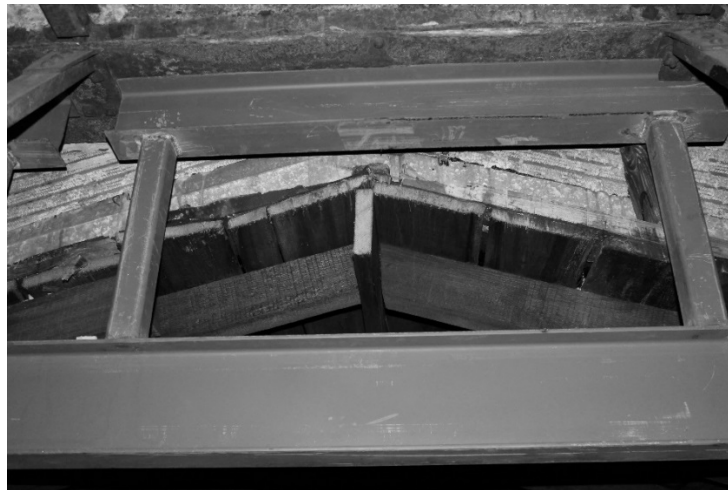
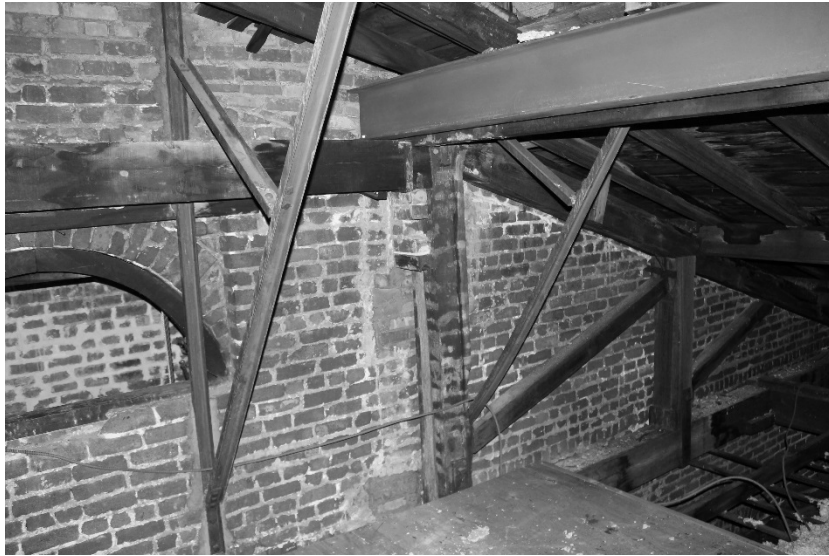
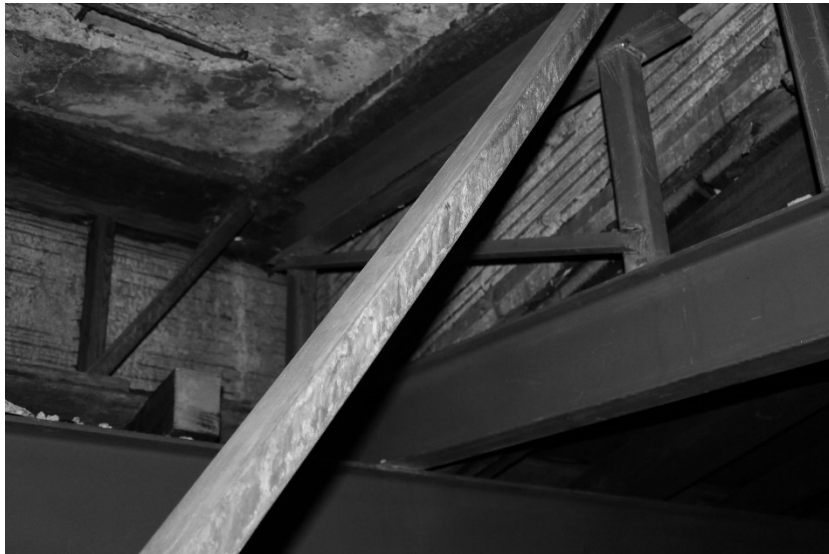
and louvers. (The House Doctor, 2001). Figures 64 to 67 are photographic evidence of the steel stabilization work performed in the church steeple.

FIGURE 64. Image of steel structural members in the steeple of the church. (Photograph by the author)

FIGURE 65. Image of steel structural members in the steeple of the church. (Photograph by the author)

FIGURE 66. Image of steel structural members in the steeple of the church. (Photograph by the author)

FIGURE 67. Image of steel structural members in the steeple of the church. (Photograph by the author)

In 2001 the FABC engaged the services of the ‘House Doctor’. The House Doctor, owned by Charlie Angell, is a local general contractor who specialized in historic restoration of commercial exteriors and interiors and residential restoration and remodeling. Charlie and his team of craftsmen undertook a complete, ‘ground up’ restoration of the FABC steeple, beginning with structural remediation and including exterior restoration to perfectly match the building’s original appearance. Having diagnosed the situation (the entire steel superstructure had rusted out in parts) and with Kern Coleman and Company serving as supervising engineer, the House Doctor installed steel I-beam supports under the steeple and prepared and coated other areas of rusting with specialized primers and rust inhibitors. With the structure stabilized, Charlie Angell and his team replaced missing and loose brick and concrete and caulked all visible cracks. This included exterior repairs and refinishing, including stucco repair. Final touches included a rebuilt staircase leading to the steeple and roof, repair to damaged eaves and front entry roofs, and installation of new, custom-milled windows

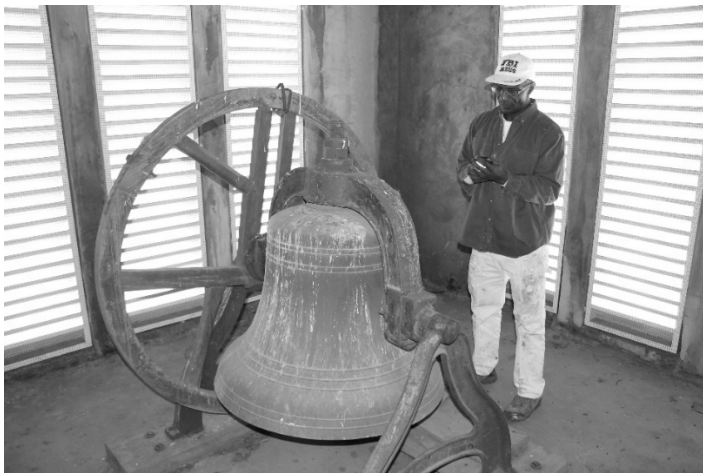
in Baltimore, Maryland. The bell is made of bronze, is mounted on its original wooden wheel and metal frame, and is located in the current steeple and still operational. Figure 68 and Figure 69 are photographs of the bell. Figure 70 and Figure 71 show the roofing area directly above the location of the bell.

FIGURE 68. Image of original steeple bell (Photograph by the author)

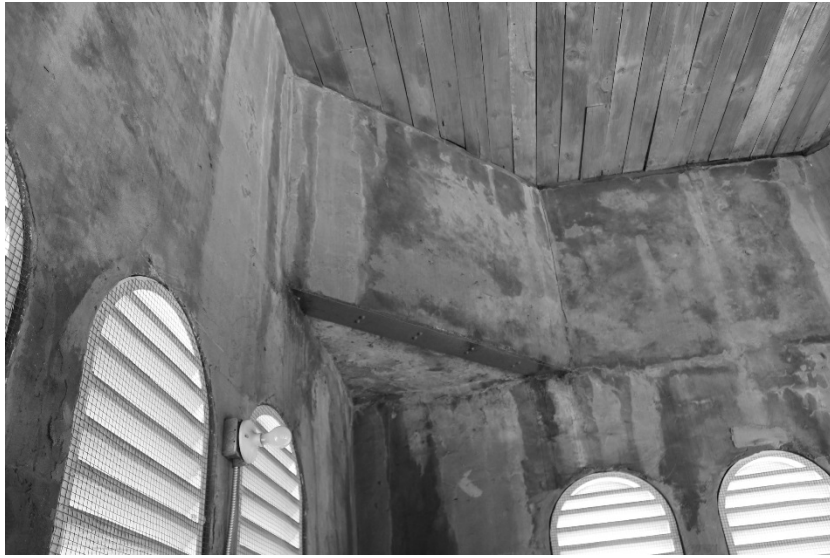
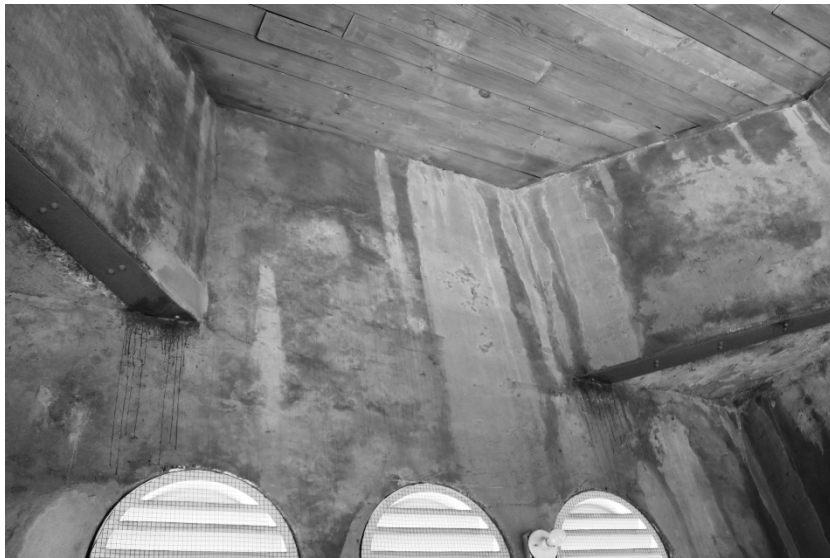
The current steeple is accessible by a series of ladders which are vertically connected through openings in the floor. The space where the bell is located is constructed of light metal framing with a topping slab of concrete, which is showing signs of deterioration through cracks in the floor. The walls of the steeple appear to be concrete with metal plates installed at angles in each corner. These walls serve as a foundation for the wood framing that forms the conical top of the steeple. The outside of the steeple is finished with stucco.

FIGURE 70. Image of the interior of the existing steeple.
(Photograph by the author)

FIGURE 71. Image of the interior of the existing steeple.
(Photograph by the author)

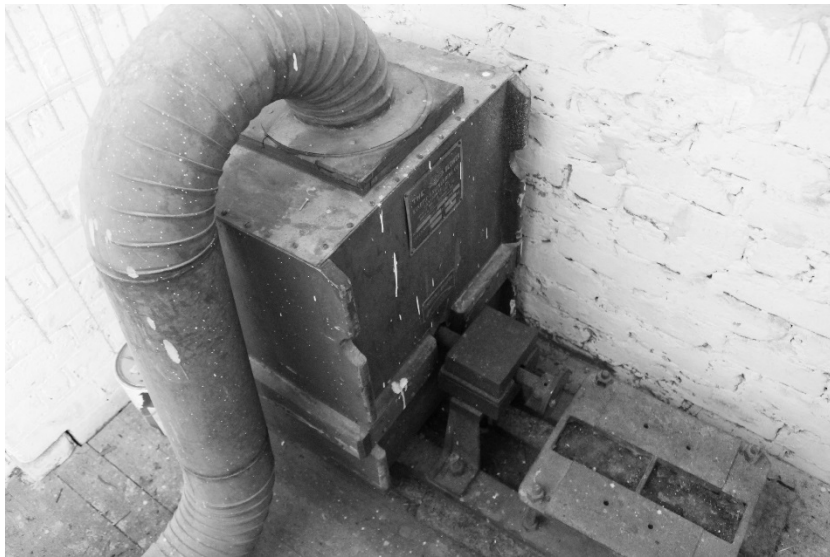
This report did document that the FABC was interested in having it restored and at the time this report was prepared, FABC was seeking estimates for the work. (The Organ Society, 2013). Figure 73 shows the extent of repair needed for a portion of the organ while Figure 74 shows the organ's kinetic blower, a device that provides wind to the organ pipes.

FIGURE 74. Image of kinetic organ blower located in the bell tower of the building. (Photograph by the author)

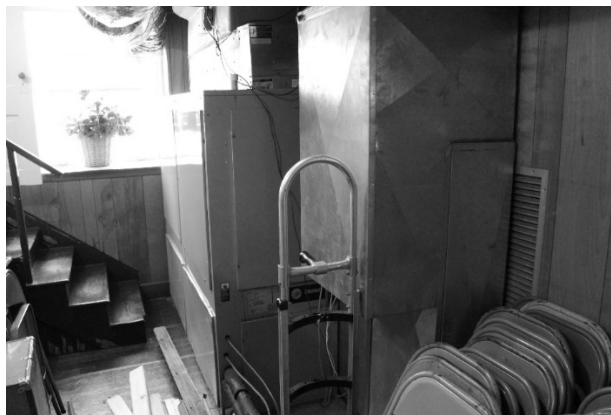
The church has two (2) heating, ventilation, and air conditioning (HVAC) units located in the lower level of the church, as Figure 75 illustrates. There are four (4) condensing units located on the exterior, near the west parking lot, with two of the units shown in Figure 76. Ductwork to carry conditioned air throughout the building has been installed in a sensitive manner as to respect the historic nature of the interiors of the church. Figure 77 shows an existing HVAC floor grate located in the main sanctuary. I have not found any documentation as to when the building installed mechanical air conditioning, but according to the Savannah Electric and Power Company, a possible time frame may have been in the 1950s:

FIGURE 75. Image of one of the HVAC units. (Photograph by the author)

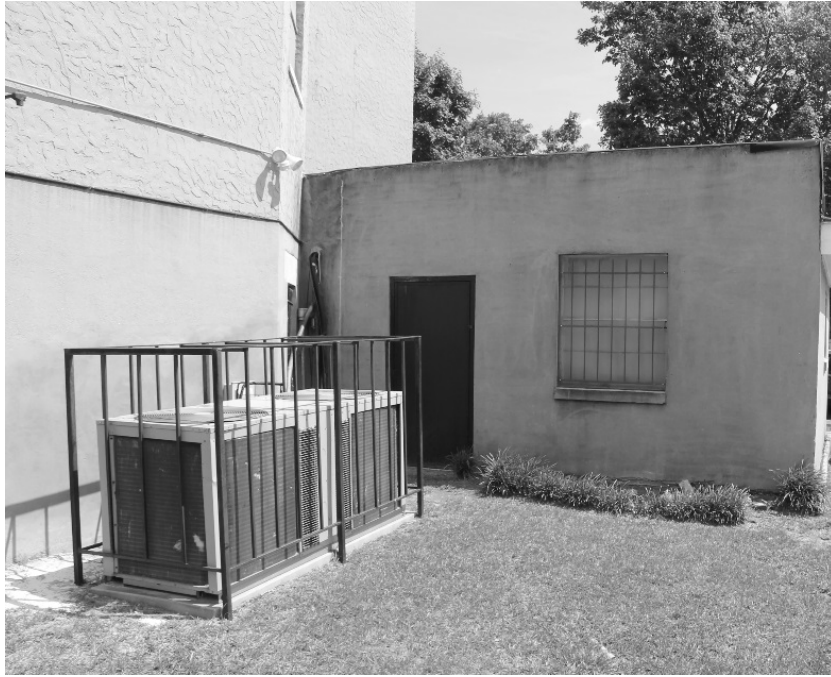
FIGURE 76. Image of a pair of condensers. (Photograph by the author)
