45TH **TURBOMACHINERY** & 32ND **PUMP SYMPOSIA**
HOUSTON, TEXAS | SEPTEMBER 12 – 15, 2016
GEORGE R. BROWN CONVENTION CENTER

Investigation of Steam Turbine blade

Blade failure was observed on a backpressure steam turbine (driving a centrifugal compressor) after it was in service for more than one year.

This paper presents details of observations, inspections carried out and root cause analysis of the turbine blade failure.

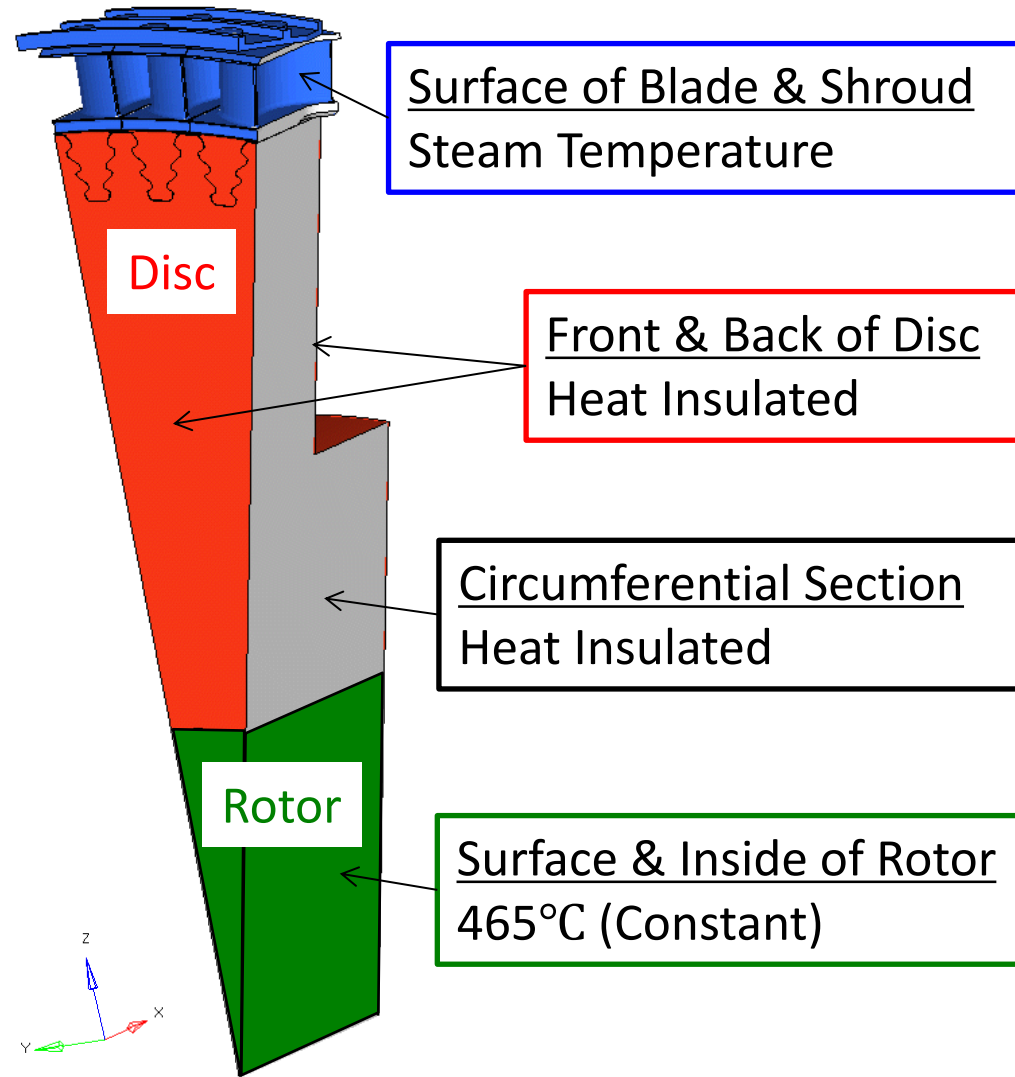
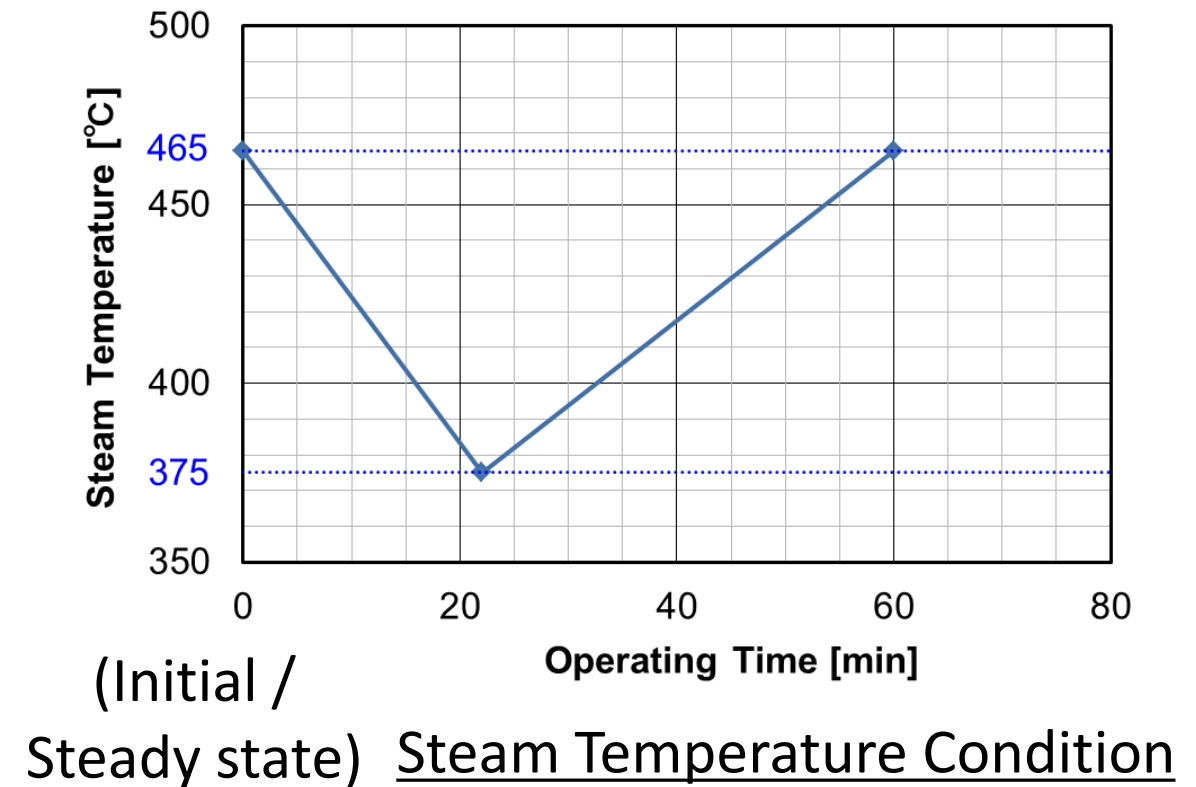
Analysis Model & Thermal Boundary Condition

Steam Temp.		Operating Time			Operating Speed
Reduction	Reheating	Reduction	Reheating	Total	
-4 °C/min	+2.4 °C/min	22 min	38 min	60 min	Nor. (4700 rpm)

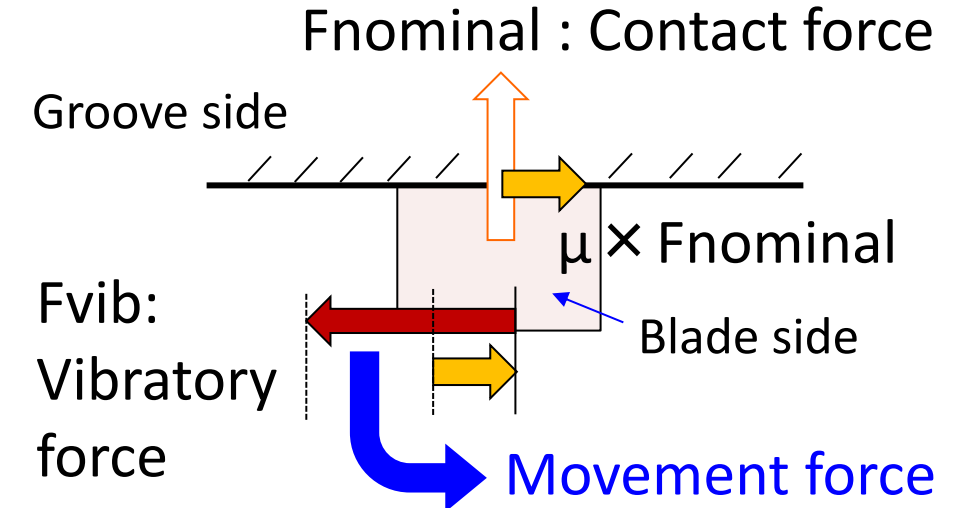
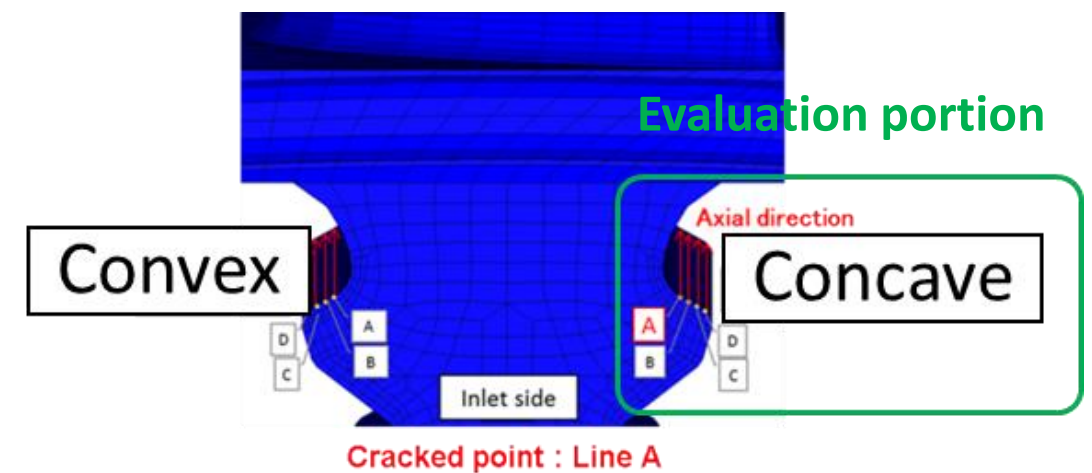
- ✓ Slip between rotor groove and blade was possible as the vibratory forces exceeded contact force on blade root during temperature excursion event

$F_{vib} > \mu \times F_{nominal} \Rightarrow$ Slipped

$F_{vib} < \mu \times F_{nominal} \Rightarrow$ Not Slipped

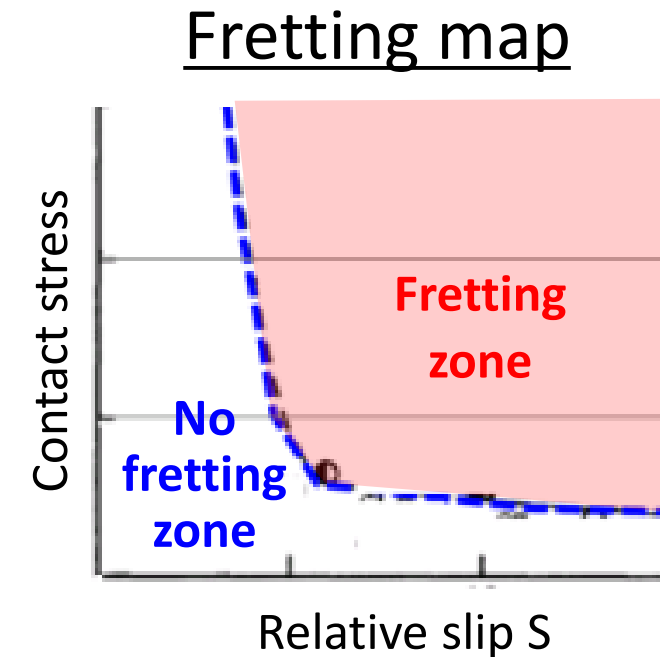
Schematic of fretting crack

Relative slip & contact stress is plotted on fretting criteria (based on experimental data in OEM).

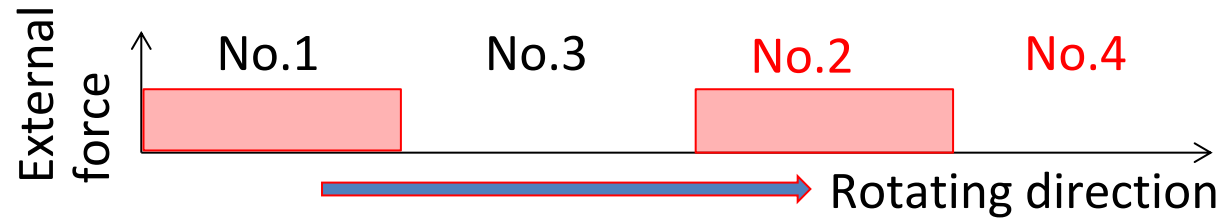
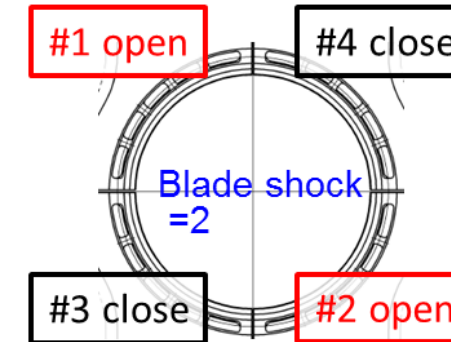
Original

2 time external force occurs on blade during one rotation

Vibratory stress can be reduced about 50% due to GV opening location change for No,2 and 4.

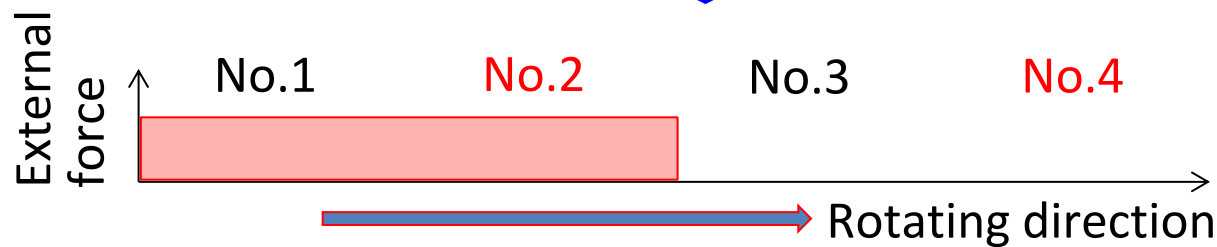
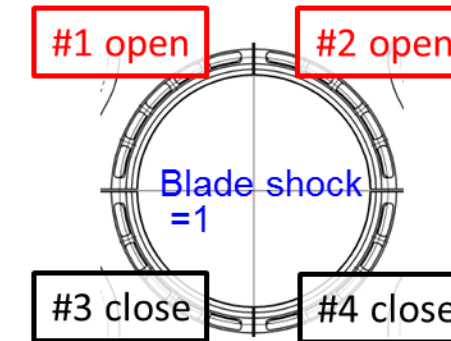
After modification

1 time external force occurs on blade during one rotation
