45TH **TURBOMACHINERY** & 32ND **PUMP SYMPOSIA**
HOUSTON, TEXAS | SEPTEMBER 12 – 15, 2016
GEORGE R. BROWN CONVENTION CENTER

High Vibration Analysis of Eddy Current Drum Coupled Motor to a Vertical Centrifugal Pump – Solution Based on EMA, ODS and FEA

Problem Statement

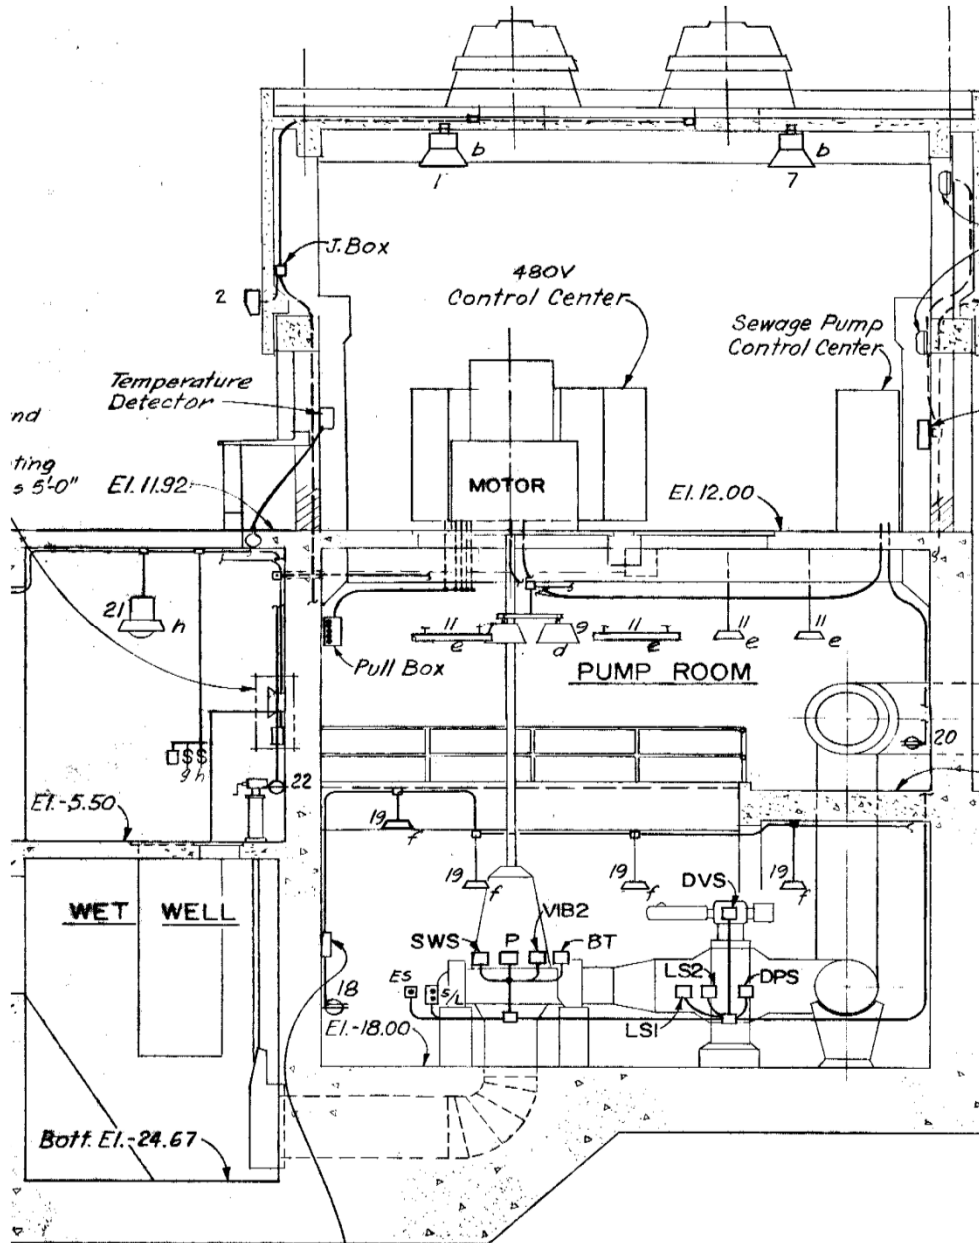
Outline Drawing

Motor

HP: 1000 or 1500
 Volts: 4160
 Phase: 3
 Hertz: 60
 RPM: 294 or 592
 AMPS: 137 or 187
 Weight: 44,000 lbs

Pump

Type: Centrifugal
 Application: Gray Water
 Speed Range: 228 to 590 RPM

* Eddy current coupling allows the constant dual speed motor to operate at pump range shown.

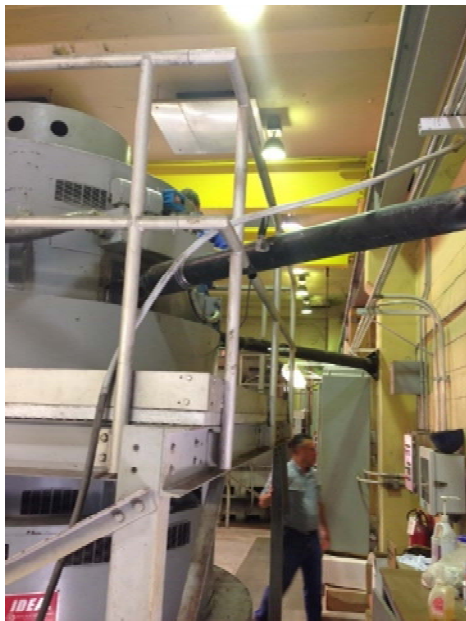
Vibration Response Before and After Modifications
