ASIA TURBOMACHINERY AND PUMP SYMPOSIUM

Investigation of Steam Turbine blade failure

Blade failure was observed on a backpressure steam turbine (driving a centrifugal compressor) after it was in service for more than one year.

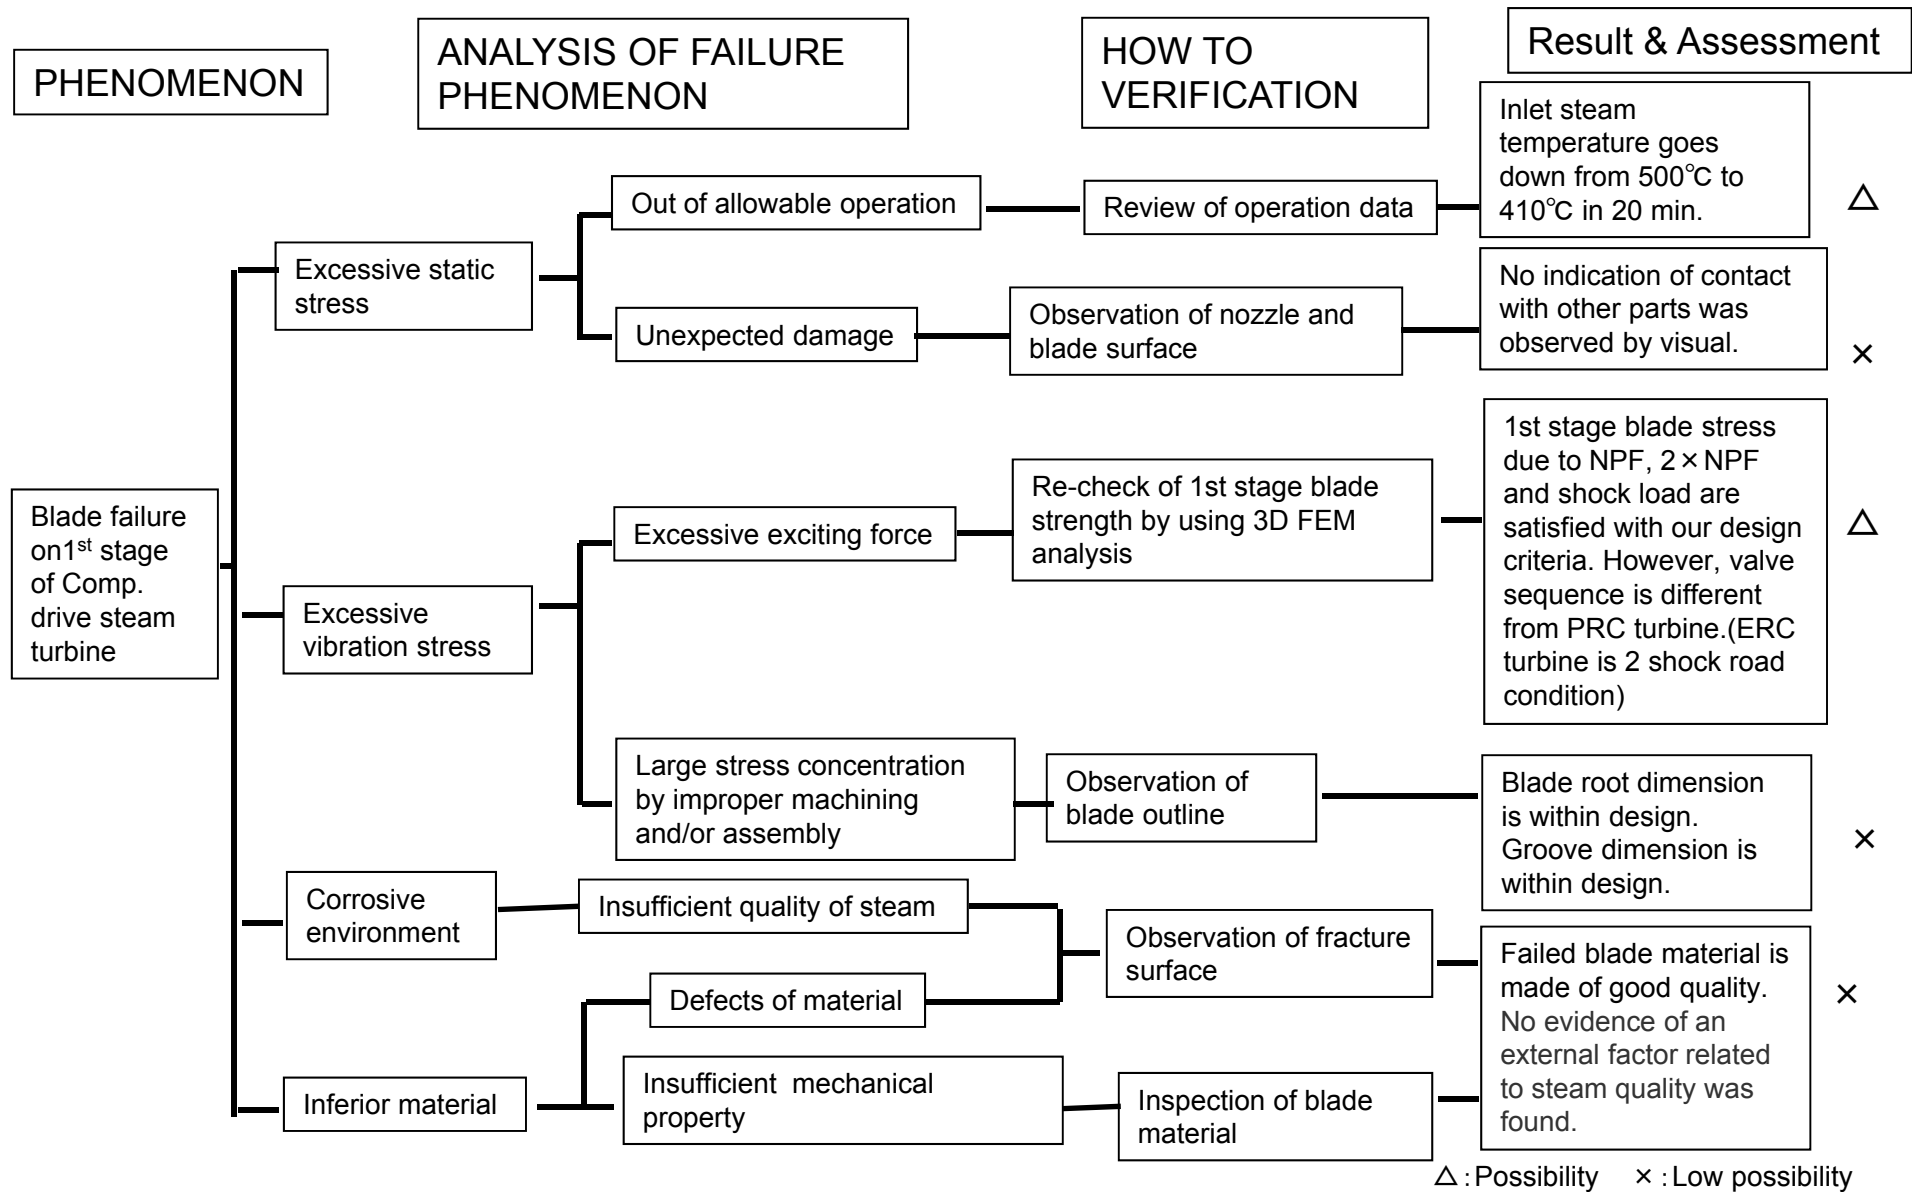
6. Possible cause (1/2)

The temperature changed from approximately from 500 degree C to 410 degree C in roughly 20 minutes and then recovered to rated temperatures in approximately 30 minutes. This event had occurred approximately 1 month before the failure of the turbine blade.

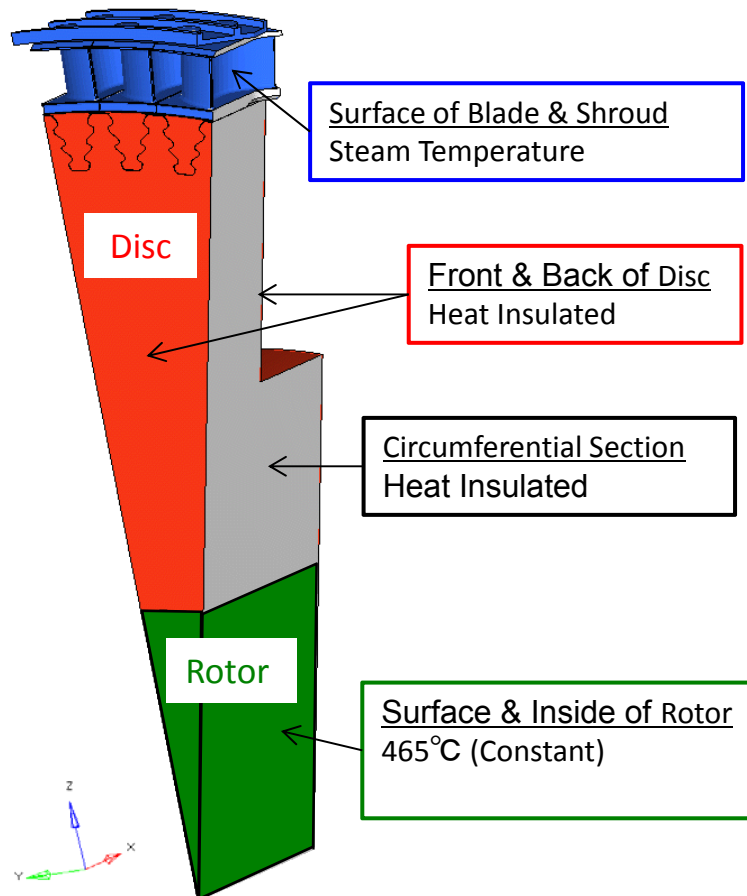
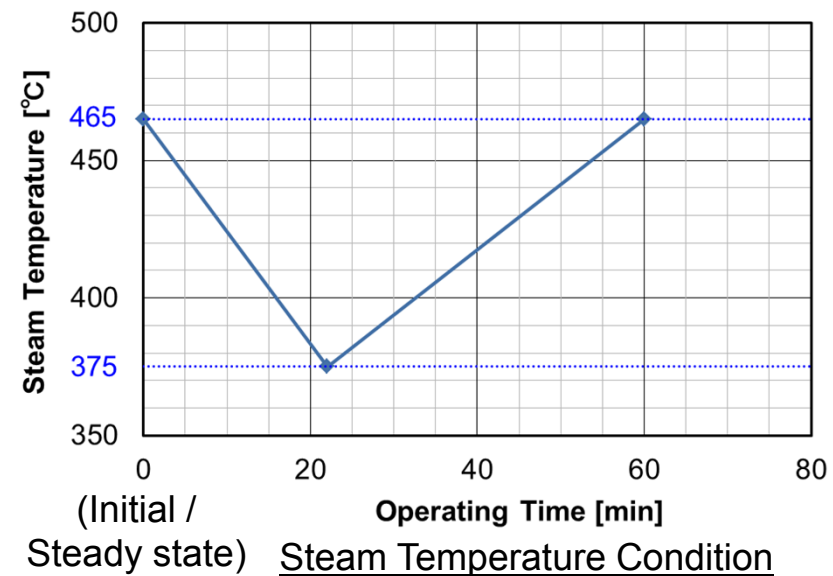
Analysis Model & Thermal Boundary Condition

Steam Temp.		Operating Time			Operating Speed
Reduction	Reheating	Reduction	Reheating	Total	
-4 °C/min	+2.4 °C/min	22 min	38 min	60 min	Nor. (4700 rpm)

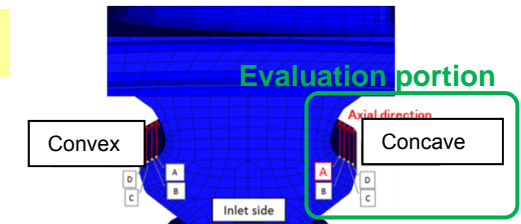
Slip level for contact area

- Relative slip occur at 307sec (cooling rate is 4 degree Celsius / min).

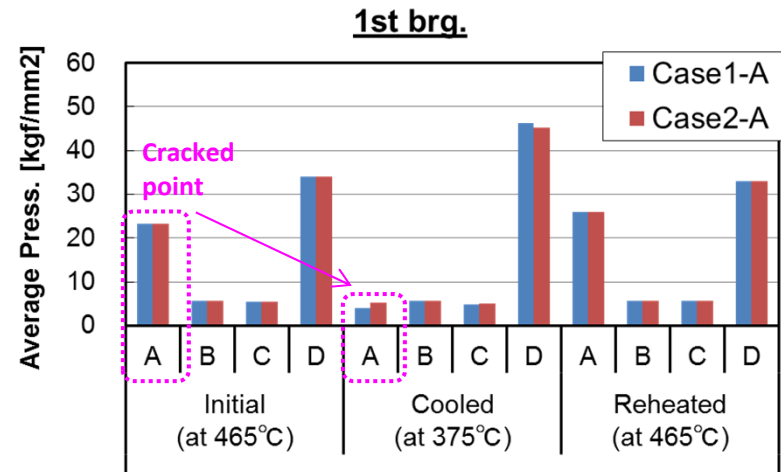
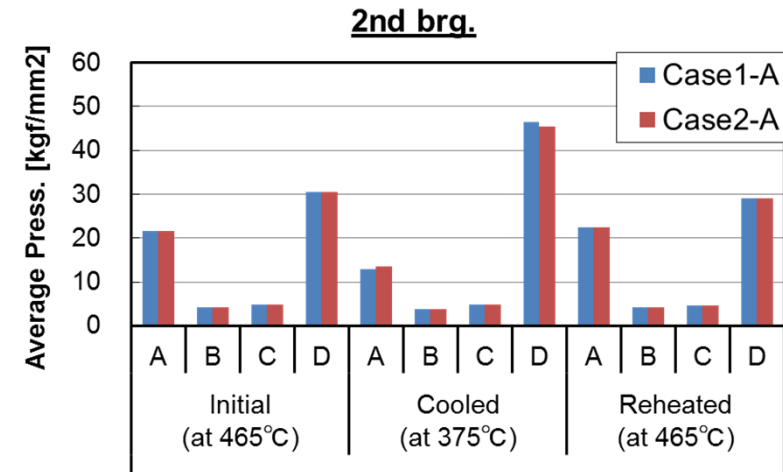
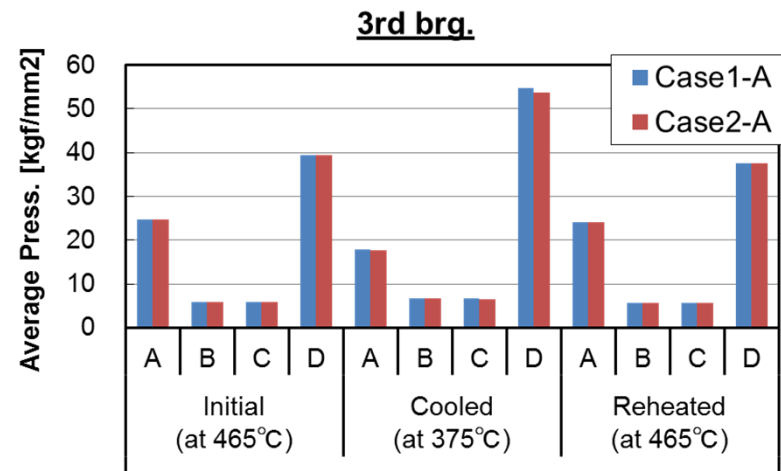
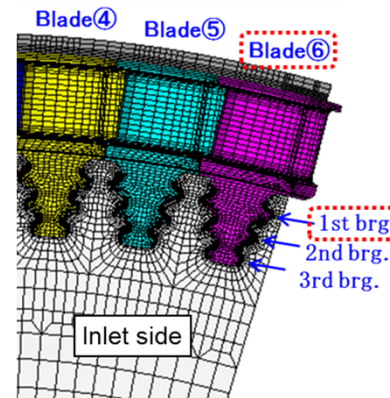
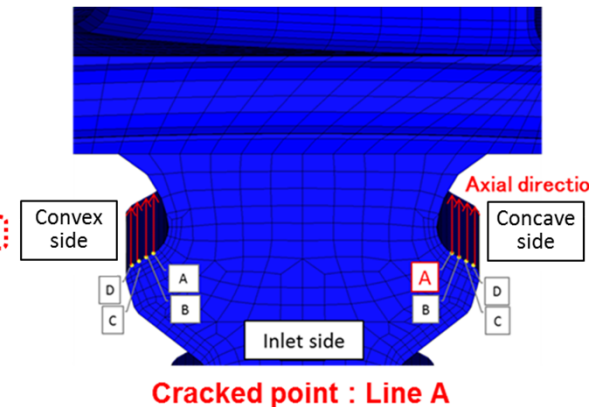
Average of contact pressure (at Blade⑥ / Concave side)

- ✓ At the 1st brg. Line A (cracked point), the contact pressure significantly reduce after steam cooled.
- ✓ After steam reheated, the contact pressure become nearly equal to initial condition again.
