ASIA TURBOMACHINERY & PUMP SYMPOSIUM
SINGAPORE | 22 - 25 FEBRUARY 2016
M A R I N A B A Y S A N D S

PTT Public Company Limited

SULZER PUMPS

Hydraulic Power Recovery Turbine Operational Failure and Design Enhancements

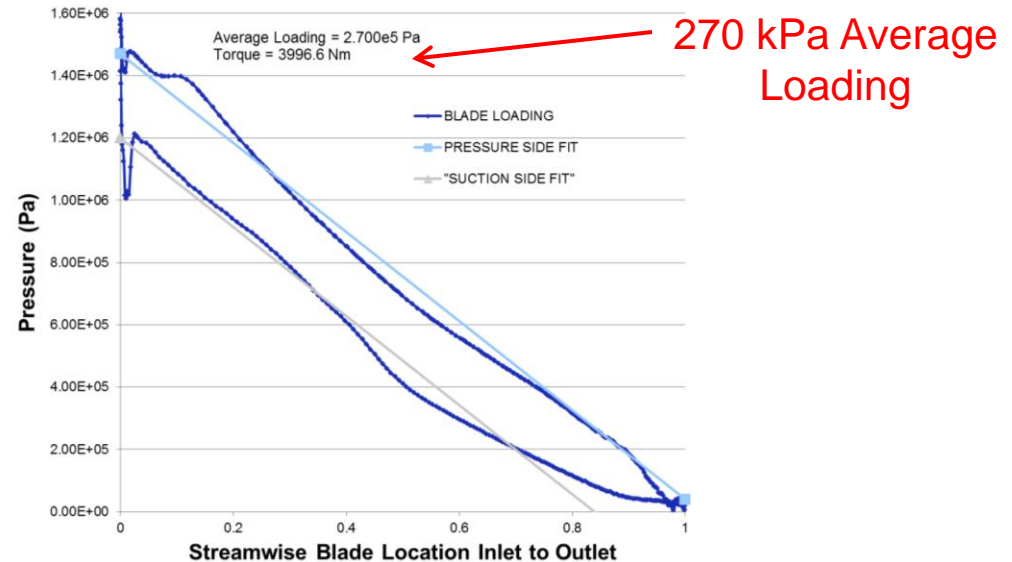
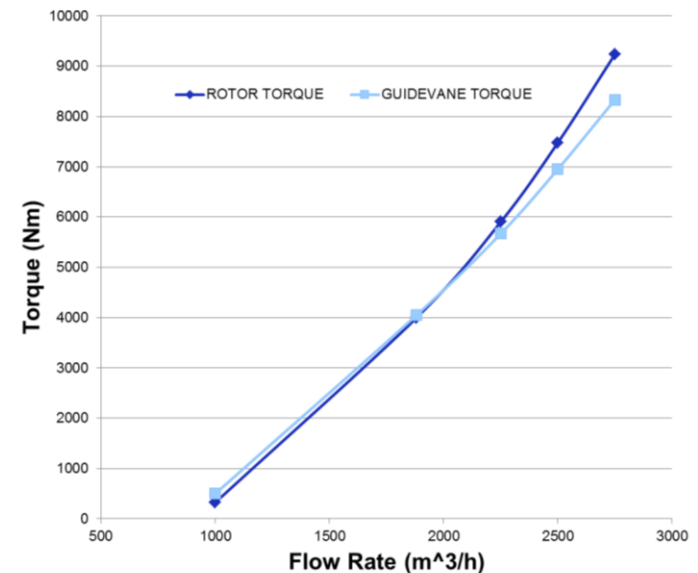
HPRT 14X14C HST CFD Steady State Analysis - Torque & Vane Pressure Loading Estimates

$$T_{CFD} = 3997 \text{ [Nm]}$$

$$T_{Rated} = 4180 \text{ [Nm]}$$

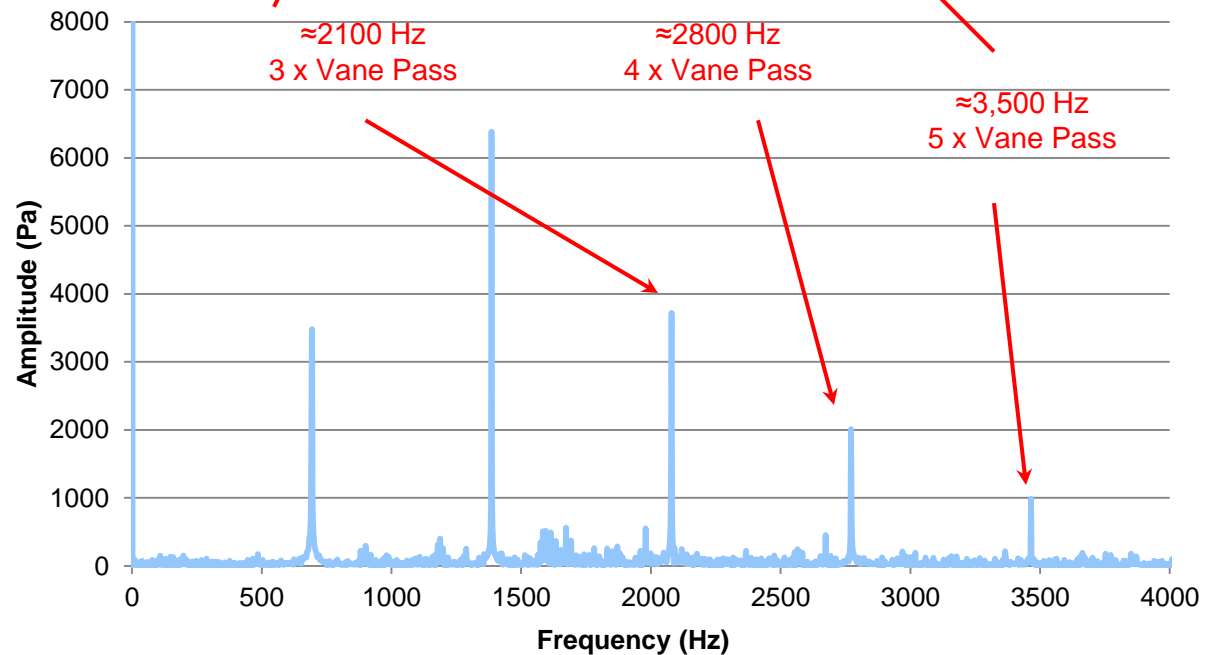
■ CFD estimated HPRT outlet pressure spectra

- 1x (700 Hz) 3500 Pa
- 2x (1400 Hz) 6400 Pa
- 3x (2100 Hz) 3800 Pa
- 4x (2800 Hz) 2000 Pa
- 5x ((3500 Hz) 1000 Pa

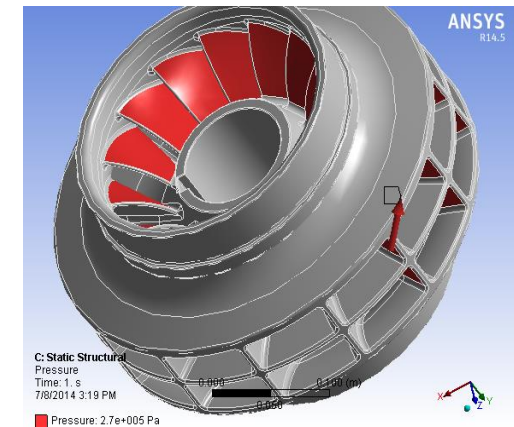
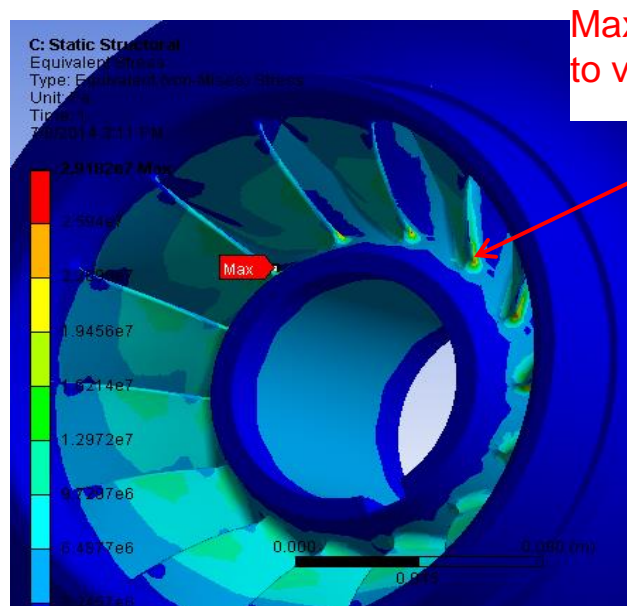
14X14 HST Runner FE Analysis Results - Equivalent (von-Mises) Stress

- 270 kPa blade pressure loading from CFD analysis

- Max von-Mises Stress Approx. 29 MPa
 - < 6% of Yield Stress for CD4MCu (Duplex SS)
 - < 4.5% of Yield Stress for CB7Cu-1 (17-4 pH H1150)

Max stress localized to vane fillets on hub

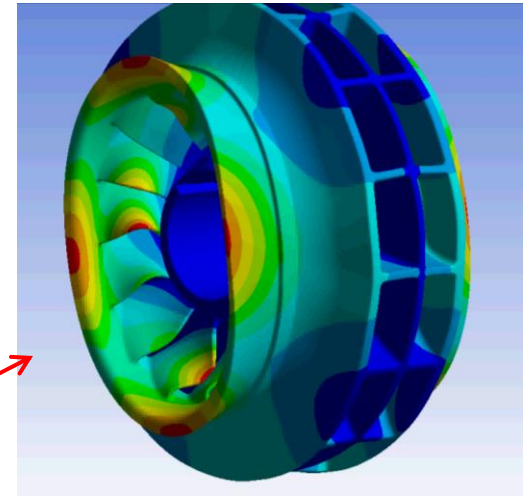
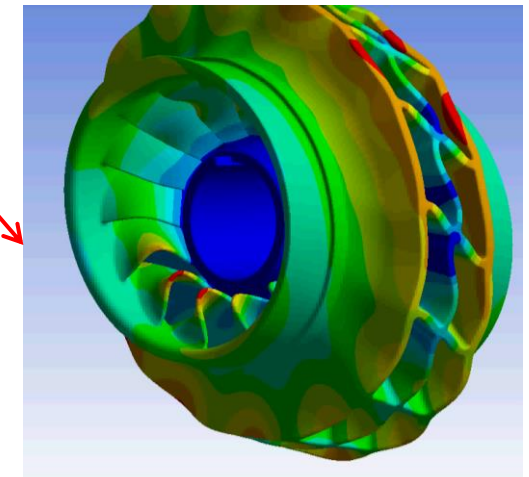
HPRT 14X14C HST Runner FE Analysis Results- Modal Shapes & Natural Frequencies

- Many runner structural natural frequencies in the range of 1 – 2 KHz.

- Not possible to know exact frequency of any mode during operating due to fluid added mass and damping.
- Possibility exists that a runner structural vibration mode is excited by:
 - IGV – Runner hydrodynamic interaction
 - System Excitation source:
 - water hammer (valve closure)
 - system surge (compliance resulting from gas/vapor pockets)
