ASIA TURBOMACHINERY & PUMP SYMPOSIUM
SINGAPORE | 22 - 25 FEBRUARY 2016
M A R I N A B A Y S A N D S

Polytropic Efficiency Improvements and Sustenance on Centrifugal Compressor: Corrosion Erosion and Impact of Fouling

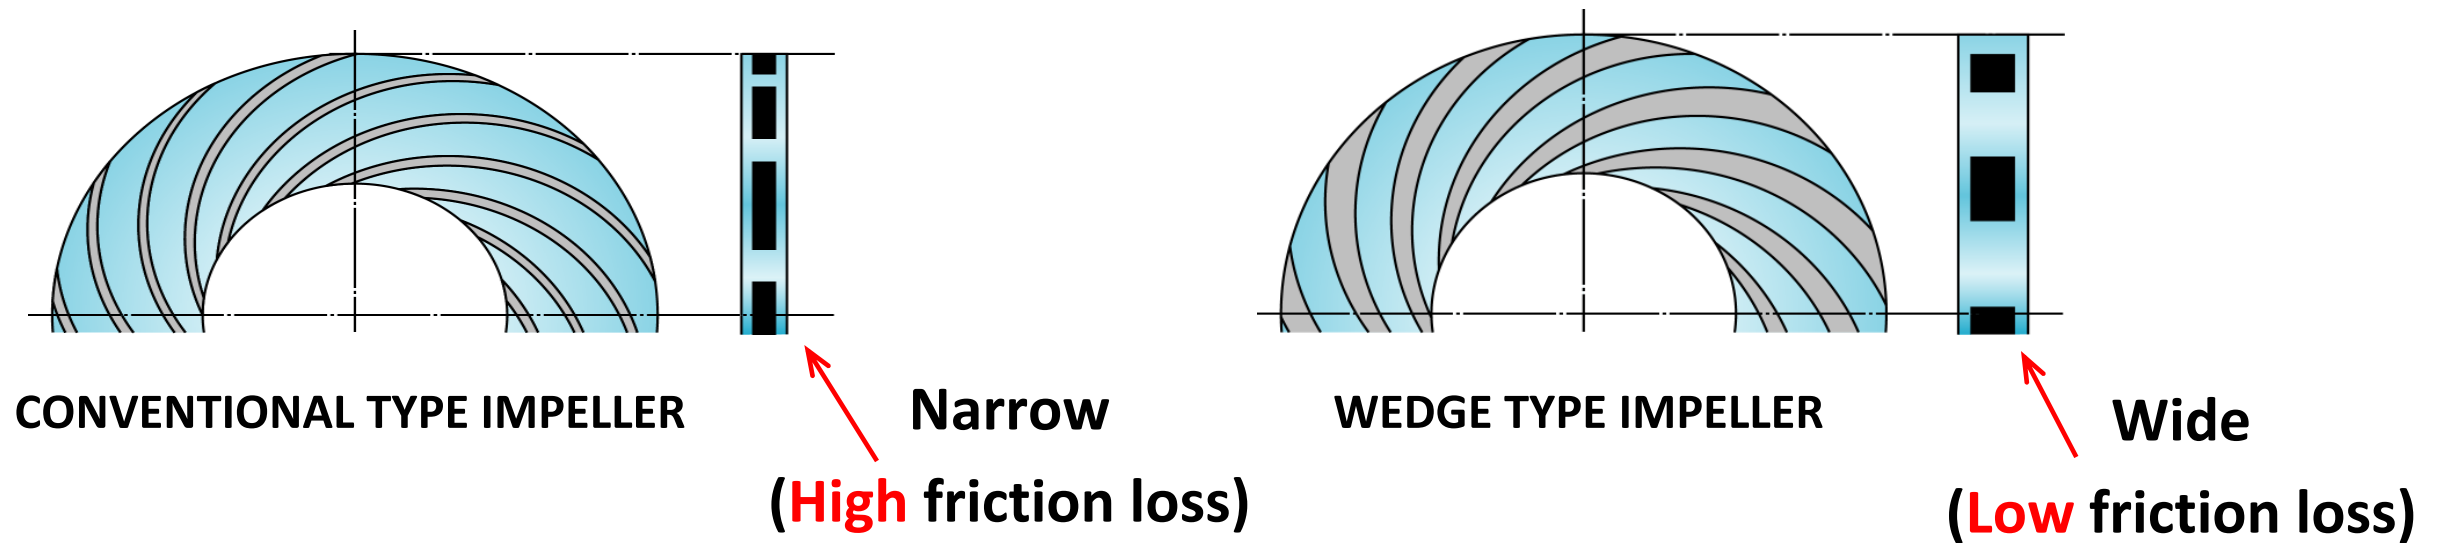
- Wedge Type impeller : Efficient impeller for low flow coefficient ($\Phi_1=0.008$)

To increase design poly efficiency

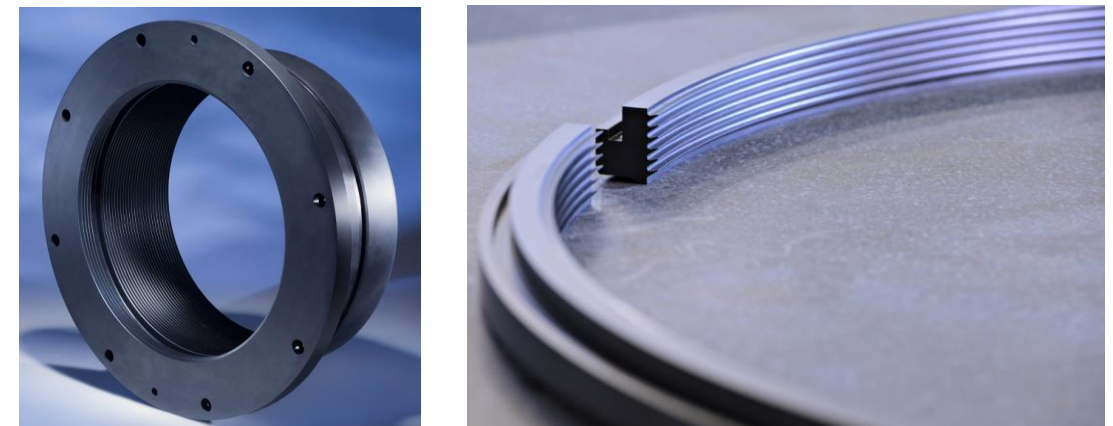
Since PEEK material are resistance to corrosive agent, labyrinth will keep their shape even under corrosive atmosphere, which maintain smaller leakage.

- PEEK labyrinth : reduce leakage with very narrow gap
