ASIA TURBOMACHINERY & PUMP SYMPOSIUM
SINGAPORE | 22 - 25 FEBRUARY 2016
M A R I N A B A Y S A N D S

ExxonMobil

Investigation & Resolution on Oxidation Feed Pump Pulsation Related fatigue failures

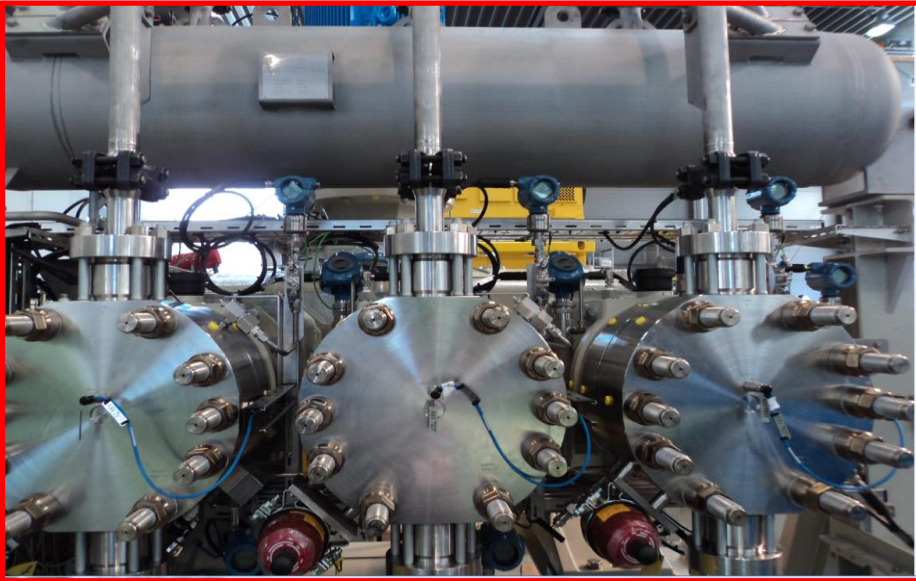
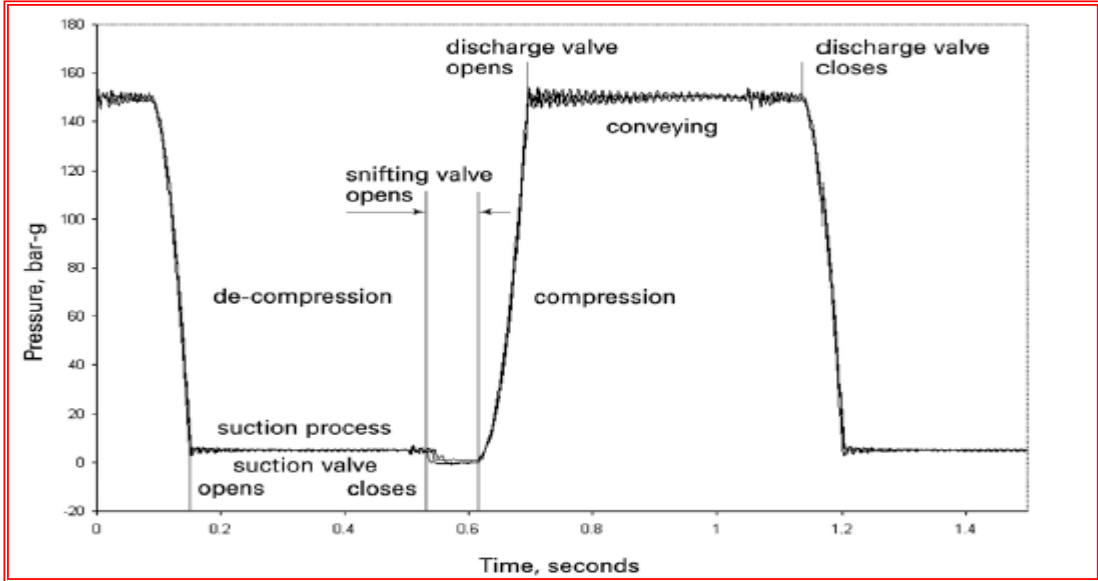
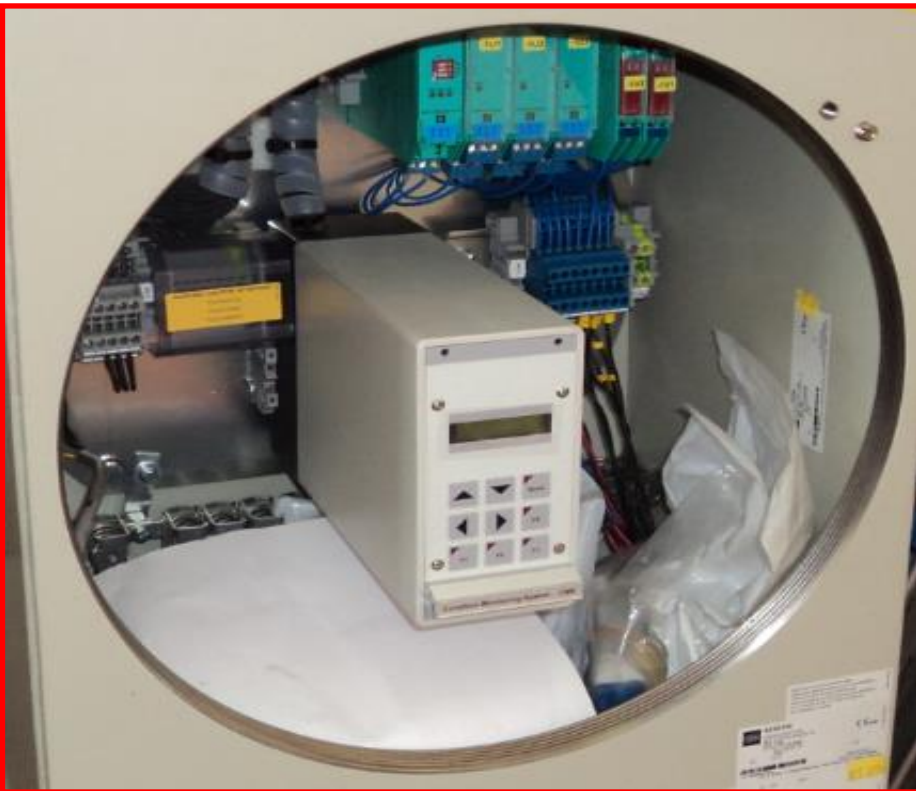
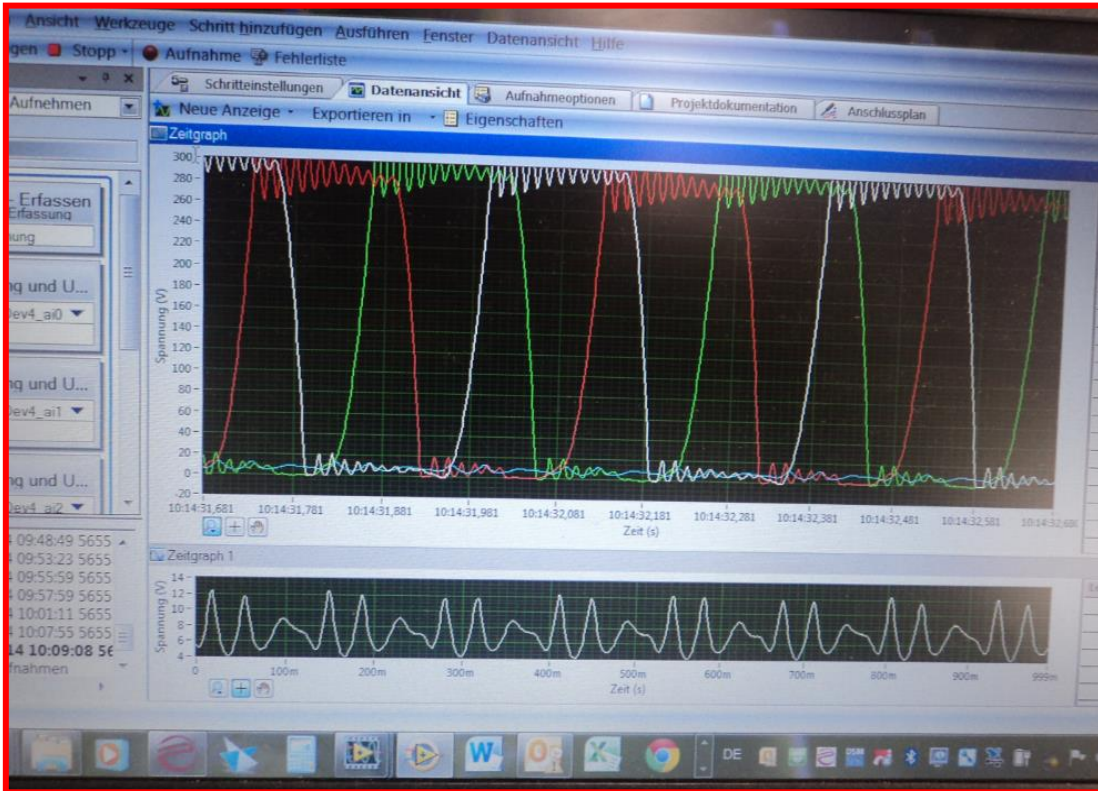
CMS Oscillographic Wave forms

- Significant reduction in piping vibration levels by 95% (87.5 to 7 mm/sec r.m.s.)
- Overall vibration levels were reduced significantly in all directions after orifice installation
- Vibration results on newly added two pumps are deemed acceptable even with five pumps in parallel mode operation
