Effects of shaft geometric unconformities on the rotor-dynamic behavior in hard coupled equipment

This case study deals with a 25MW turbo-generator train with a semi-rigid connection between generator and gearbox.

The rotor-dynamics of the train in subject was negatively influenced by a geometrical out-of-tolerance on the generator flange, causing a distortion in the shaft line which introduces a pre-stress on the rotor system.

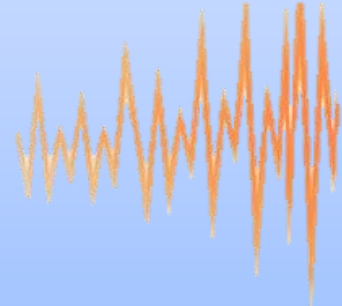
- 25MW Turbogenerator with semi-rigid connection between Gearbox and Generator
- Unexpected high radial vibration on Generator, even at low speed
- Abnormal vibration detected also on Gearbox LS shaft

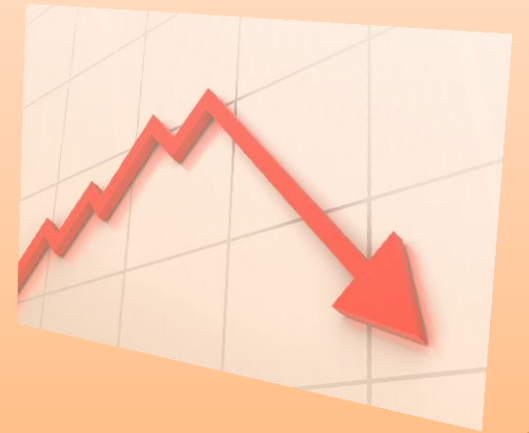
Vibration above the acceptance limits

- Failed string test
- Reduced availability at site

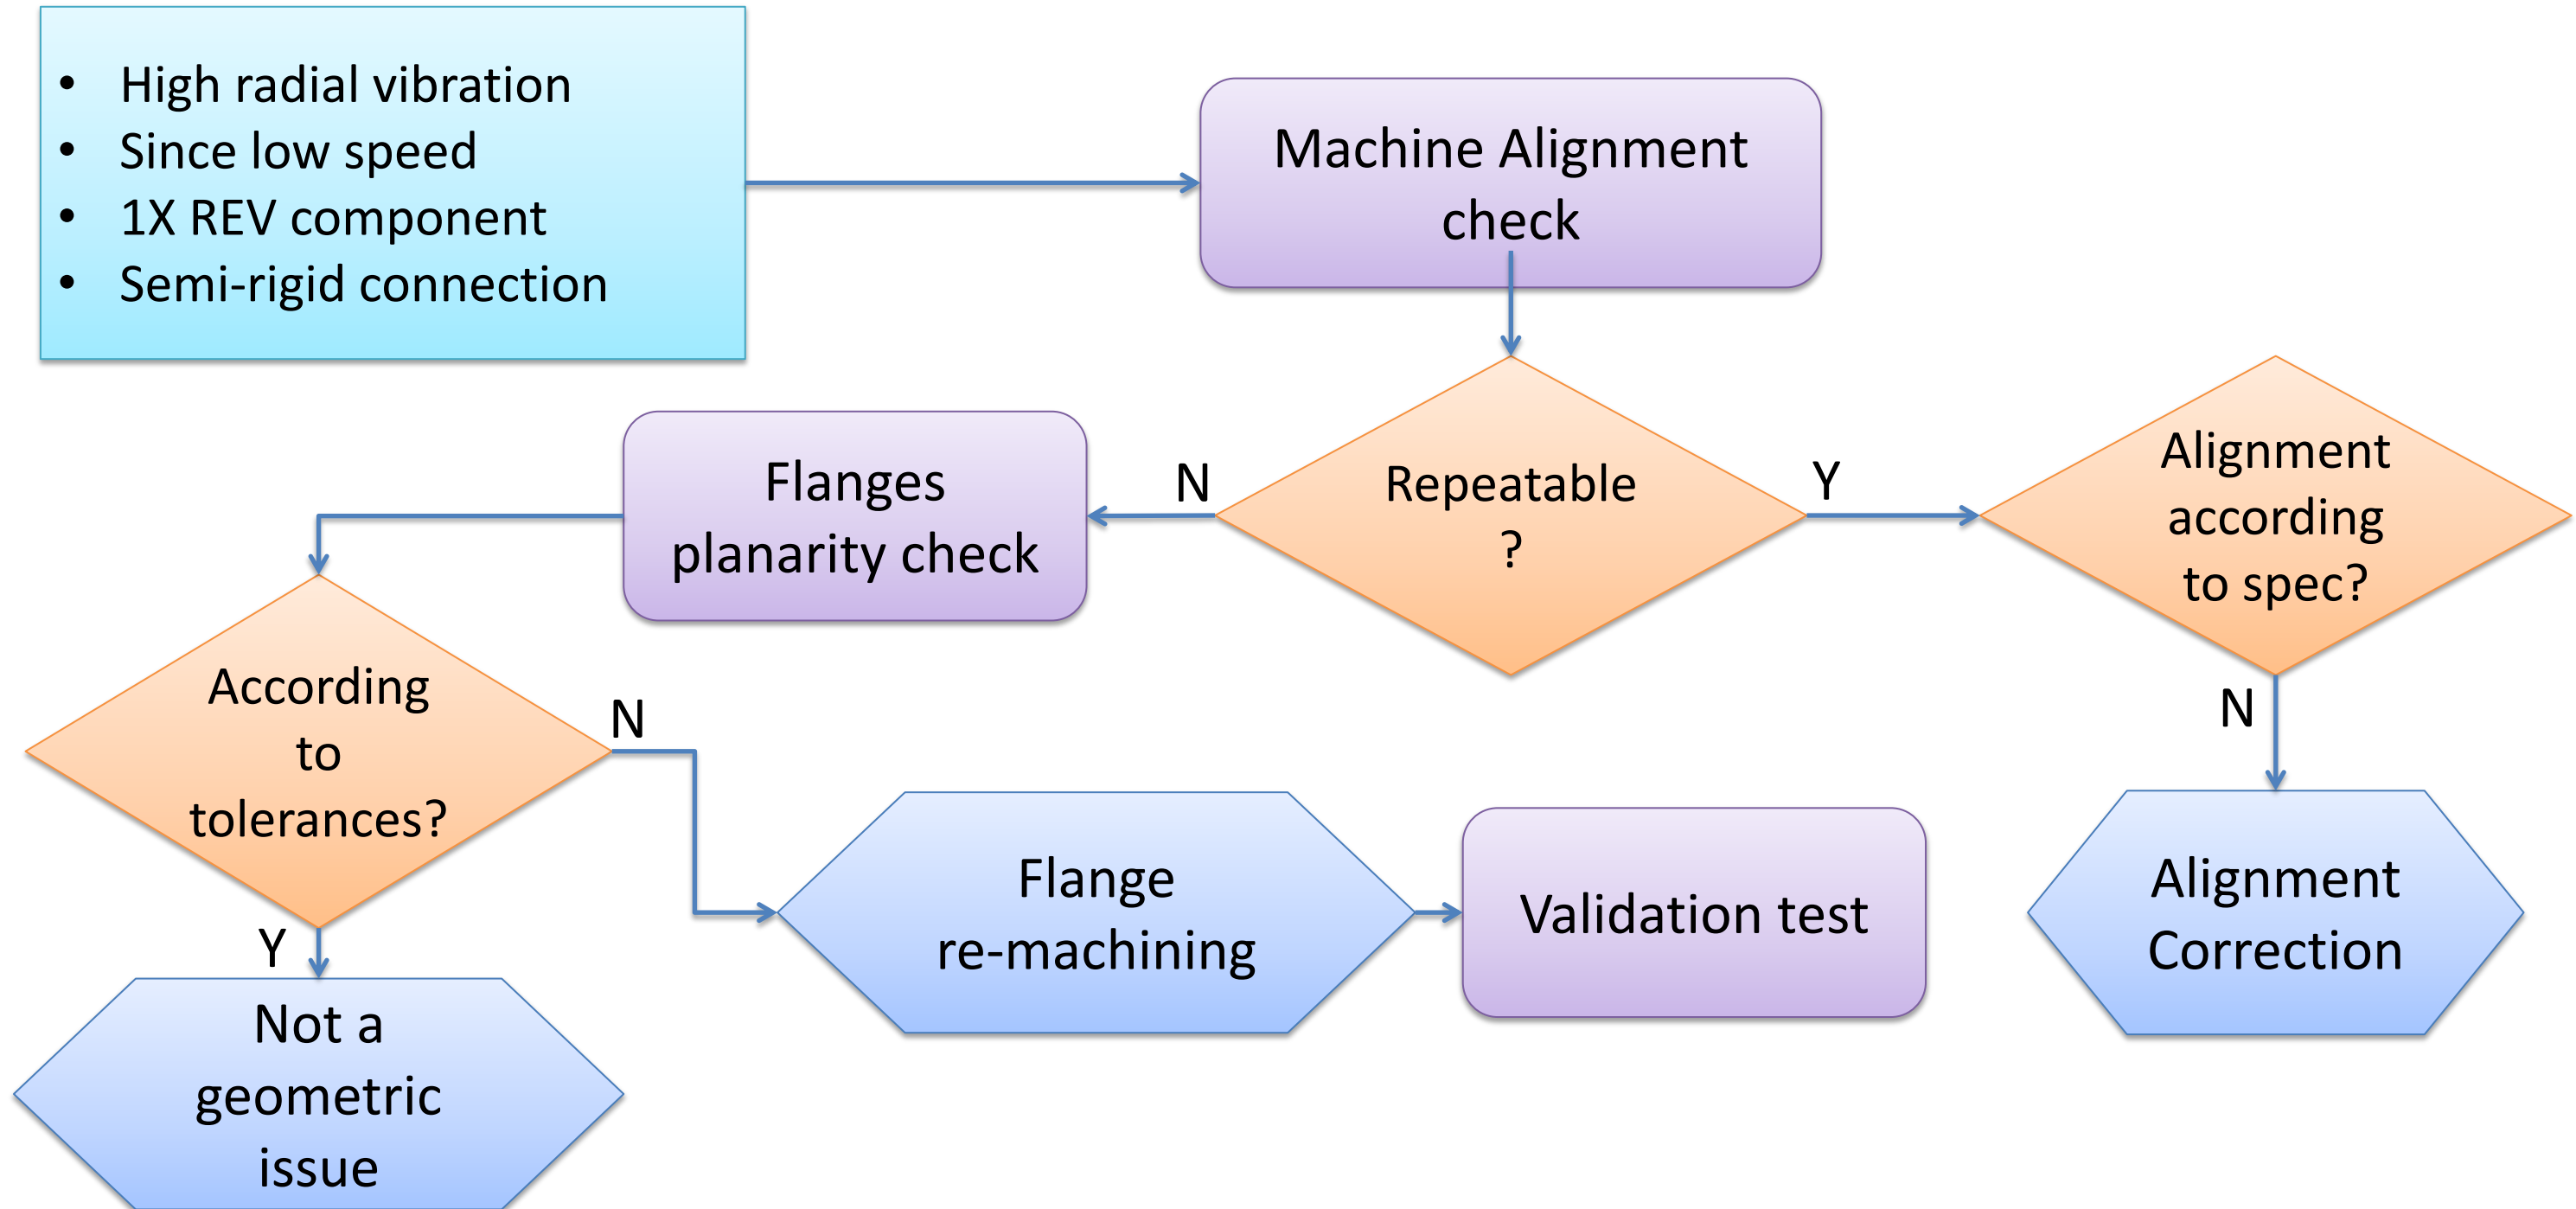
Keypoints and basic troubleshooting

- High radial vibration
- Since low speed
- 1X REV component
- Semi-rigid connection

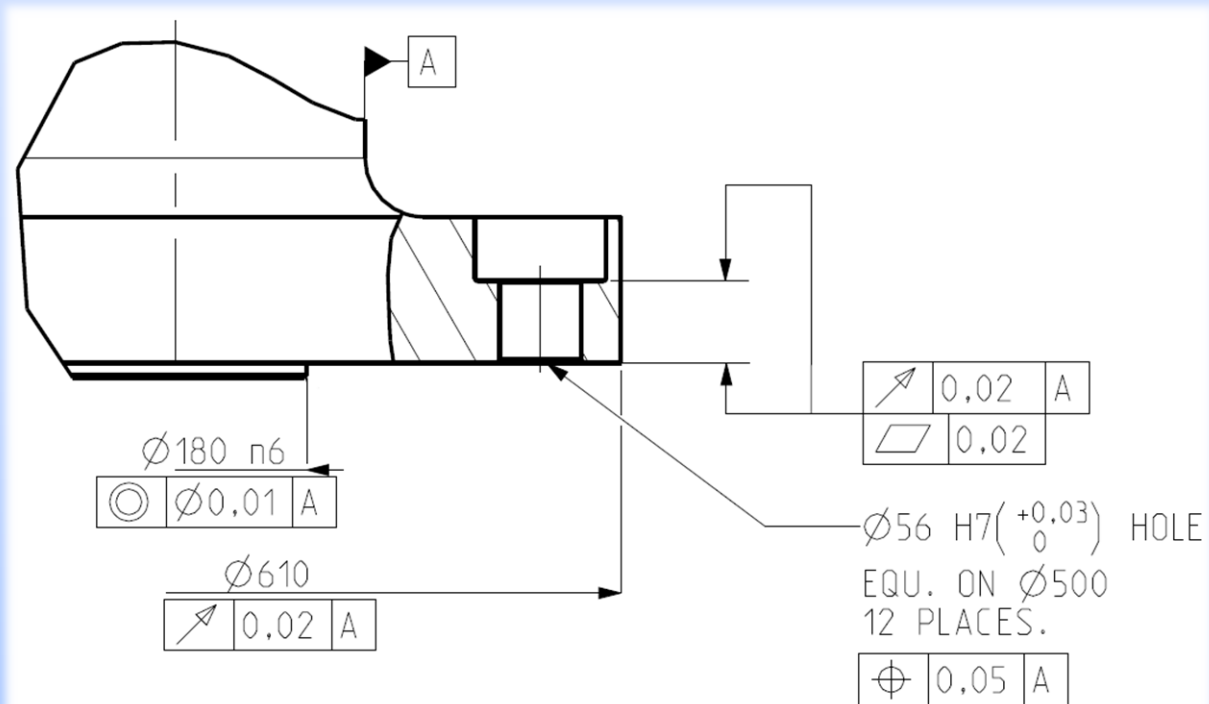
Tight geometric tolerances recommended in case of semi-rigid connection:

- ☑ Planarity tolerance
- ☑ Spigot concentricity tolerance

- Production process was found to be robust: shaft journal grinding to be carried out using the flange as reference to avoid perpendicularity deviations; hence, perpendicularity control on flanges not required by the process
- However, pre-defined shaft production sequence was not followed (actual sequence was based on machine tool availability)
