RESOLVING INTERMITTENT VIBRATION SPIKES ON STEAM TURBINES

Rajakumar Thiagarajan
Rotating Equipment Engineer

42nd Turbomachinery
29th Pump SYMPOSIA

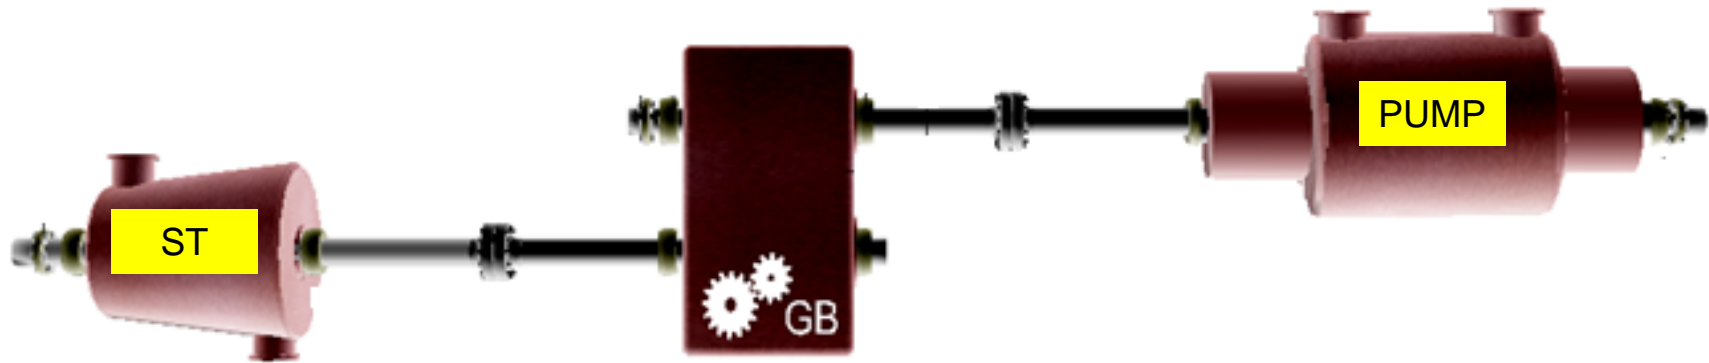
Machine Description

Turbine Type:	Back pressure (5 stage)
Bearings:	Tilting pad
Seals:	Mechanical Labyrinth
Coupling:	Diaphragm
Power:	3840KW
Speed:	3602 RPM
