Turbo-Expander Compressor Active Magnetic Bearing Trips Reduction - A Case Study

RasGas

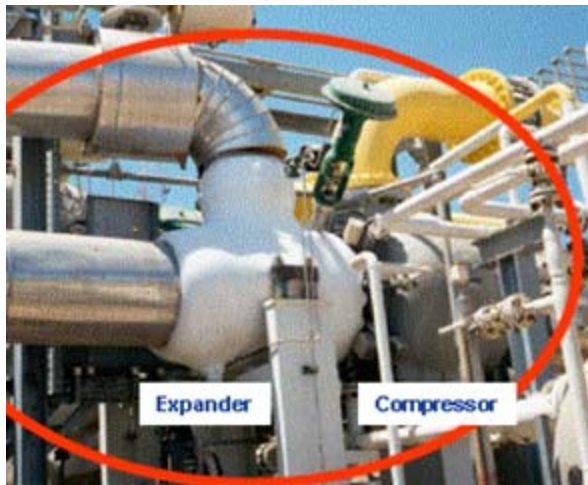
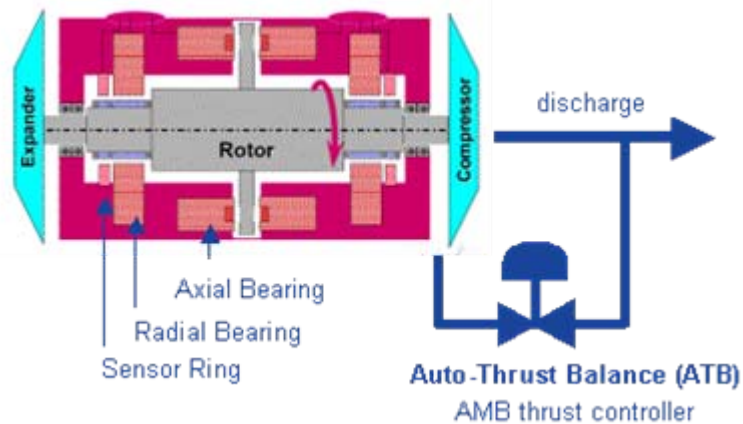
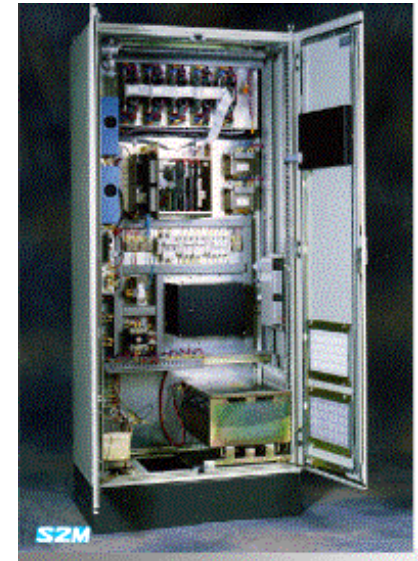
Active Magnetic Bearing
Control Cabinet

- OEM primary vendor of the TEC single shaft arrangement
- Sub-supplier for Active Magnetic Bearing
- Magnetic bearing is a relatively new technology in this application
- Operator relatively new in application that uses AMB technology

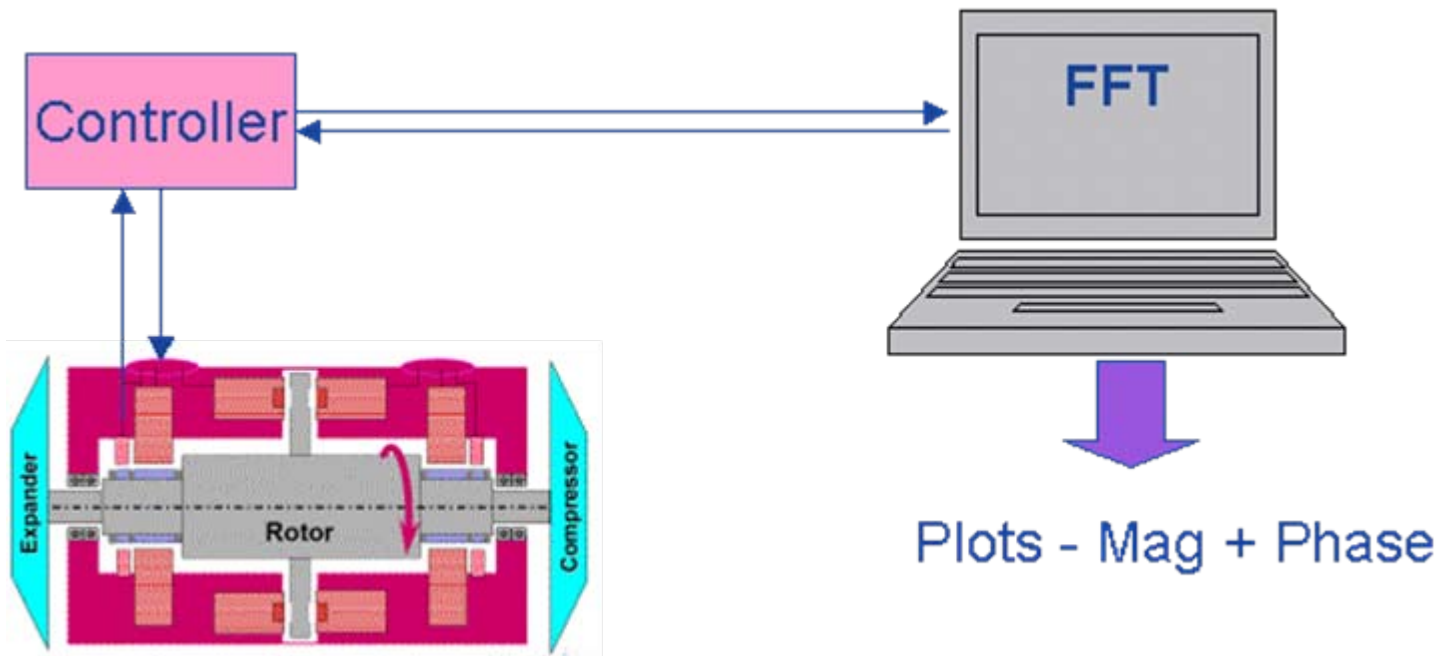
- Control Loop Transfer Function (TF) Changed
 - TF is the ratio of output of a control system to its input; once set up, it represents the system signature (ie, natural frequencies)
 - Change of TF during active operation is rare, but RasGas experienced twice in 2009

- High frequency TF change in Unit #1 unit (*Figures A1-A3*)
 - Mitigated by software modification
 - Machine operational, but fault unknown
- Low frequency change in Units #2 & #3 unit (*Figure B1*)
 - Cannot restart, reinstall old unit
 - Severe rubs of stator and rotor (photos)
 - Root cause identified
