# Speed Signal Deterioration at High Speeds in Electronic Governor and Trip Systems

*40<sup>th</sup> Turbomachinery Symposium Case Study*

Manufacturing and Engineering Support, The Americas  
Lyondell Chemical Company, A LyondellBasell Company

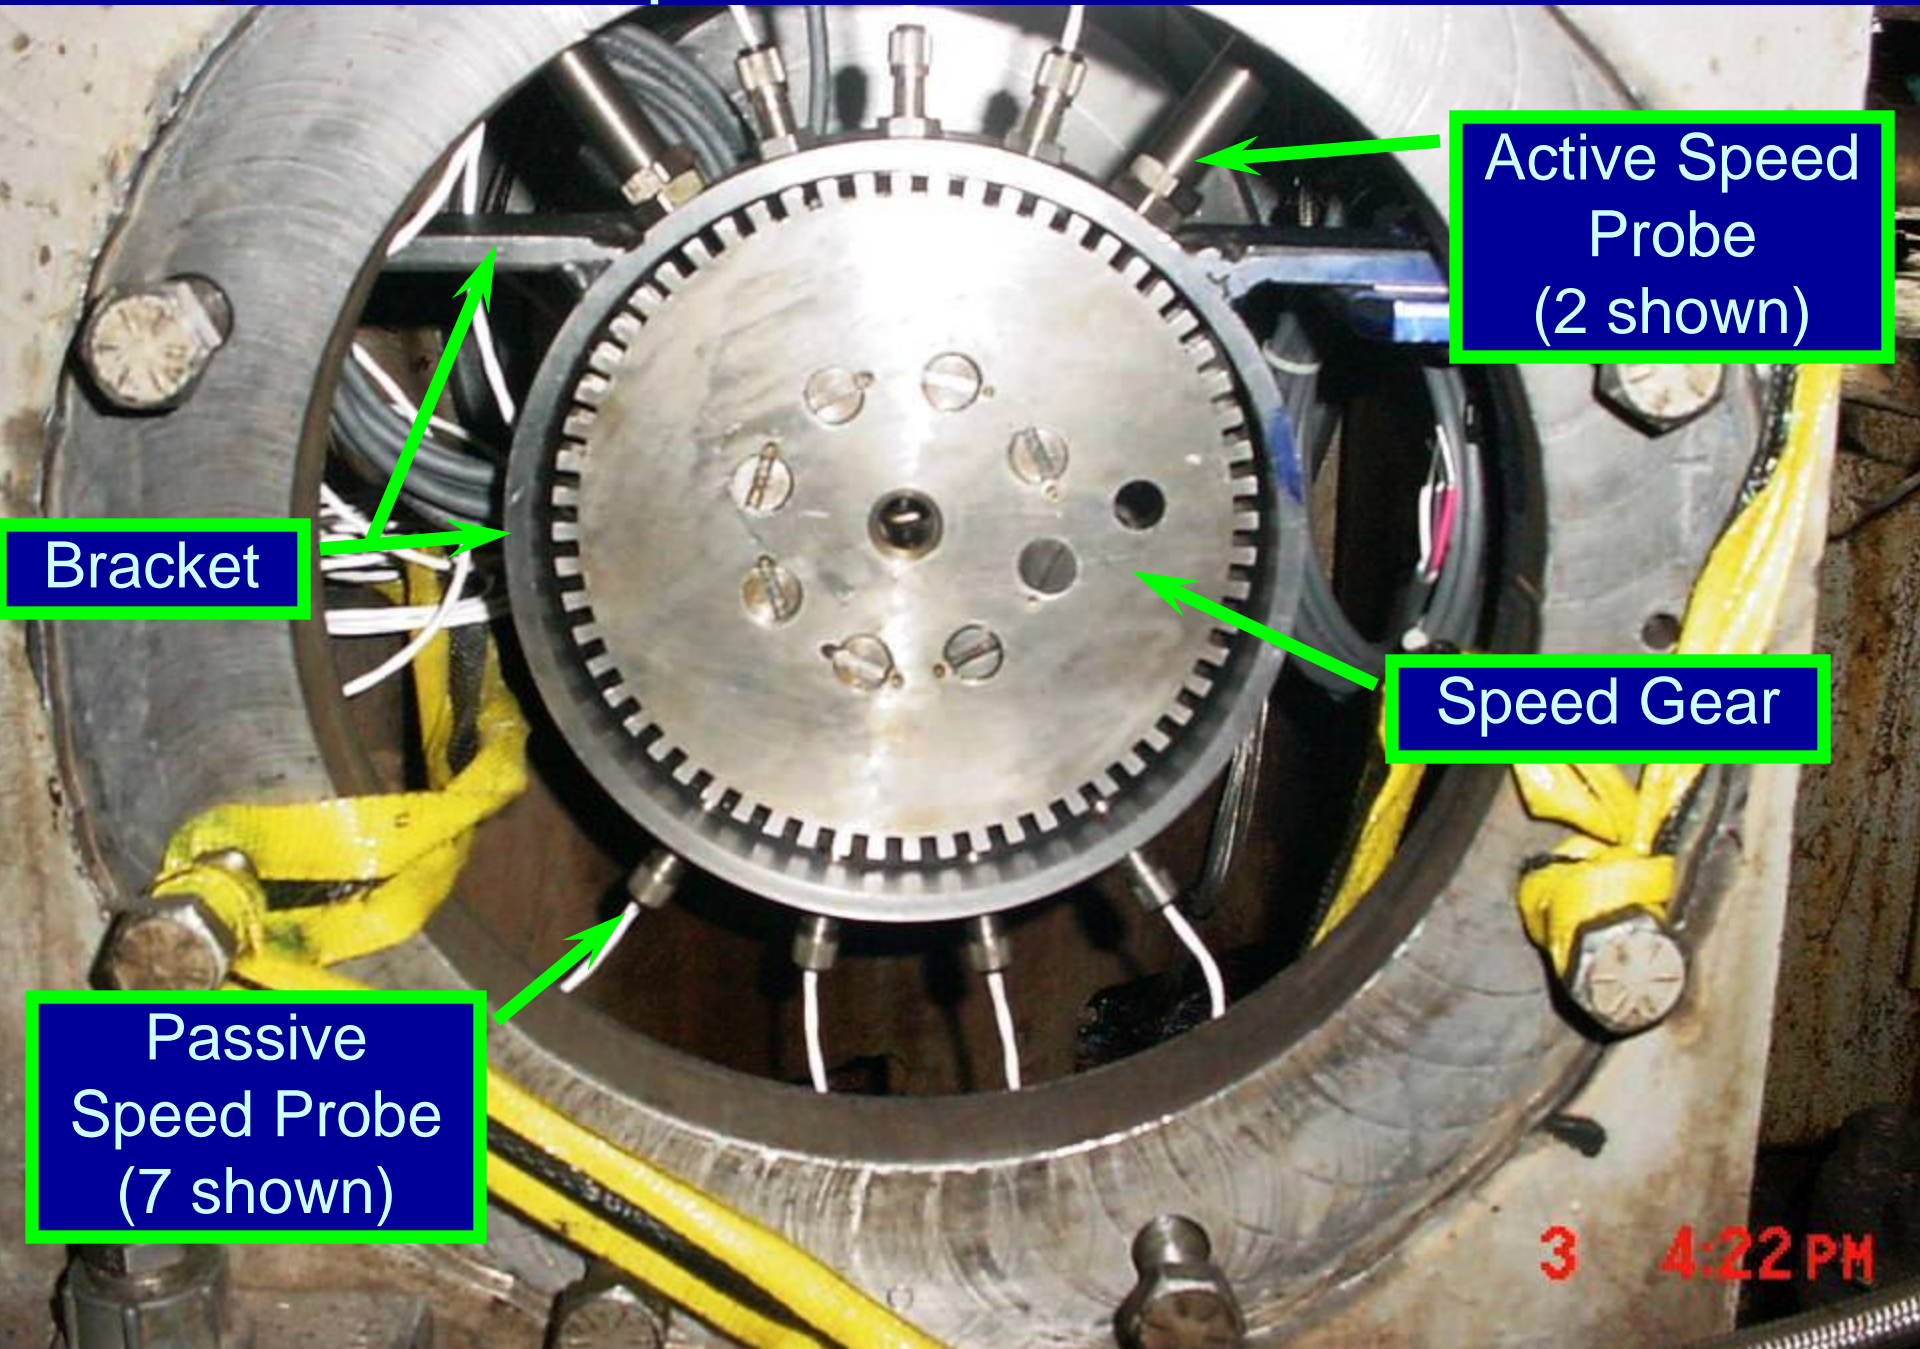
# Axial View of Speed Gear, Probes and Bracket

Active Speed Probe  
(2 shown)

Bracket

Speed Gear

Passive Speed Probe  
(7 shown)

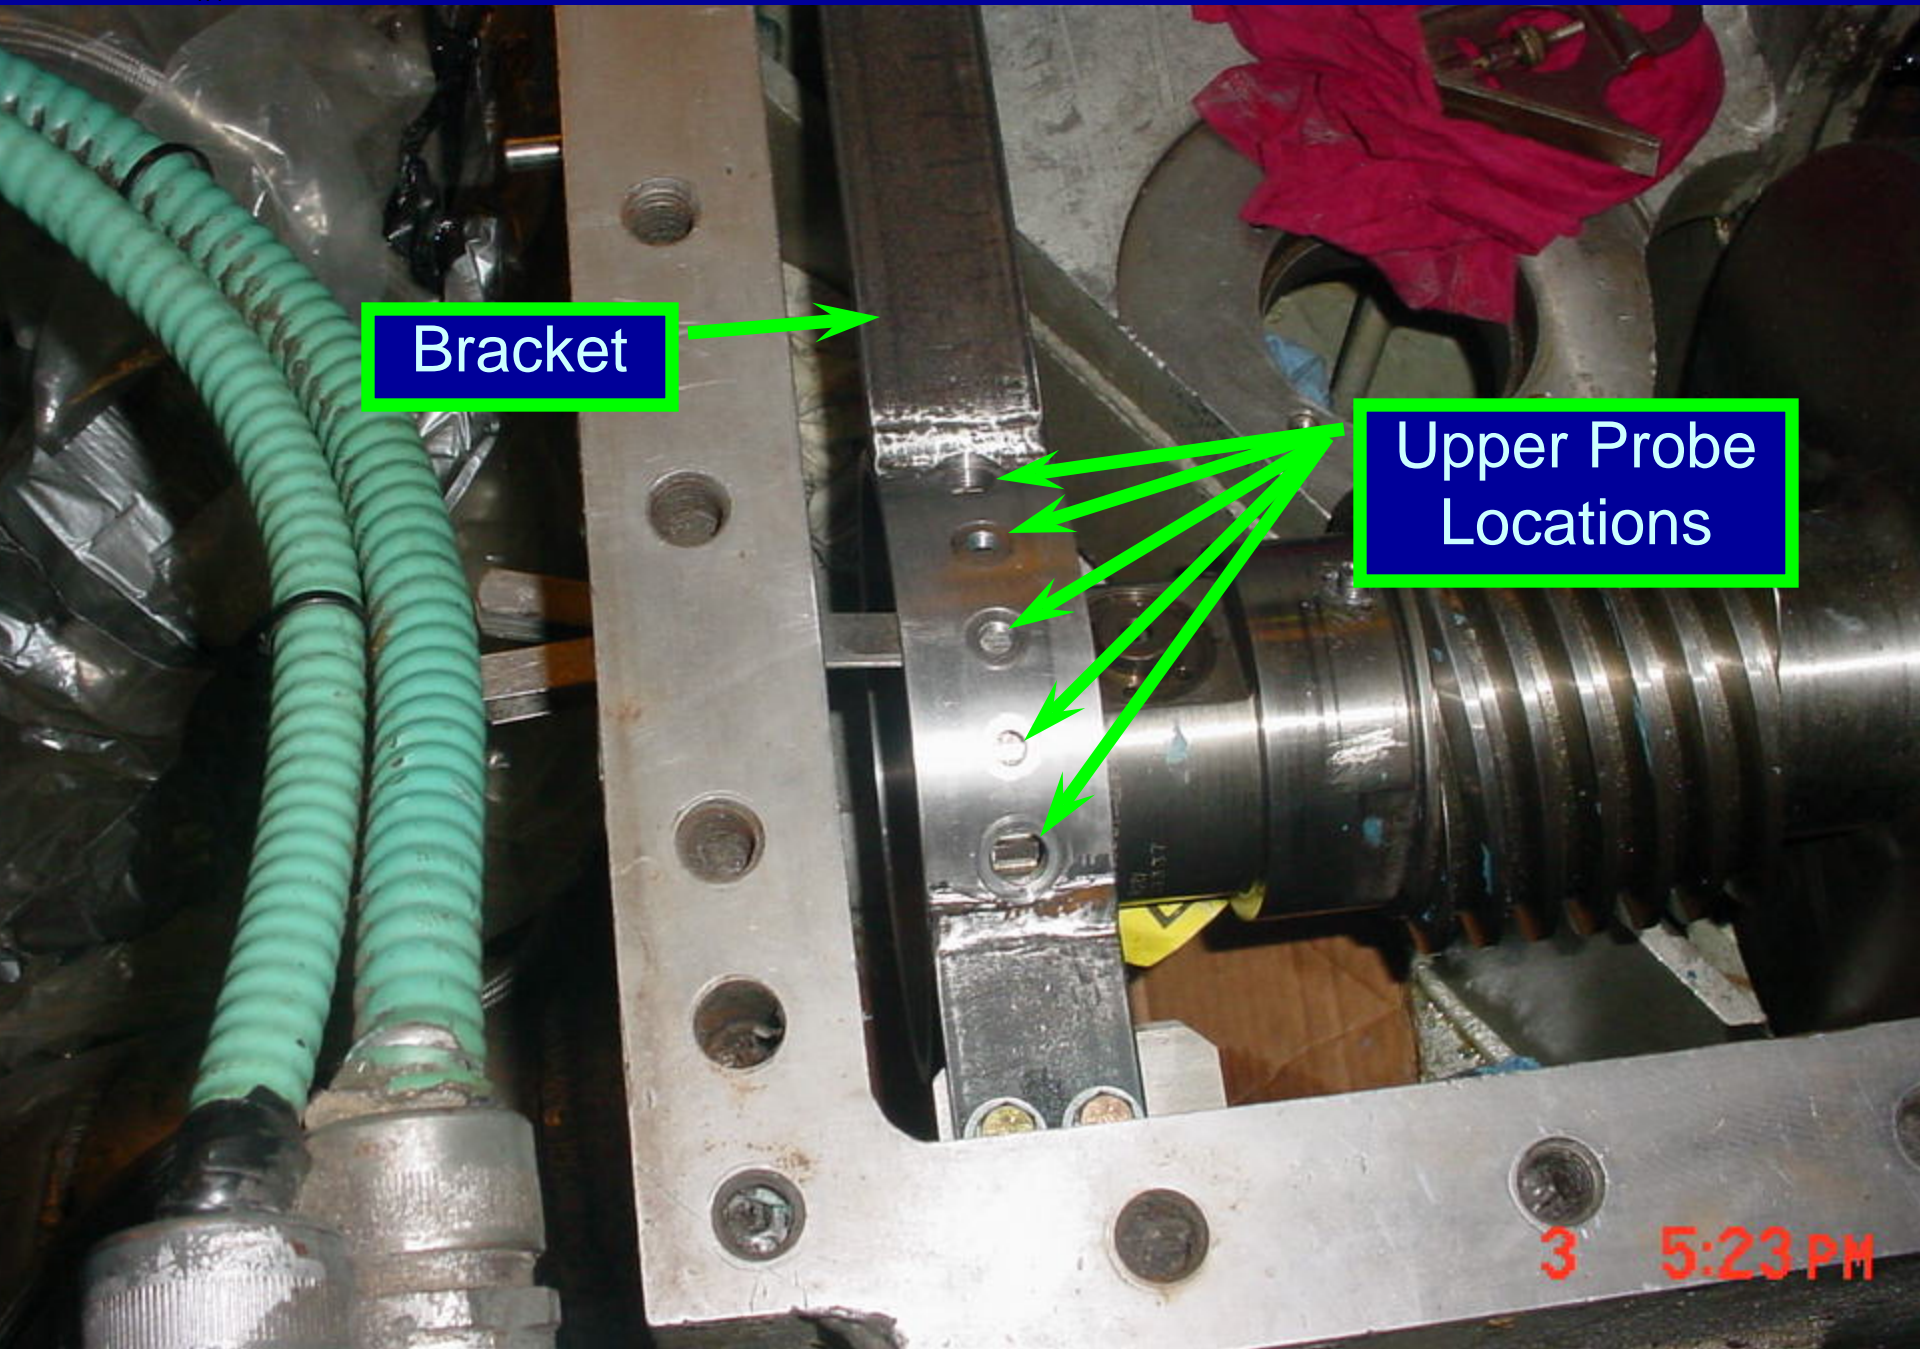
# Plan View of Bracket

Bracket

Upper Probe  
Locations
