Development and Testing of a Very High Speed Oil Lubricated End Face Mechanical Seal

Six large radial inflow turbines were designed to expand isobutane for two electric power plants in Nevada which use heat from the earth (geothermal energy) as the energy source. Double end face mechanical seals lubricated by oil were selected to stop the isobutane from leaking out of the closed loop system and into the atmosphere. Two of the largest providers of mechanical seals in the world provided reference lists showing that this application was pushing the tip speed limits for existing liquid end face mechanical seals. A vendor was selected and the seals were purchased.

16 MWe Expander-Generator

Very High Speed Wet Seal Application

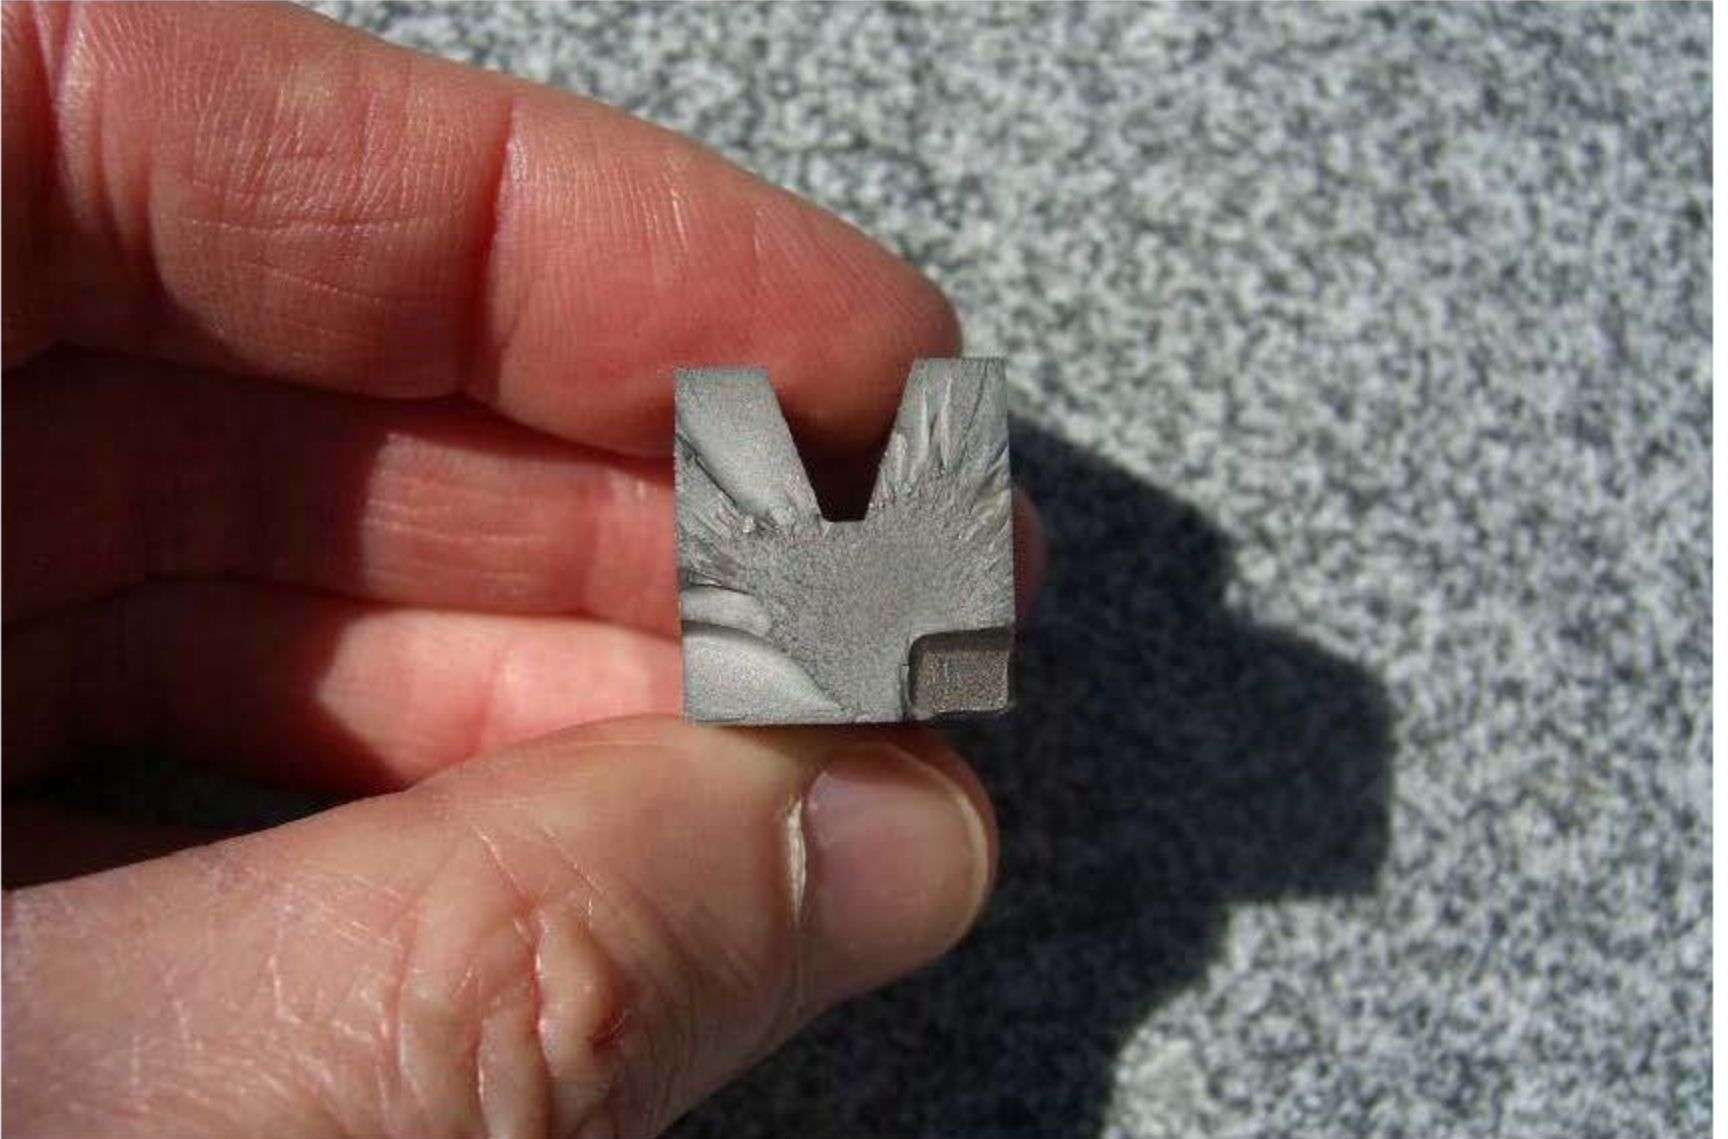
Initiation Site

- Failure caused by hoop stress overload.
- Hoop stress overload caused by thermal growth of sleeve into bore of rotating ring.
- Failure mode very much like overspeed (also from high hoop stress).
- Subsequent overspeed of identical rotating ring showed very similar surface.

- Stronger material for rotating ring.
- Axial pin drive for lower stress concentration factor.
- Drive slot drilled before sintering (no EDM).
- New, lower thermal growth sleeves with more clearance when operating.
- 10,000 rpm overspeed testing on rings (154% of design speed).
