Turbomachinery Symposium 2008

Case study

Evaluation and Successful Modification of Impeller Using Forced Response Analysis

GE Oil & Gas, Bethlehem, PA

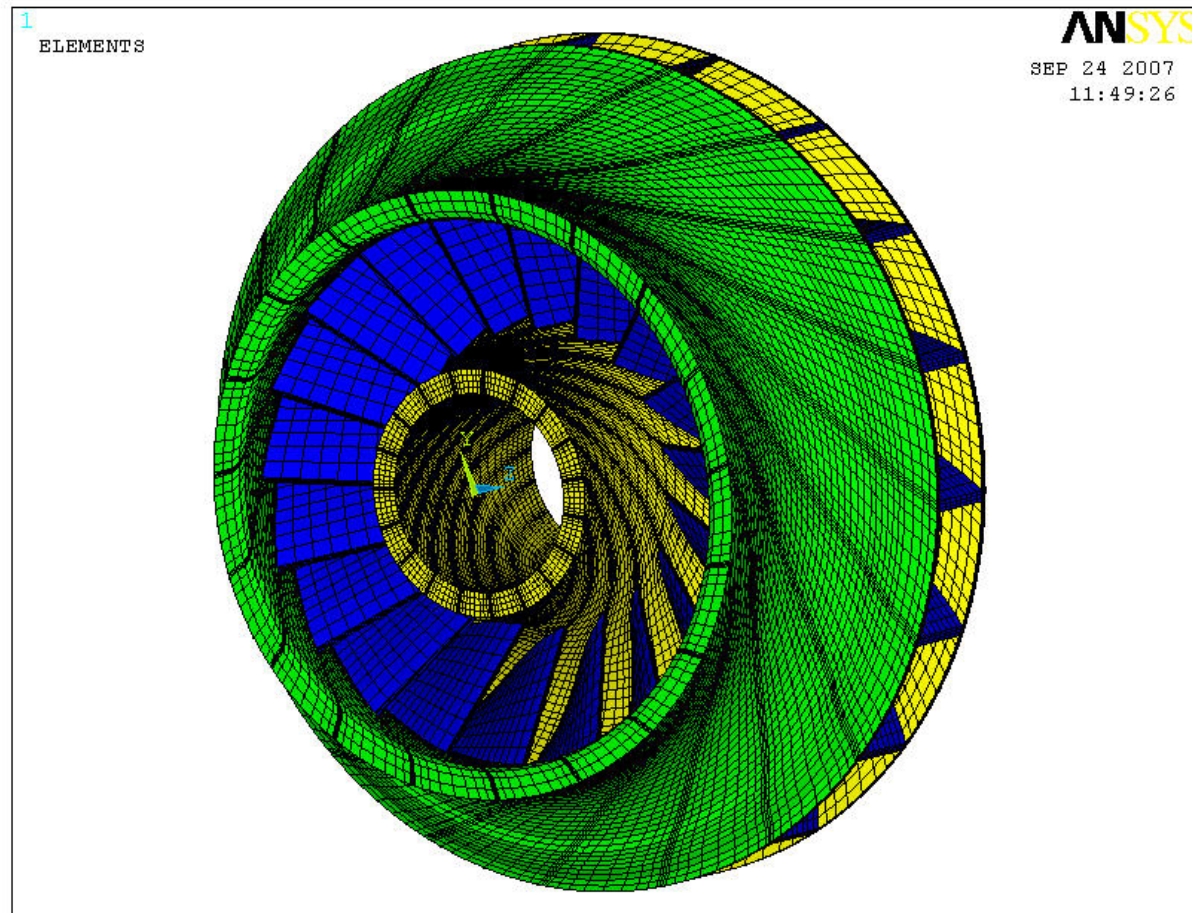
Figure 2: FEA Model of the Original Design

The unit has 12 Inlet Guide Vanes (IGV). Modal Analysis indicated possibility of resonance condition with 2x(IGV) forcing frequency and impeller natural frequencies at,

- 1) 1937 Hz, 5-ND (1C)
(5 Nodal Diameter, 1st Order Mode)**
- 2) 2006 Hz, 5-ND (2C)
(5 Nodal Diameter, 2nd Order Mode)**

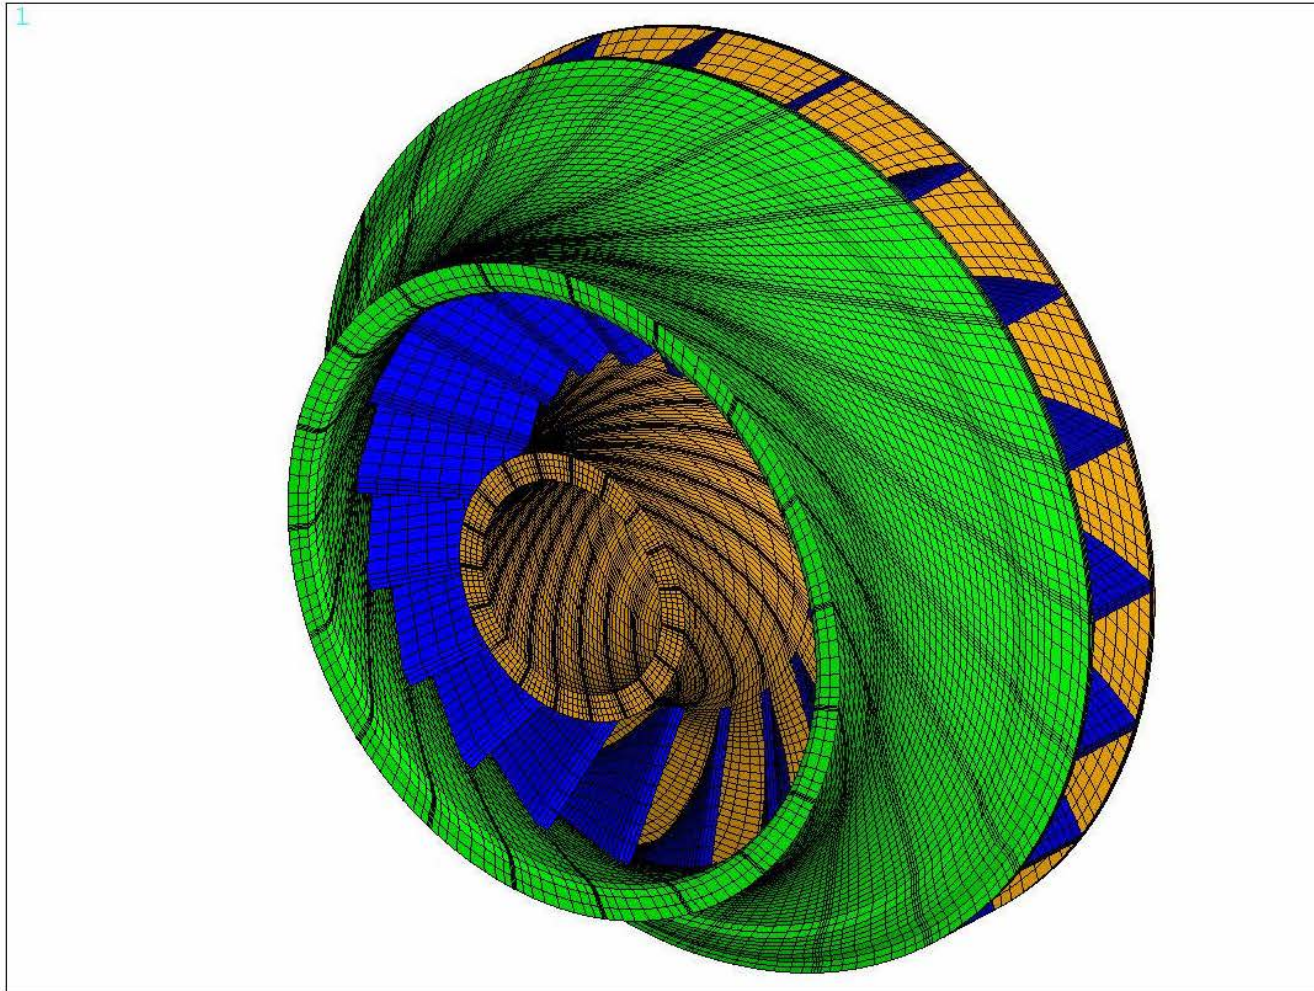
Figure 12: FEA Model Modified Design, Blade Trimmed at Inlet 0.75 in.

- The FEA Model with modified design, blade trimmed at leading edge by 0.75 inch, was created.**
- The Frequency variation of the Tested Blades with the FEA model was 3.32- 6.38 % (lower).**
- The FEA Model and Modal Analysis results are shown in Figure 12 to Figure 16.**
- The Goodman Diagram Based on the Results of Forced Response Analysis is shown in Figure 17.**

- 1) Weld repair current damaged impeller.
- 2) Machine back blade Leading Edge 0.75 in. (Re-radius Leading Edge to maintain 0.17 in. normal thickness).
- 3) Perform Modal Analysis and Forced Response Analysis of new assembly.

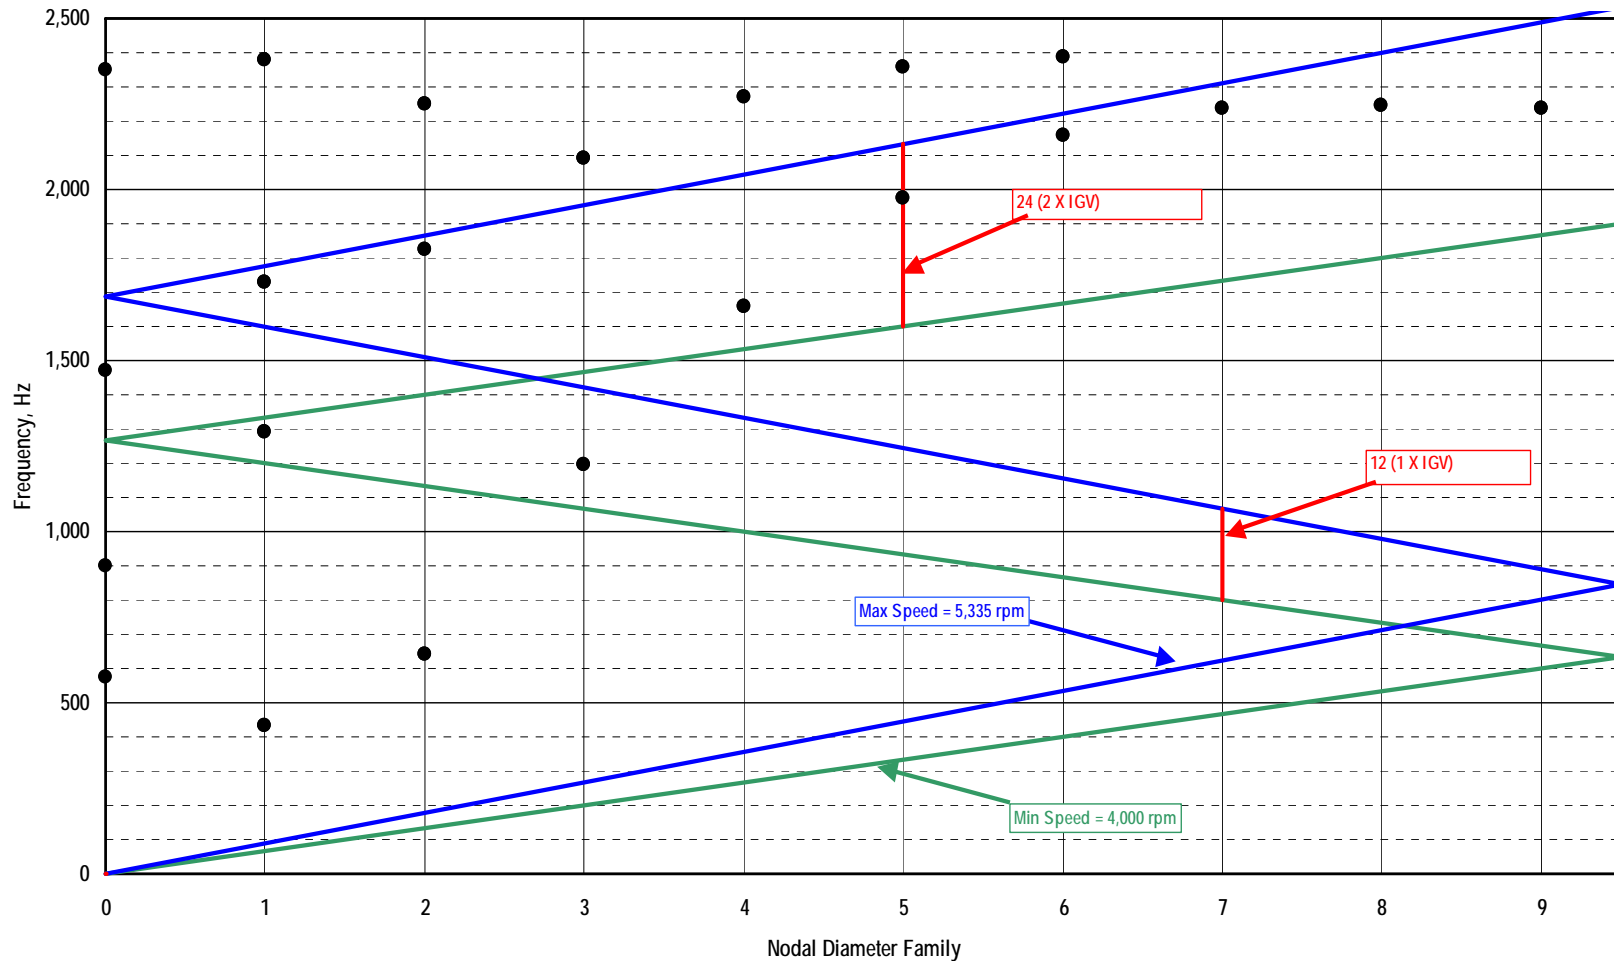
Figure 16: Interference Diagram, Modified Design

Modified Design
Impeller, Blade leading Edge Cut (0.75 inch)
