37th Turbomachinery Symposium

VFD Induced Coupling Failure

John Kocur, Jr. Ph.D
Machinery Specialist, ExxonMobil

Joe Corcoran
Manager Global Services & Training, Kop-Flex

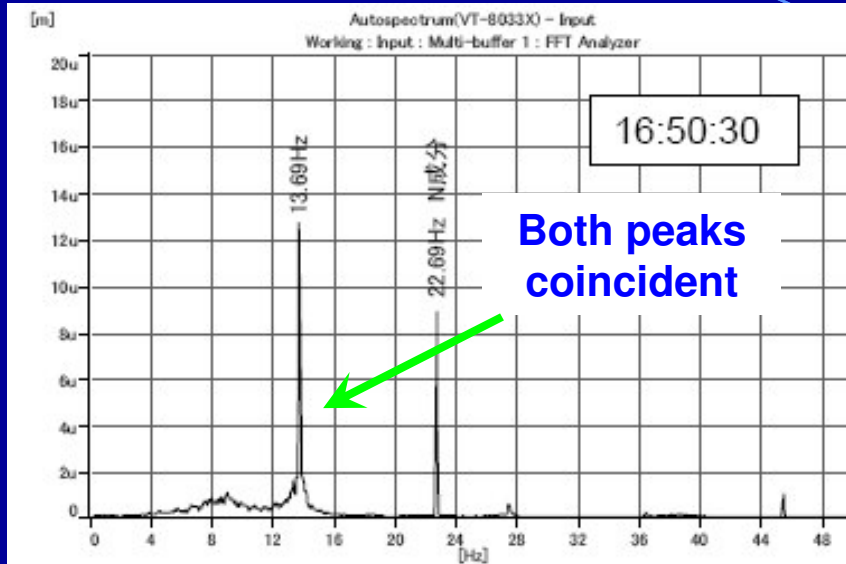
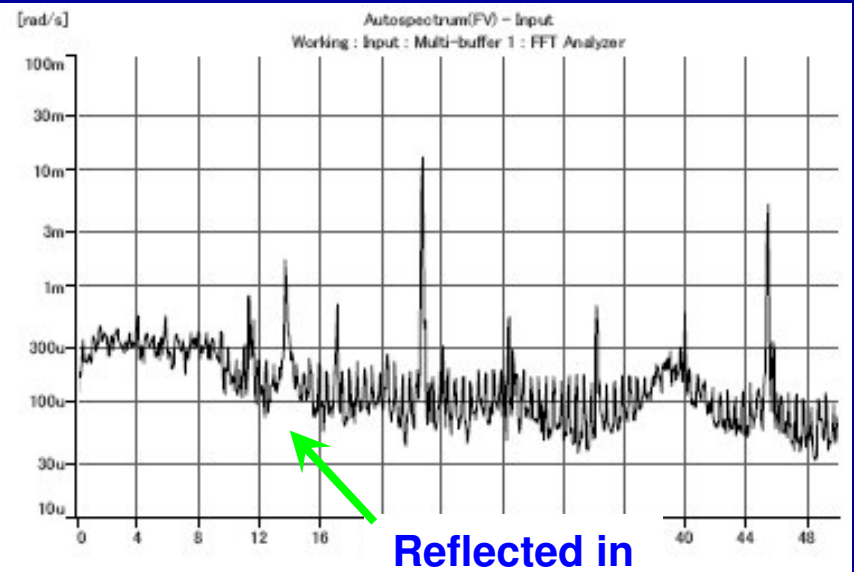
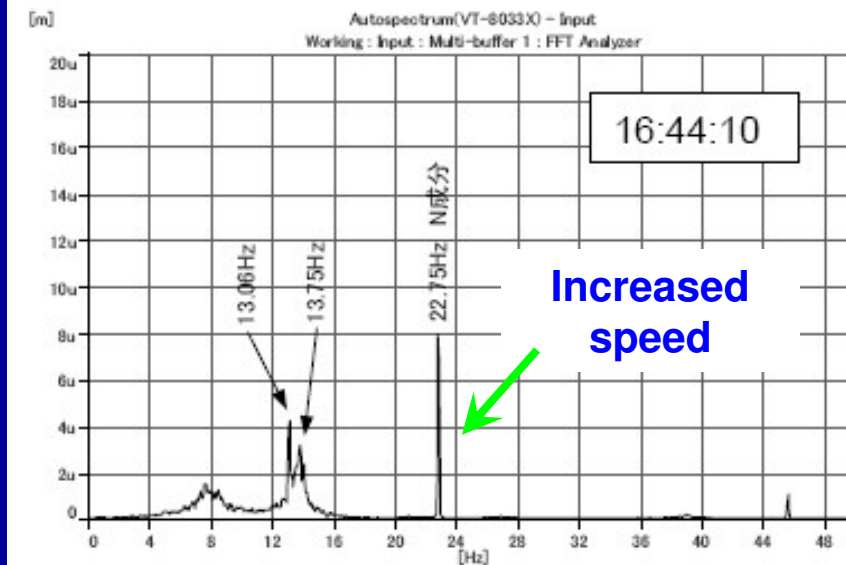
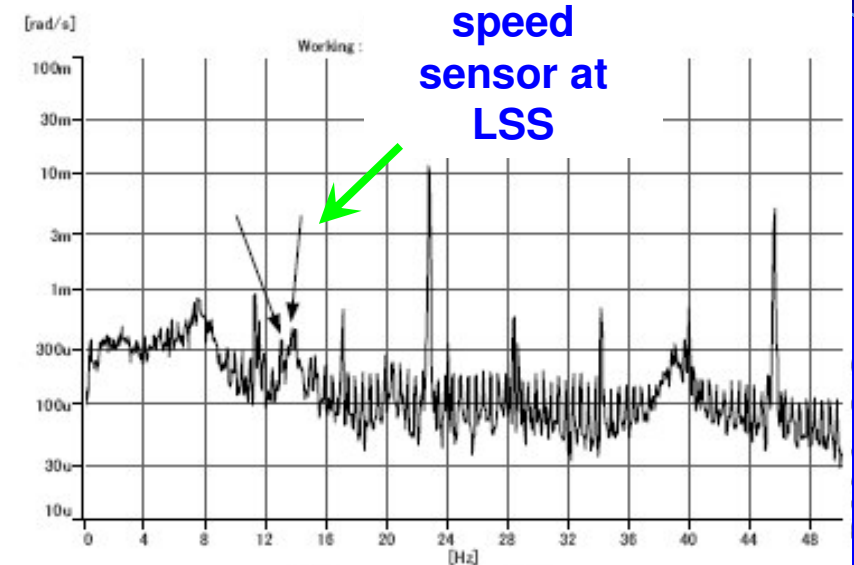
Vibration Measurements

- **Vibration signatures prior to failure**
 - Gear radial subsynchronous vibration at 13.7 Hz
 - Coincident with 1st torsional natural frequency
- **Instrumented LS coupling for torsional measurements**
 - Torsional pulsations were identified
 - Two distinct factors involved

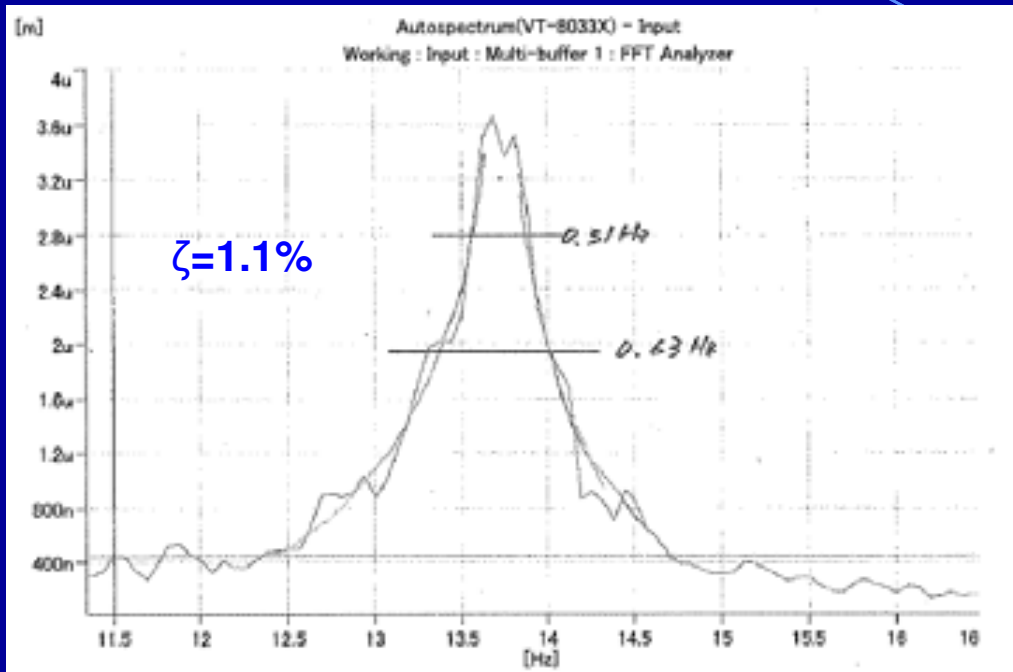
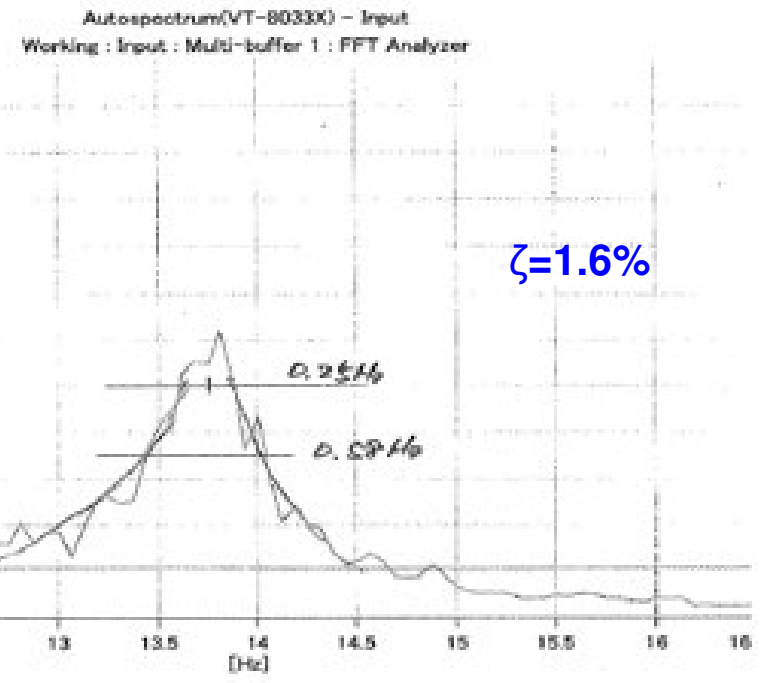
Damping Estimation

Damping estimation from the response around the natural frequency

Seems to confirm the popular assumption that trains w/ disk/diaphragm couplings have 1.6% of critical damping

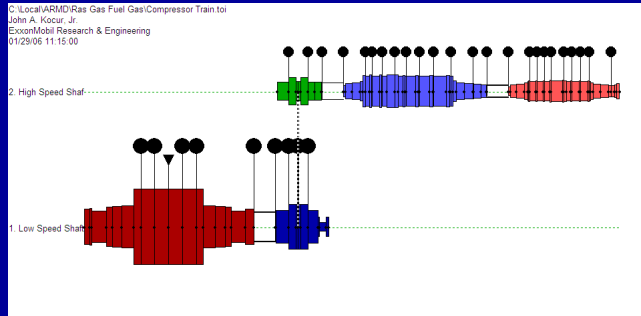
Estimate of Motor Pulsating Torque

- **Unfiltered speed signal introduced 13Hz component into controller algorithm**

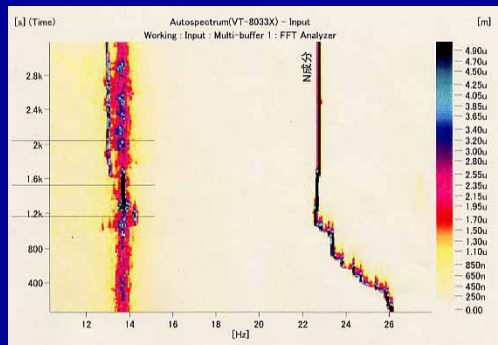
Alternating Torque

- **Re-excitation of 1st TNF not sufficient to cause failure**
 - Testing and analysis revealed this causes pulsating torque at 20% of rated
- **During coincidence with sidebands pulsating torque can reach 80% of rated**
 - Several sidebands present
 - Coincident during specific speeds
 - Can explain the time to failure
