Centrifugal Impeller Failure via a Thermite Reaction

Author: Mike Stanko
Praxair Inc.
Engineer
Turbomachinery Group

CASE STUDY ABSTRACT

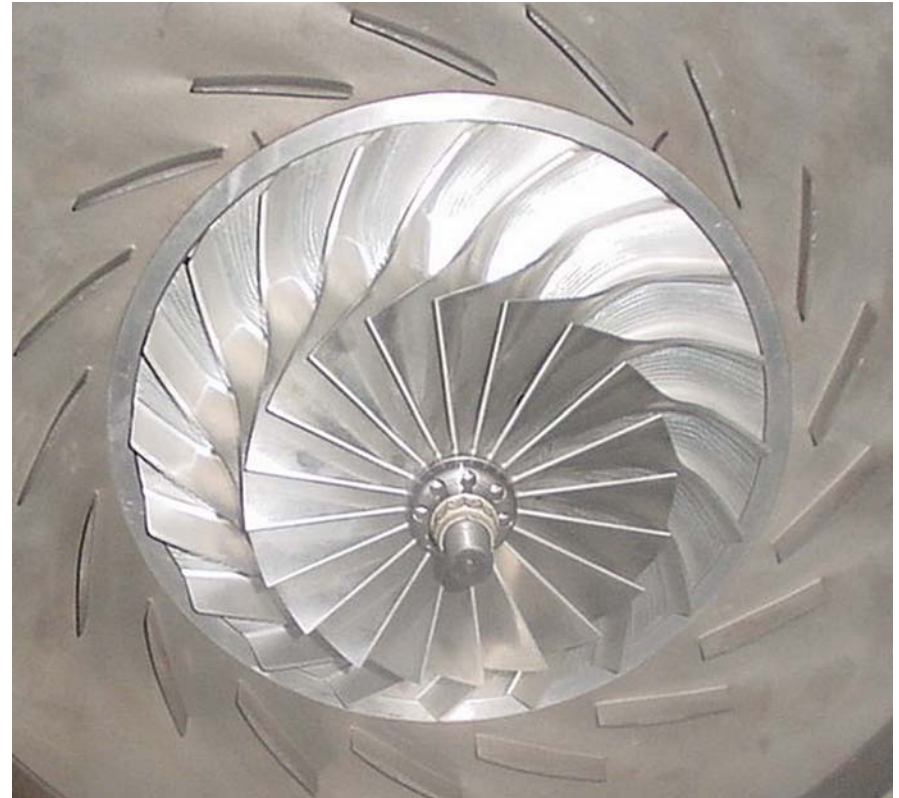
FAILED

Initial investigation focused on the 1st stage centrifugal compressor impeller and upstream dust filter. Most of the aluminum impeller was missing and portions of the air filter element had melted. With the sequence and cause unclear, a formal root cause analysis (RCA) was undertaken.

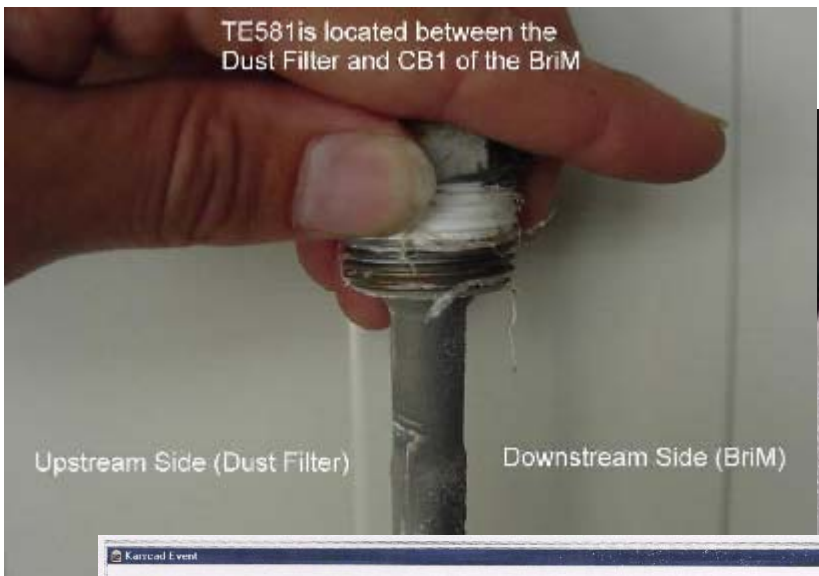
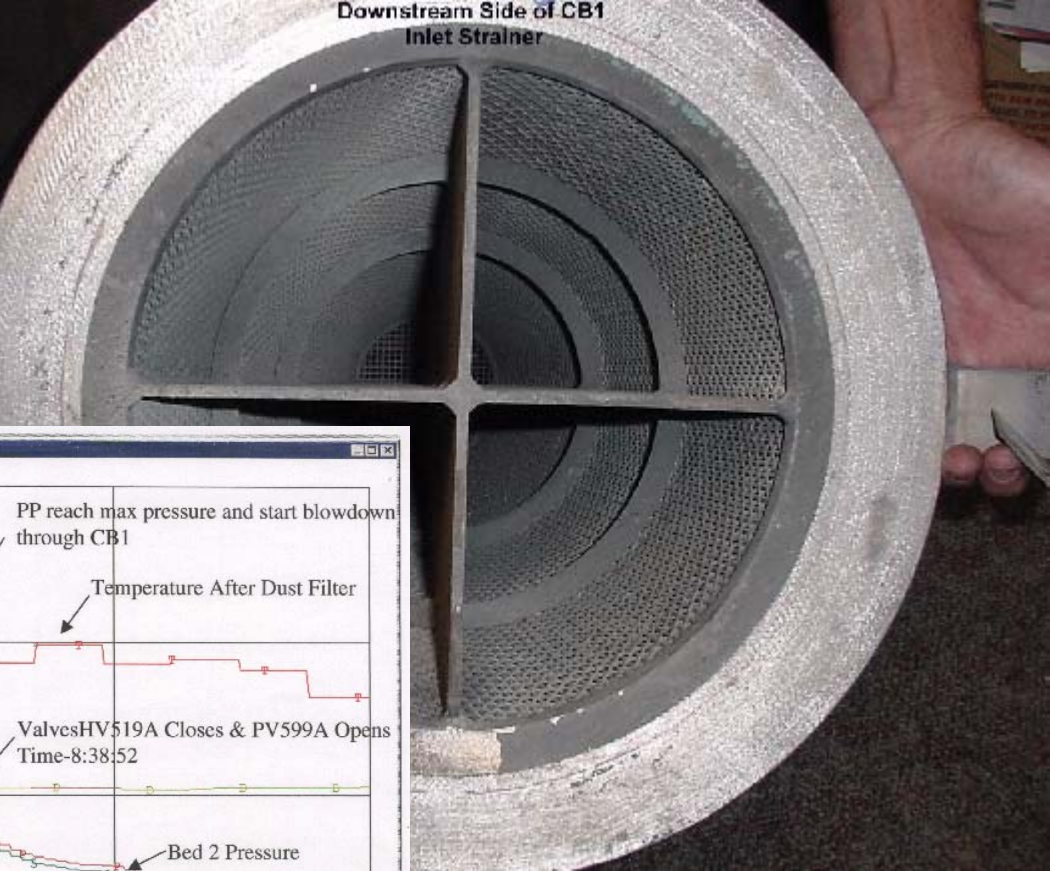
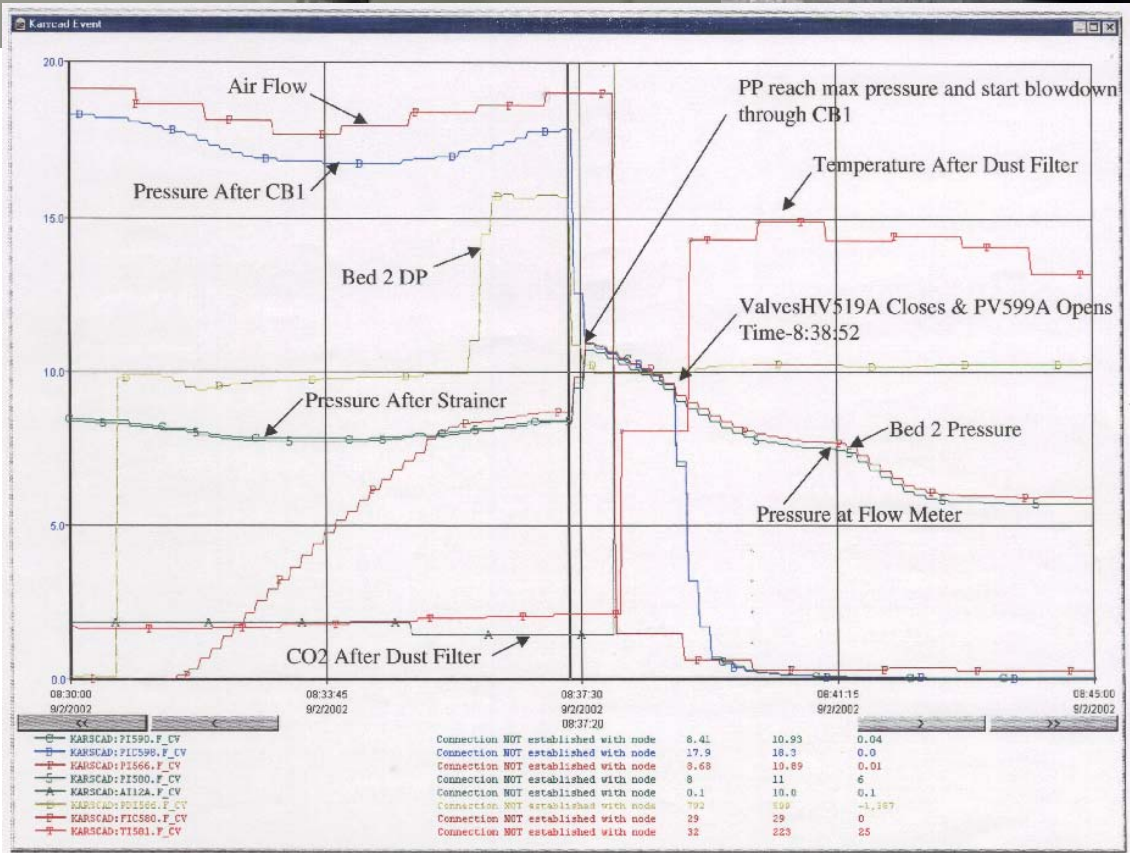
CONFIRMING EVIDENCE

The RCA process ultimately revealed that an unexpected **thermite reaction** occurred and consumed most of the aluminum impeller. During compressor shutdown, products of the intensely exothermic thermite reaction backflowed into the upstream dust filter causing the element to partially melt. The thermite reaction initiated in the impeller back disk seal area where metal oxides and fuel (debris) had collected. Viscous heating and temperatures greater than expected allowed the rotating labyrinth seal to **creep**. Contact with the babbitted stationary seal generated additional heat and further accelerated the creep process. Frictional heating in the impeller back disk seal initiated the reaction.

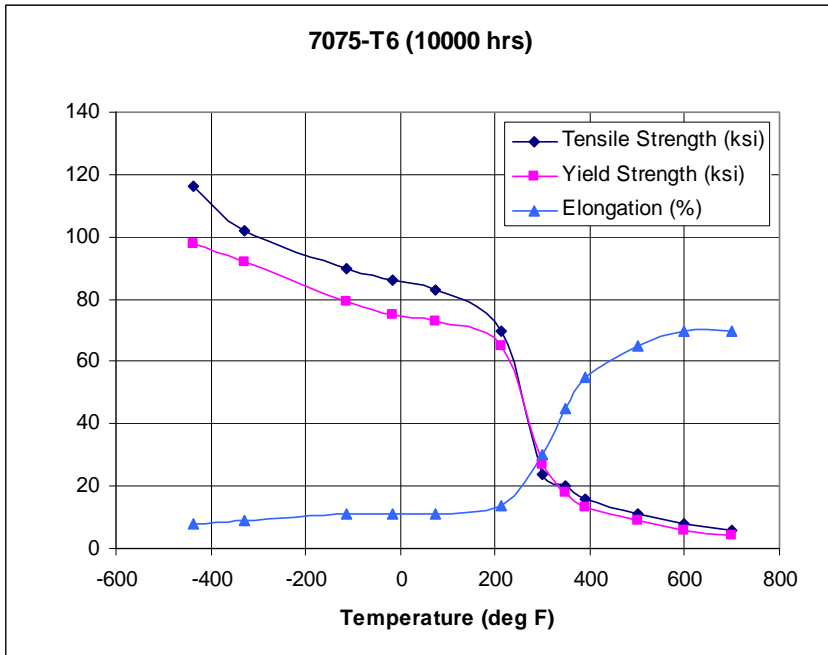
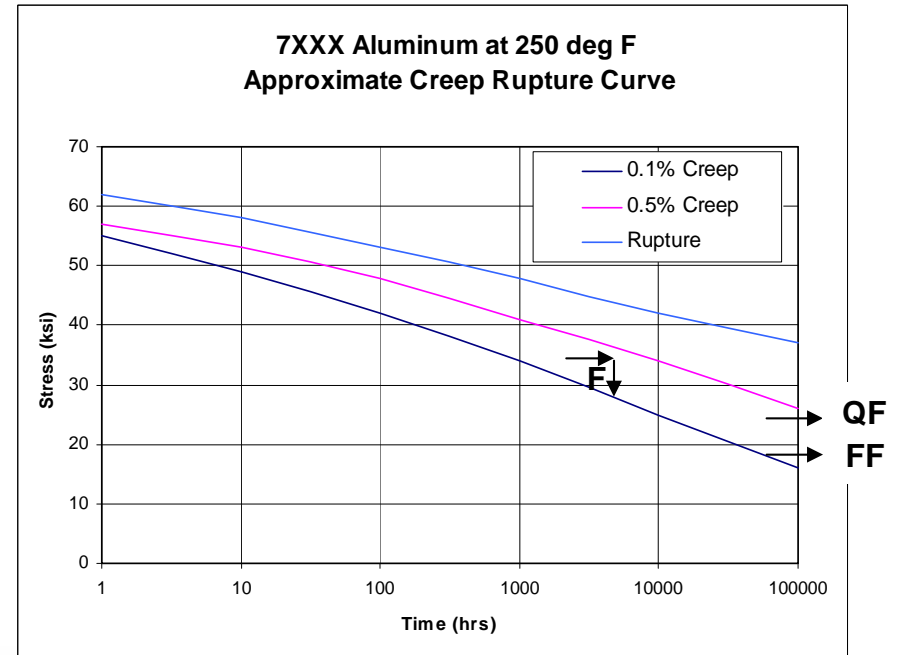
CREEP AND COMPARISON

- **CREEP IN THE ALUMINUM IMPELLER BACK DISK ROTATING LABYRINTH SEAL**
- **SHUTDOWN AND INSPECTED A “TWIN” IGC**
- **THE DISCIPLINE TO CHECK EVERYTHING YIELDED THIS KEY FINDING!**

Corrective actions to prevent reoccurrence included a creep resistant impeller back disk seal and a **passive debris removal** system to prevent debris particles from collecting in the impeller back disk seal area. This compressor and a twin have operating reliably since 2003. Recent inspection revealed neither back disk seal creep nor the collection of debris particles. These facts have verified the effectiveness of the solution.
