# REDESIGN OF A HIGH SPEED COMPRESSOR DRIVE STEAM TURBINE TO OVERCOME CAPACITY, EFFICIENCY, AND RELIABILITY ISSUES

**Richard Olivier**

**Hayden Brown**

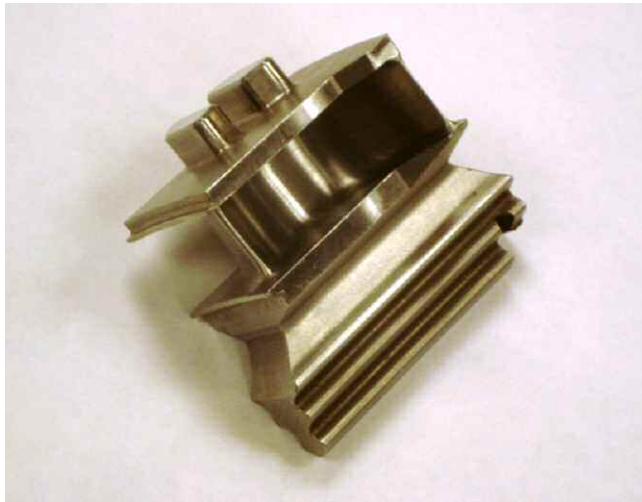
Figure 3. Redesigned Stage One Blade.

The turbine was completely redesigned including a new bladed rotor assembly, all new stationary nozzle plates and nozzle diaphragms, all new seals, new bearings, new inlet control valves, and significant modifications to the casing. Flow area on the first stage was increased to provide the capacity to pass 400,000 lbm/hr of steam through the high pressure (HP) section and generate more power on the stage. In order to keep stresses within design limits with the increased loading on the blade resulting from the increased blade height and torque, a significantly wider airfoil was used. A three-hook, axial entry dovetail was used to accommodate the high centrifugal loading at 11,000 rpm along with an integral cover with two tenons to carry an outer cover. Figure 3 shows the new stage one blade.

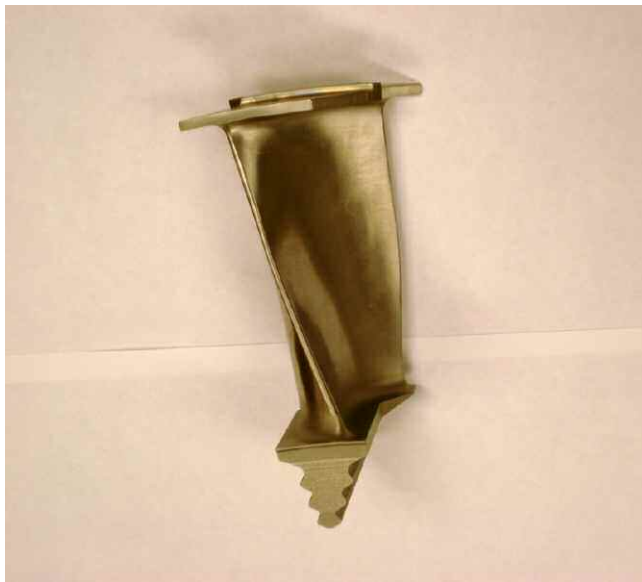
Figure 4. Redesigned Stage Six Blade.

At the reduced maximum low pressure (LP) section flow it was possible to design a single flow last stage blade that could fit within the constraints of the existing casing. The redesign utilized a single 5 inch tall blade to replace the two rows of 3.7 inch blades on the original design. The conversion to a single flow exhaust section eliminated the pressure loss through the crossover along with the inefficient radial flow nozzle on stage five. The new last stage blade was designed with an optimized 3-D airfoil for improved efficiency, along with a three hook axial entry dovetail and a z-lock

integral cover. The z-lock cover provides continuous coupling of the blade tips to suppress the fundamental tangential mode of blade vibration (which is a primary concern for tall blade reliability) along with increased damping. The suppression of vibration and the damping significantly reduce potential vibratory stress in the blade compared to the original unshrouded blade that failed. Figure 4 shows the new last stage blade.

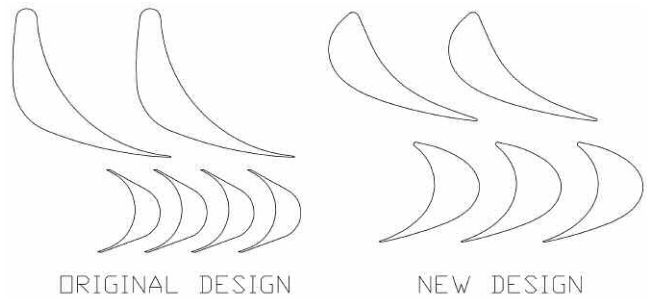
Figure 5. Comparison of Airfoil Profiles.

Rotating and stationary airfoils on all stages of the turbine were redesigned for optimum efficiency at the new operating conditions along with tip seals to reduce leakage losses. Figure 5 shows a comparison of the old technology airfoils typical in the original design and the modern, high efficiency airfoils utilized in the new steam path. The old stationary nozzle designs accelerate the steam through the converging inlet channel and then turn the flow at the exit resulting in high cross channel pressure gradients and therefore high secondary losses. The new design nozzle passage turns the flow and then accelerates it resulting in low secondary and profile losses. The improved inlet wedge angle on the new nozzle efficiently accepts a wide range of inlet steam flow angles lower potential for flow separation. The old rotating blade design was characterized by flat and circular arc construction with sharp

surface curvatures conducive to flow separation. The new blade design provides uniform flow acceleration virtually eliminating flow separation and minimizing profile losses. Thinner trailing edges on the new design minimize wake losses and blade inlet angles are optimized to minimize incidence loss.

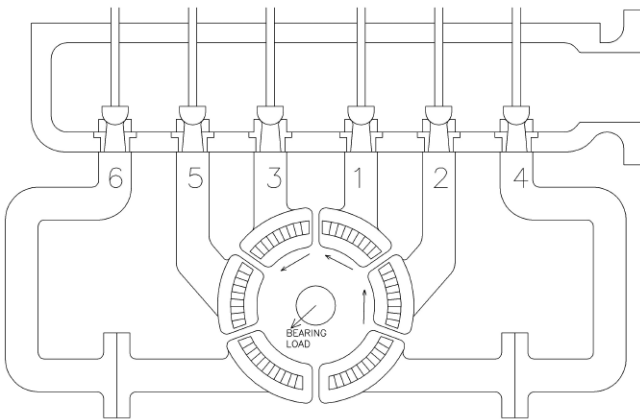
Figure 9. Revised Valve Opening Sequence.

The redesigned turbine was installed and run at part load for an extended period of time. The high pressure journal bearing temperature was very high and continued to climb as steam flow to the turbine was increased. The elevated bearing temperature was determined to be the result of steam forces from the partial arc of nozzles on the first stage pushing the HP end of the rotor into the side of the bearing resulting in elevated reaction and undesirable loading angle on the HP journal bearing. Figure 8 shows the configuration of the first stage nozzle arcs and valve opening

sequence. With the first three valves open, the steam force exerted on the stage one wheel pushes the turbine rotor down and to the left. This steam force coupled with the rotor gravity load results in a very high load on the HP journal bearing, which caused the elevated bearing temperature. A new V1 camshaft assembly was installed with revised opening sequence as shown in Figure 9. With this opening sequence, the maximum bearing load was reduced and the unit was able to increase load without exceeding bearing temperature limits.
