Managing an Induction Motor Vibration

BP

Whiting Indiana

Main Air Blower Motor

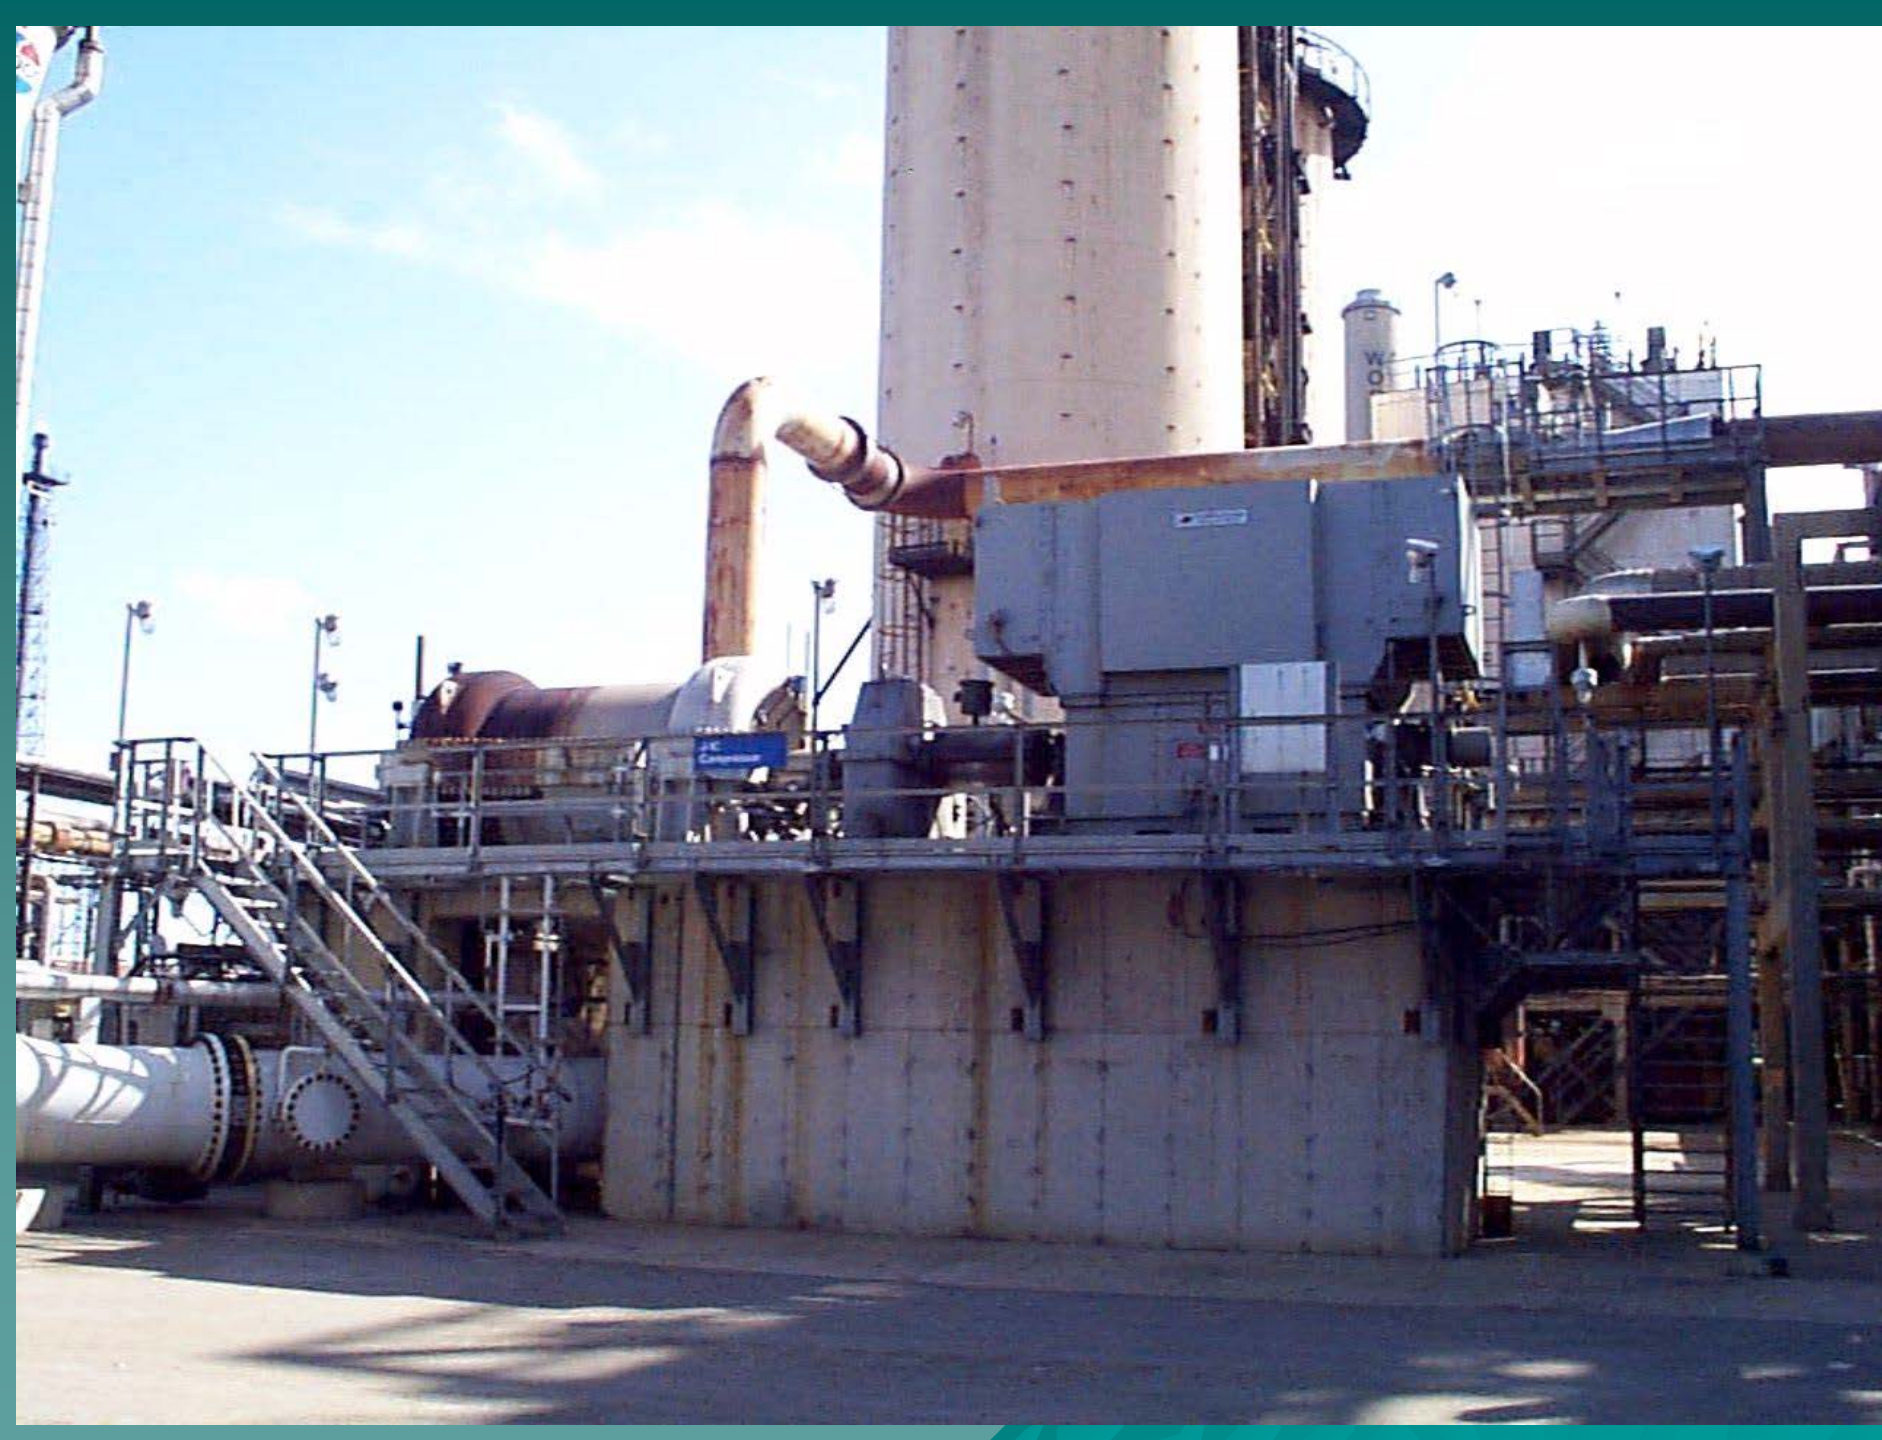
- ◆ 10000 Horsepower 13,200 volt 4 pole motor
- ◆ Purchased Fall 1994
- ◆ Required in-rush current limit design for startup
- ◆ Vibration Acceptance criteria on test stand
 - 1.1 mil (p-p) 1X shaft vibration
 - 0.8 mil (p-p) 2X shaft vibration
 - 2.0 mil (p-p) overall

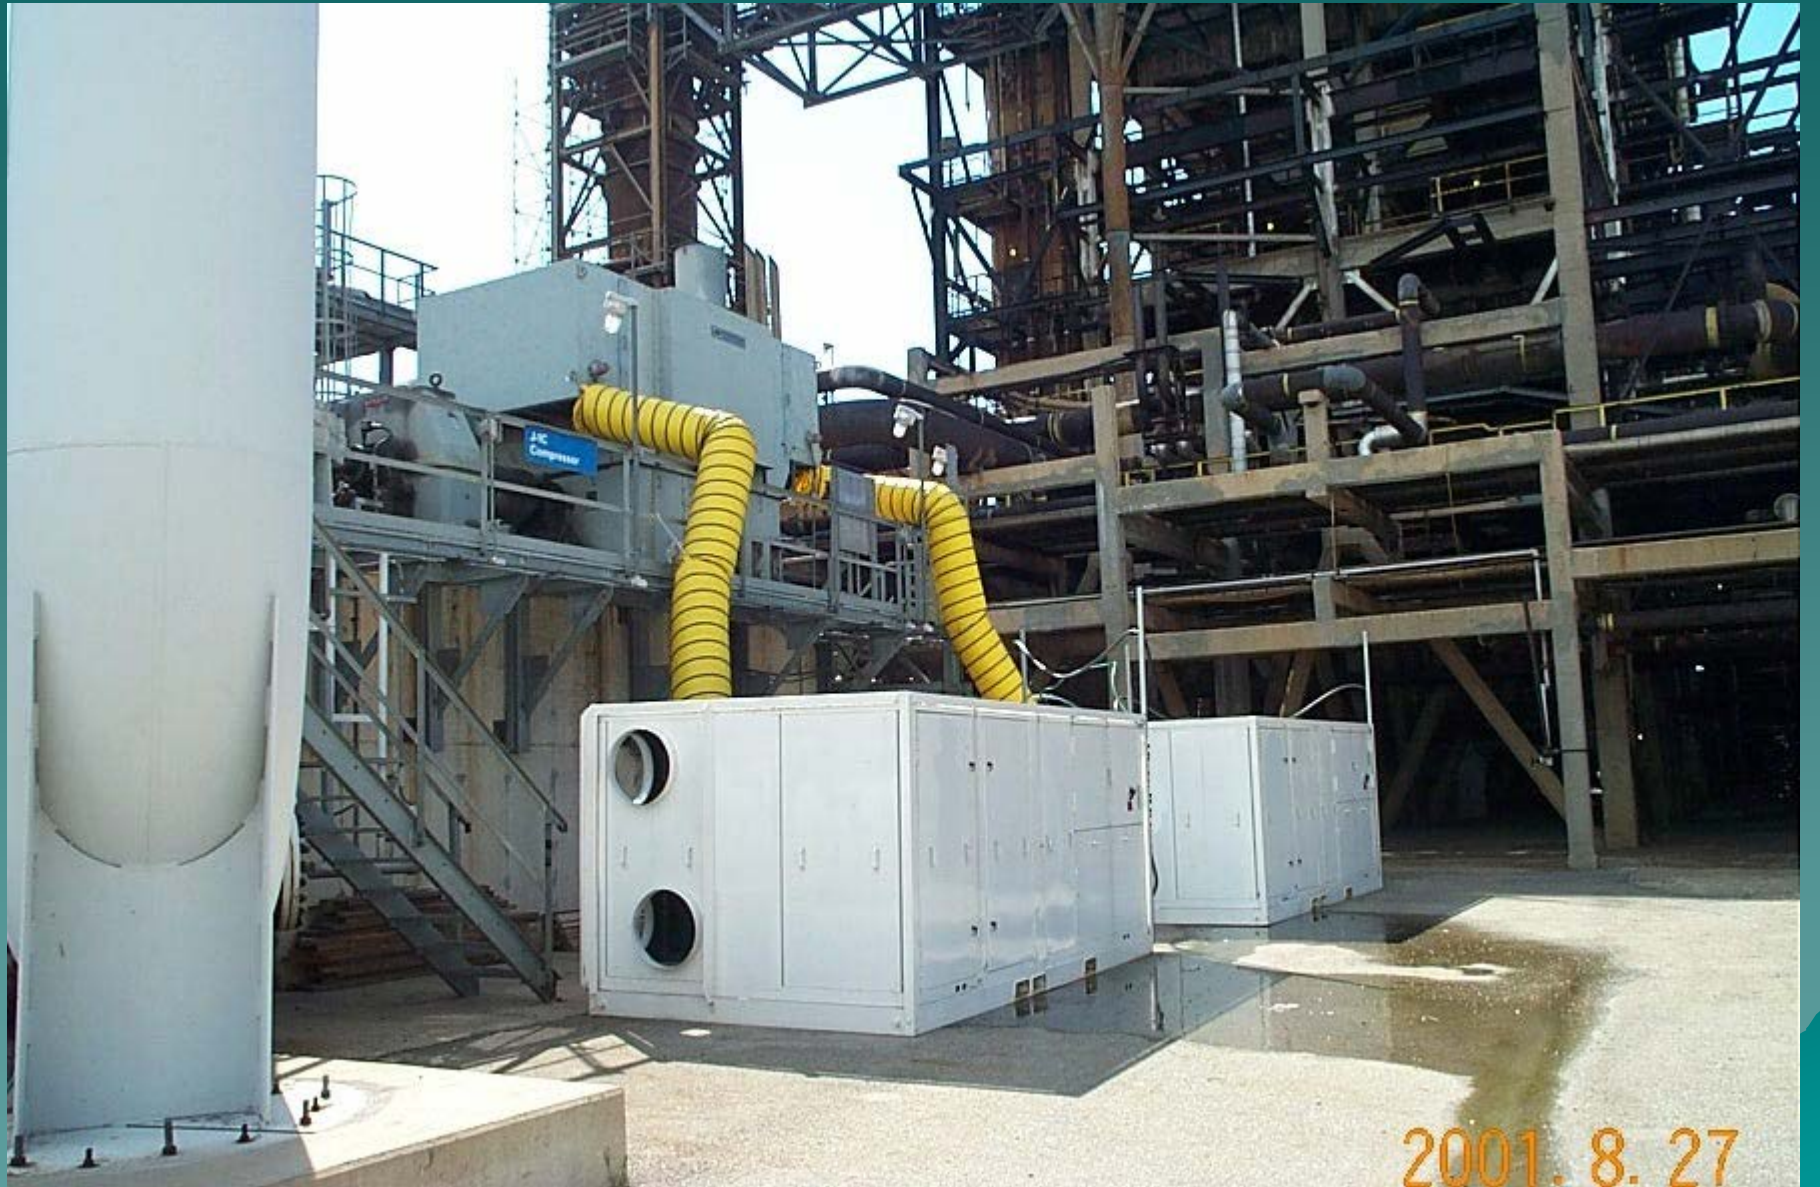
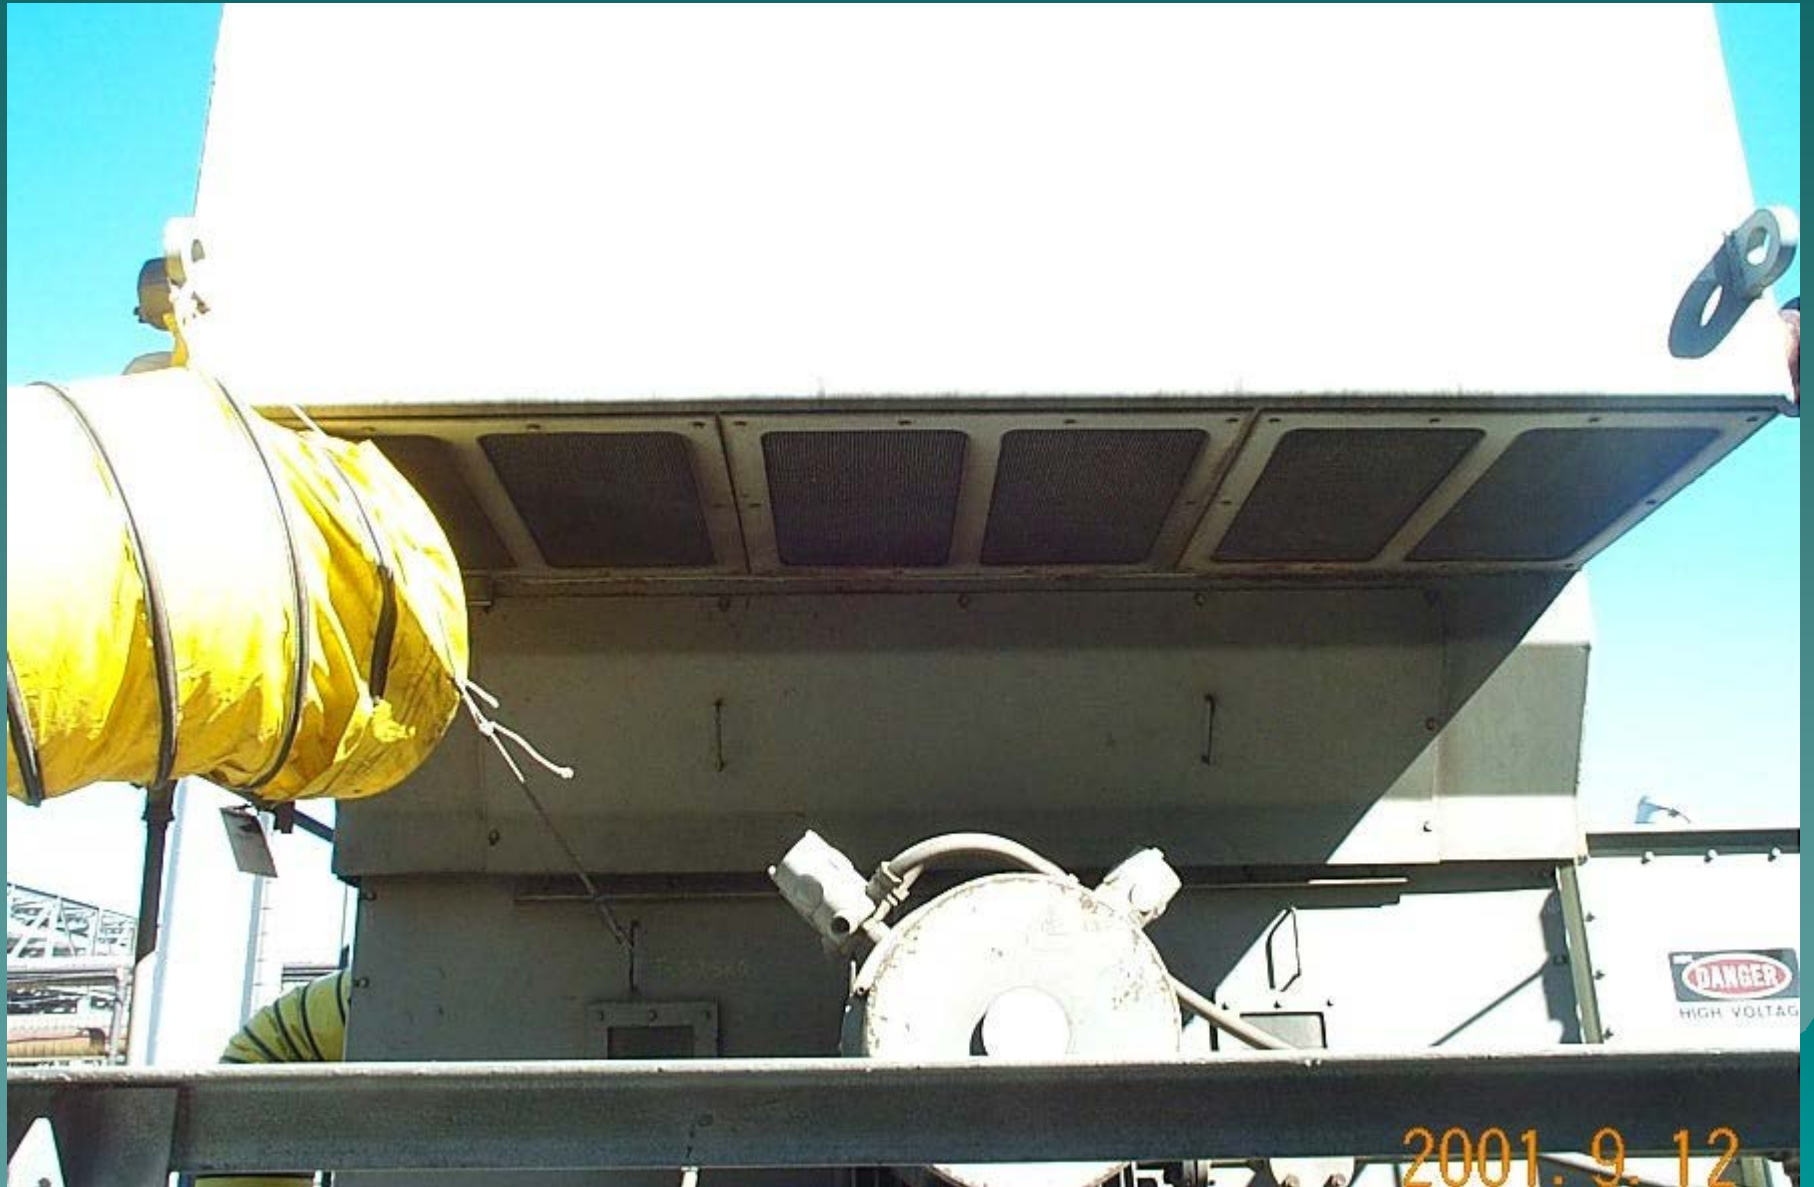
2001. 8. 27

Ambient Temperature increase causes increase in motor vibration

- ◆ Added air 2 conditioner units to cool inlet air to the Motor
- ◆ Cost effective
- ◆ Deferred motor maintenance

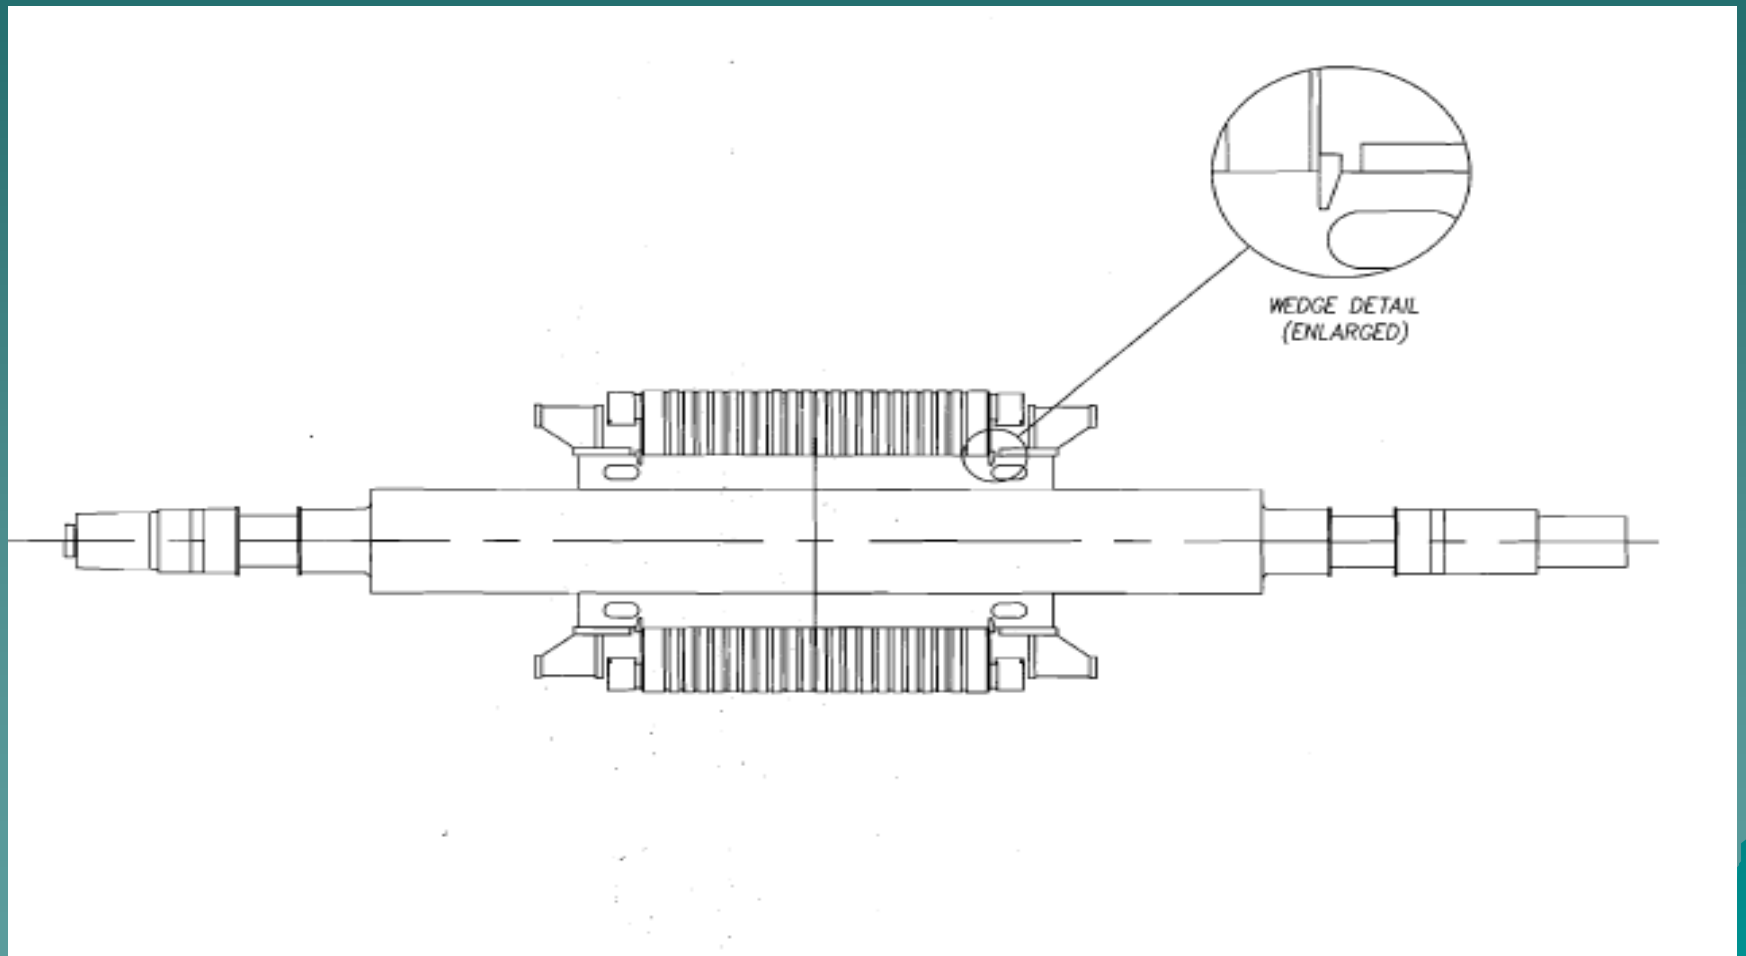
Original Rotor Configuration

- ◆ Laminations without duct spacers shift to block air path and break off when not "clamped" by spacers.
- ◆ Increases at each startup could be explained by additional laminations breaking off on acceleration (not likely)
- ◆ Rotor expanded during heating and could not return to original position due to excessive restriction of tapered positioning pins. (most likely)

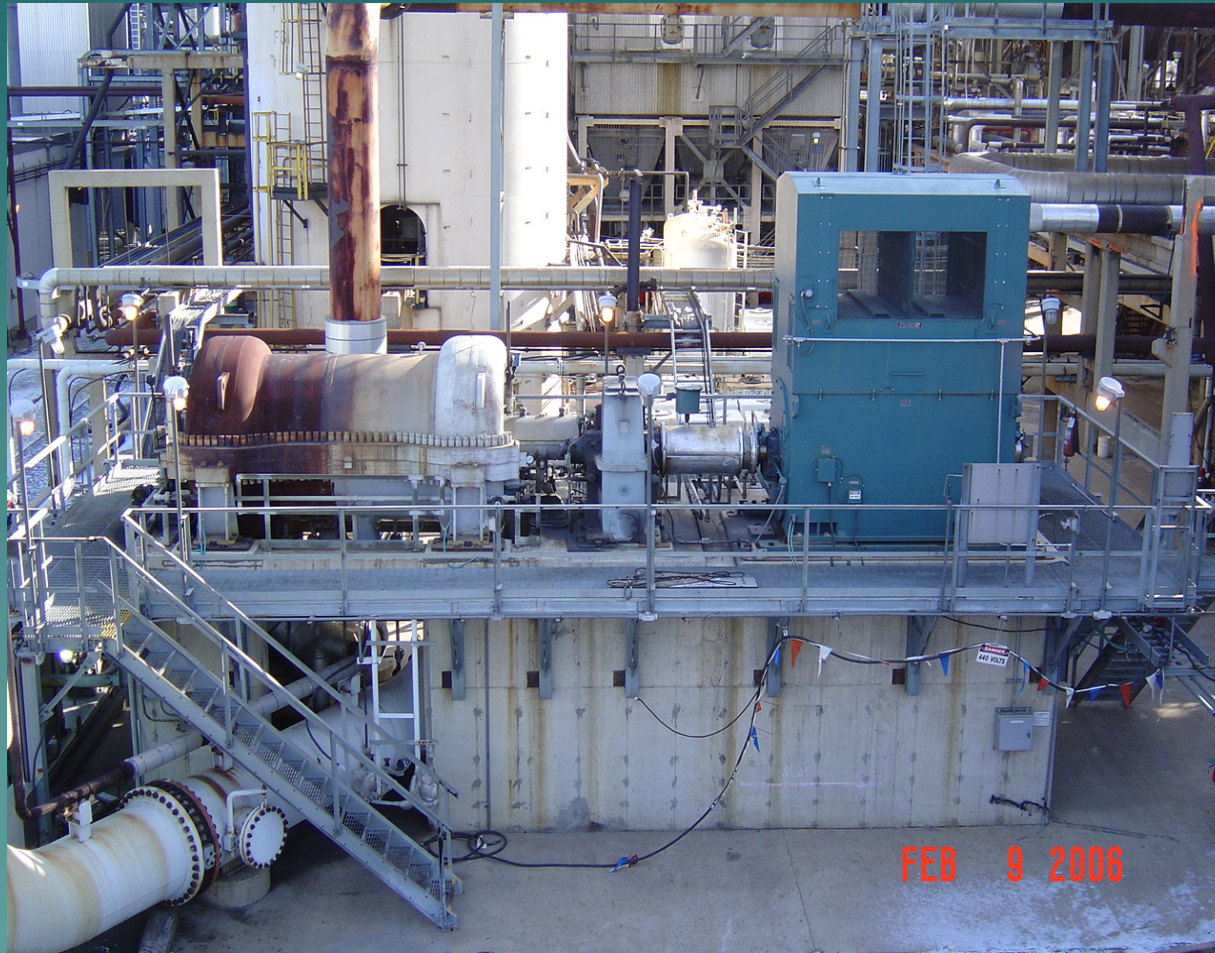
New Motor after Installation

- ◆ Different motor torque characteristics when we changed from Wye to Delta
- ◆ Review of couplings, gear, and compressor capability – SF ok.
