***“High Vibrations & Component Failure In  
Turbomachinery Due to Magnetic Currents”  
: Its Detection, Diagnosis & Correction***

**National Fertilizers Limited,  
Panipat Unit, INDIA**

Scope : The Case Study details this typical problem due to residual magnetism in Synthesis Gas Compressor at National Fertilizers Limited, Panipat Unit, INDIA, in which the problem lead to repeated overhauls of compressor, replacement of three numbers of rotors, damage to number of bearings & Oil film seal rings . It details work associated in diagnosis of the problem, measure taken for temporary relief, so as keep machine running and final work done for permanent solution of the problem.

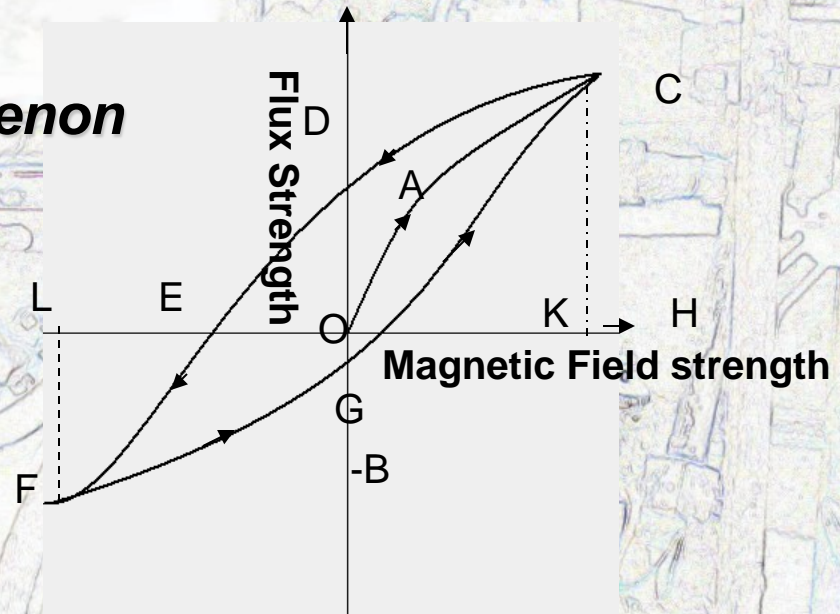
OC: Induced Magnetism

OF: Induced Reverse Magnetism

If we take a coil with demagnetized closed ring in it & pass an electrical current through that coil, then it produces a magnetic field perpendicular to that coil.

If this magnetic induction is quickly removed then the closed ring retains this magnetism which is called Remanent Flux Density or Residual Magnetism, which will be proportional to the current that was passed through this coil.
