Charge Compressor 2/3 Stage Fouling/High Vibration

DuPont Sabine River Works

Problem

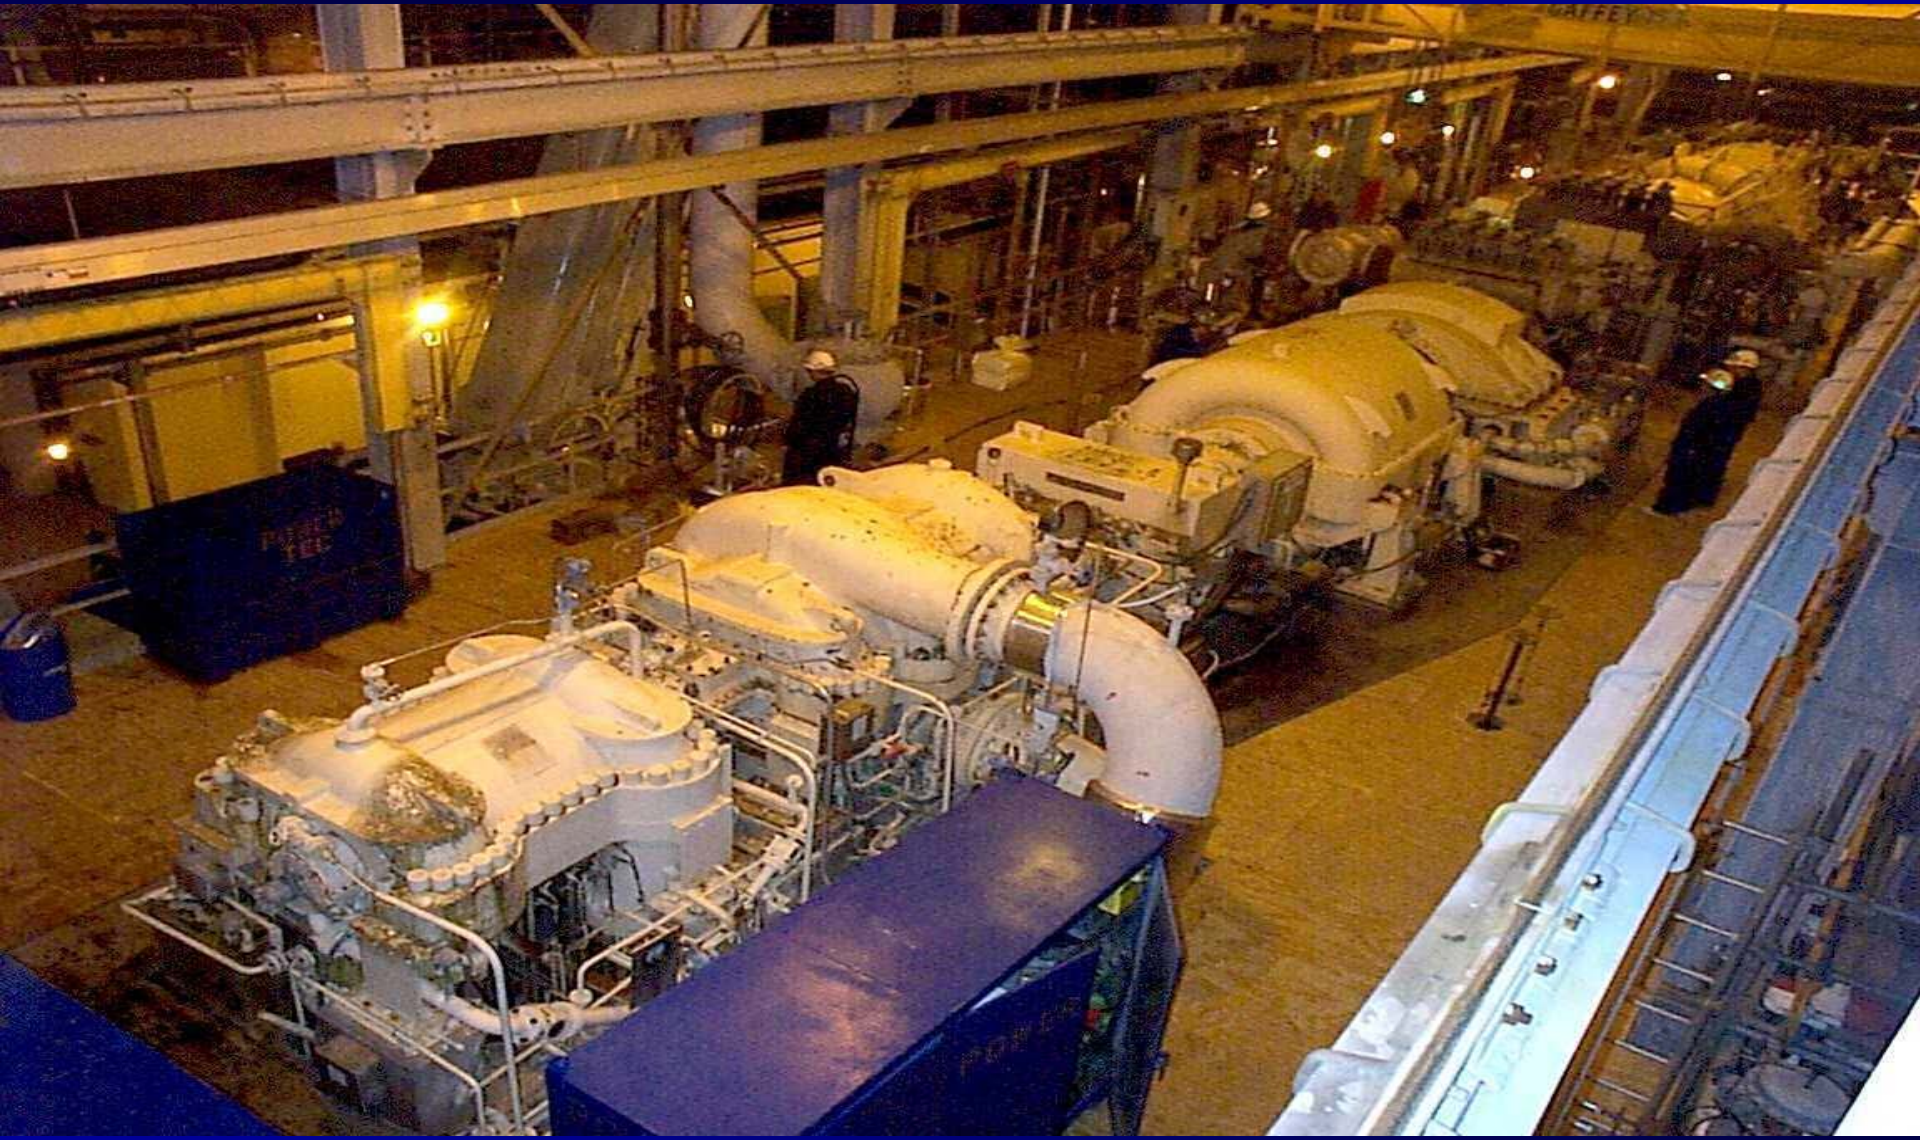
GB201 Compressor Train

- Significant performance loss and high vibration on the Charge Gas 2/3 stage compressor was experienced one year following the 2003 Turnaround.
- This followed two consecutive, highly successful runs after application of antifoulant coating in 1995.
