Case Study: Fast Response Vibration Interlock of High Pressure Reciprocating Compressor

Invista Sabine River Works

H2 Compressor Rod Failures

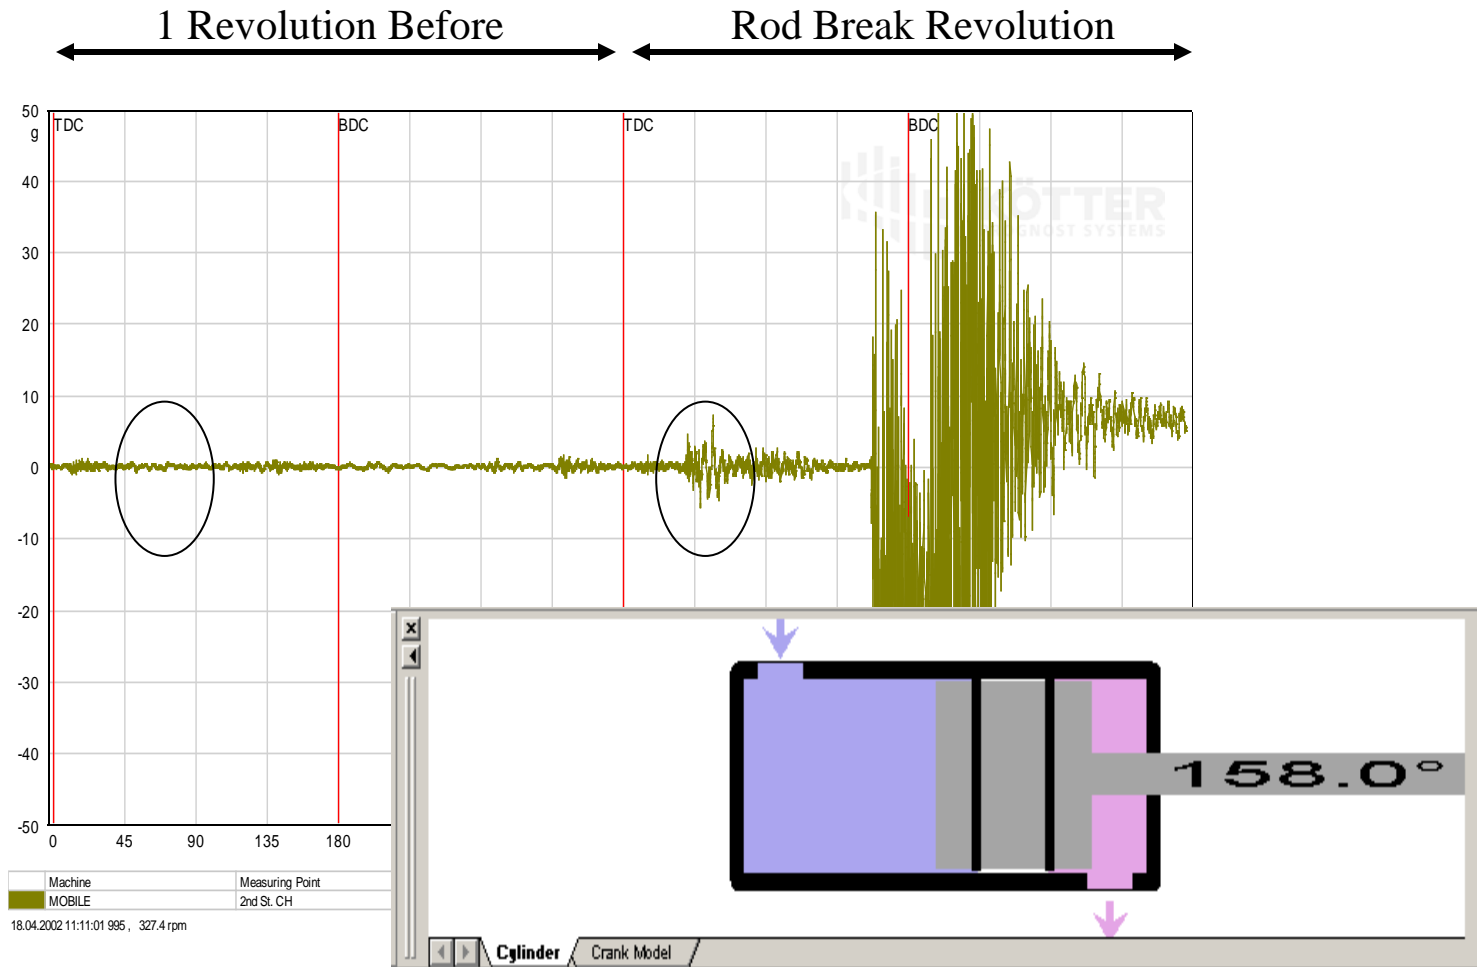
H2 Compressor Rod Failures

- Sudden Catastrophic 2nd Stage Rod Failure on H2 compressor
 - Bent Crankshaft to Crosshead Connecting Rod
 - 3 Weeks Later
 - Sudden Catastrophic 2nd Stage Rod Failure on other H2 compressor
 - Identical (carbon copy) in nature to first failure
 - Vibration Interlock System
 - Shutdown Both Compressors Within 1 Second
-

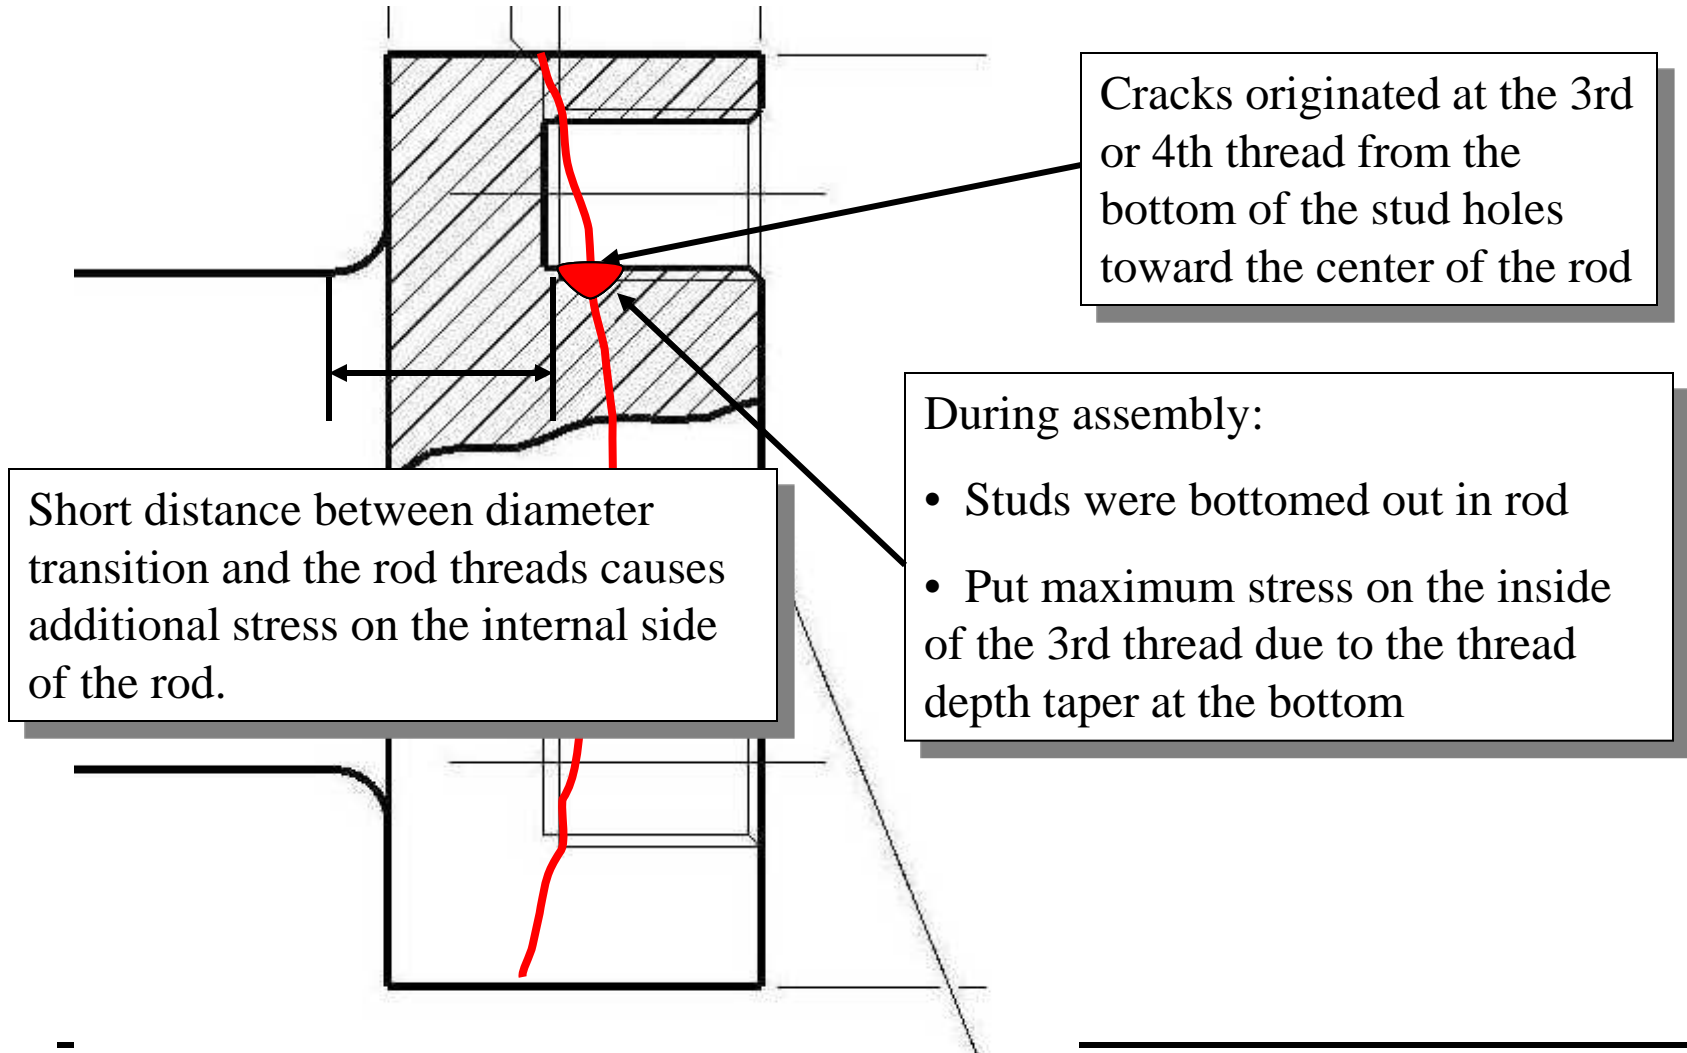
Rod Failure Analysis

- Items considered
 - Changes in process conditions
 - Rod / Piston assembly
 - Metallurgy & Rod QA
 - Length of service
 - Key Factors
 - Rod & piston installation assembly
 - Torquing threaded stud into bottom of stud holes caused excessive stress in threads
 - Rod Taper / stud hole proximity
 - Close proximity accentuated the stress level in the threads
-

- QA Check Sheet for New Rods
 - Correct metallurgy
 - Meets specifications
 - Rod & Piston Assembly Procedure
 - Detailed instructions
 - Manufacturer input to proper assembly
 - 3 Year Rod Change Out
 - Removed rods are tested and re-furbished if no wear evidence is detected
-
