TWO UNUSUAL AND CATASTROPHIC BEARING FAILURES CAUSED BY ELECTRICAL ARCING IN THE OIL FILM, THEIR CAUSES, AND THE SURPRISINGLY SIMPLE SOLUTIONS THAT CURED THEM

Jigger Jumonville

Erik Rasmussen

ABSTRACT

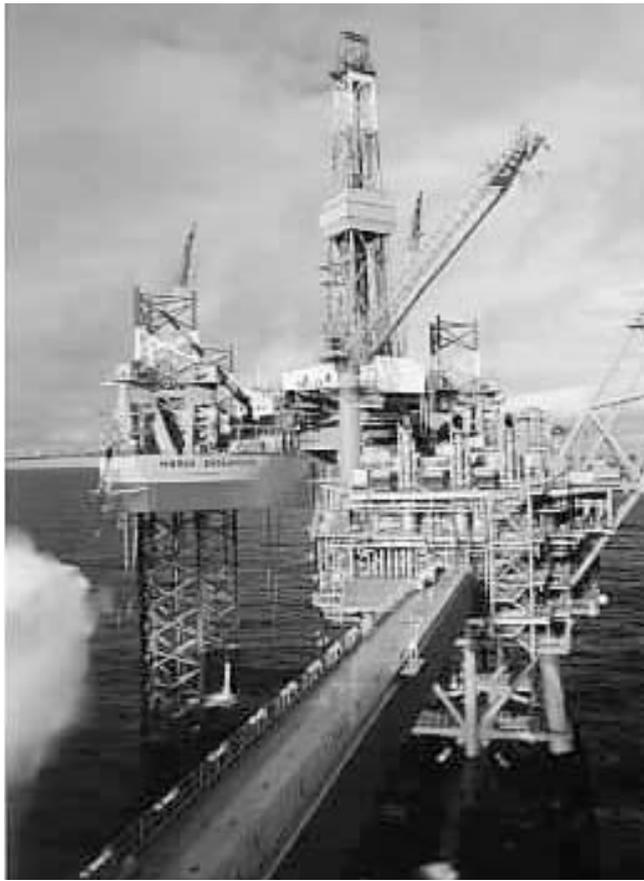
This unit is located on an offshore platform in the North Sea, as shown in Figures 7 and 8. The turboexpander is designed to produce about 3000 hp (2240 kW) at a speed of about 12,500 rpm. Very soon after startup, it was noticed that the bearings were experiencing rapid failures. Initial operating life ranged from a few weeks to a few months. All bearing failures exhibited signs of electrical arcing in the oil film. Magnified views of this arcing are shown in Figures 9, 10, and 11.

Figure 7. Offshore Platform Where Turboexpander Is Installed.

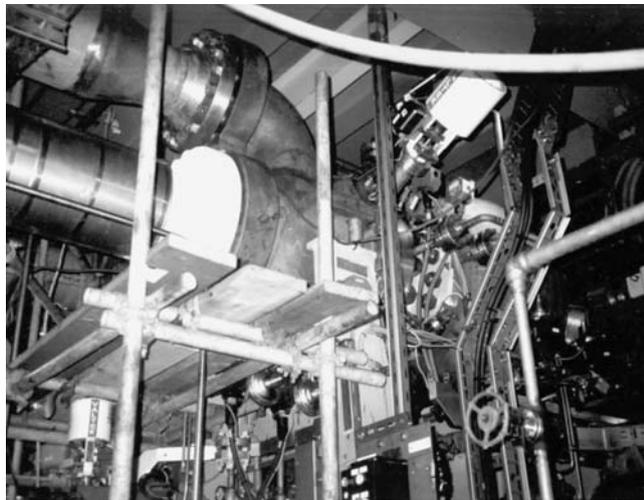
Figure 8. Turboexpander Installation Showing Tight Working Space Available on Offshore Platform.

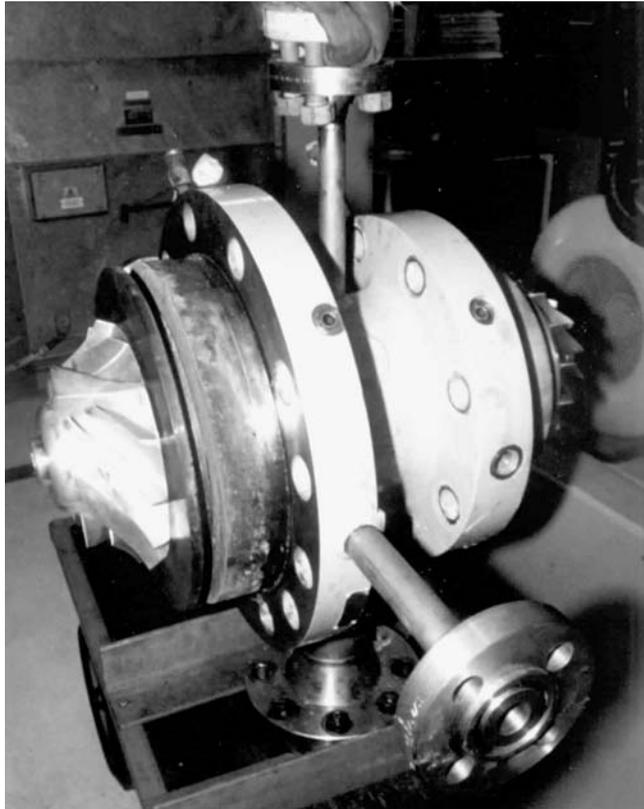
A turboexpander, in its most common form, looks quite a lot like an automotive turbocharger. On one end of a common shaft is located a radial inflow turbine, and on the other end is a centrifugal compressor. In between, the shaft diameter is increased to form a very rigid shaft, supported by fluid film bearings. Typically, the bearings and shaft run in a pressurized bearing housing that is hermetically sealed from the atmosphere outside the bearing housing. The rotating assembly for this machine is shown in Figure 12.

Figure 12. Turboexpander Rotating Assembly.

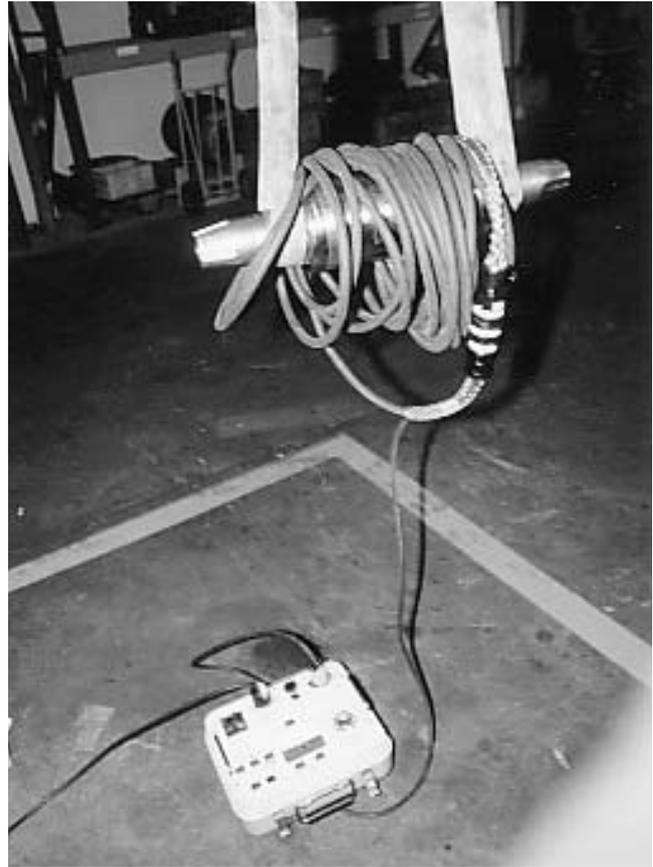
Unfortunately, the consultant found very little that could explain the failures being observed in this application. All components were checked, and any areas that seemed suspicious were degaussed to bring them to acceptable levels of magnetism. Figure 13 shows the shaft being degaussed, and Figure 14 shows the bearing housing being degaussed. The machine was put back together and restarted. Within a short time, the bearings failed again due to arcing in the oil film (Figures 15, 16, and 17).

Figure 13. Turboexpander Shaft Degaussing Setup.

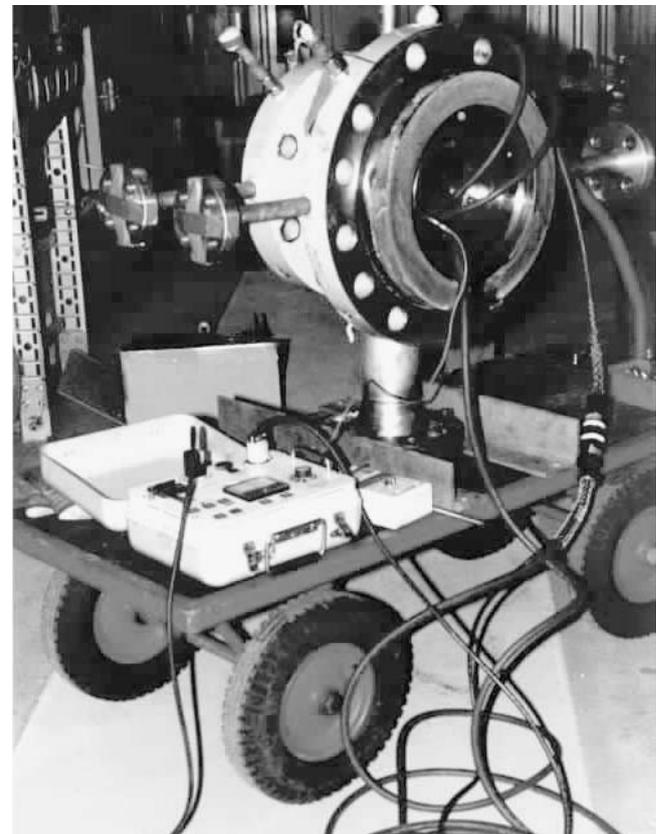
Figure 14. Turboexpander Bearing Housing Degaussing Setup.
